## Peace of Mind Automotive Inspection Report.

| Score | 4 / 4 (100%) | Flagged items | 1 | Actions | 0 |
|---|---|---|---|---|---|
| Vehicle Year / Make / Model / Color | | | | | 2015 ford f350 |
| Mileage | | | | | 197800 |

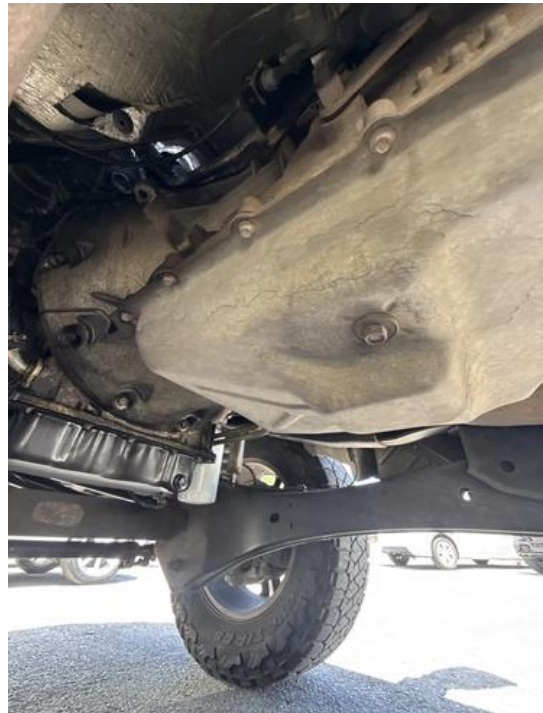
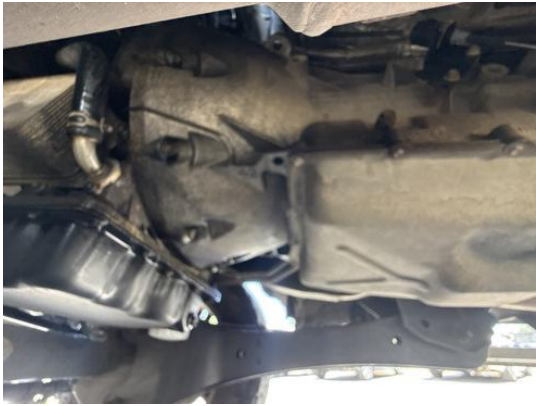
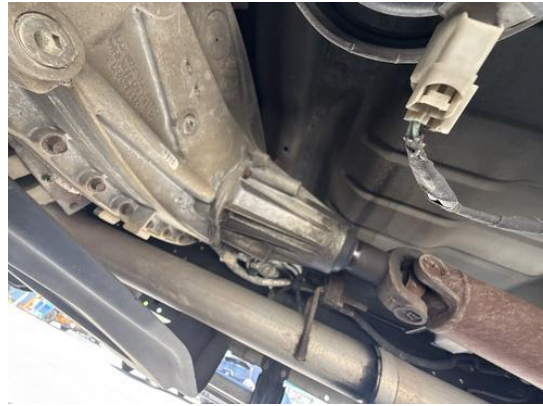
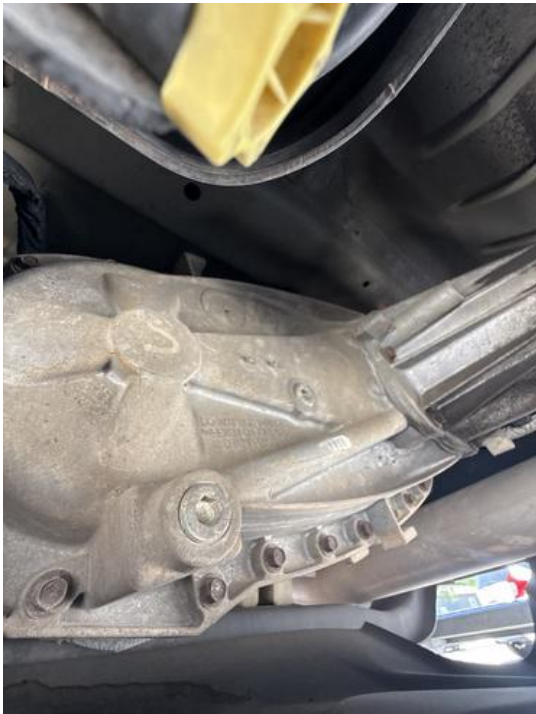
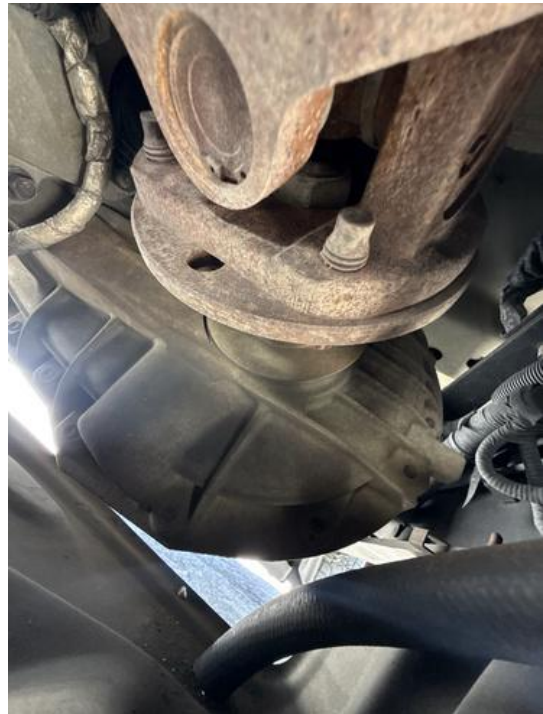
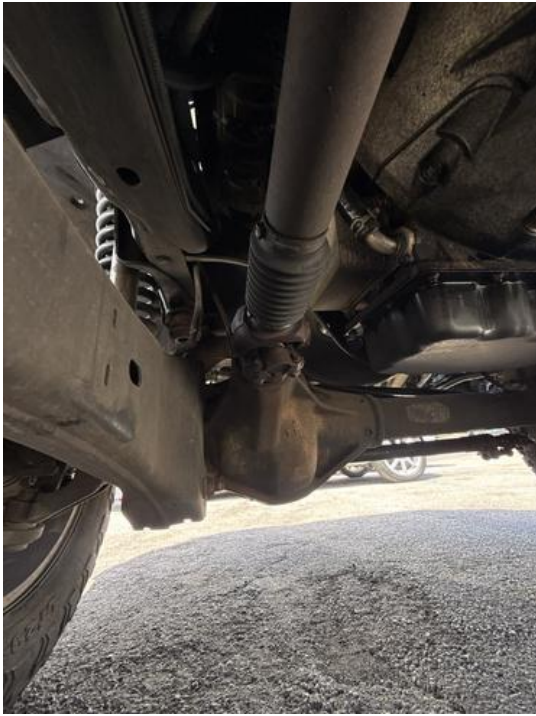
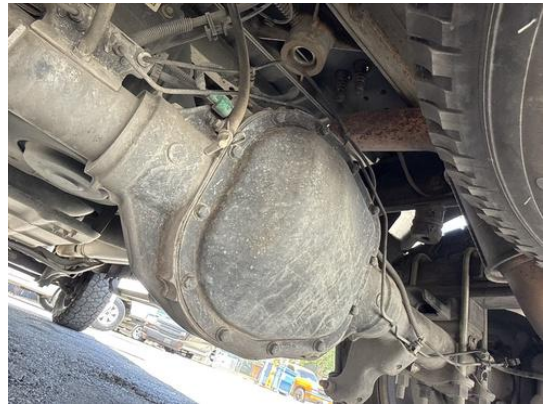
No transmission fluid leaks from the transmission casing or the transmission pan area. The tail shaft seal is free of any fluid leaks. The driveshaft is in healthy condition. Shift transitions out on the road are correct across the board. No fluid leak out from the rear differential. No fluid leak out from the front differential or the center differential. 4 x 4 system functionality is correct.

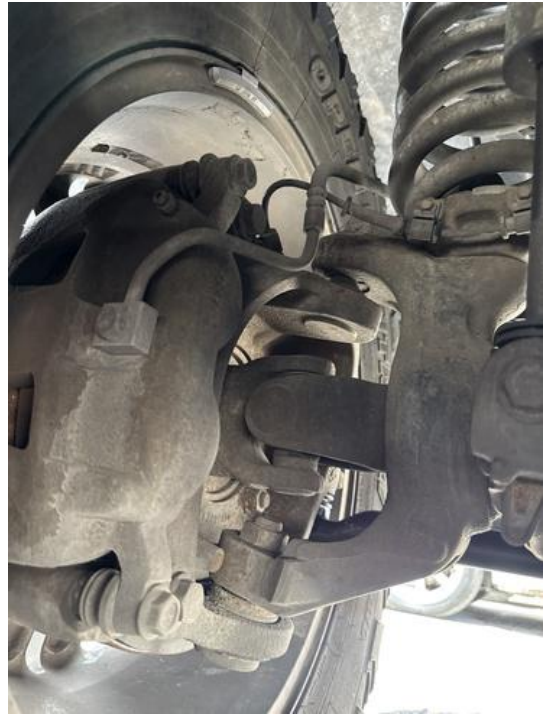
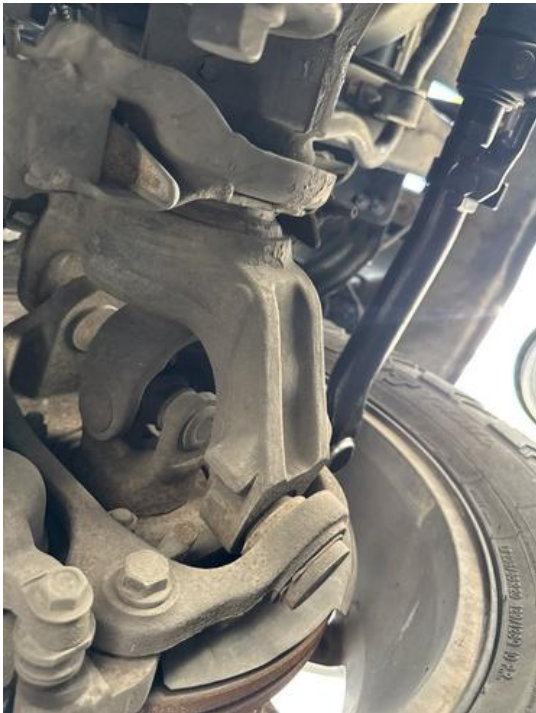
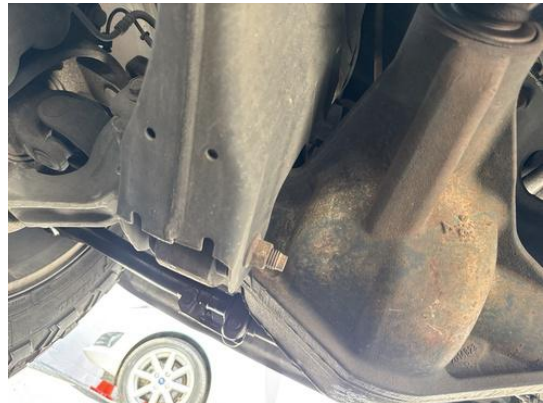
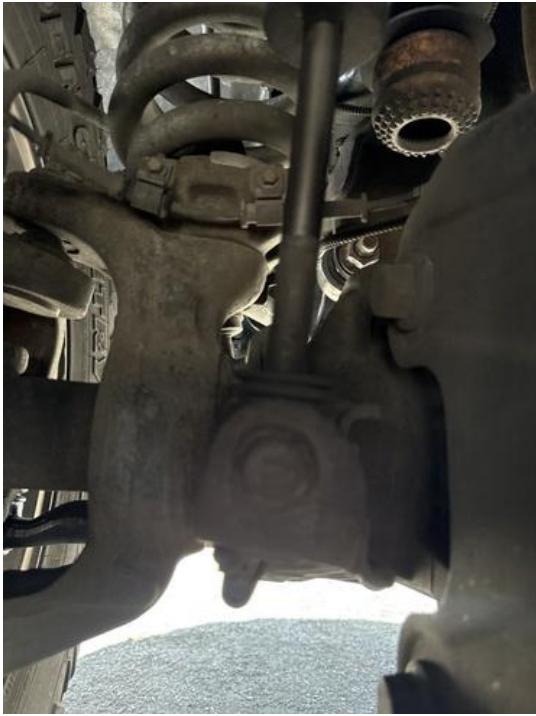
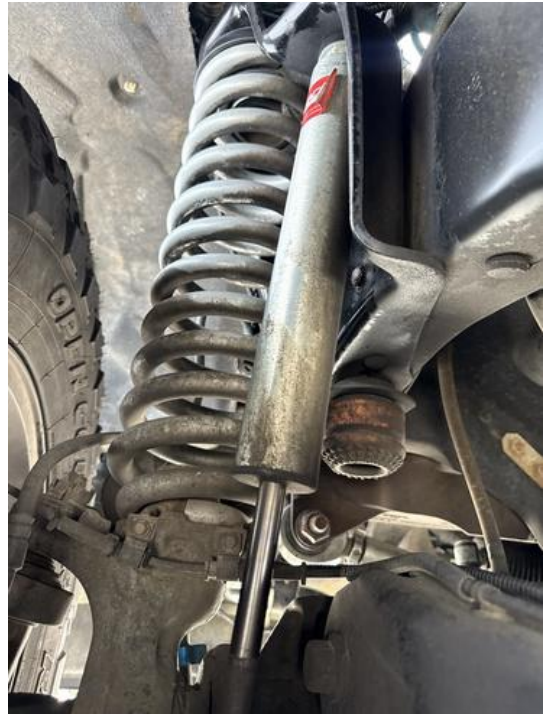
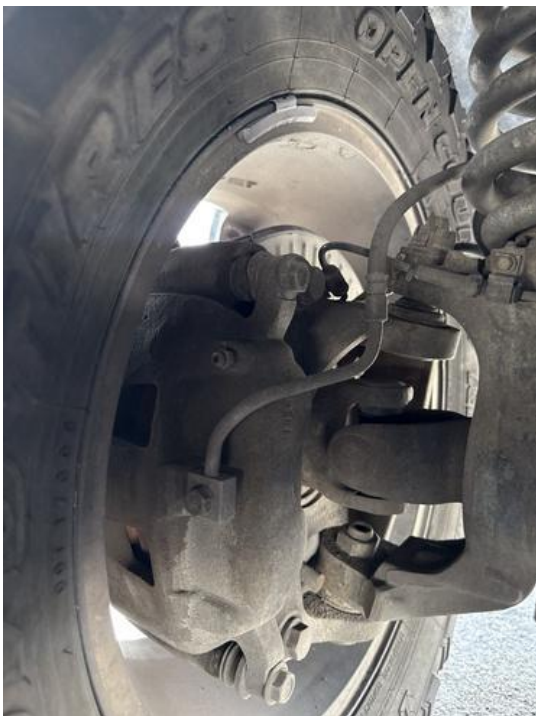
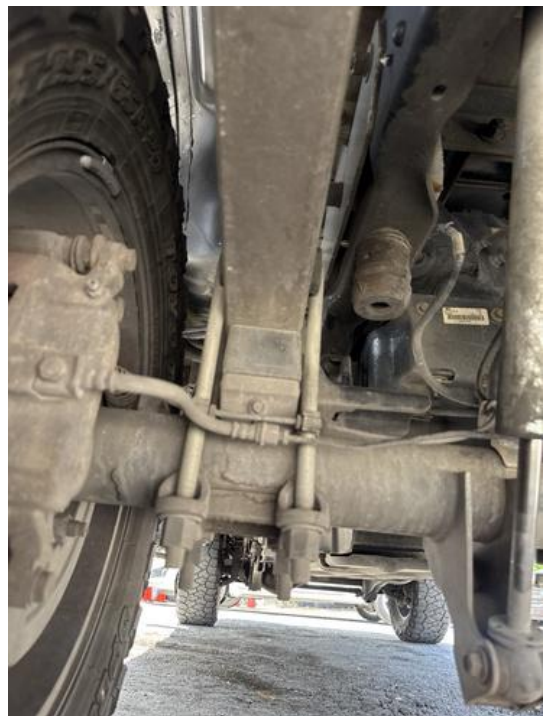
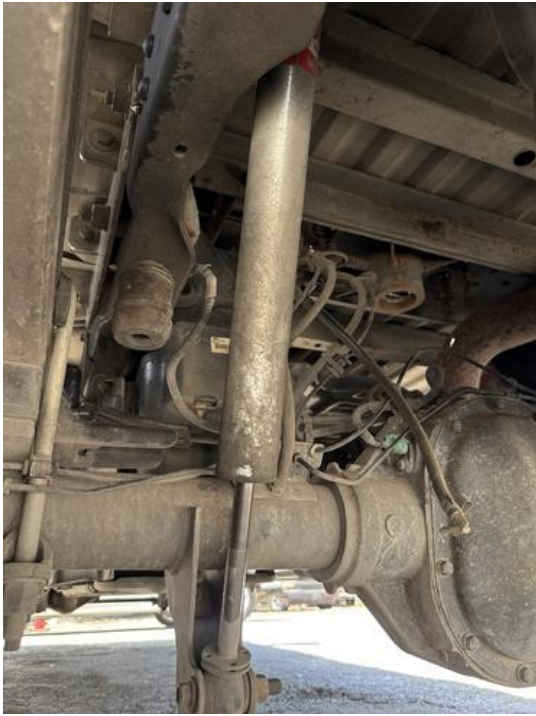
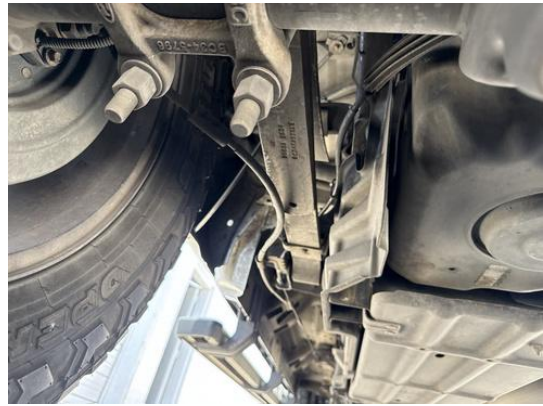
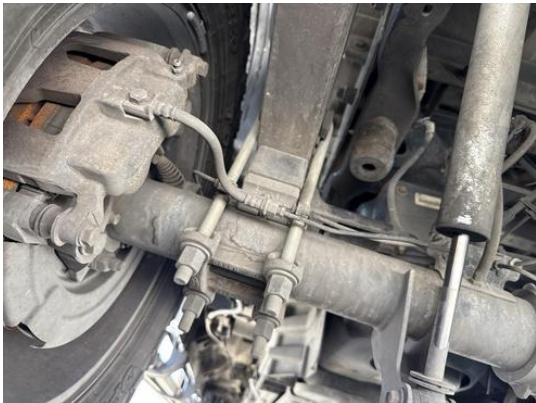
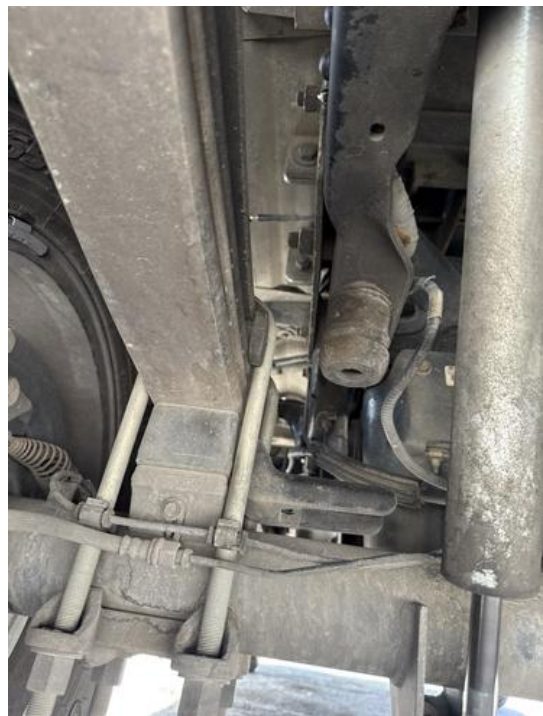
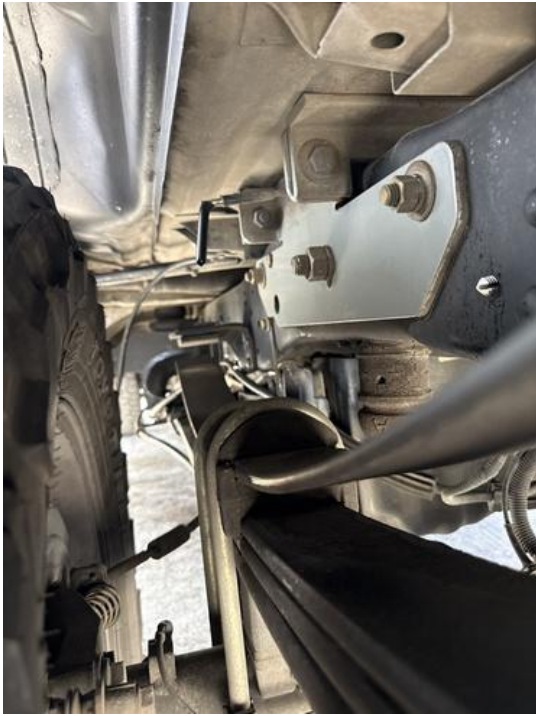
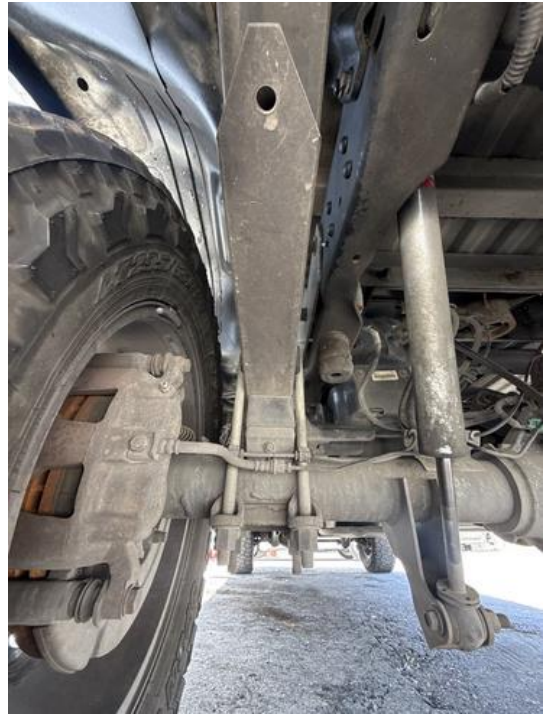
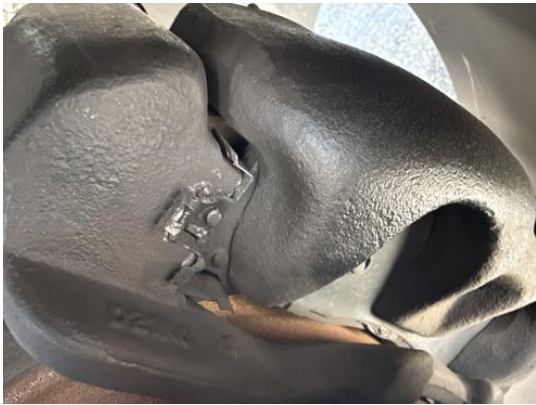
Normal fatigue notice to the suspension components. All of the suspension components seem to be original. None of the suspension components are blown out and due form the replacement. The No excessive surface rust on the exposed metal. No abnormal noise or feedback from the suspension while out on the road. All of the rubber in relation to the mounts, joints and bushings has decent texture.
