# Peace of Mind Automotive Inspection Report.

Score	4 / 4 (100%)	Flagged items	0	Actions	0
<b>Site conducted</b>					Unanswered
<b>Customer name</b>					Lmj auto motor sales
<b>Date / Time</b>					May 19th
<b>Payment method</b>					Invoice
<b>Inspection cost</b>					199
<b>Vehicle Year / Make / Model / Color</b>					Honda accord 2015
<b>VIN</b>					12414 last 5

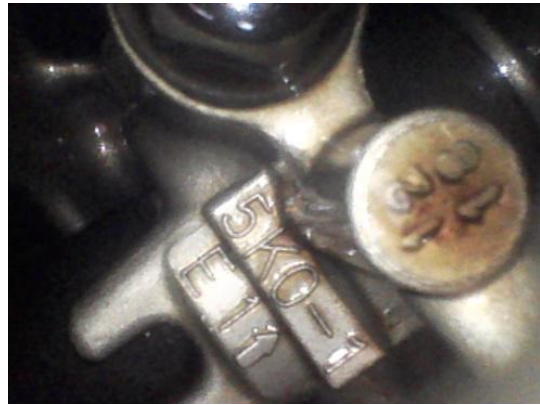
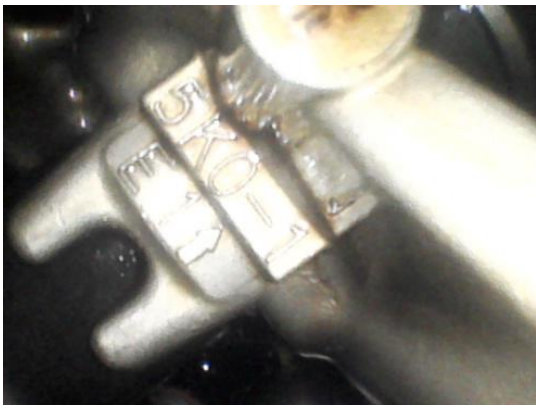
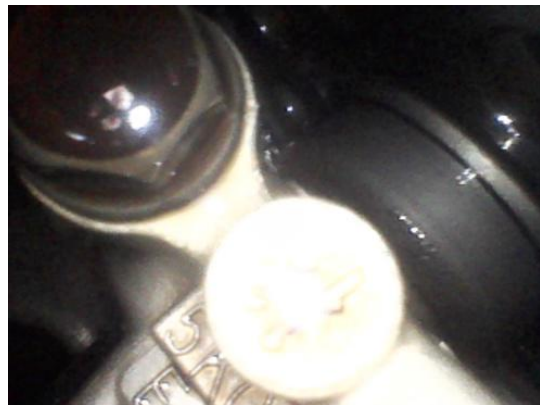
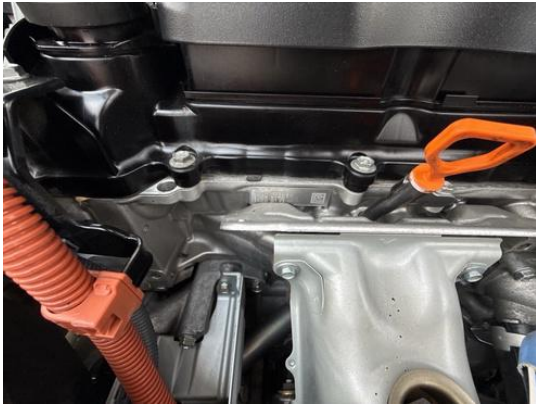
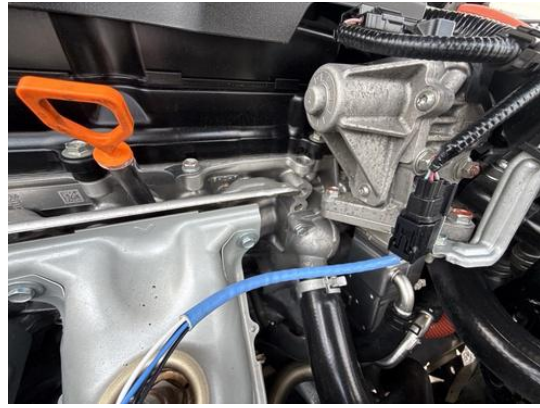
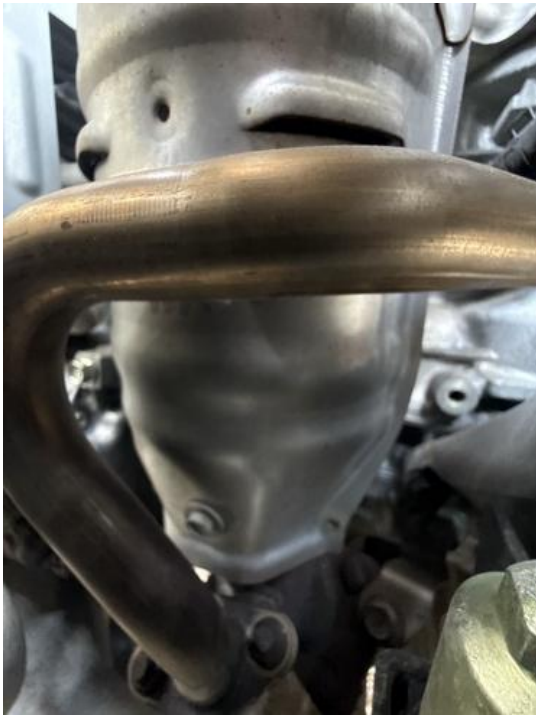
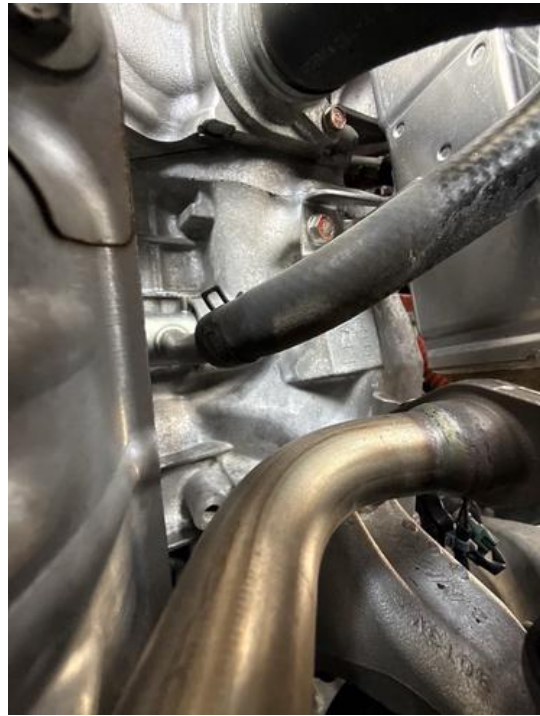
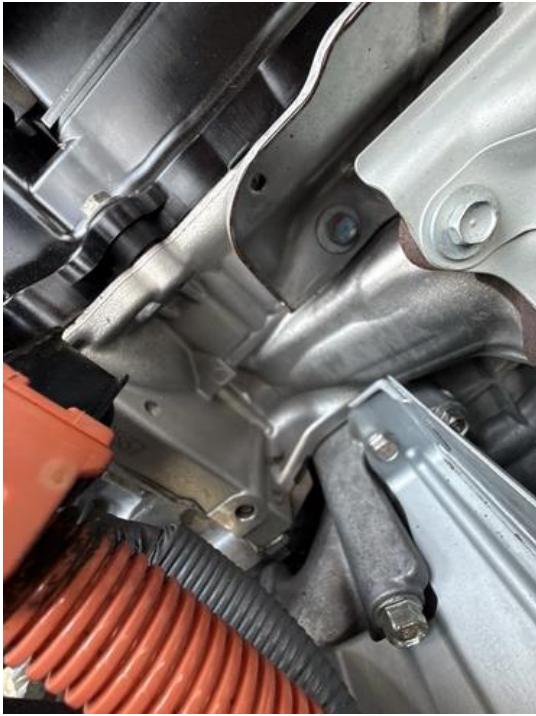
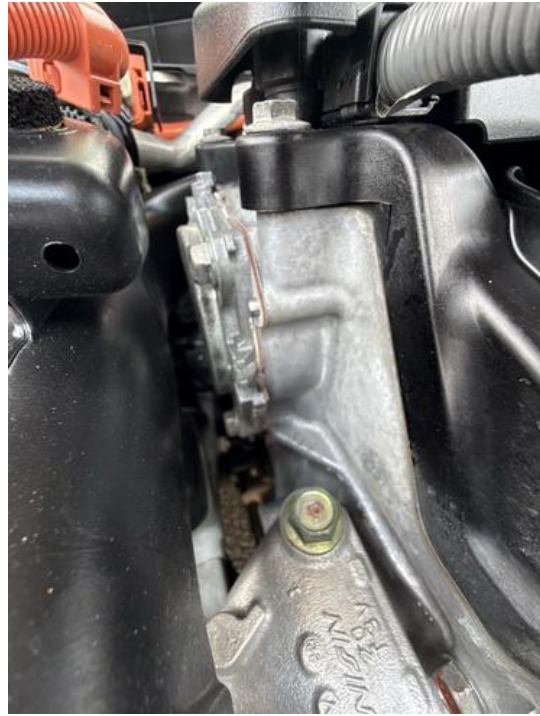
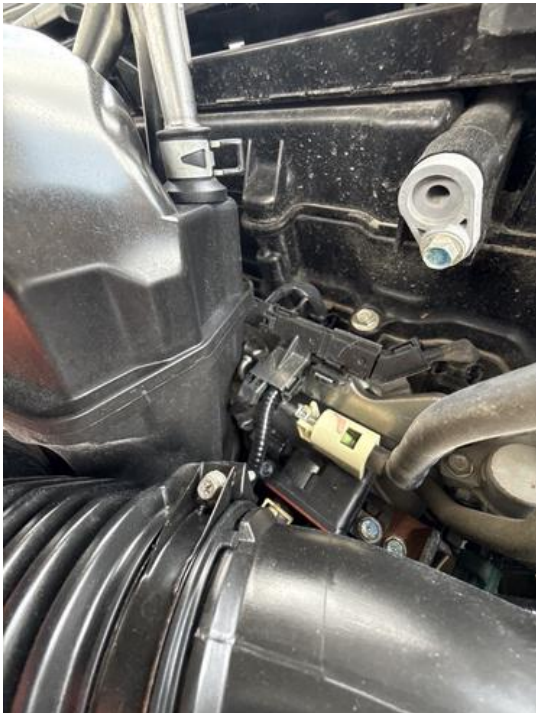
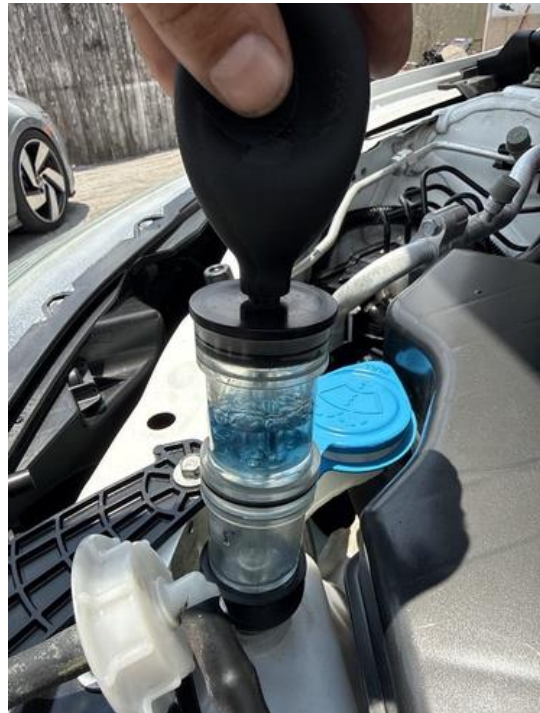
Engine clean internally, no gunk or sludge presents. Proper signs of maintenance present. Block test passed, no internal combustion leak out. Coolant mixture correct and cooling system functionality is healthy. All external engine accessories in good working. No leaks or seepage from anywhere on the engine. External drive belts in decent condition. Currently no concern in mechanical issues present in relation to the engine or related accessories.

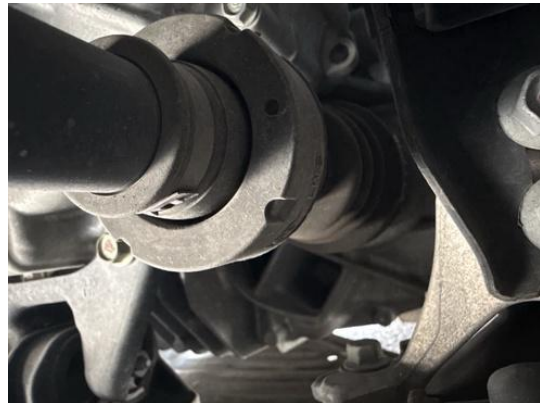
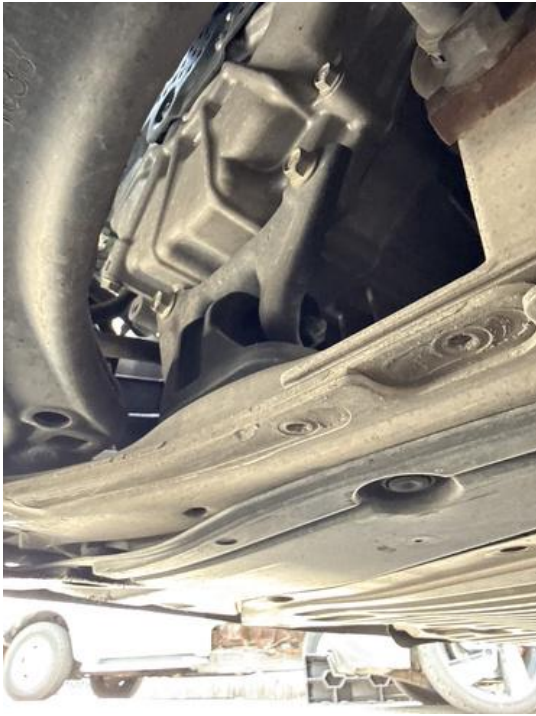
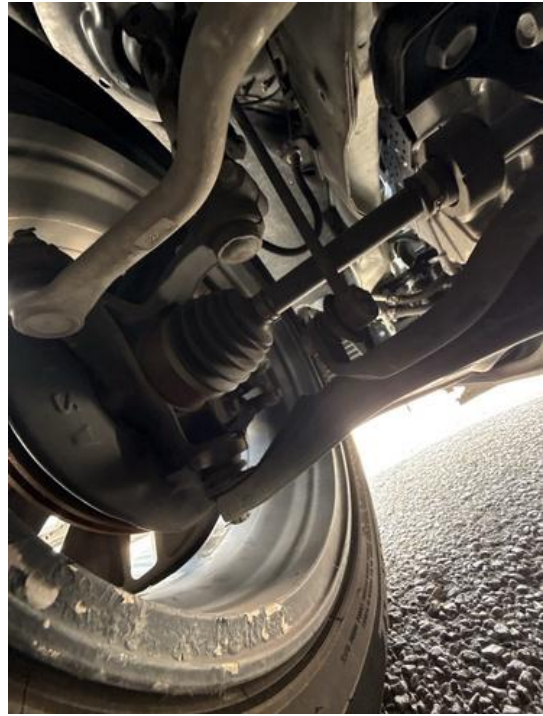
Transmission / Differentials		
Transmission fluid level	Healthy	
Transmission fluid condition	Healthy	
Transmission fluid leaks	None	
<p>No transmission fluid leaks from the transmission casing. The left and right side axle seals are free of any fluid leaks. Both left and right side CV axle are in healthy condition. Shift transitions out on the road are correct.</p>

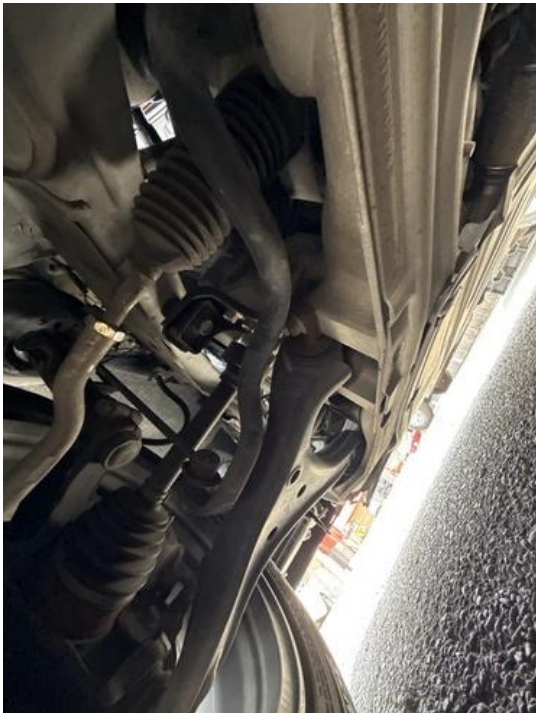
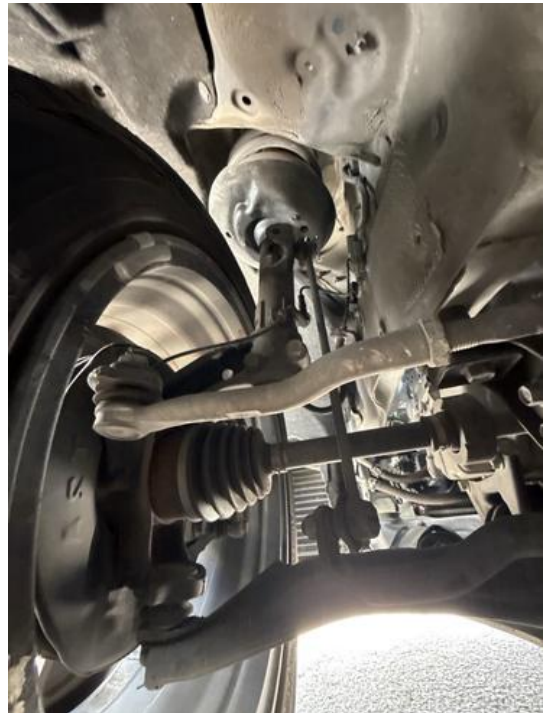
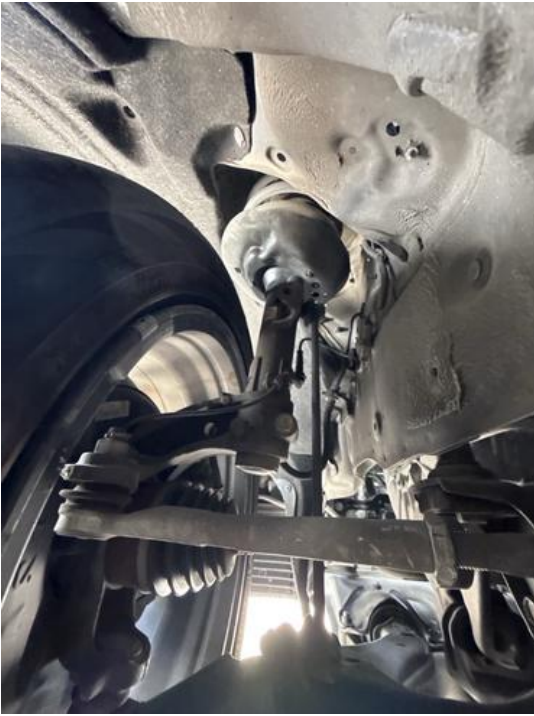
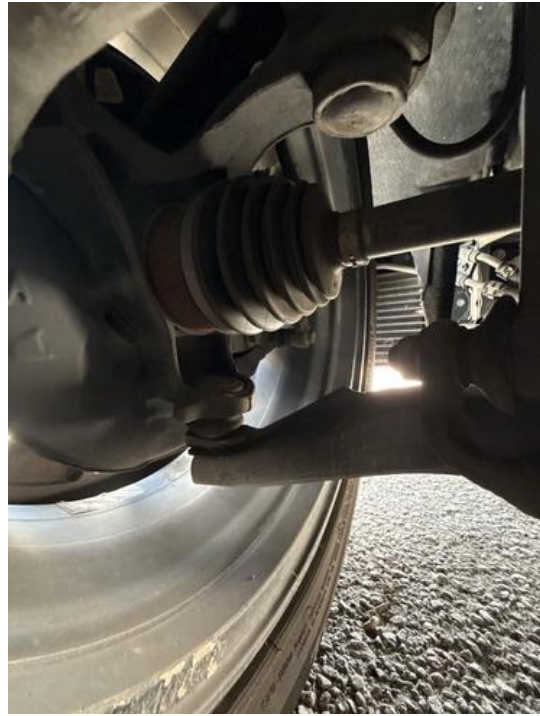
Normal fatigue notice to the suspension components. All of the suspension components seem to be original. None of the suspension components are blown out and due form the replacement. The No excessive surface rust on the exposed metal. No abnormal noise or feedback from the suspension while out on the road. All of the rubber in relation to the mounts, joints and bushings has decent texture.

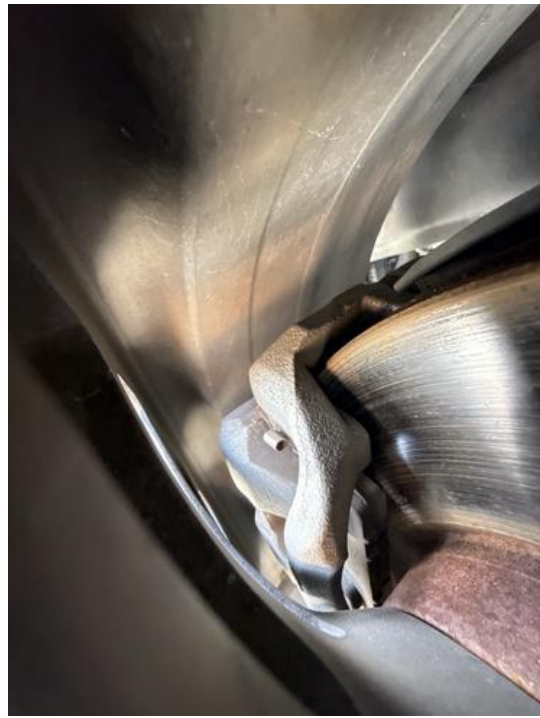
Photo 143

<b>Braking system condition</b>	
<b>Brake fluid condition</b>	Healthy
<b>Brake fluid level</b>	Healthy
<b>Brake fluid leaks</b>	None
<b>Moisture content in brake fluid</b>	None
<b>Brake lines</b>	Healthy
<b>Brake calipers front</b>	Healthy
<b>Brake calipers rear</b>	Healthy
<b>Brake drums rear</b>	N/A
<b>Brake rotors front</b>	Healthy
<b>Brake rotors rear</b>	Healthy
<b>Front brake pad life remaining</b>	75-100% remaining
<p>About 75% brake pad life remain remaining on both the front and rear brake system.</p> <div style="display: flex; justify-content: space-around;"> <div style="text-align: center;">
