## Peace of Mind Automotive Inspection Report.

| Score | 4 / 4 (100%) | Flagged items | 0 | Actions | 0 |
|---|---|---|---|---|---|
| Vehicle Year / Make / Model / Color | | | | | 2015 Lexus RX350 |
| VIN | | | | | 84895 last 5 |

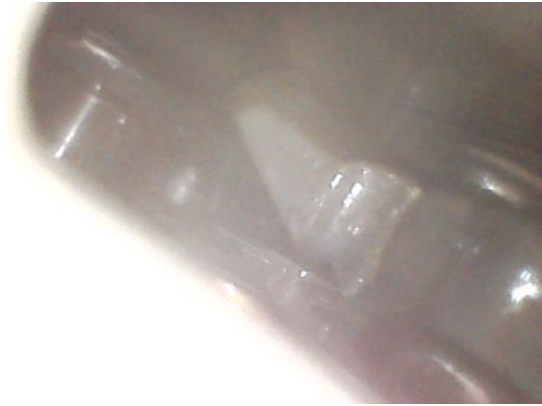
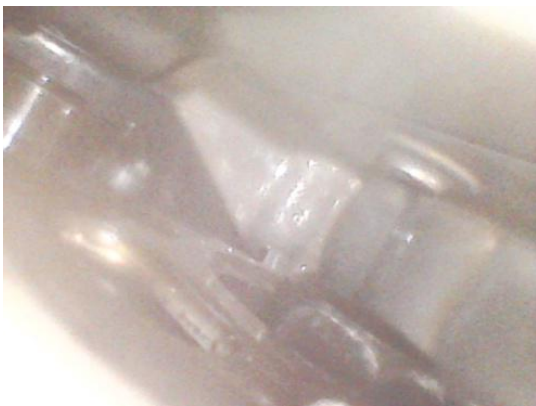
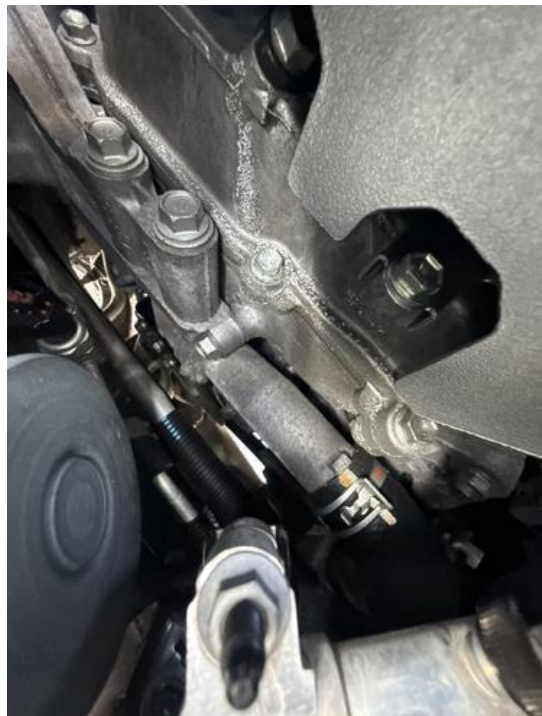
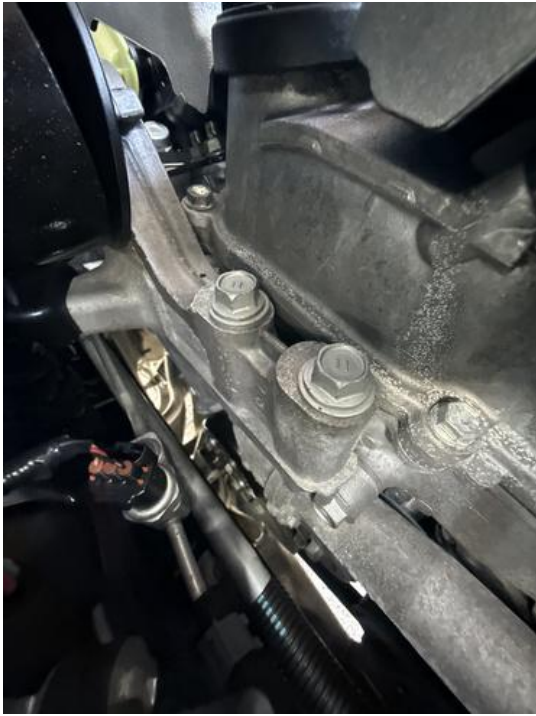
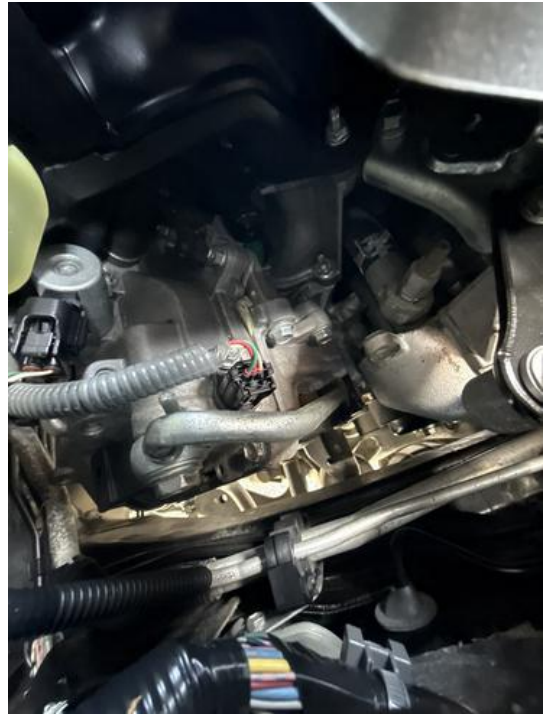
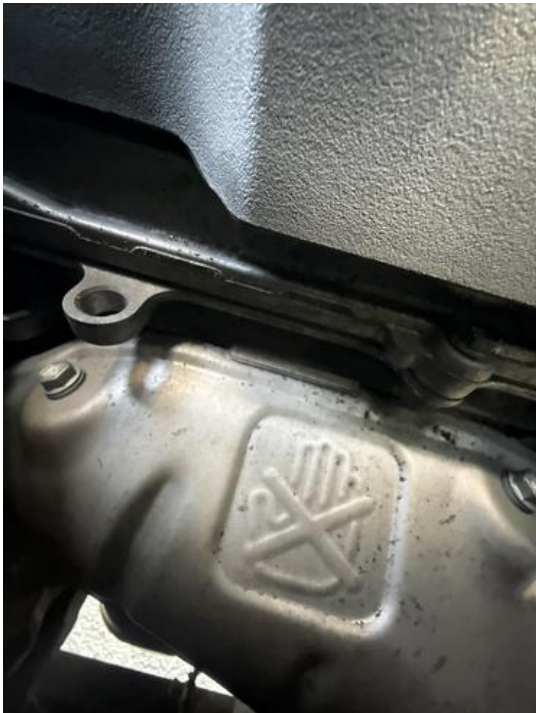
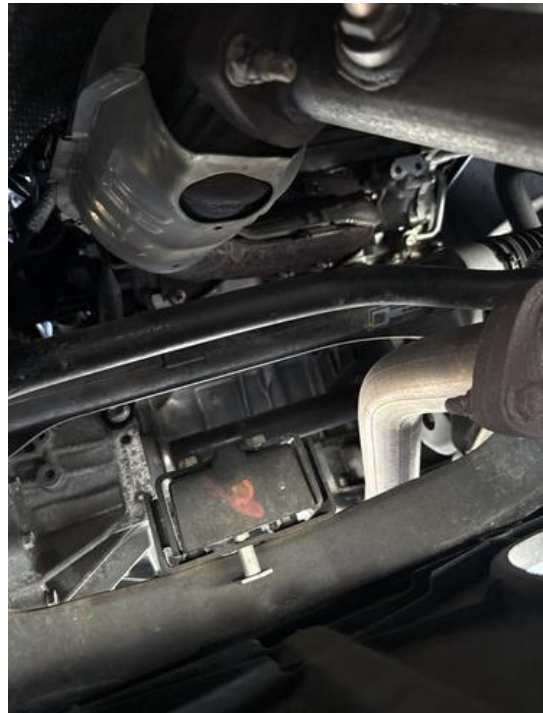
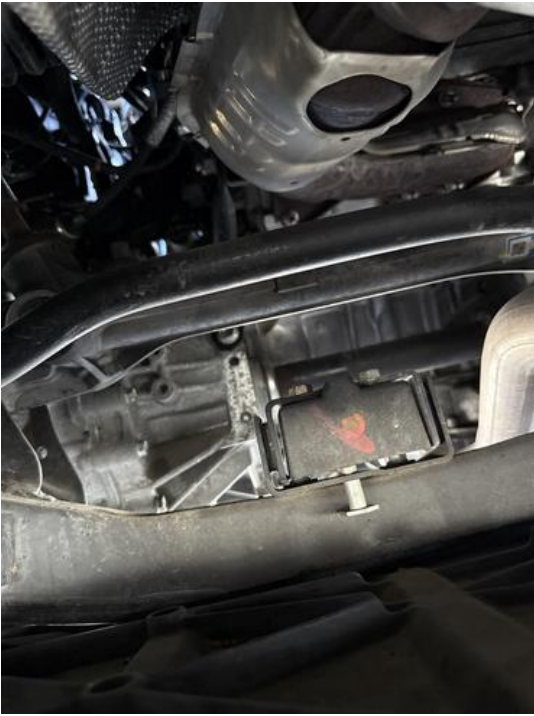
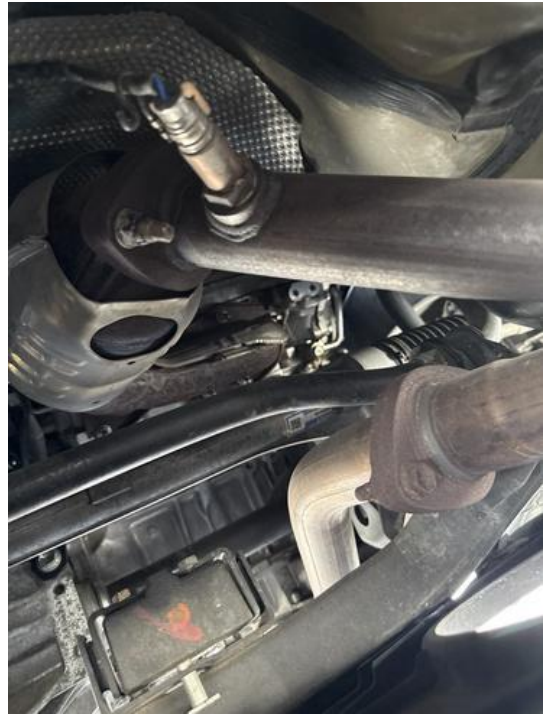
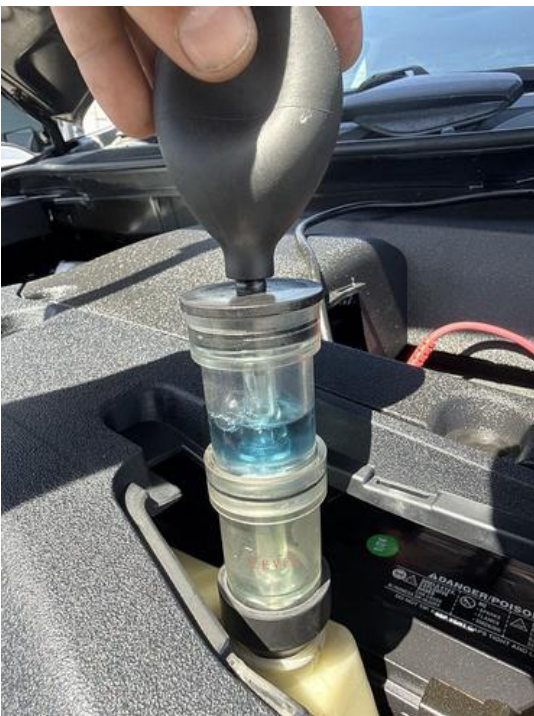
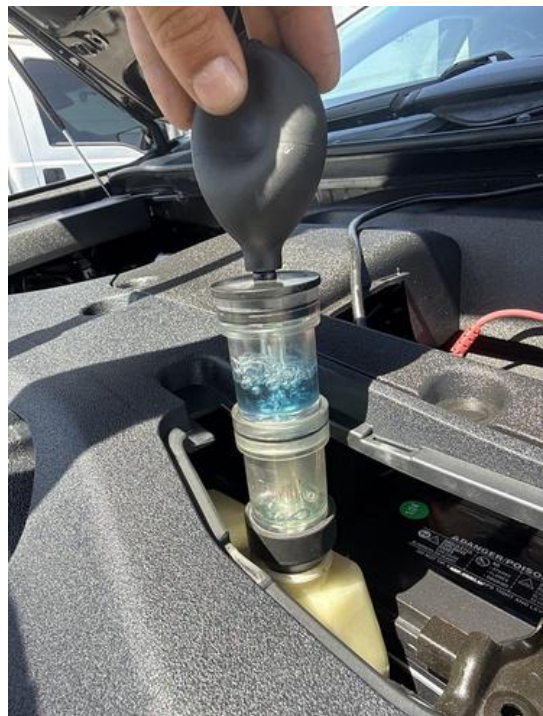
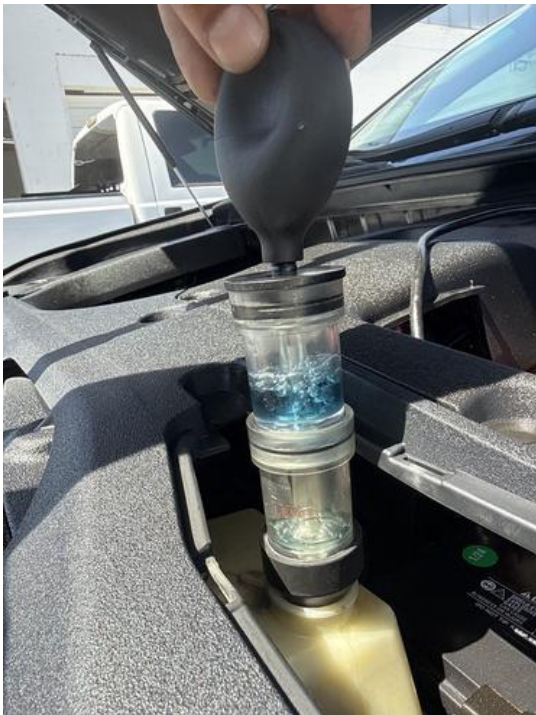
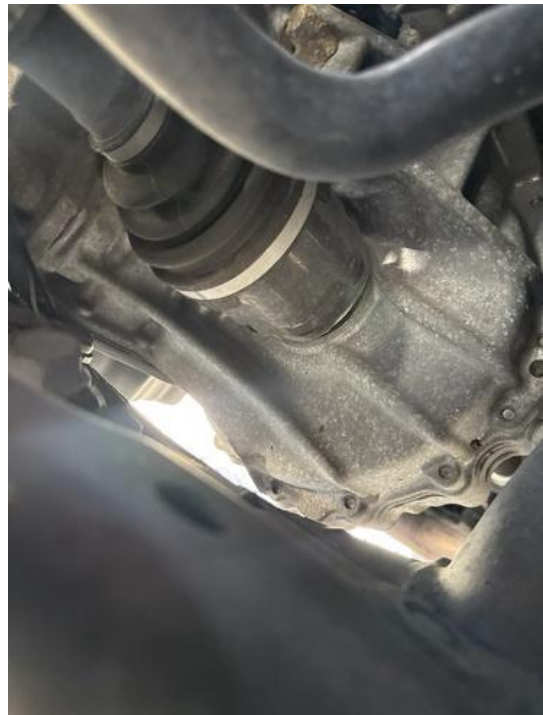
Engine clean internally, no gunk or sludge presents. Proper signs of maintenance present. Block test passed, no internal combustion leak out. Coolant mixture correct and cooling system functionality is healthy. All external engine accessories in good working. No leaks or seepage from anywhere on the engine. External drive belts in decent condition. Currently no concern in mechanical issues present in relation to the engine or related accessories.

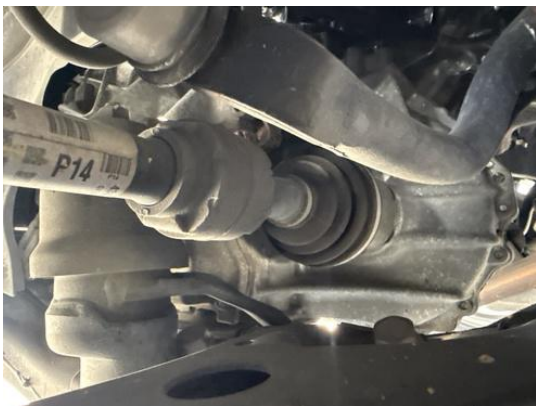
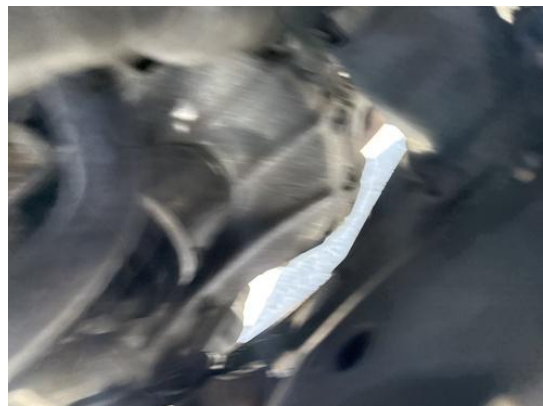
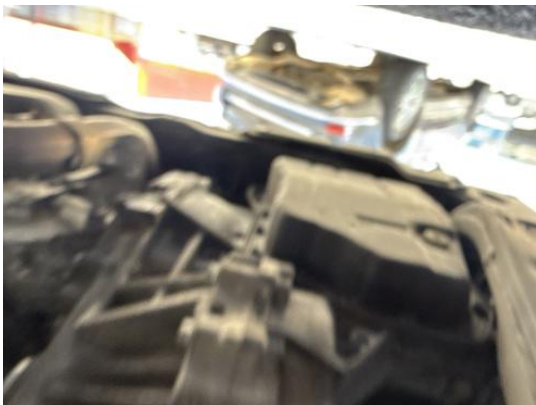
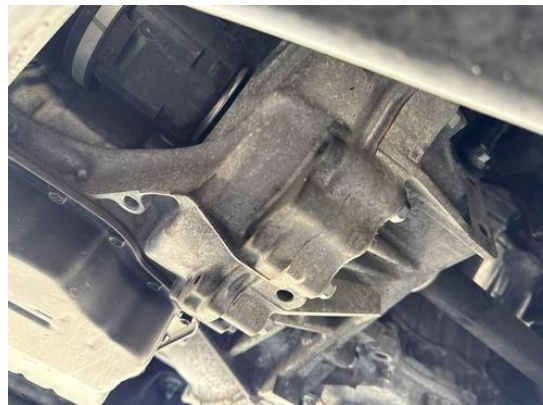
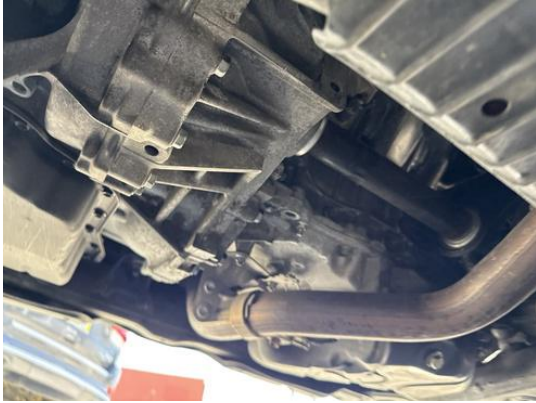
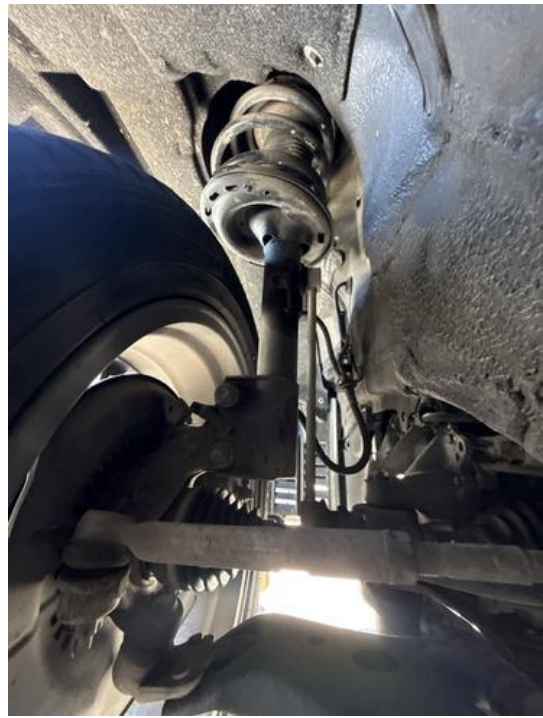
No transmission fluid leaks from the transmission casing or the transmission pan. Both left and right side axle seals are free of any fluid leaks. Both left and right side CV axle are in healthy condition. Shift transition out on the road is correct.

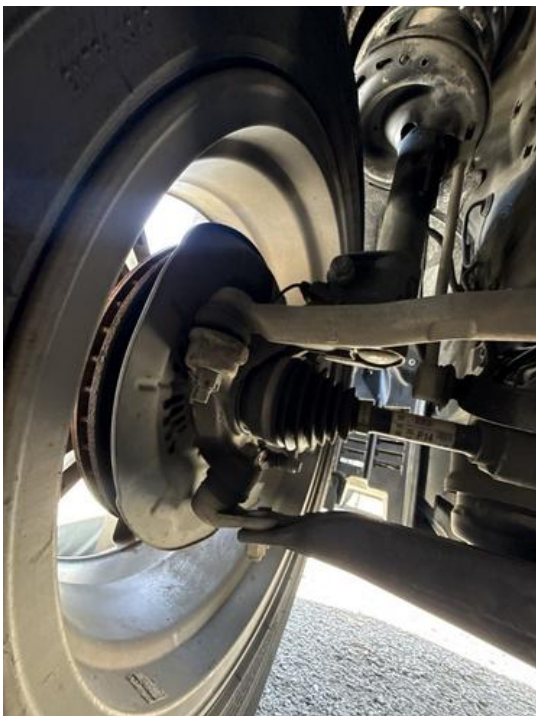
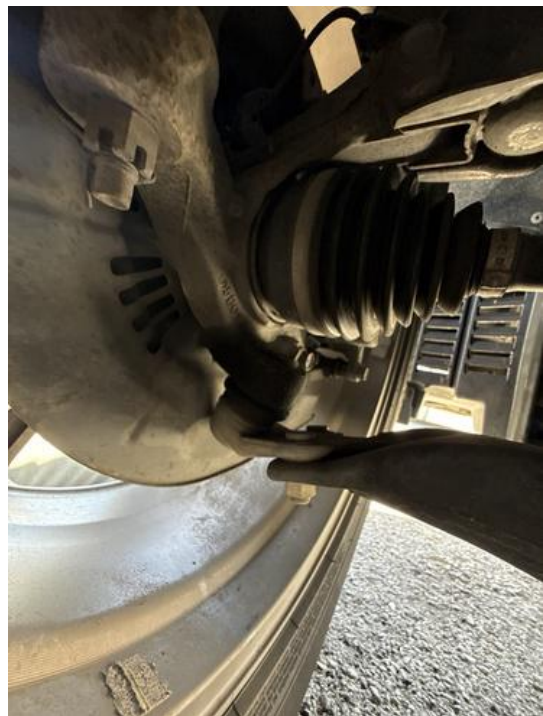
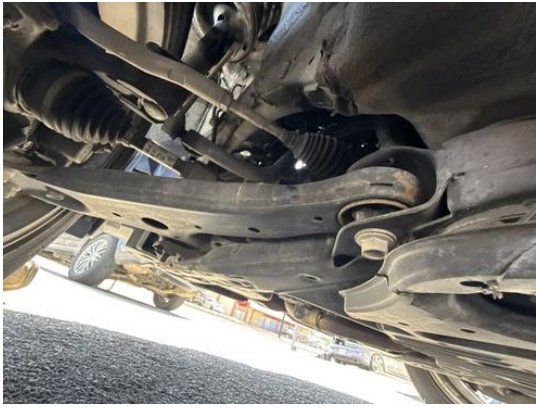
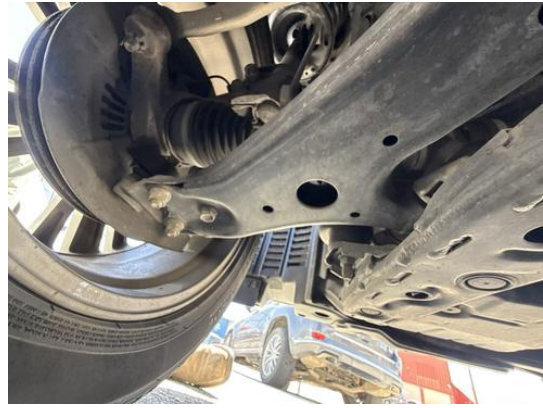
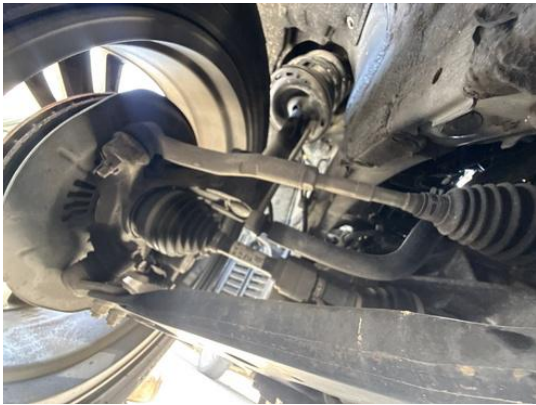
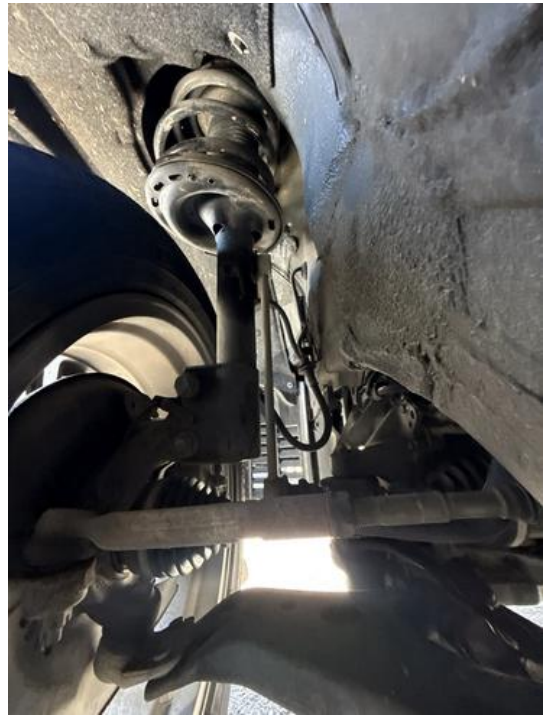
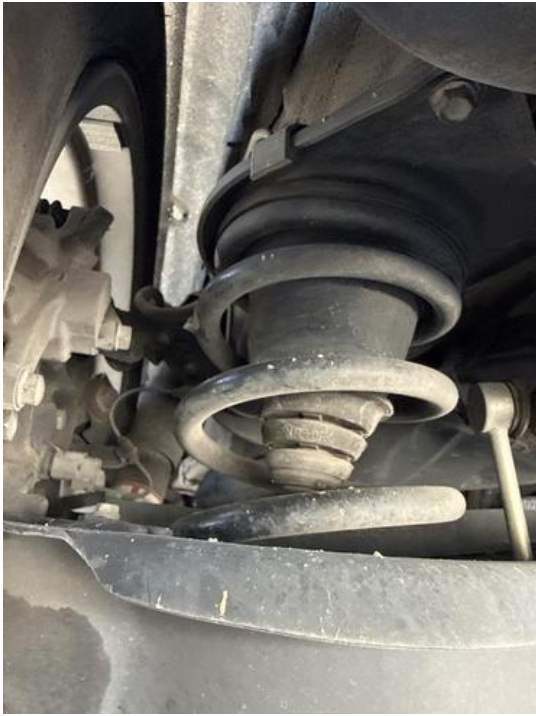
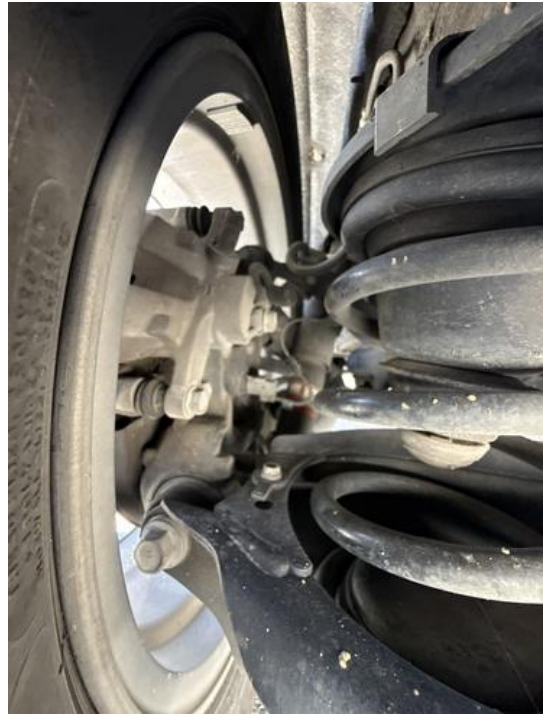
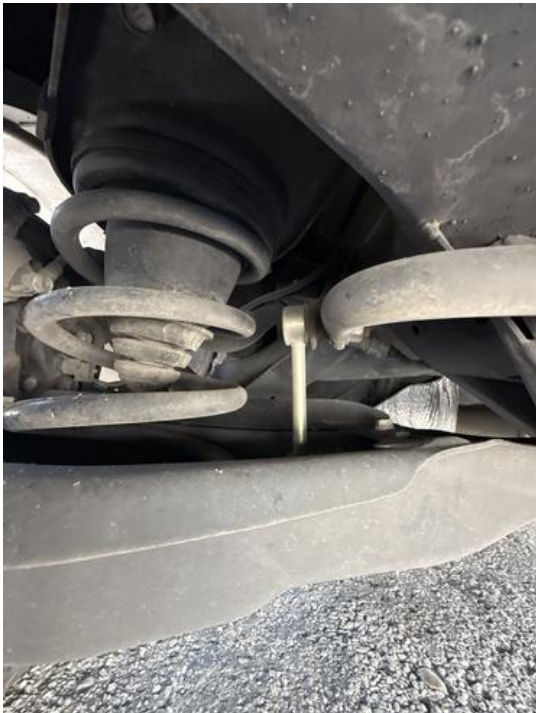
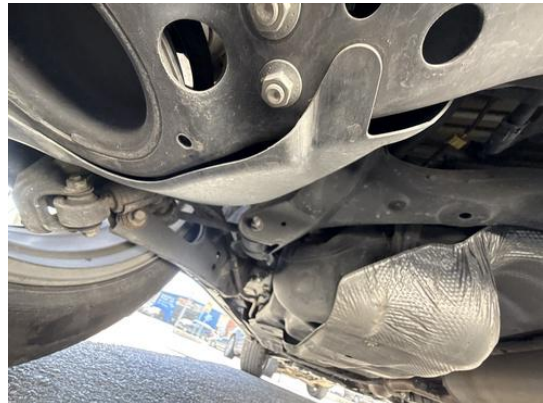
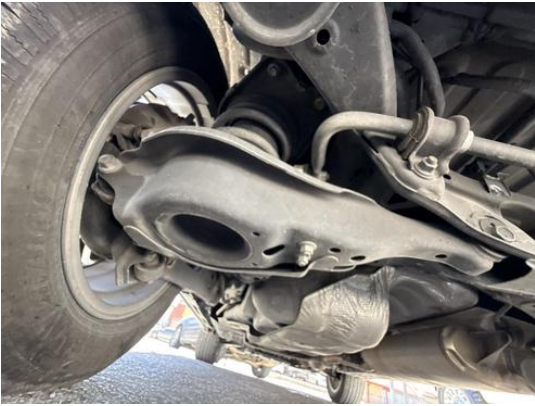
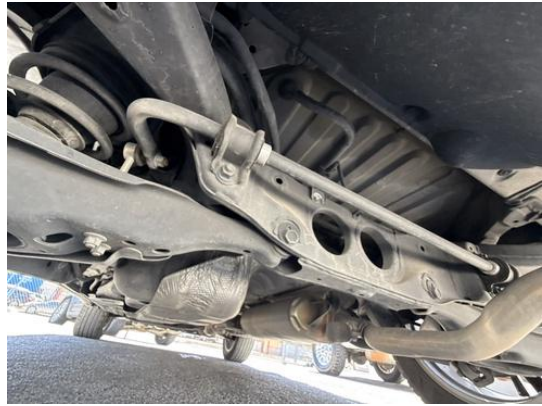
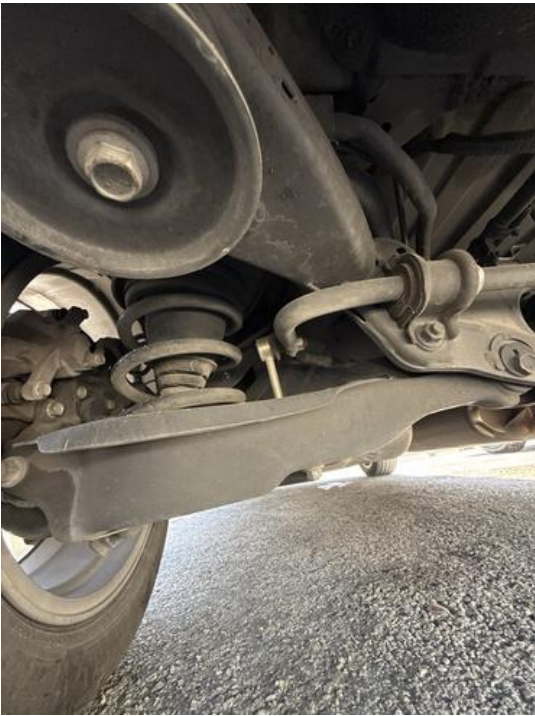
Normal fatigue notice to the suspension components. All of the suspension components seem to be original. None of the suspension components are blown out and due form the replacement. The No excessive surface rust on the exposed metal. No abnormal noise or feedback from the suspension while out on the road. All of the rubber in relation to the mounts, joints and bushings has decent texture.
