# Peace of Mind Automotive Inspection Report.

Score	4 / 4 (100%)	Flagged items	0	Actions	0
<b>Site conducted</b>					Unanswered
<b>Customer name</b>					Lmj auto motor sales
<b>Date / Time</b>					May 18th
<b>Payment method</b>					Invoice
<b>Inspection cost</b>					Fleet account
<b>Vehicle Year / Make / Model / Color</b>					2015 Lexus RX
<b>VIN</b>					55719 last 5

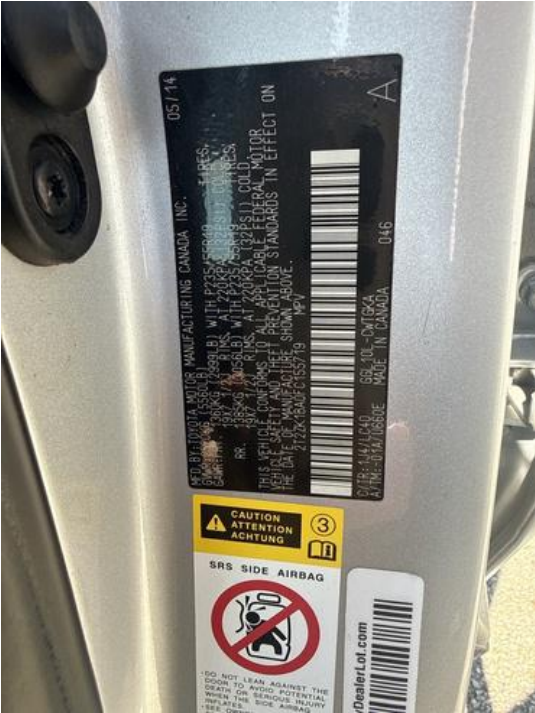
Photo 1					
<b>license plate</b>					Dealer
<b>Mileage</b>					158264
<b>Color</b>					Silver

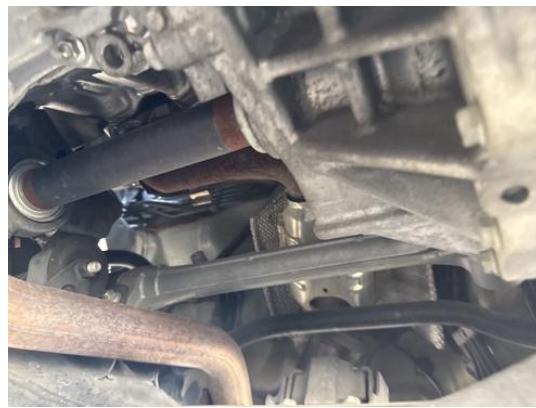
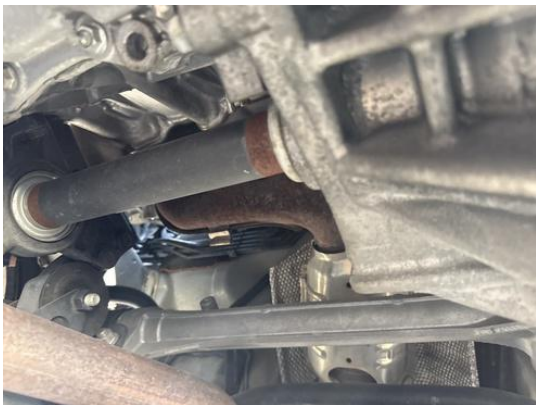
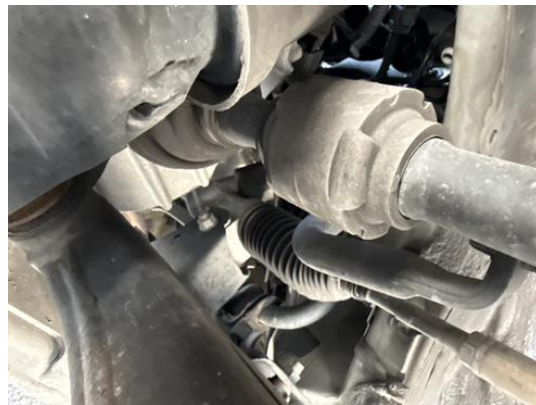
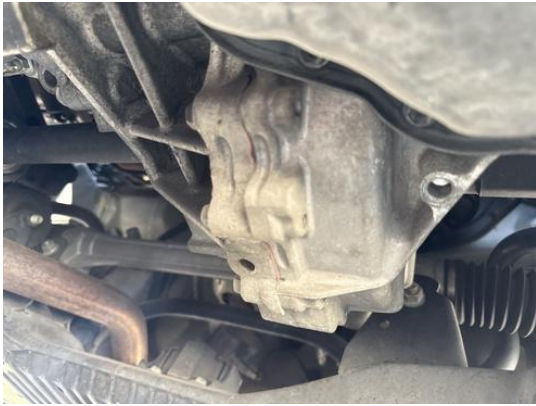
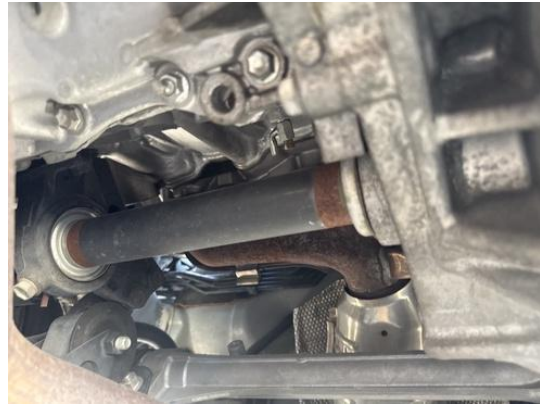
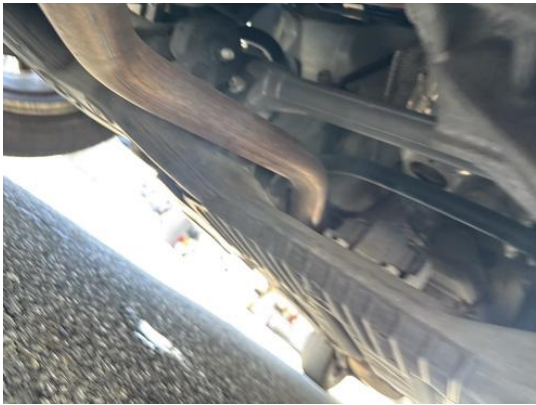
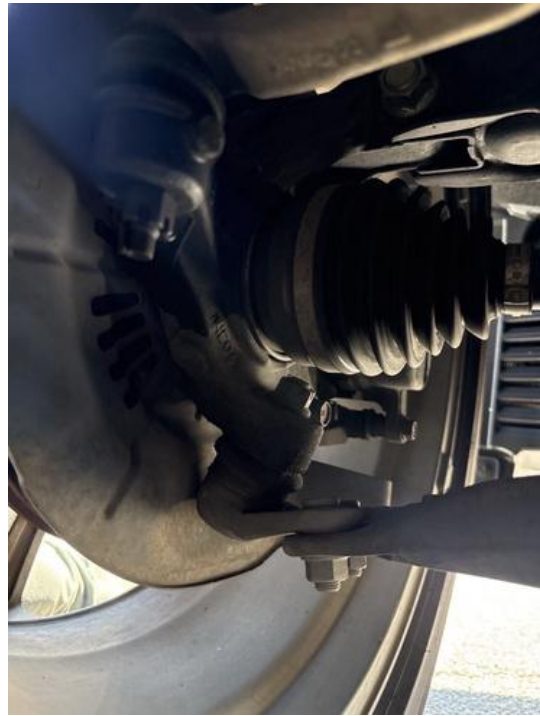
No transmission fluid leaks from the transmission casing. Both left and right side CV axle are in healthy condition. No trans fluid leak out from either of the axle seals. Shift transitions are correct out on the road.

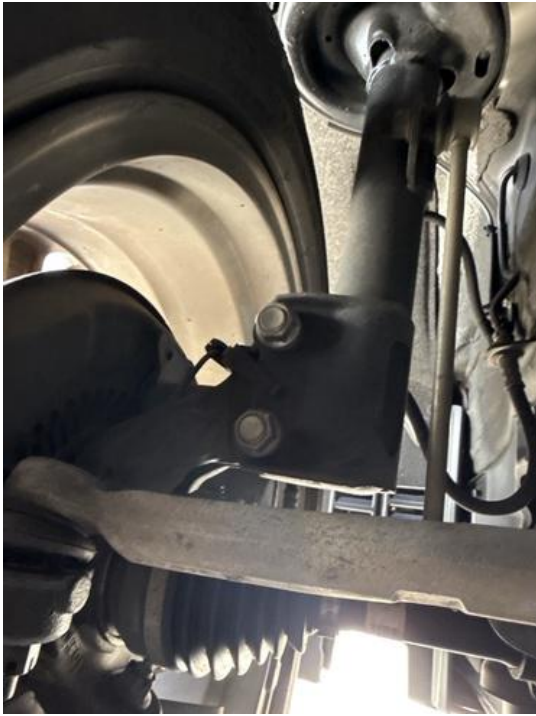
Photo 168

Normal fatigue notice to the suspension components. All of the suspension components seem to be original. None of the suspension components are blown out and due form the replacement. The No excessive surface rust on the exposed metal. No abnormal noise or feedback from the suspension while out on the road. All of the rubber in relation to the mounts, joints and bushings has decent texture.

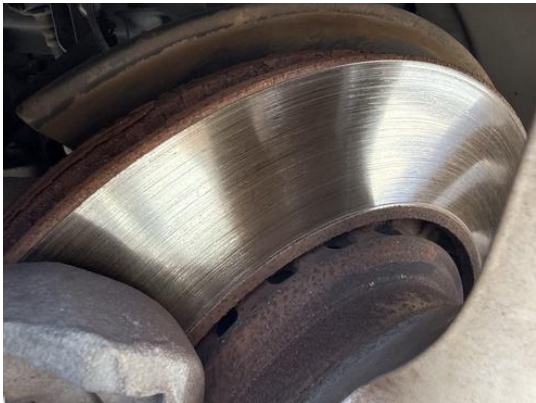
Photo 184

Braking system condition	
Brake fluid condition	Healthy
Brake fluid level	Healthy
Brake fluid leaks	None
Moisture content in brake fluid	None
Brake lines	Healthy
Brake calipers front	Healthy
Brake calipers rear	Healthy
Brake drums rear	N/A
Brake rotors front	Healthy
<p>Very subtle pulse noticed in the brakes when braking from high speeds the front brake pads were likely replaced without the front brake rotors being resurfaced</p>	
Brake rotors rear	Healthy
Front brake pad life remaining	50-75% remaining
<p>Right around 60% brake pad life remaining</p>	
<div style="display: flex; justify-content: space-around;"> <div style="text-align: center;">
