Peace of Mind Automotive Inspection Report.

Site conducted	Unanswered
Customer name	Luis LMJ auto motor sales
Date / Time	Jan 21st
Payment method	Invoice
Inspection cost	199
Vehicle Year / Make / Model / Color	2016 Honda civic
VIN	11871 last 5

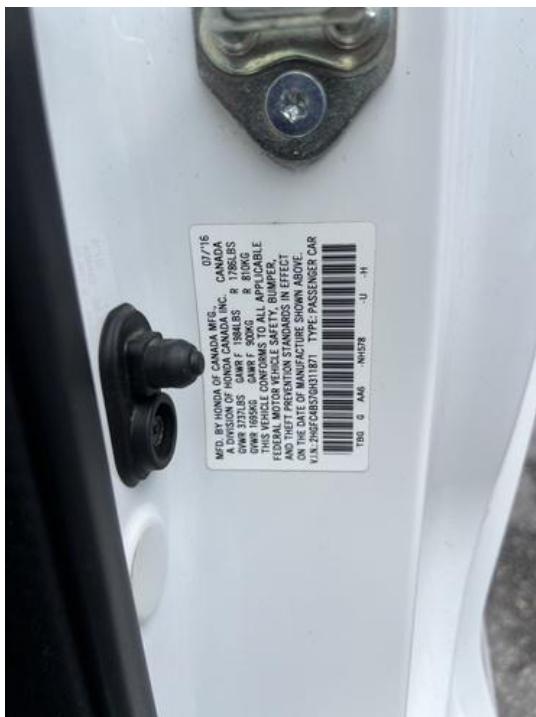
Photo 1	
license plate	Dealer
Mileage	127690
Color	White

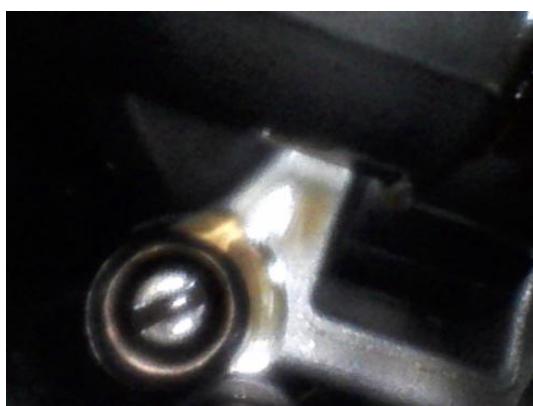
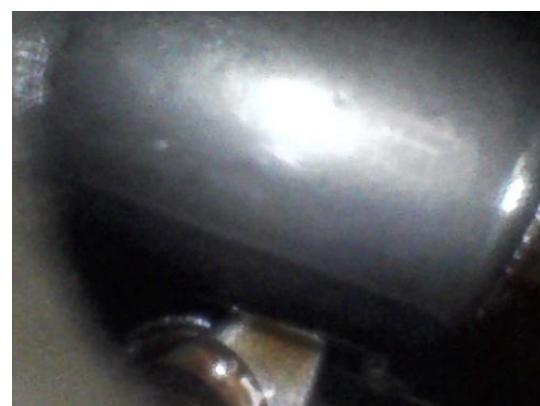
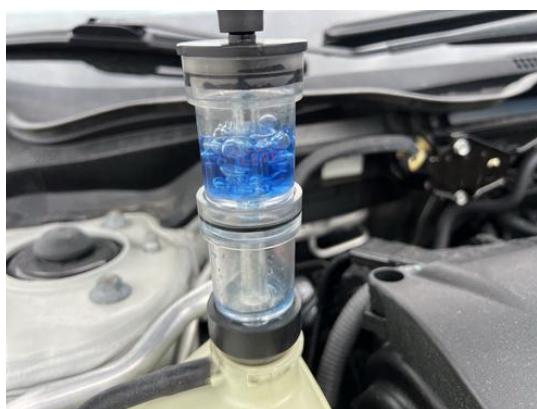
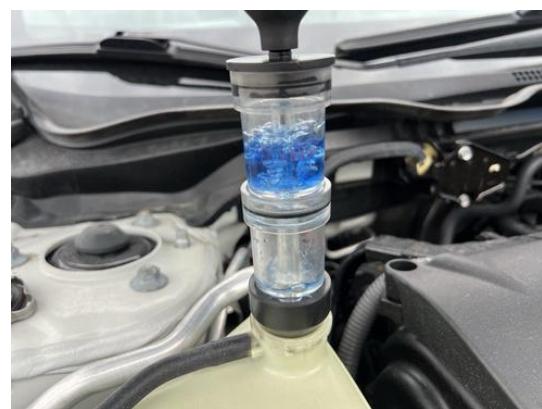
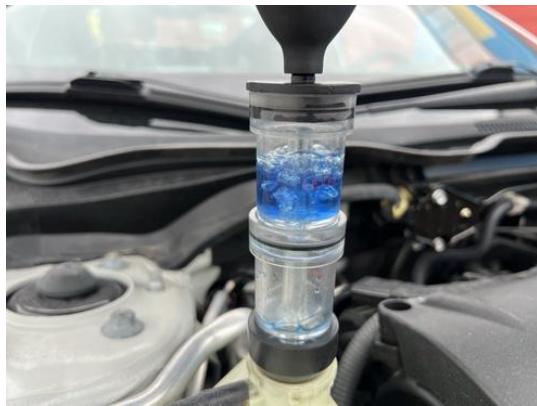
Engine clean internally, no gunk or sludge presents. Proper signs of maintenance present. Block test passed, no internal combustion leak out. Coolant mixture correct and cooling system functionality is healthy. All external engine accessories in good working. No leaks or seepage from anywhere on the engine. External drive belts in decent condition. Currently no concern in mechanical issues present in relation to the engine or related accessories.

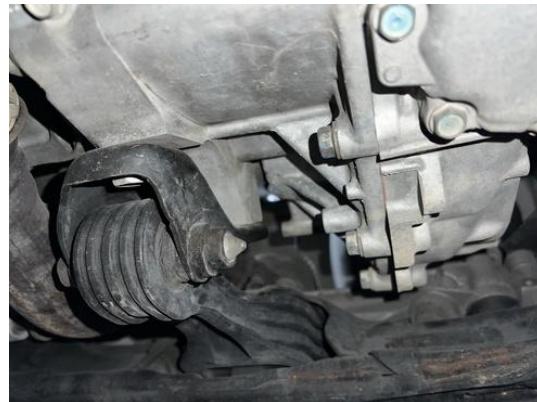
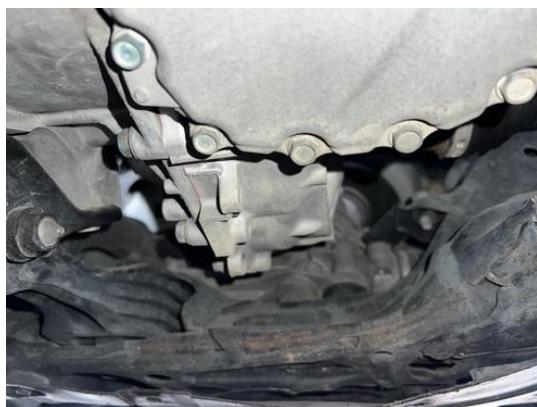
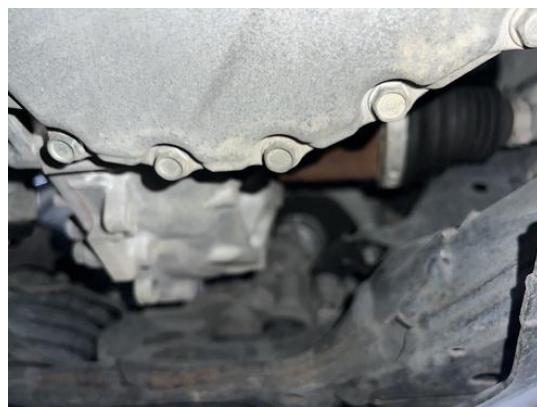
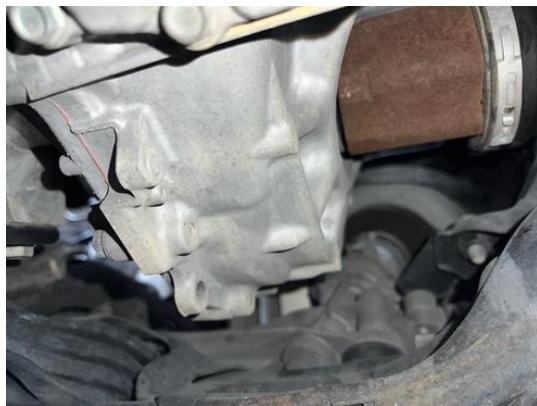
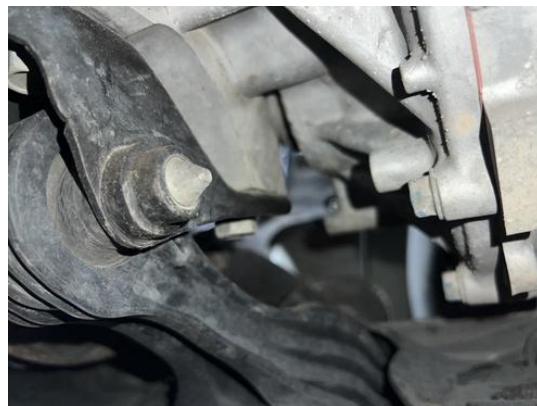
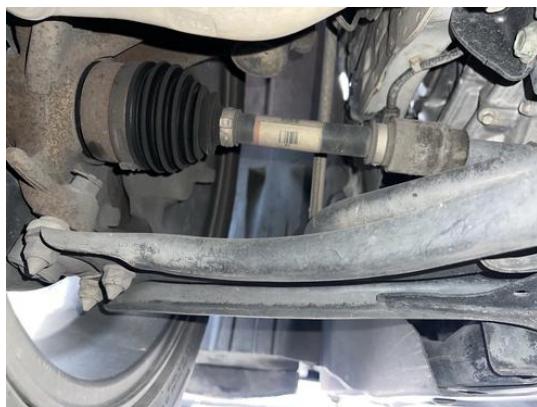
No transmission fluid leak out from the transmission casing or the transmission pan area. Both left and right side axle seals are free of any fluid leaks. Both left and right side CV axle are in healthy condition. Shift transitions out on the road are correct across-the-board

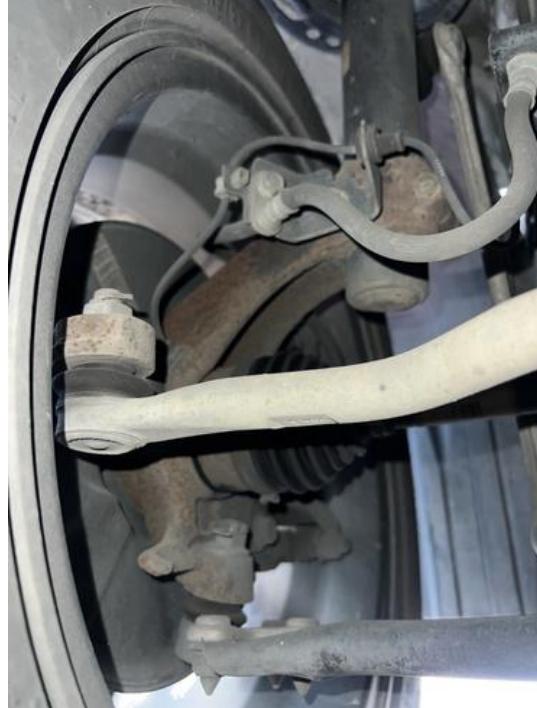
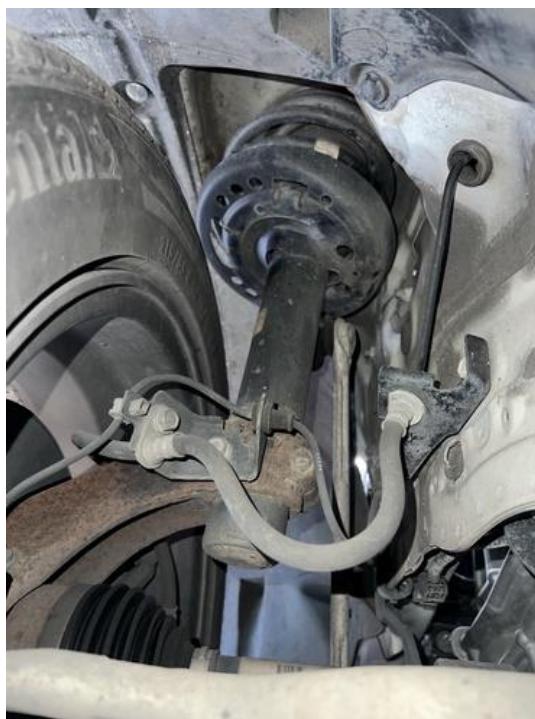
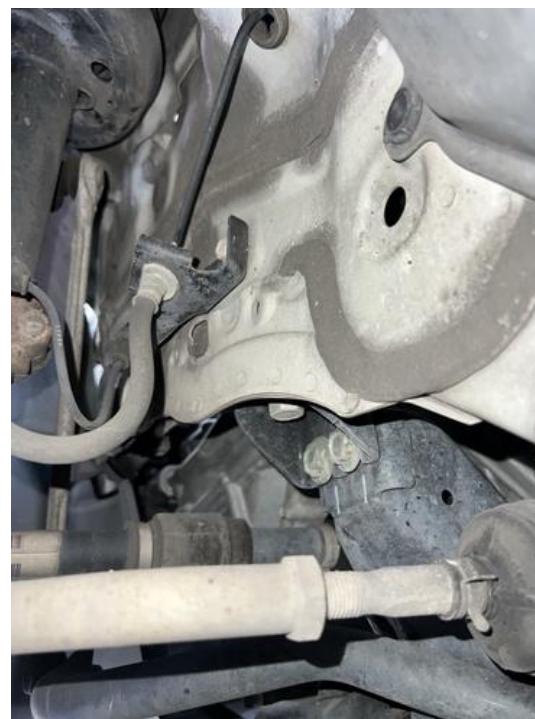
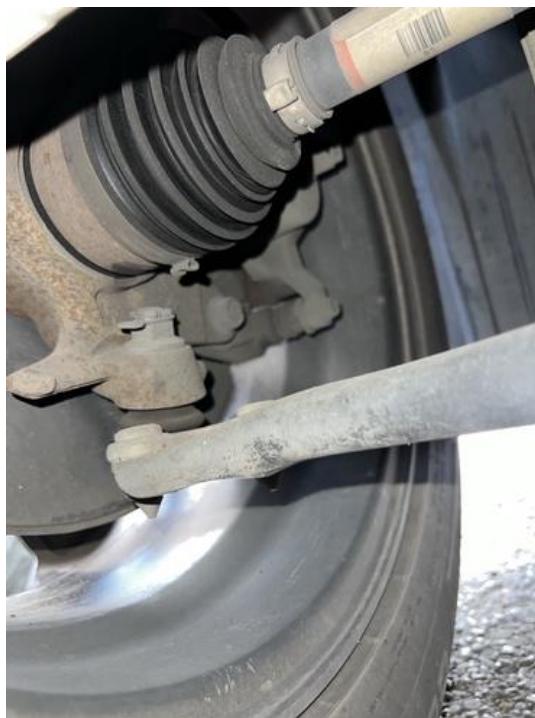
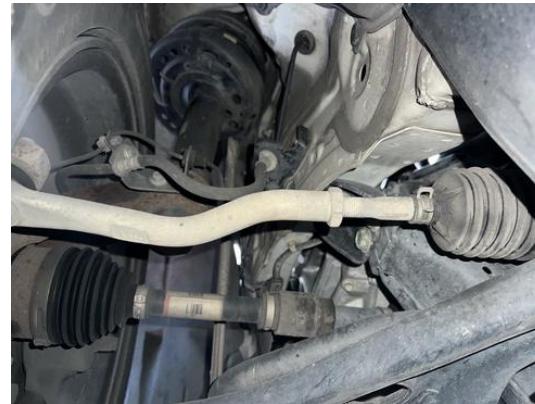
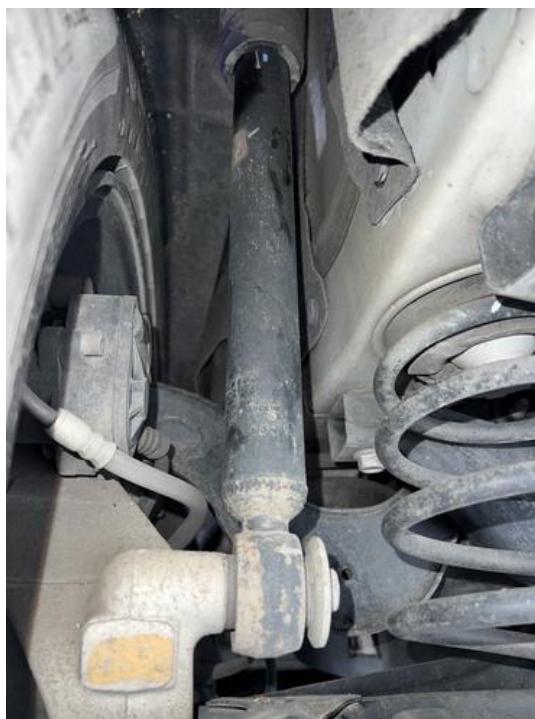
Normal fatigue notice to the suspension components. All of the suspension components seem to be original. None of the suspension components are blown out and due form the replacement. The No excessive surface rust on the exposed metal. No abnormal noise or feedback from the suspension while out on the road. All of the rubber in relation to the mounts, joints and bushings has decent texture.

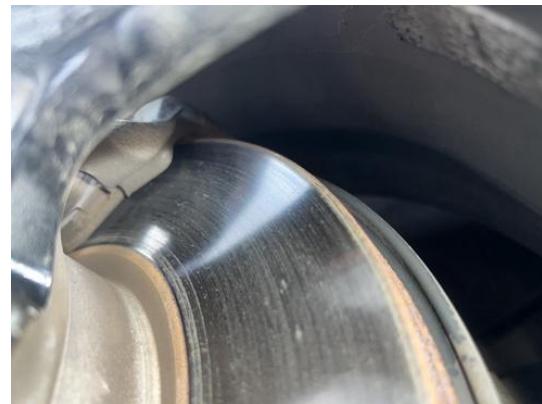
Photo 165

Brake fluid condition	Healthy
Brake fluid level	Healthy
Brake fluid leaks	None
Moisture content in brake fluid	None
Brake lines	Healthy
Brake calipers front	Healthy
Brake calipers rear	Healthy
Brake drums rear	N/A
Brake rotors front	Healthy
Brake rotors rear	Healthy
Front brake pad life remaining	50-75% remaining
