Peace of Mind Automotive Inspection Report.

Site conducted	Unanswered
Customer name	Luis LMj auto motor sales
Date / Time	Dec 30th
Payment method	Invoice
Inspection cost	Fleet
Vehicle Year / Make / Model / Color	2016 Honda CRv

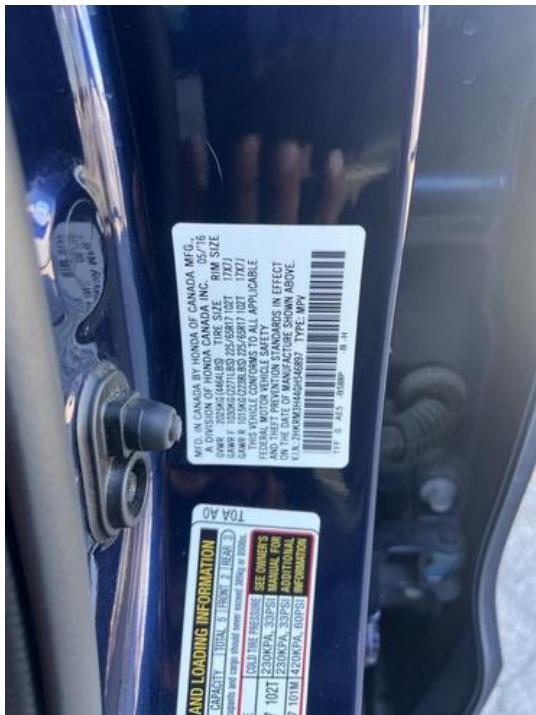
Photo 1

license plate	Dealer
Mileage	122747
Color	Blue

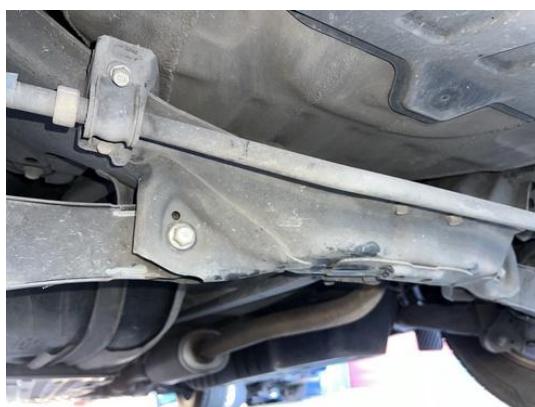
Photo 164

Normal fatigue notice to the suspension components. All of the suspension components seem to be original. None of the suspension components are blown out and due form the replacement. The No excessive surface rust on the exposed metal. No abnormal noise or feedback from the suspension while out on the road. All of the rubber in relation to the mounts, joints and bushings has decent texture.

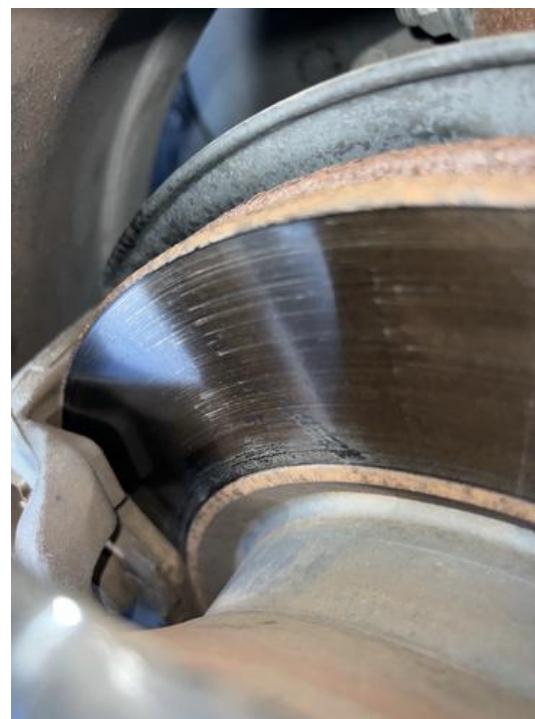
Photo 169

Brake fluid condition	Healthy
Brake fluid level	Healthy
Brake fluid leaks	None
Moisture content in brake fluid	None
Brake lines	Healthy
Brake calipers front	Healthy
Brake calipers rear	Healthy
Brake drums rear	N/A
Brake rotors front	N/A
Brake rotors rear	Healthy
Front brake pad life remaining	50-75% remaining
