Peace of Mind Automotive Inspection Report.

Score	4 / 4 (100%)	Flagged items	0	Actions	0
Site conducted					Unanswered
Customer name					Luis LMj auto motor sales
Date / Time					April 6th
Payment method					Invoice
Inspection cost					Fleet
Vehicle Year / Make / Model / Color					2016 Volkswagen Tig
VIN					03693 last 5
license plate					Dealer
Mileage					81516
Color					White

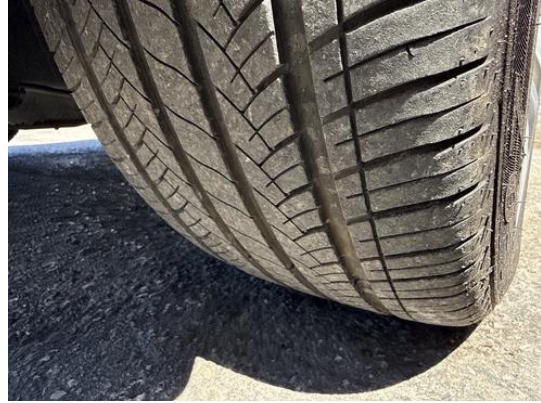
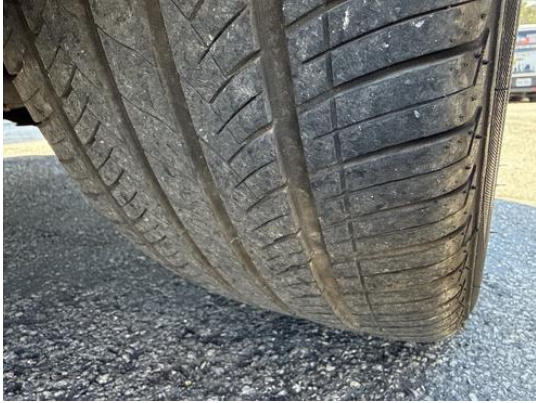
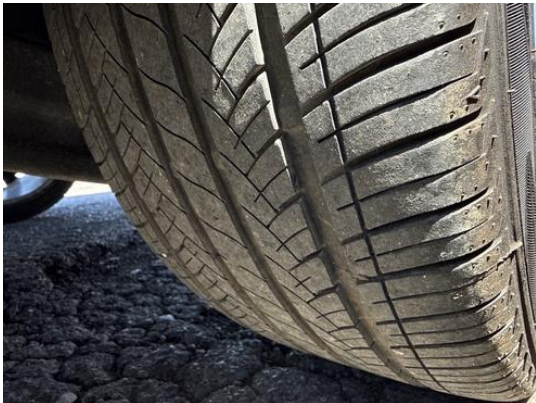
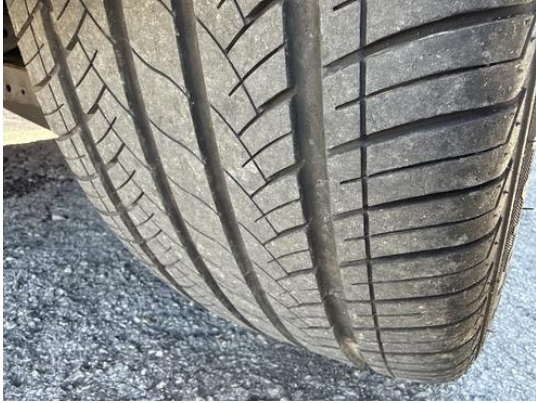
All four tires are matching, all four tires are dated from 2024. Tires are evenly worn and in decent condition with right around 65% tread life remaining.

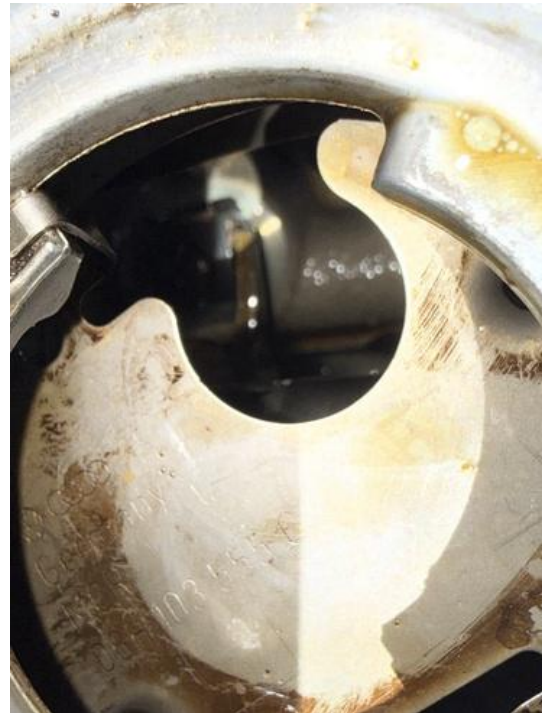
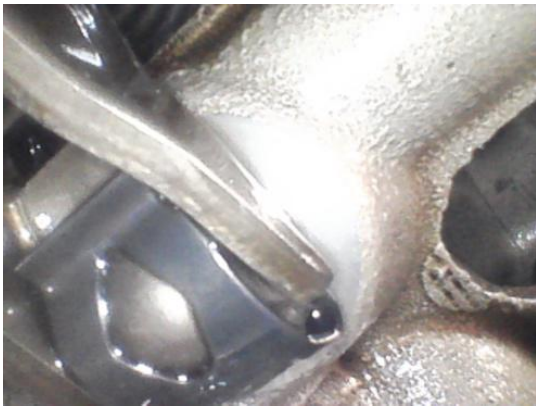
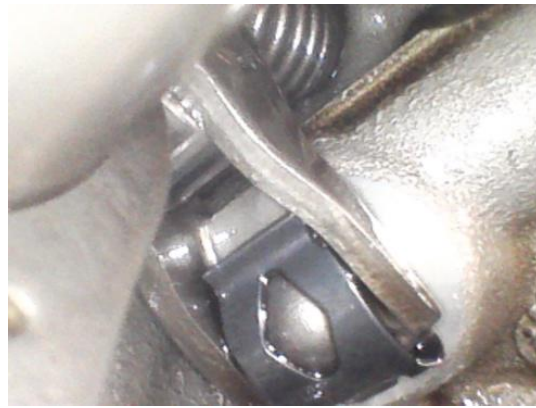
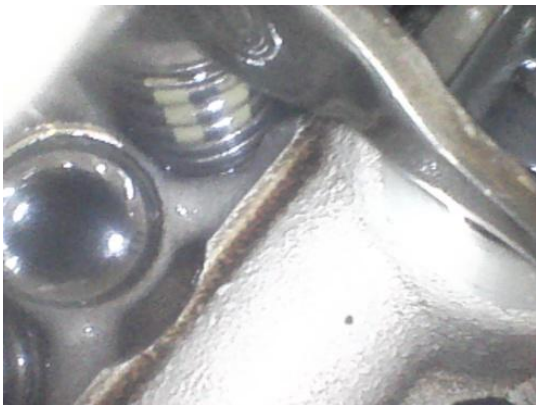
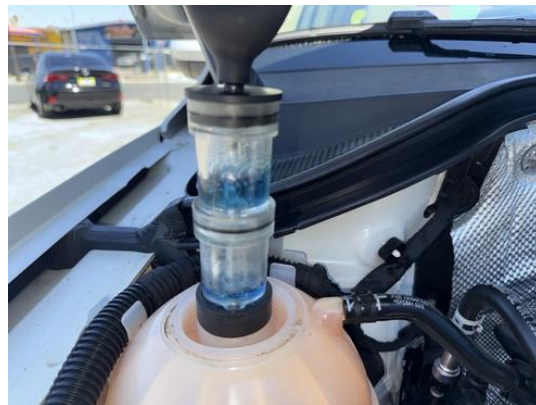
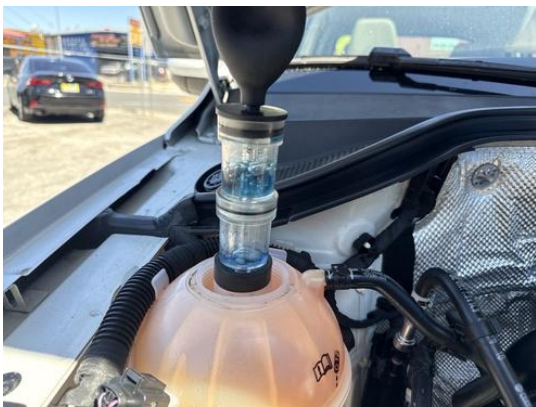
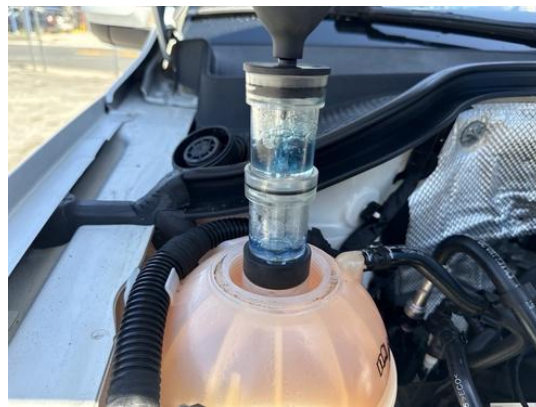
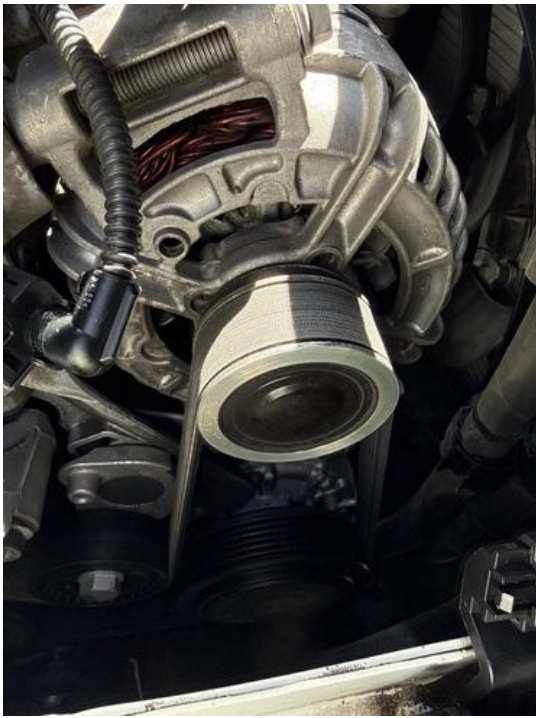
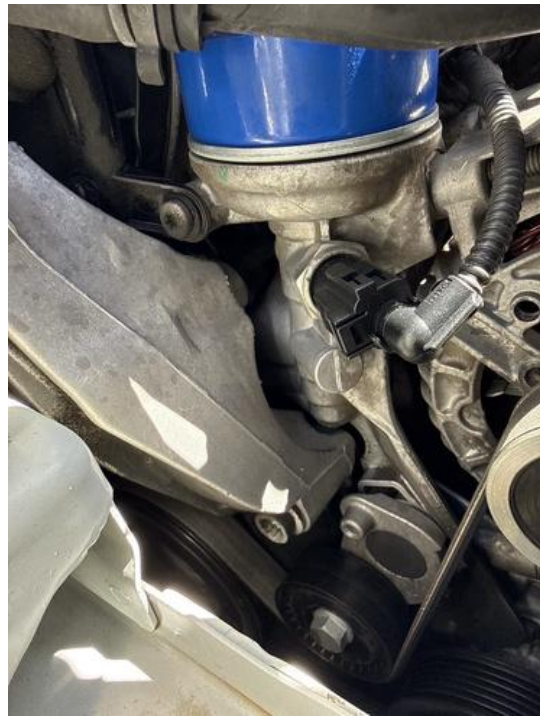
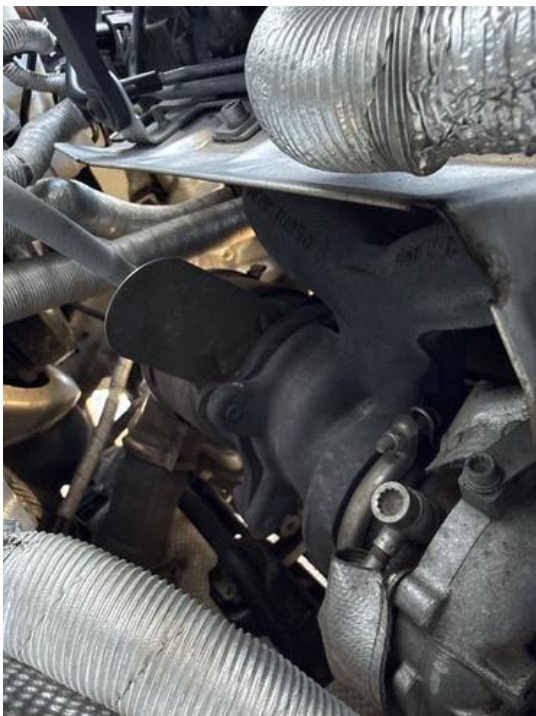
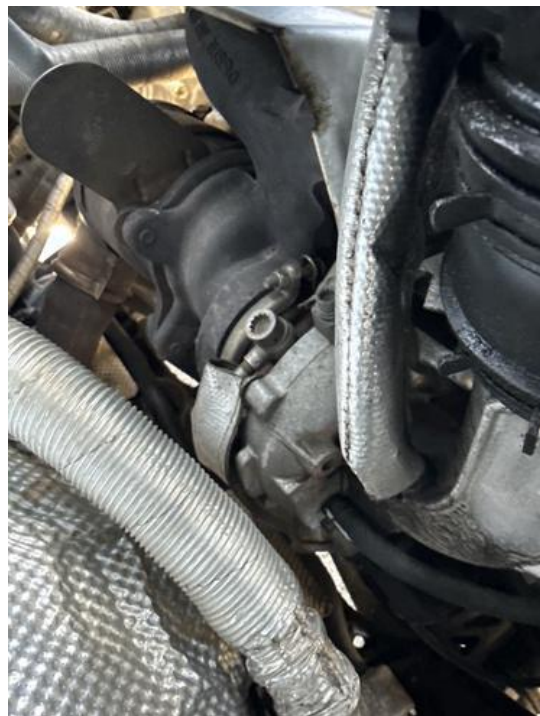
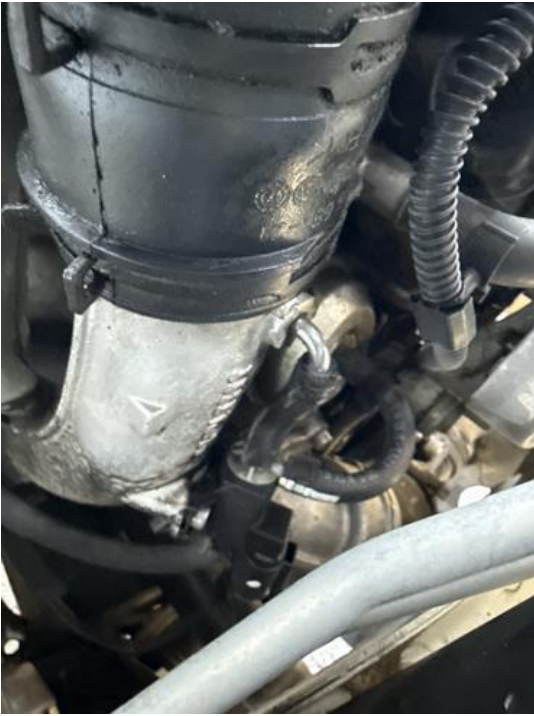
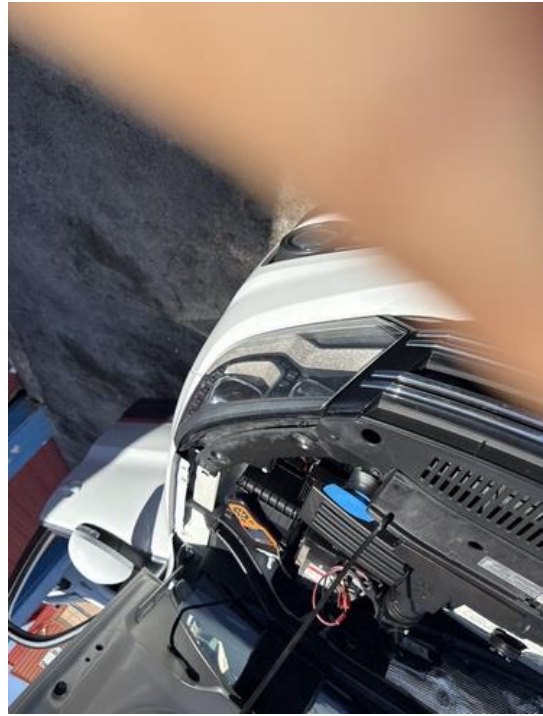
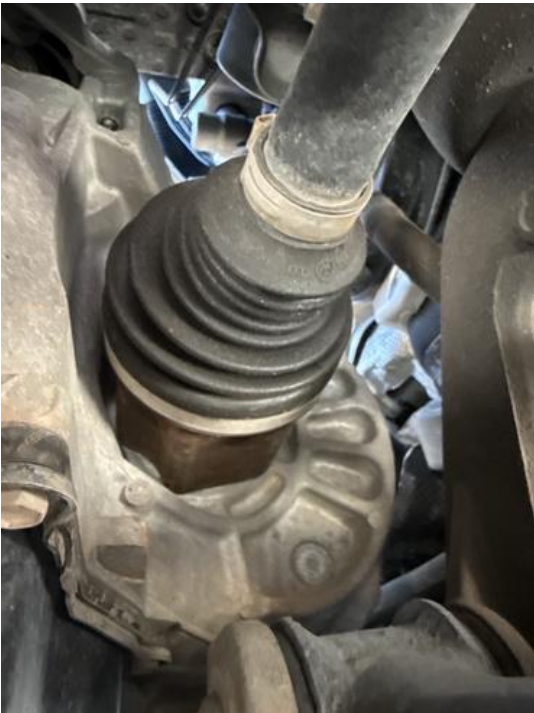
Drive belt condition	Healthy
Abnormal engine knock	None
Abnormal valve train rattle	None
Abnormal bearing noises	None
Engine gunk / sludge	None
Fuel tank	Healthy
Fuel injectors / lines	Healthy
Valve cover gaskets	Healthy
Intake manifold gasket	Healthy
Cylinder head gasket	Healthy
Oil pan gasket	Healthy
Timing cover gasket	Healthy
Rear main seal	Healthy
Timing belt / components	Healthy
Exhaust manifold	Healthy
External engine accessories	Healthy

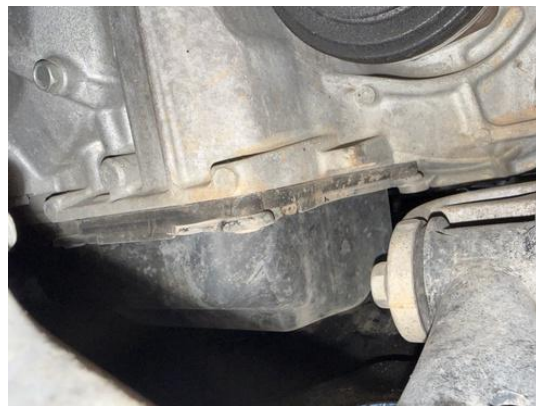
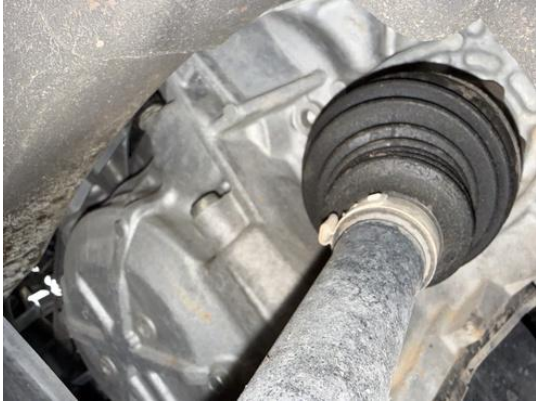
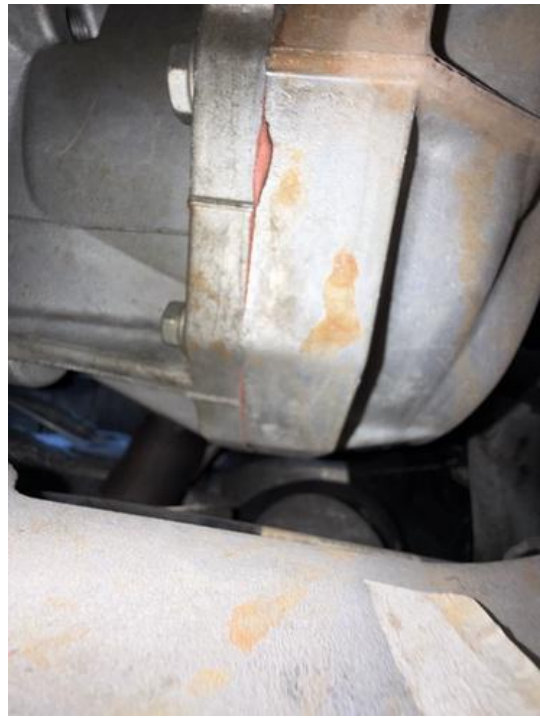
There's a very small amount of fluid residue noticed around the front differential near the passenger side. Axle seal, there was no fresh fluid able to be collected however, a future repair to expect may be replacement of the axle seal.

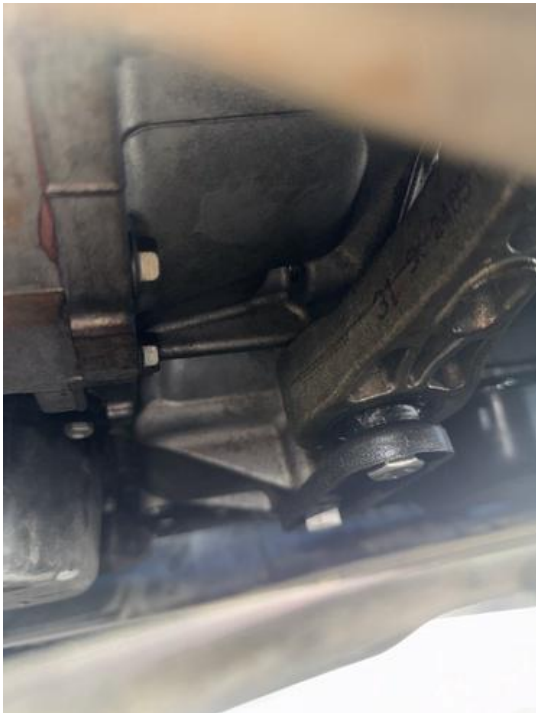
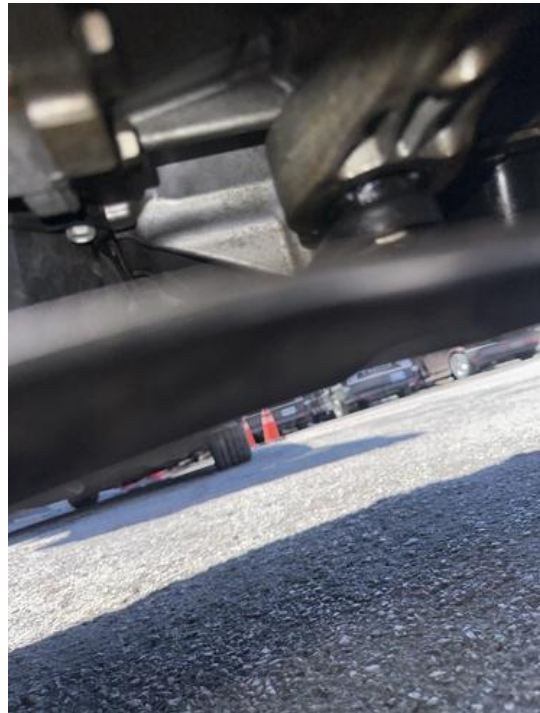
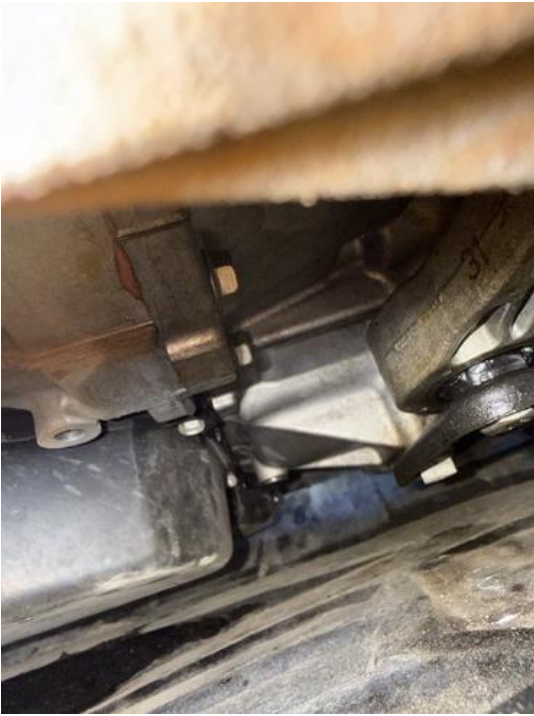
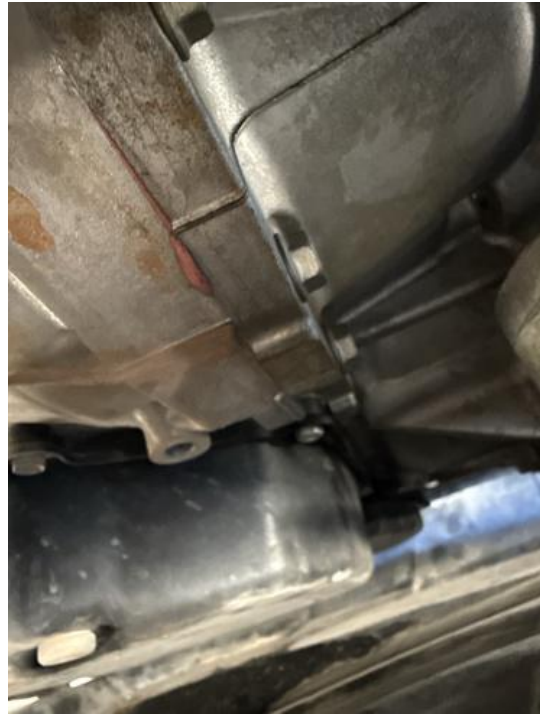
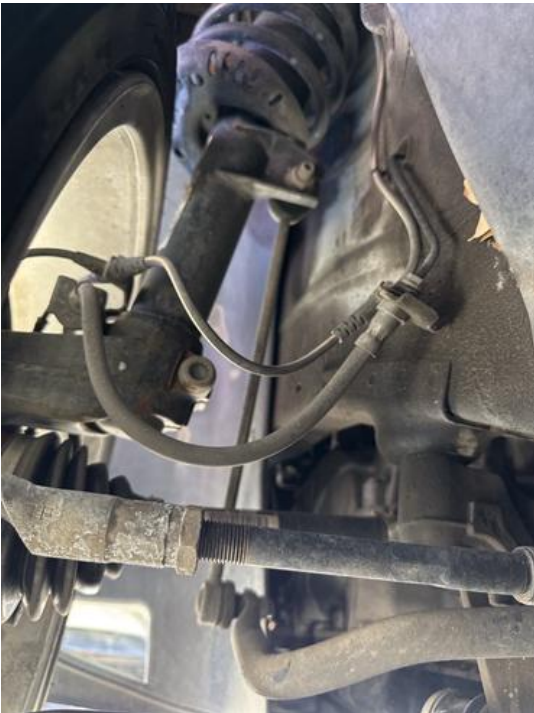
No transmission fluid leaks from Lee transmission casing. The transmission pan was free of any fluid leaks. Both left and right side CV axle are in healthy condition. Shift transitions out on the road are correct across the board.

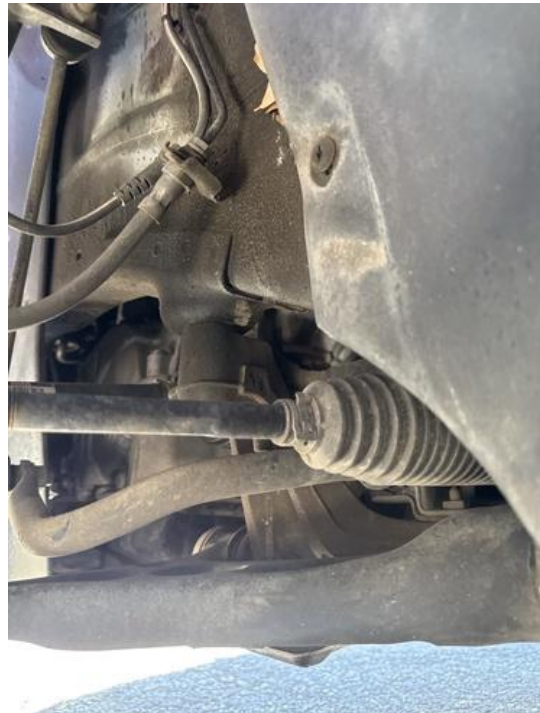
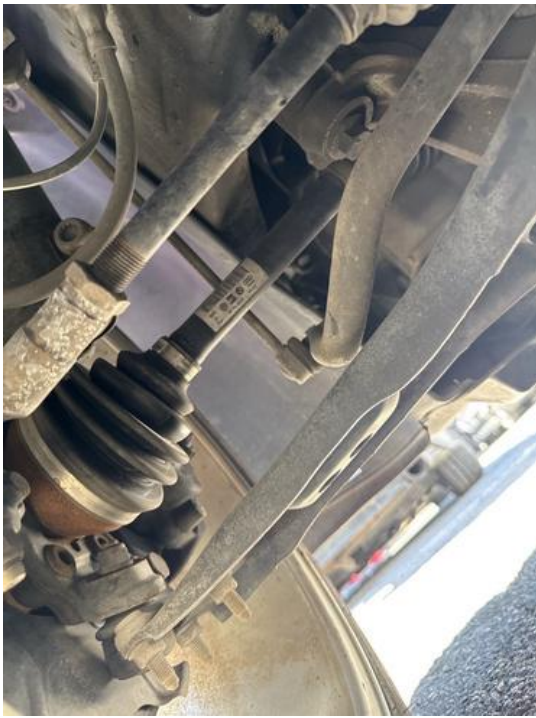
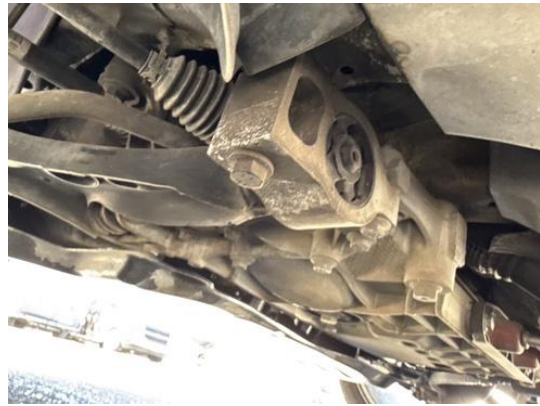
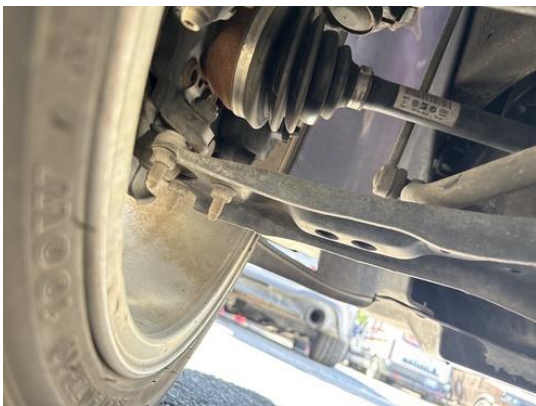
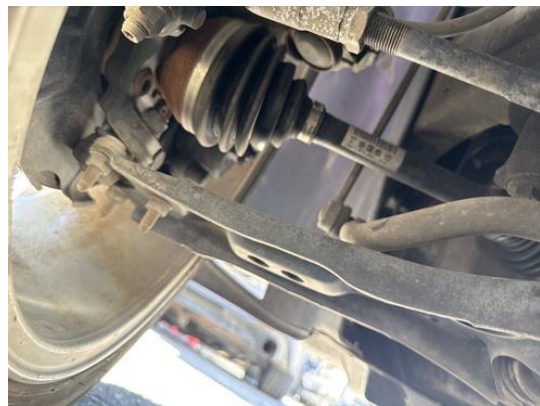
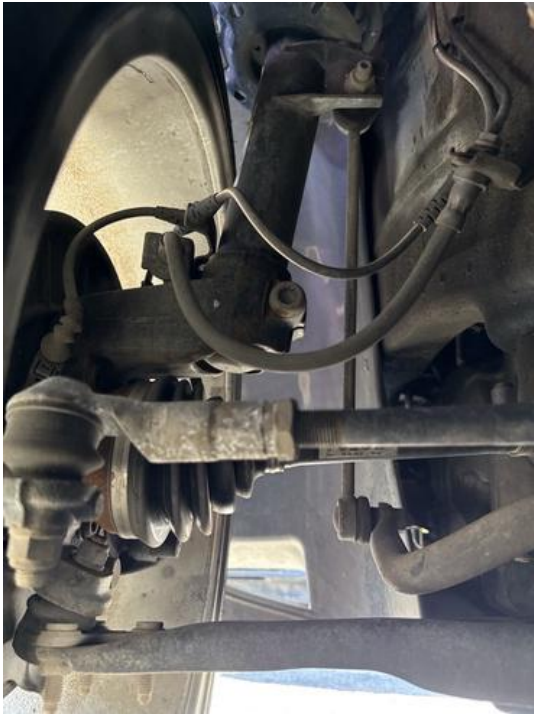
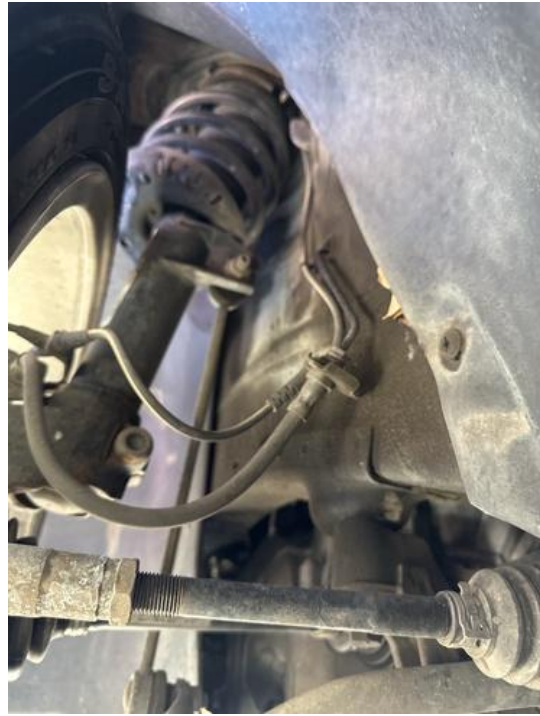
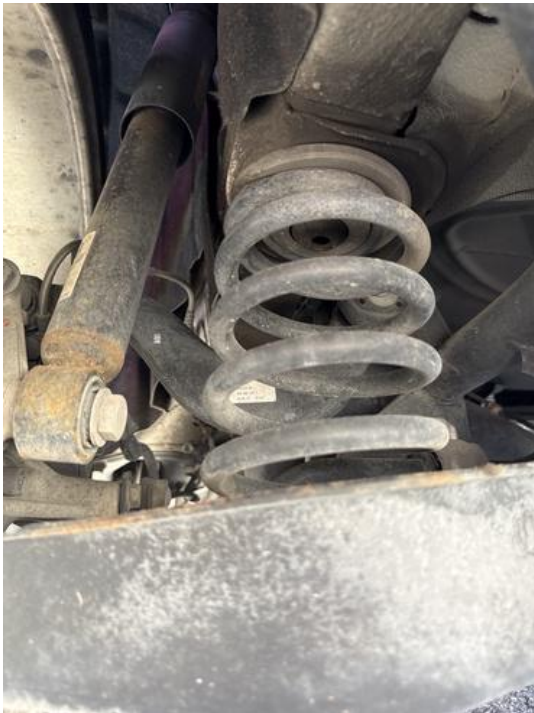
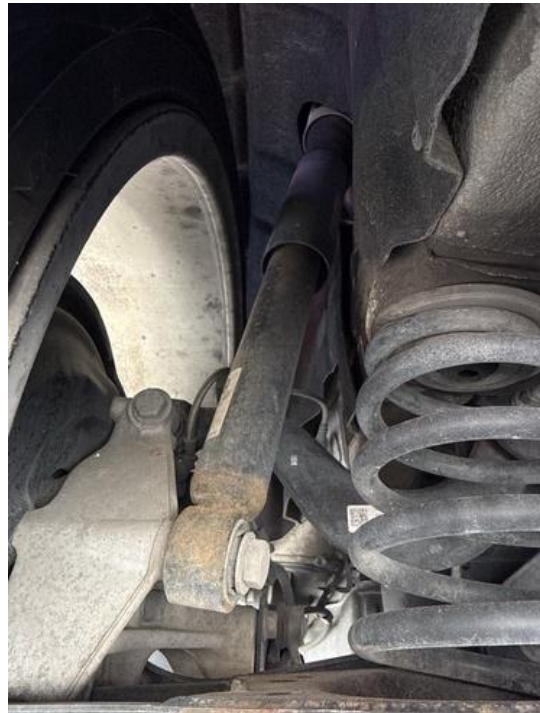
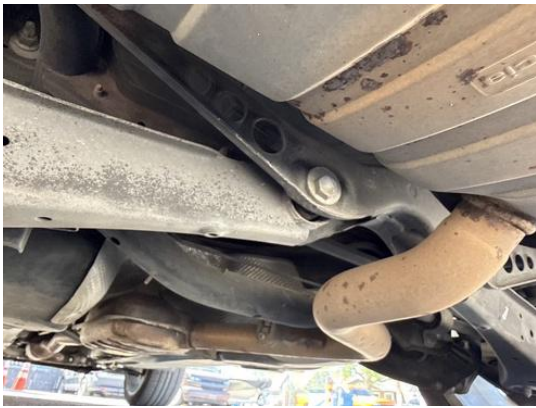
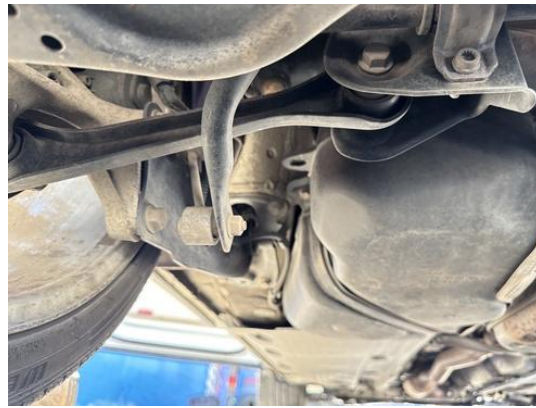
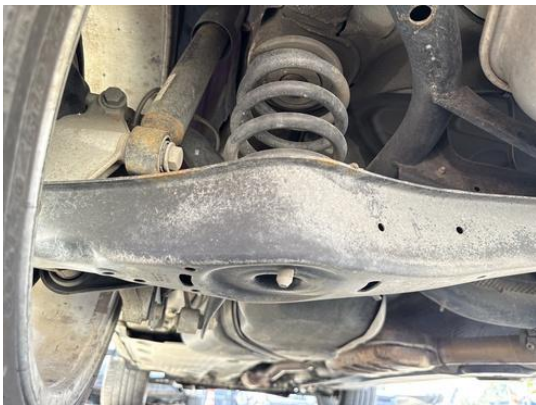
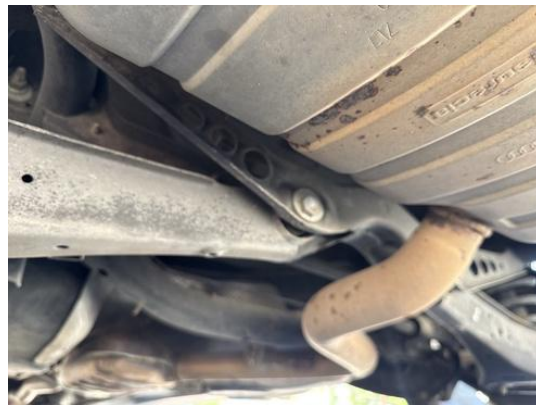
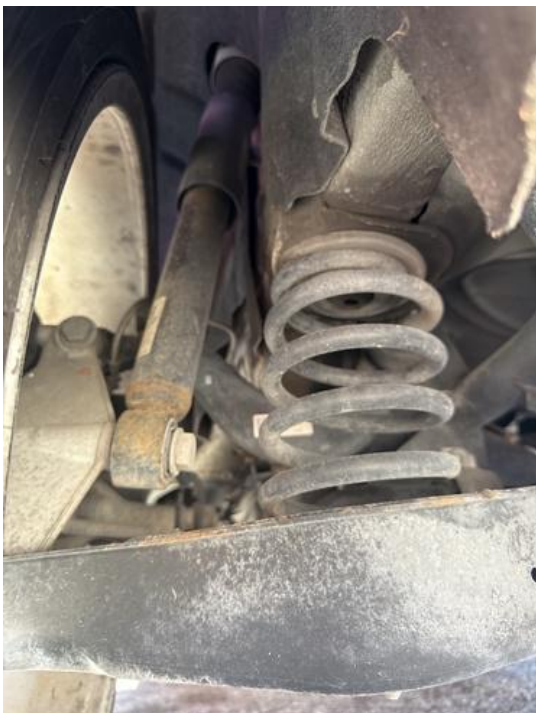
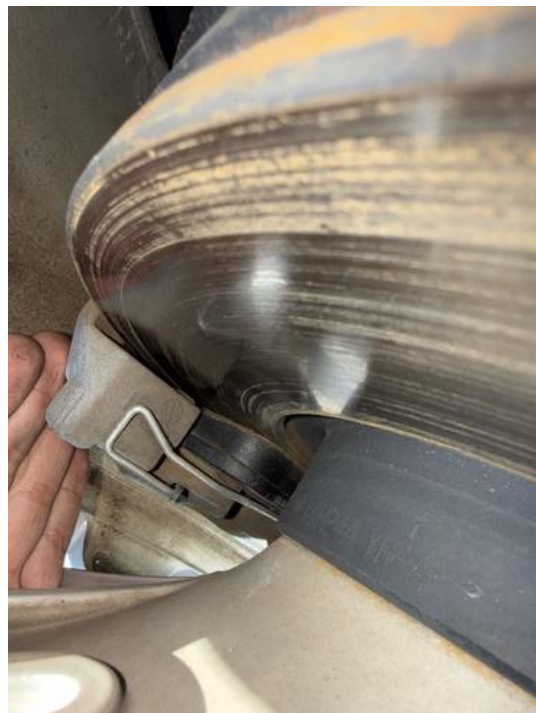
Normal fatigue notice to the suspension components. All of the suspension components seem to be original. None of the suspension components are blown out and due form the replacement. The No excessive surface rust on the exposed metal. No abnormal noise or feedback from the suspension while out on the road. All of the rubber in relation to the mounts, joints and bushings has decent texture.
