Peace of Mind Automotive Inspection Report.

Score	4 / 4 (100%)	Flagged items	0	Actions	0
Site conducted					Unanswered
Customer name					Luis Imj auto motor sales
Date / Time					June 2nd
Payment method					Invoice
Inspection cost					Fleet
Vehicle Year / Make / Model / Color					2017 Lexus RC 350
VIN					016903 last 6

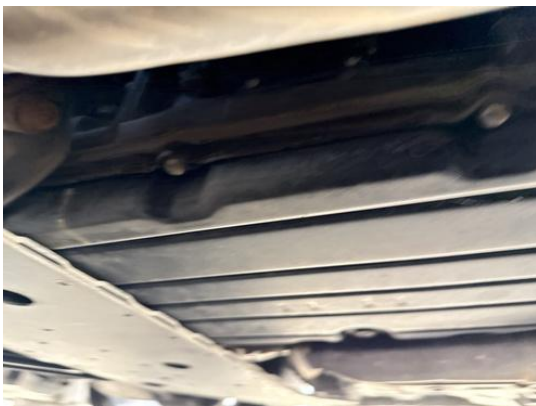
Photo 138

No transmission fluid leaks from the transmission casing or the transmission pan area. The tail shaft seal is free of any fluid leaks. The driveshaft is in healthy condition. Shift transitions out on the road are correct across the board. No fluid leak out from the rear differential.

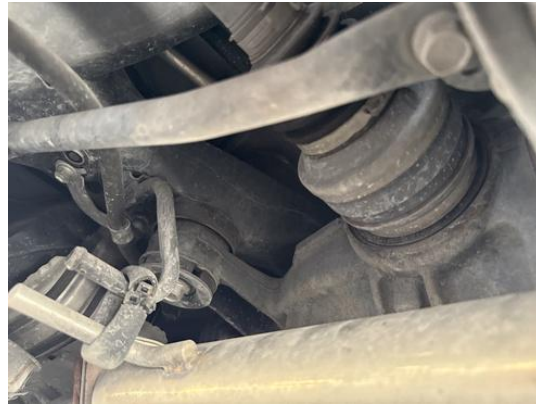
Photo 143

Rear differential condition	Healthy
------------------------------------	---------

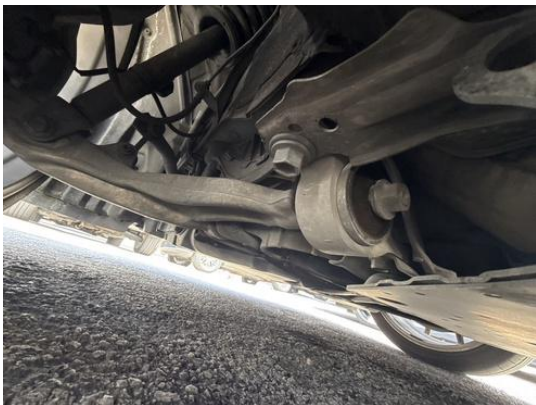
Photo 146

Normal fatigue notice to the suspension components. All of the suspension components seem to be original. None of the suspension components are blown out and due form the replacement. The No excessive surface rust on the exposed metal. No abnormal noise or feedback from the suspension while out on the road. All of the rubber in relation to the mounts, joints and bushings has decent texture.

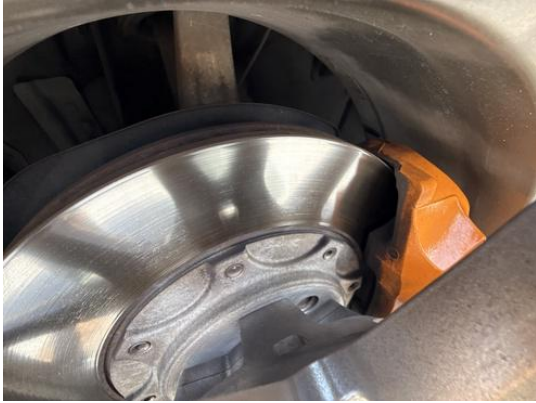
Photo 158

Braking system condition		
Brake fluid condition	Healthy	
Brake fluid level	Healthy	
Brake fluid leaks	None	
Moisture content in brake fluid	None	
Brake lines	Healthy	
Brake calipers front	Healthy	
Brake calipers rear	Healthy	
Brake drums rear	N/A	
Brake rotors front	Healthy	
Brake rotors rear	Healthy	
Front brake pad life remaining	50-75% remaining	
<p>Right around 65% brake pad life remain remaining on the front brake system and right around 75% brake pad. Life remain remaining on the rear brake system.</p>
