Peace of Mind Automotive Inspection Report.

Site conducted	Unanswered
Customer name	LMJ Auto motor sales
Date / Time	Dec 10th
Payment method	Invoice
Inspection cost	199
Vehicle Year / Make / Model / Color	2017 Ford F150

VIN	90662 last 5

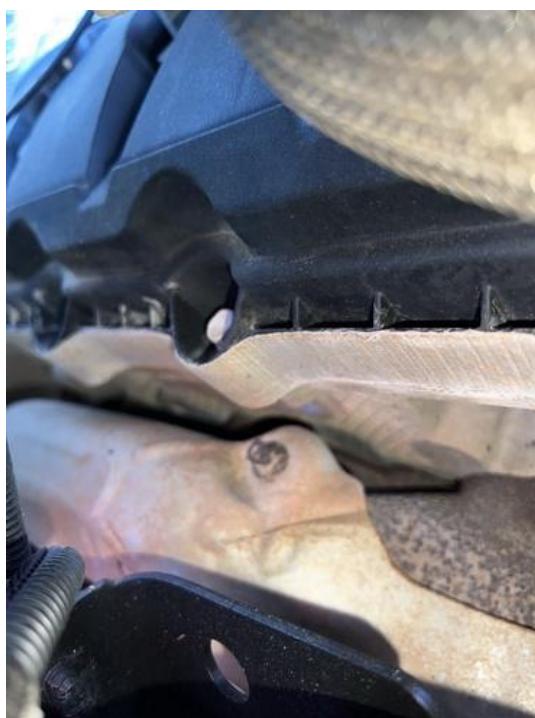
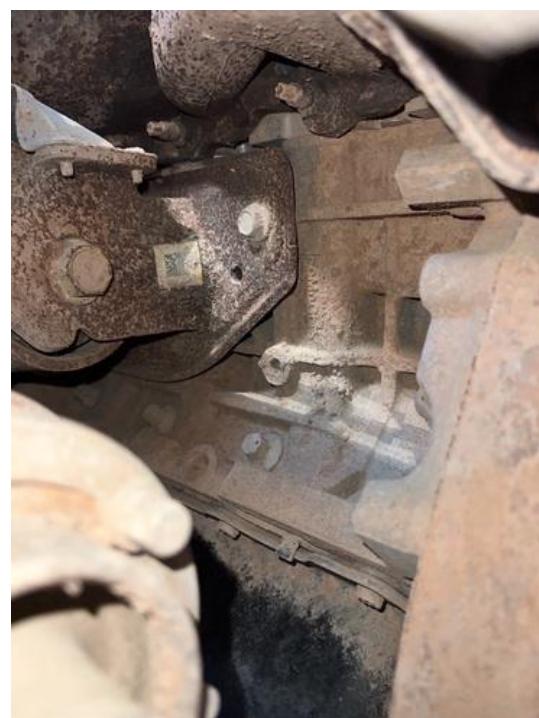
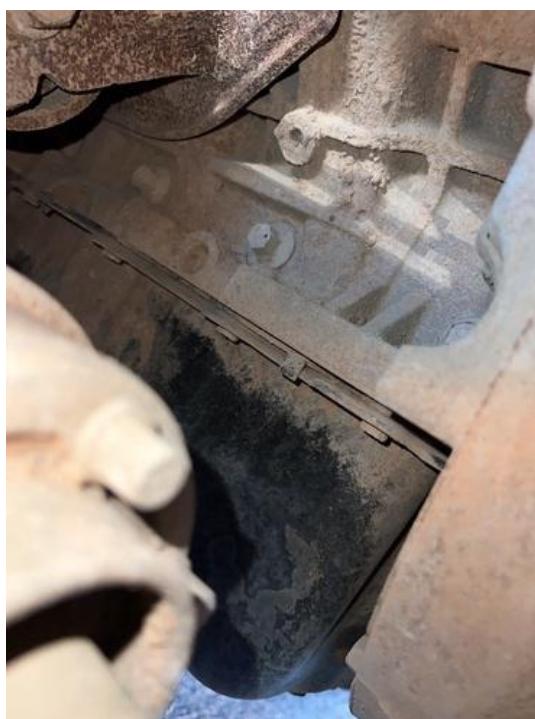
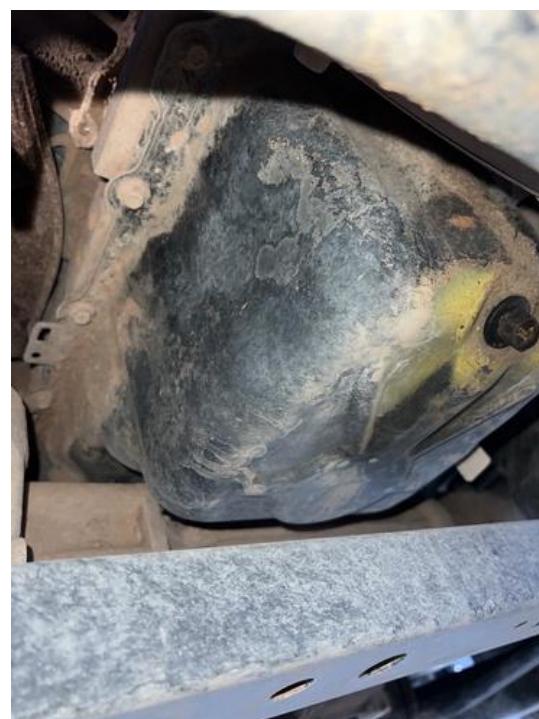
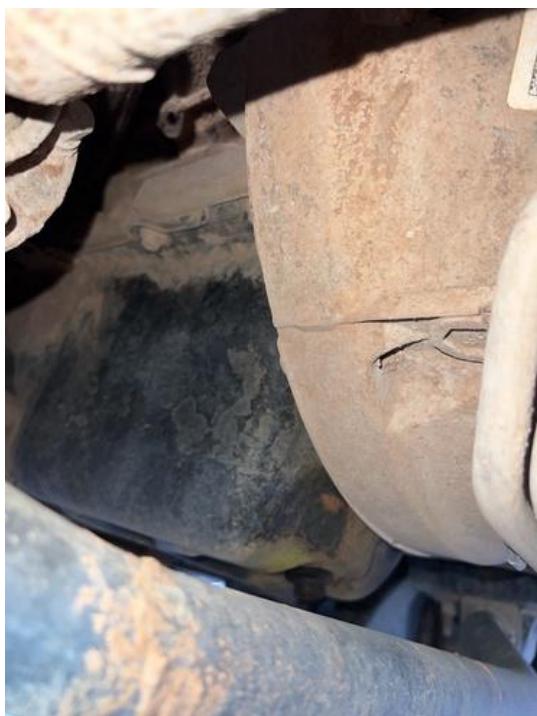
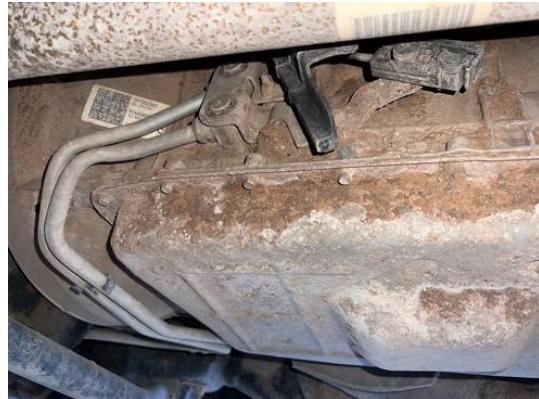
Engine block test	Pass
Coolant mixture test	Pass
Air filter condition	Normal wear
Engine oil condition	Normal wear
Engine oil level	Healthy
Engine oil leaks	None
Coolant level	Healthy
Coolant hoses	Healthy
Radiator condition / function	Healthy

Engine operating temperature	Healthy
Cooling fan function	Healthy
Drive belt condition	Healthy
Abnormal engine knock	None
Abnormal valve train rattle	None
Abnormal bearing noises	None
Engine gunk / sludge	None
Fuel tank	Healthy
Fuel injectors / lines	Healthy
Valve cover gaskets	Healthy
Intake manifold gasket	Healthy
Cylinder head gasket	Healthy
Oil pan gasket	Healthy
Timing cover gasket	Healthy
Rear main seal	Healthy
Timing belt / components	Healthy
Exhaust manifold	Healthy
External engine accessories	Healthy

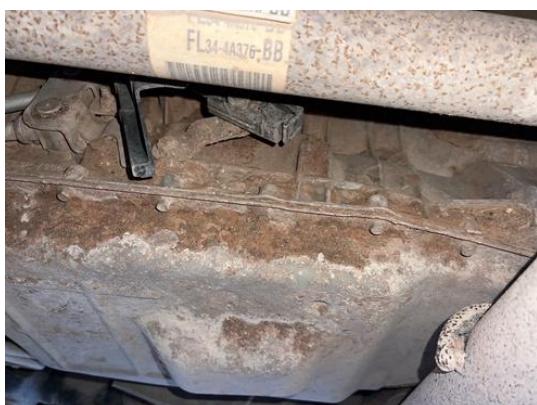
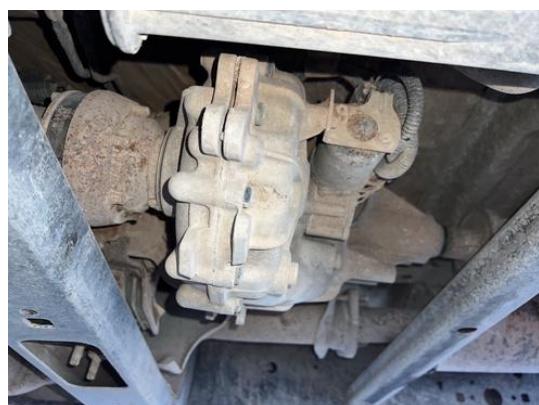
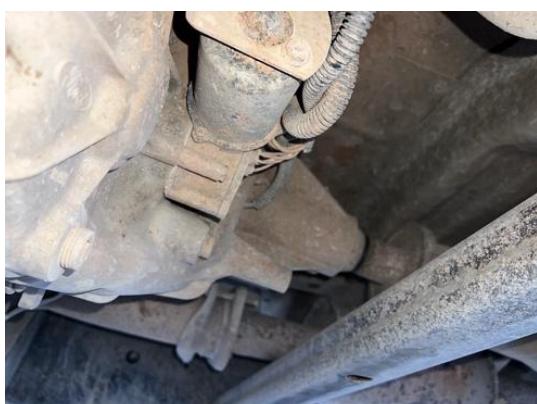
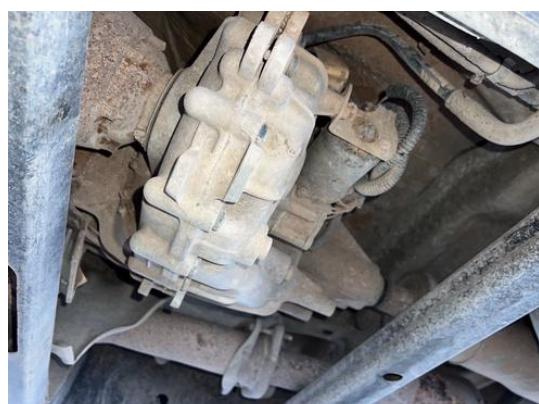
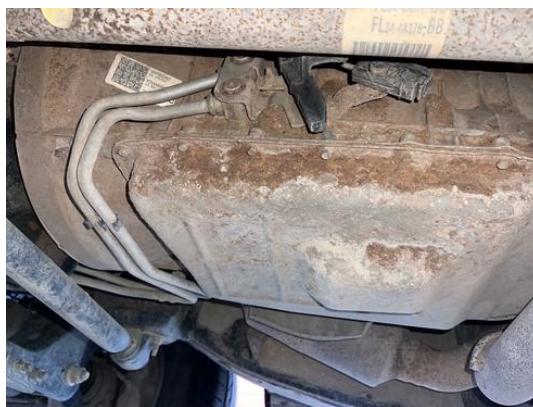
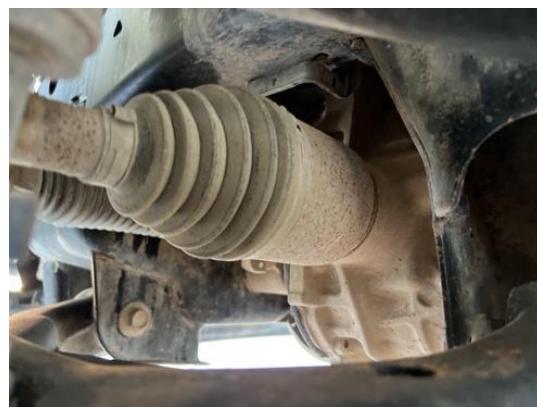
No transmission fluid leak out from the transmission casing or the transmission pan area. Drive shaft and seal is free of any fluid leaks. The rear differential is free of any fluid leak out. Shift transitions out on the road are correct across the board. No fluid leak out from the front differential or center differential. 4 x 4 system functionality is correct across-the-board

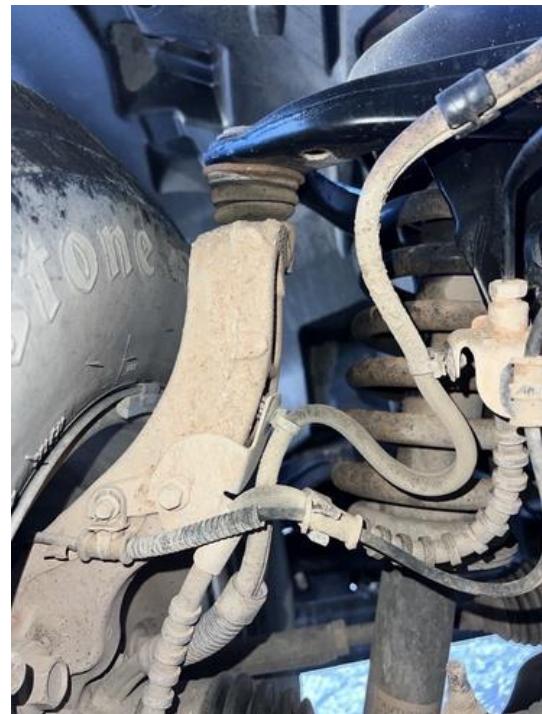
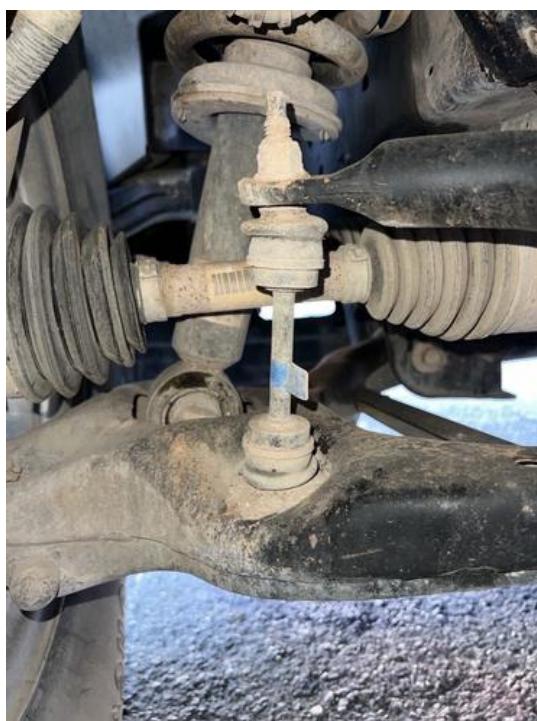
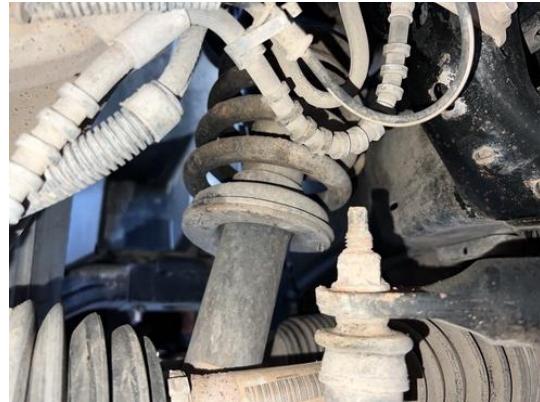
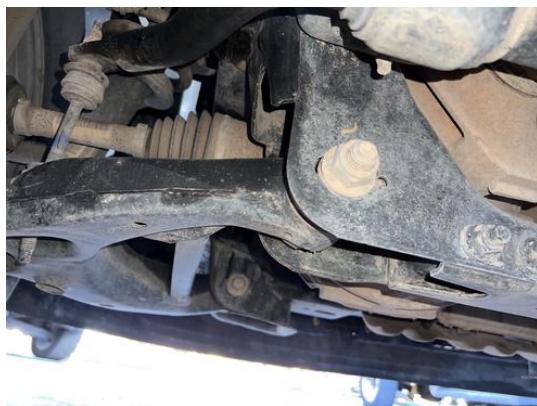
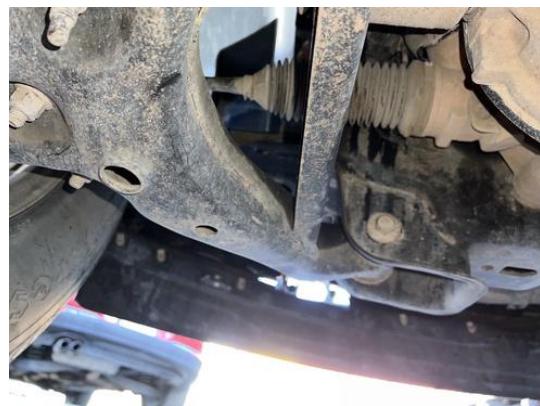
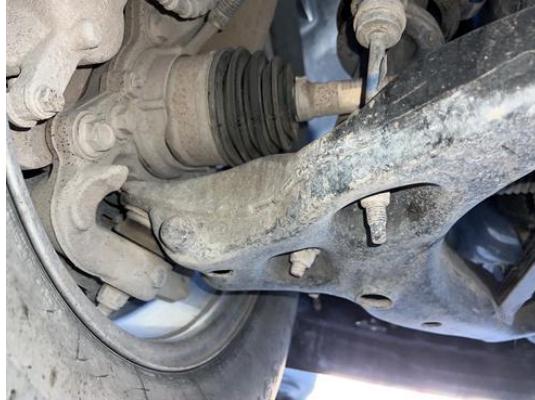
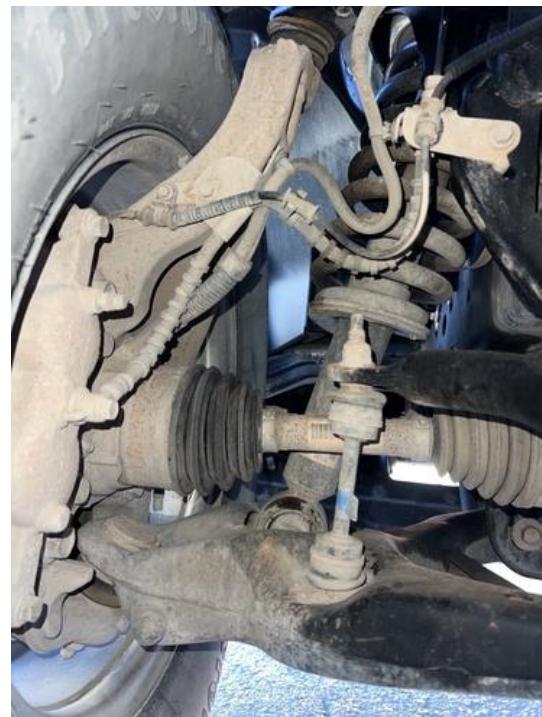
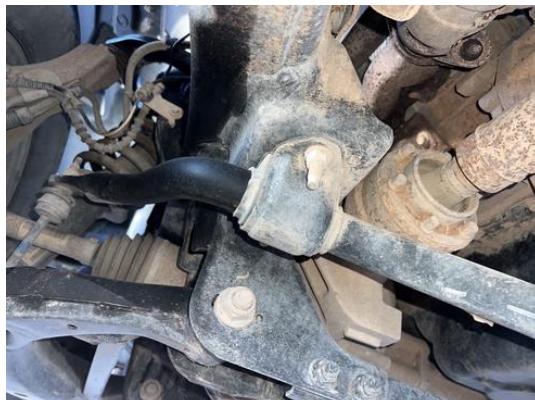
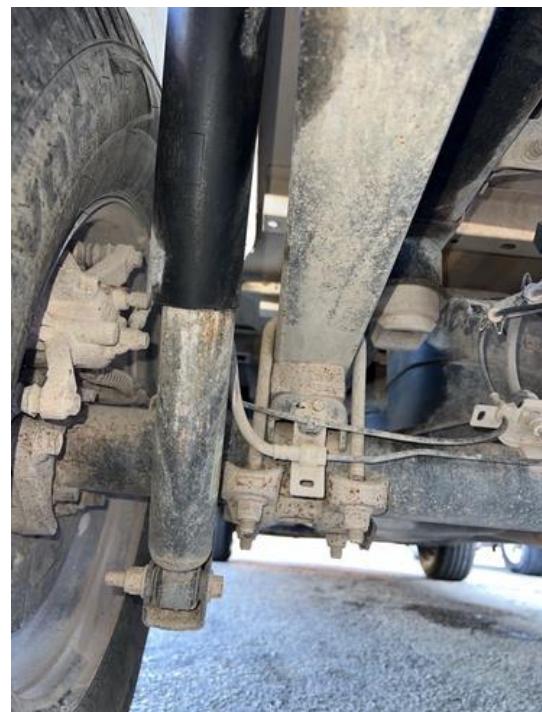
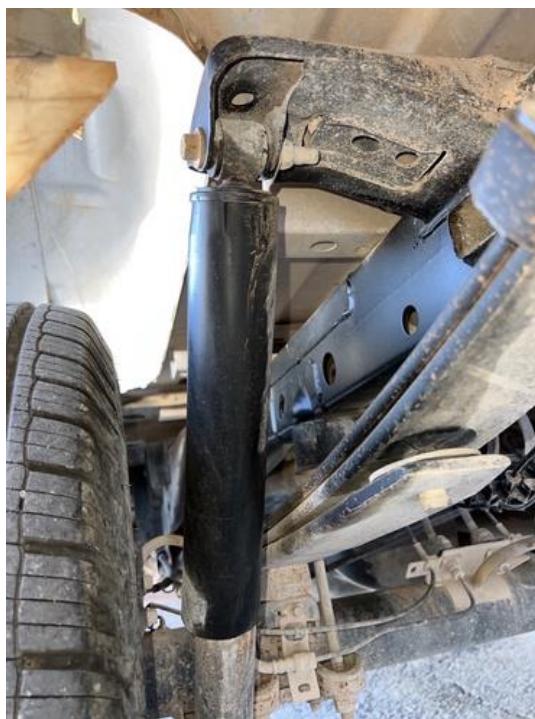
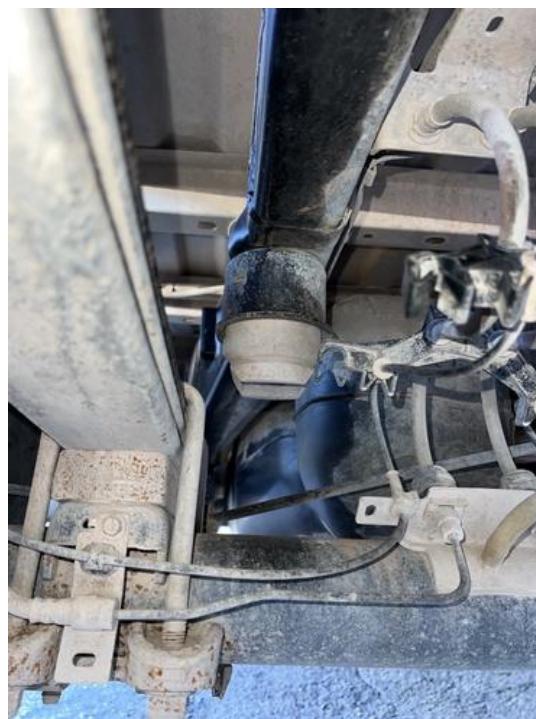
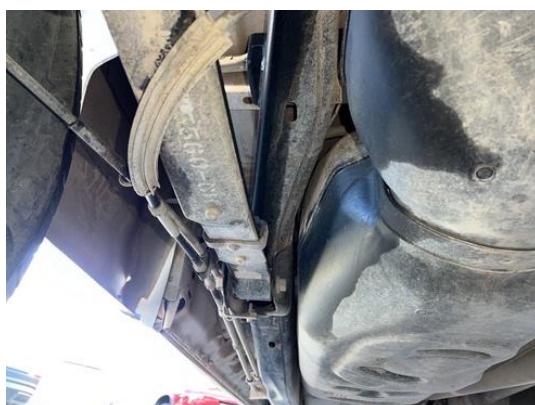
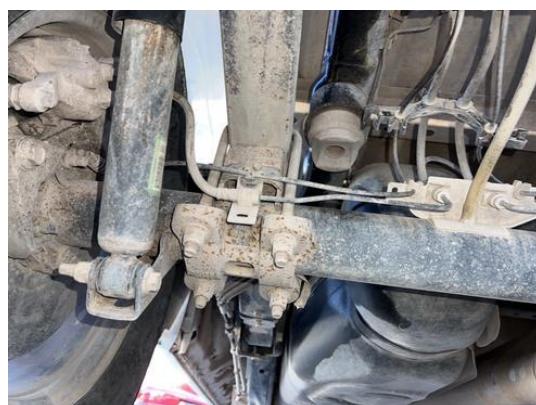
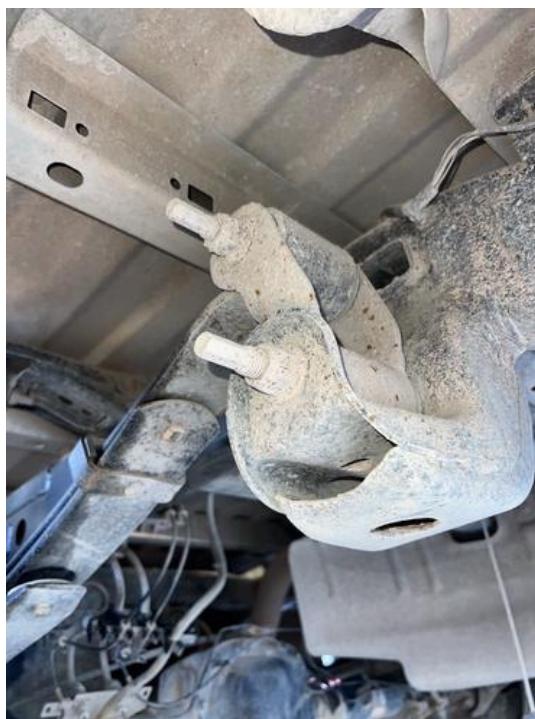
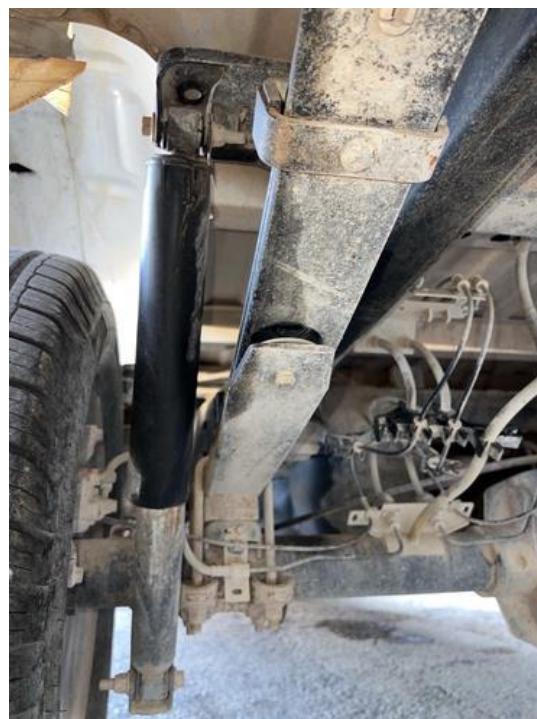
Normal fatigue notice to the suspension components. All of the suspension components seem to be original. None of the suspension components are blown out and due form the replacement. The No excessive surface rust on the exposed metal. No abnormal noise or feedback from the suspension while out on the road. All of the rubber in relation to the mounts, joints and bushings has decent texture.

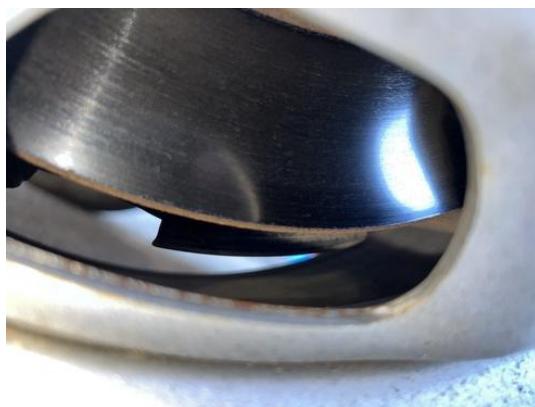
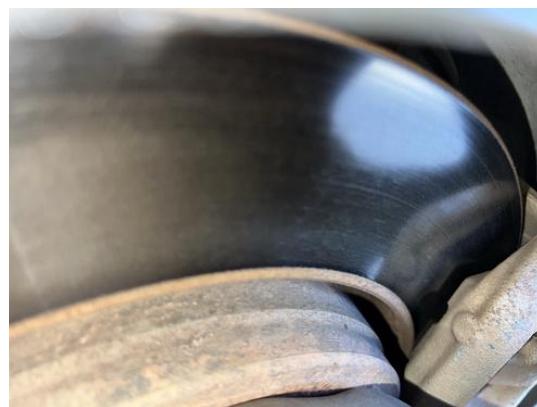
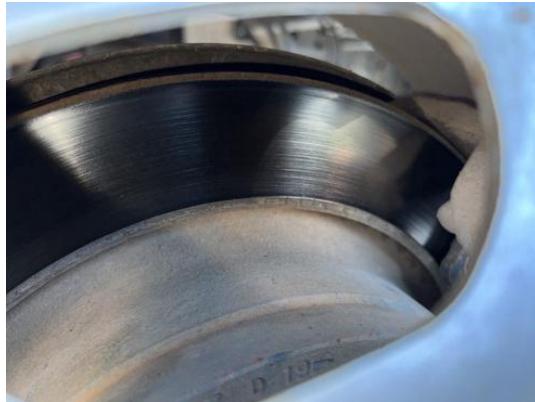
Brake fluid condition	Healthy
Brake fluid level	Healthy
Brake fluid leaks	None
Moisture content in brake fluid	None
Brake lines	Healthy
Brake calipers front	Healthy
Brake calipers rear	Healthy
Brake drums rear	N/A
Brake rotors front	Healthy
Brake rotors rear	Healthy
Front brake pad life remaining	50-75% remaining
