Peace of Mind Automotive Inspection Report.

Site conducted	Unanswered
Customer name	Luis LMJ auto motor sales
Date / Time	Dec 30th
Payment method	Invoice
Inspection cost	Fleet
Vehicle Year / Make / Model / Color	2017 Honda accord
VIN	29878 last 5

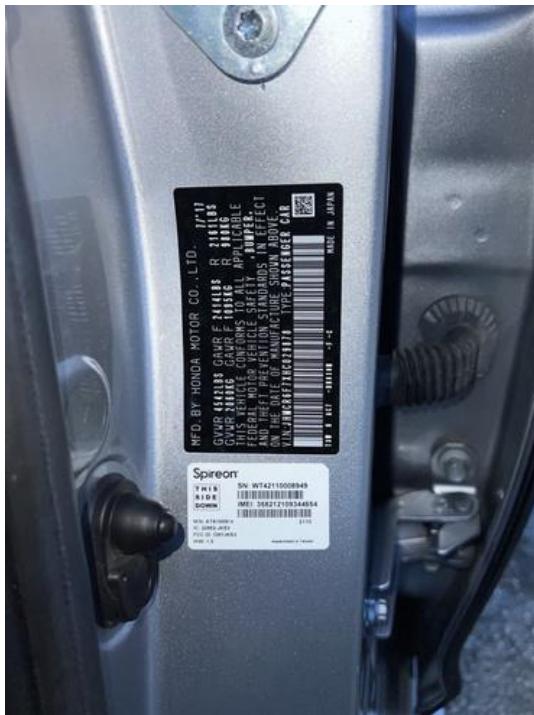
Photo 1

license plate	Dealer
Mileage	120740
Color	Grey

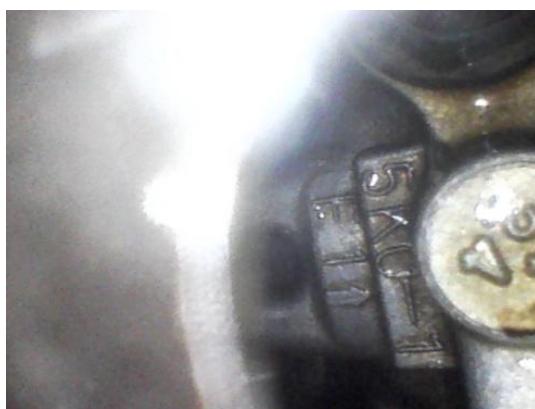
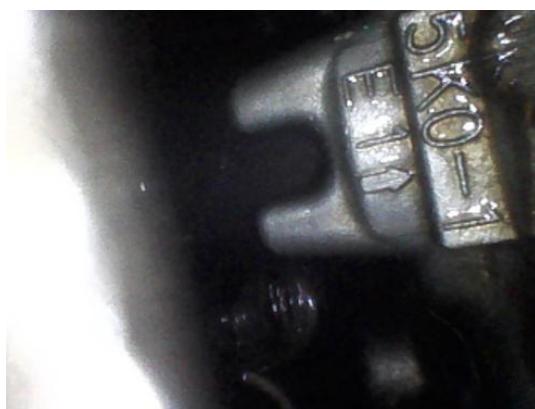
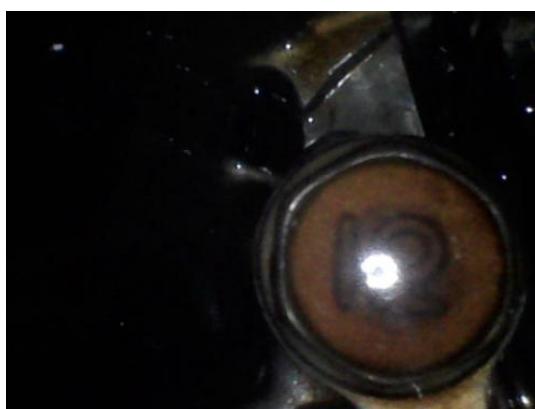
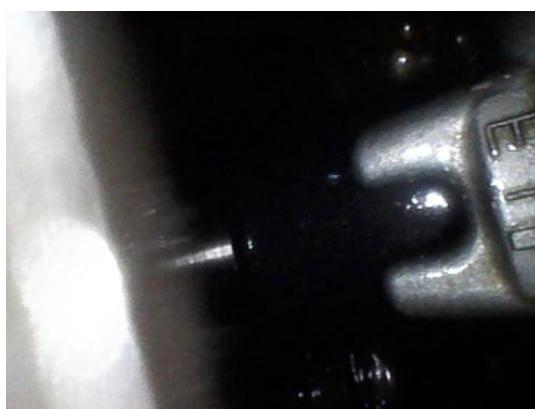
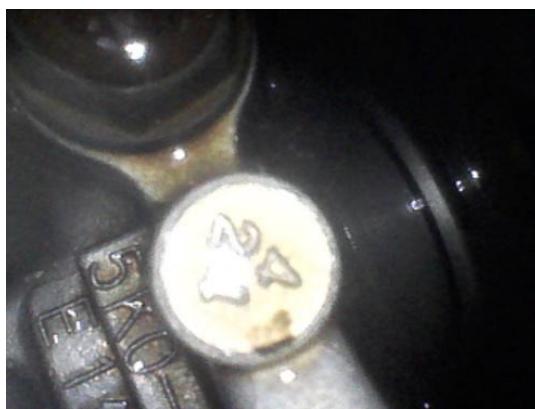
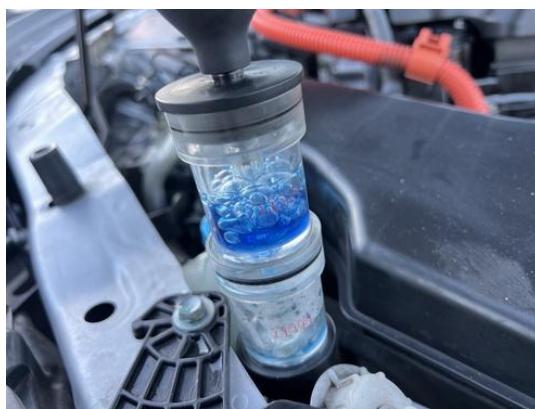
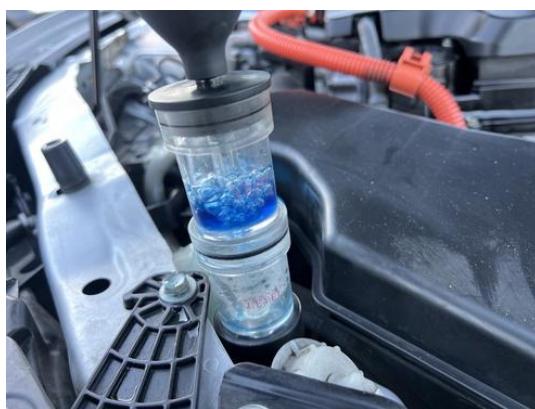
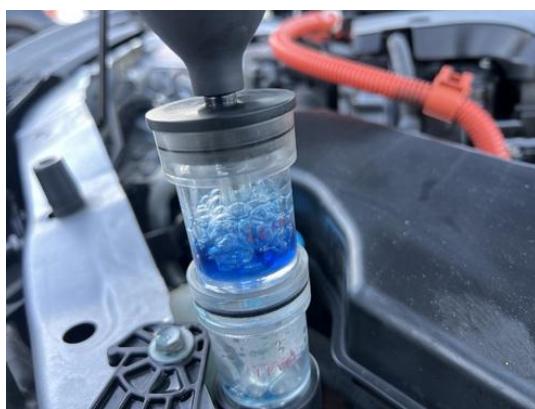
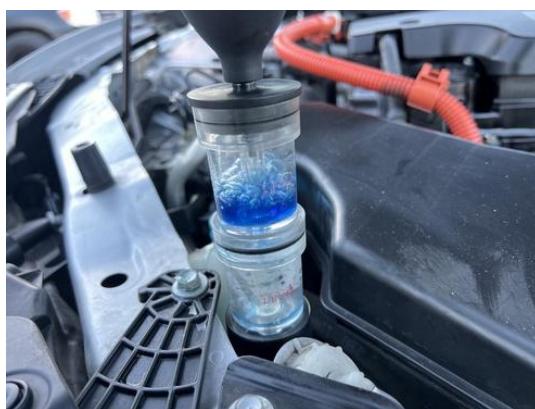
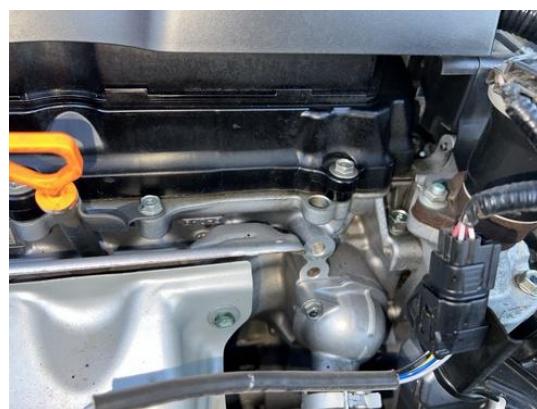
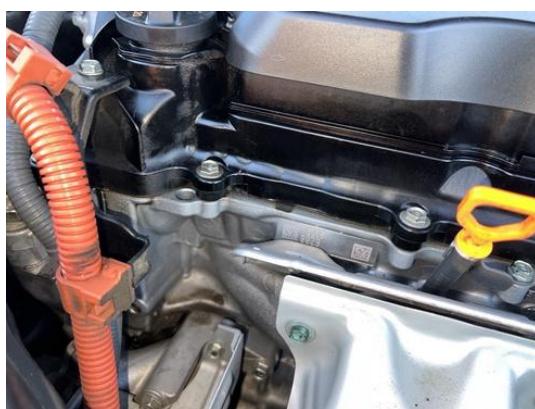
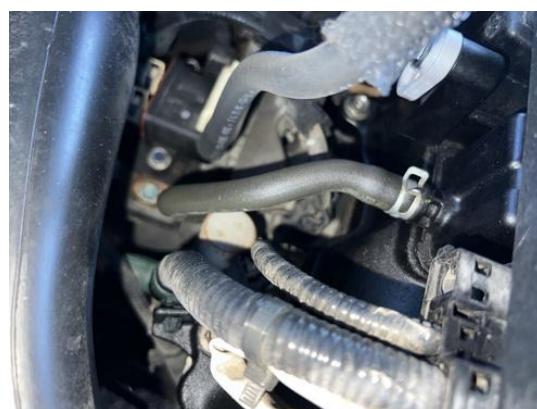
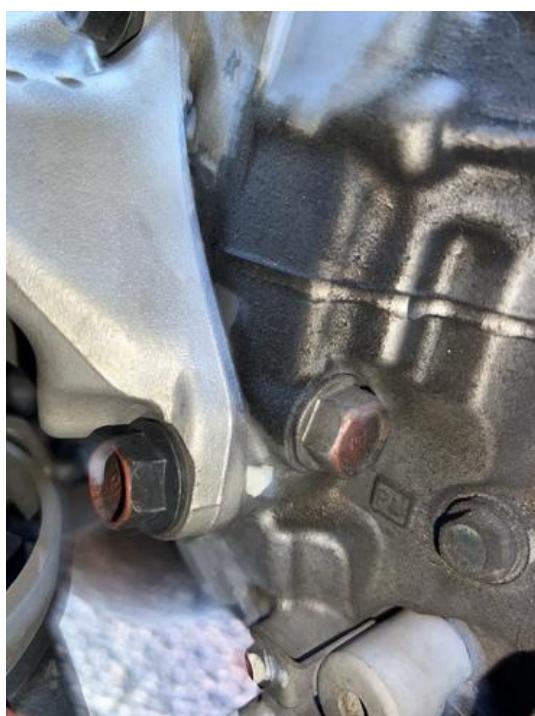
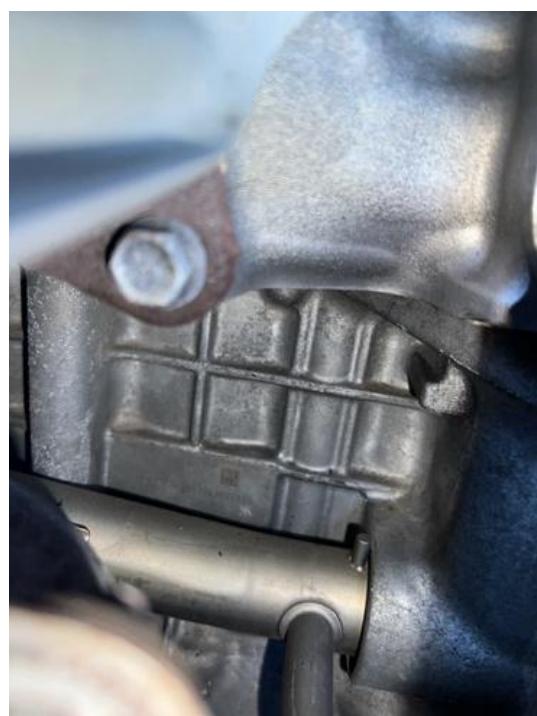
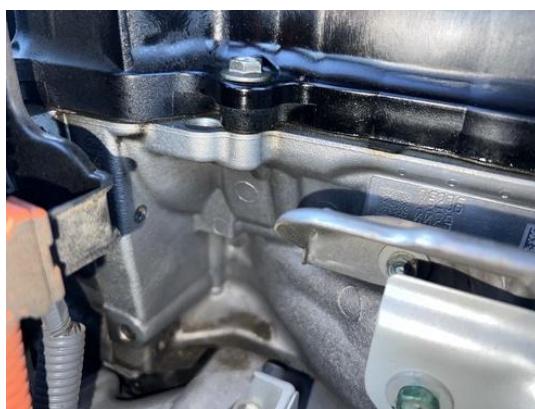
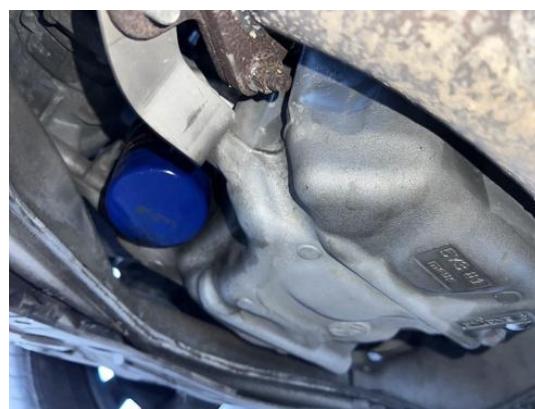
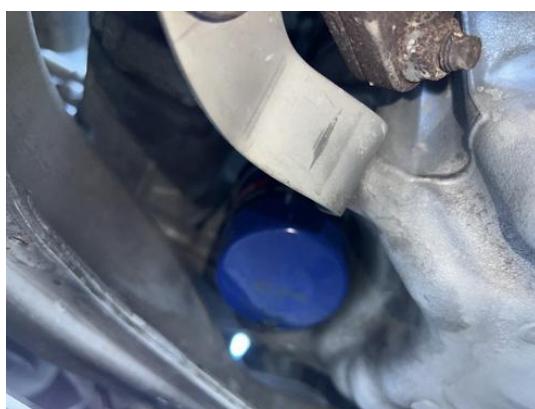
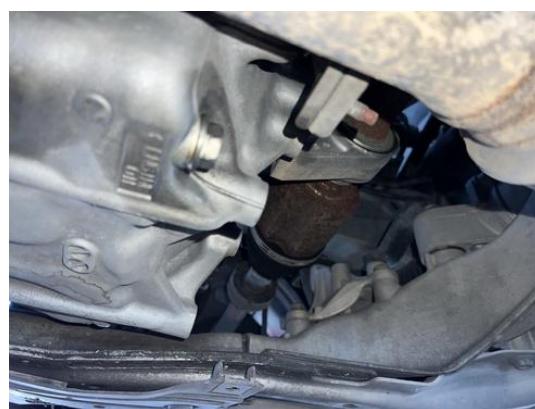
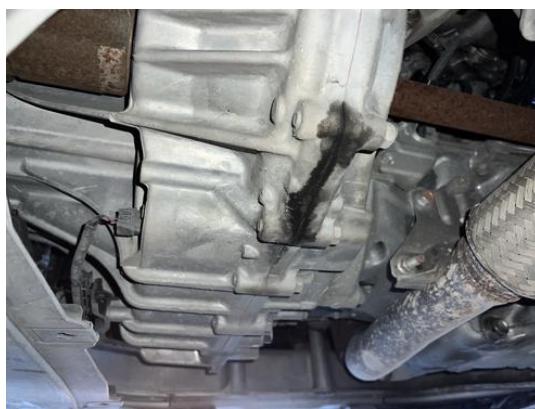
Engine clean internally, no gunk or sludge presents. Proper signs of maintenance present. Block test passed, no internal combustion leak out. Coolant mixture correct and cooling system functionality is healthy. All external engine accessories in good working. No oil leaks or seepage from anywhere on the engine. External drive belts in decent condition. Currently no concern in mechanical issues present in relation to the engine or related accessories. Proper correlation between the engine and hybrid assist system.

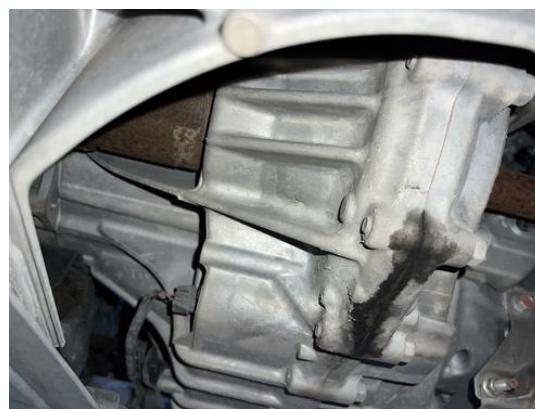
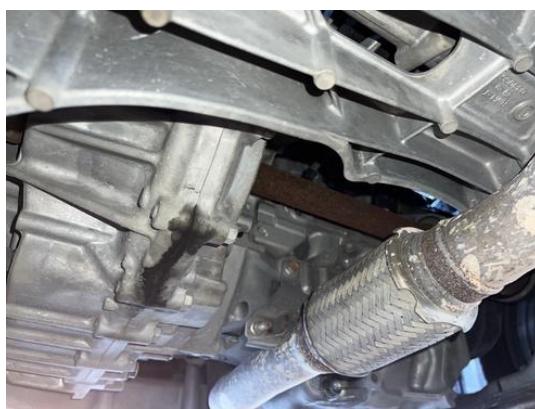
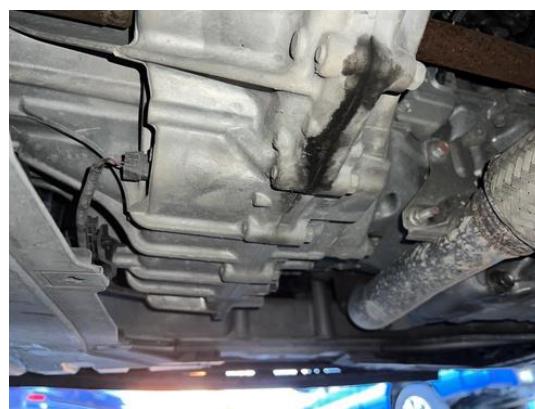
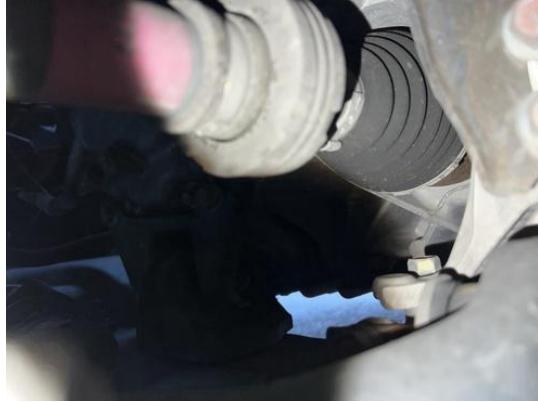
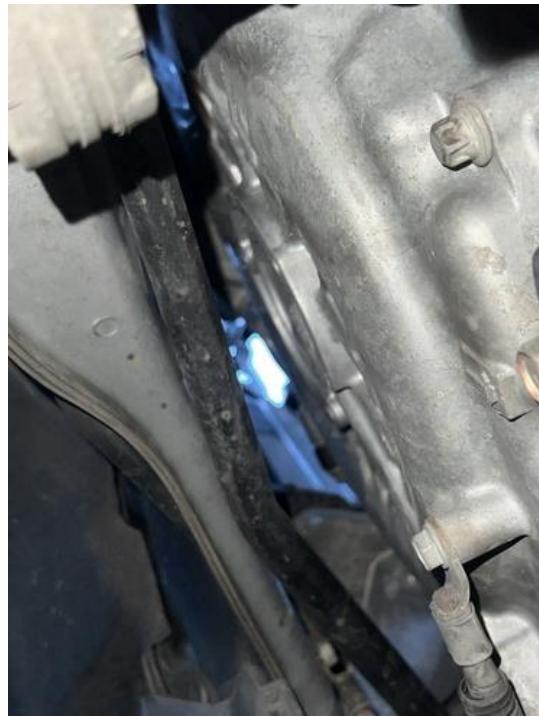
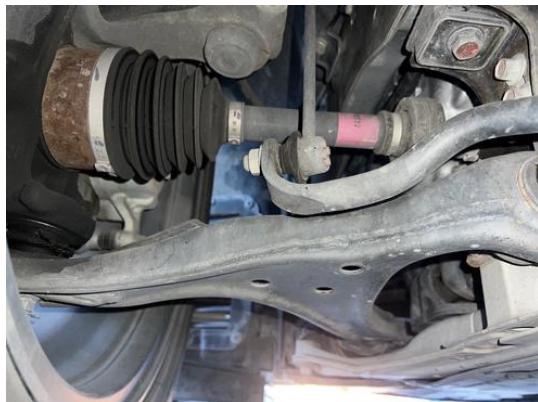
No transmission fluid leaks from the transmission casing or the transmission pan area. Both left and right side axle seals are free of any fluid leaks. Both left and right side CV axle are in healthy condition. Shift transitions out on the road are correct across-the-board

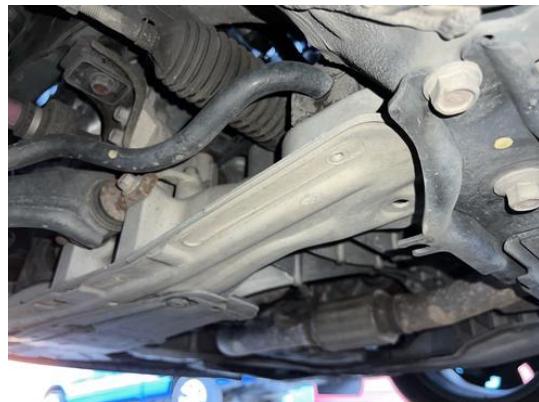
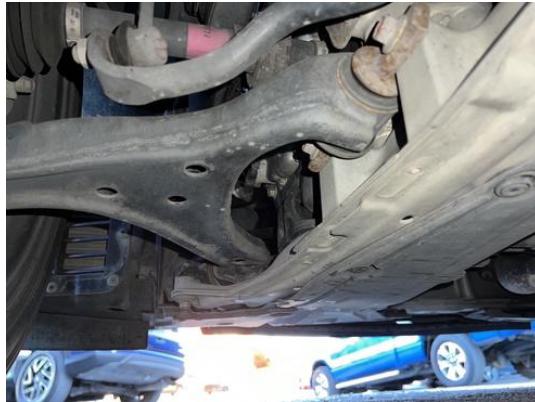
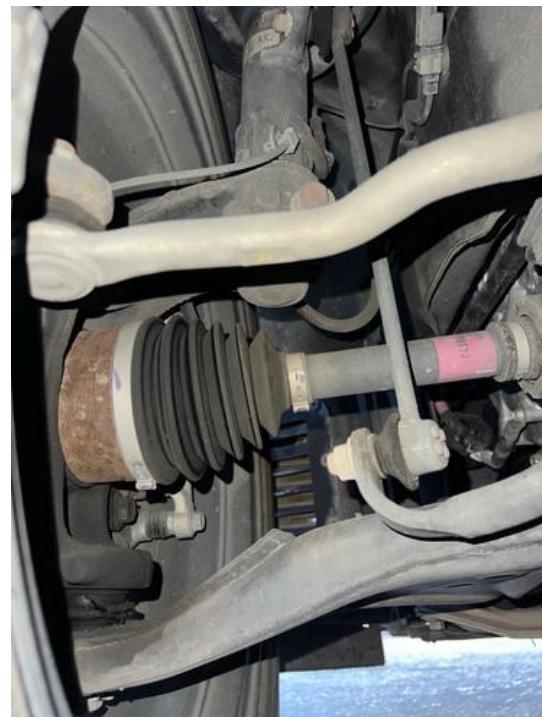
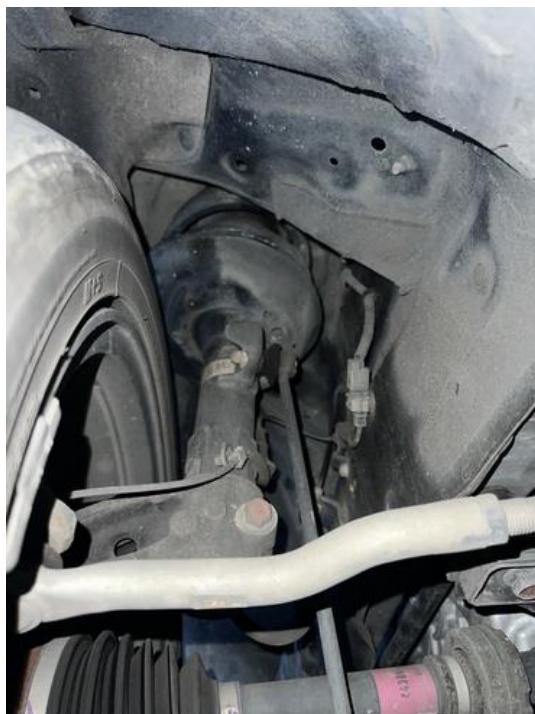
Normal fatigue notice to the suspension components. All of the suspension components seem to be original. None of the suspension components are blown out and due form the replacement. The No excessive surface rust on the exposed metal. No abnormal noise or feedback from the suspension while out on the road. All of the rubber in relation to the mounts, joints and bushings has decent texture.

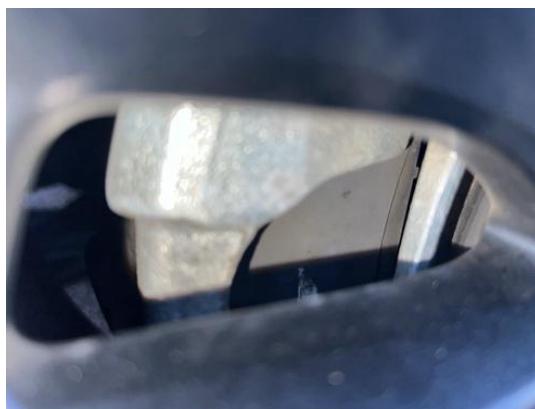
Photo 174

Brake fluid condition	Healthy
Brake fluid level	Healthy
Brake fluid leaks	None
Moisture content in brake fluid	None
Brake lines	Healthy
Brake calipers front	Healthy
Brake calipers rear	Healthy
Brake drums rear	N/A
Brake rotors front	Healthy
Brake rotors rear	Healthy
Front brake pad life remaining	50-75% remaining
