Peace of Mind Automotive Inspection Report.

Score	4 / 4 (100%)	Flagged items	0	Actions	0
Site conducted					Unanswered
Customer name					Luis LMJ auto motor sales
Date / Time					April 6th
Payment method					Invoice
Inspection cost					Fleet
Vehicle Year / Make / Model / Color					2017 Nissan versa
VIN					66814 last 5

license plate					Dealer
Mileage					67666
Color					White

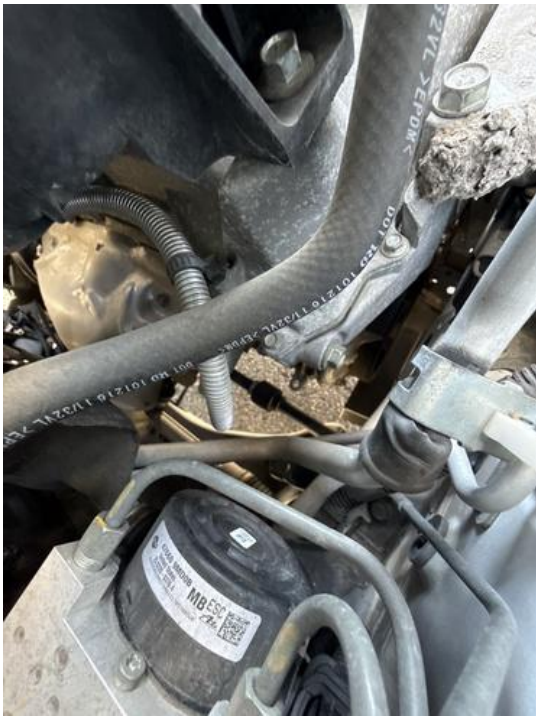
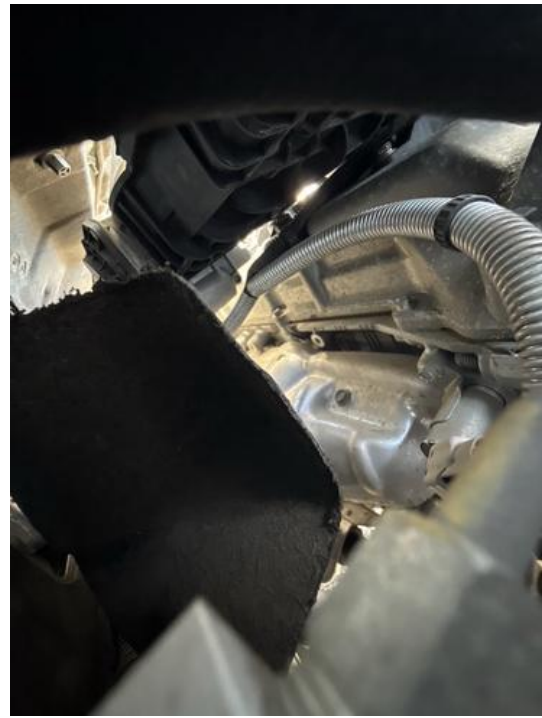
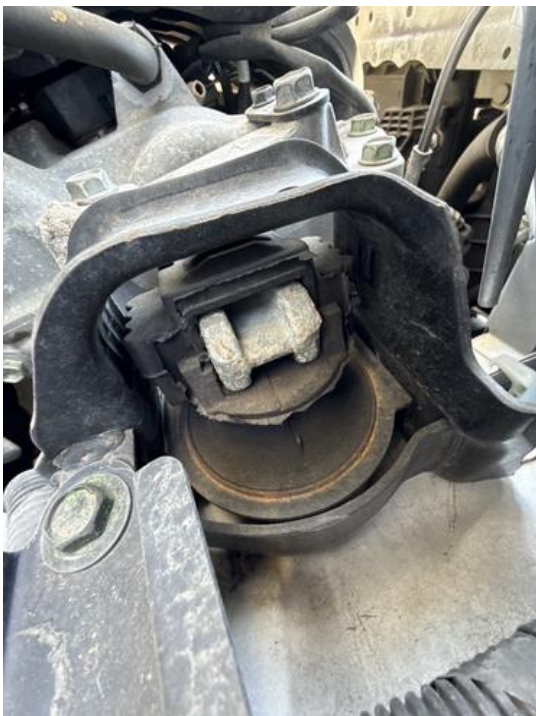
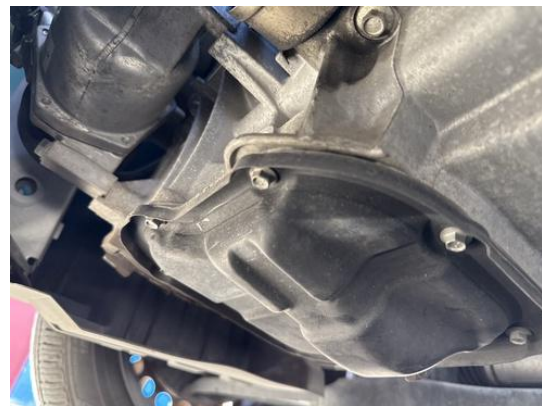
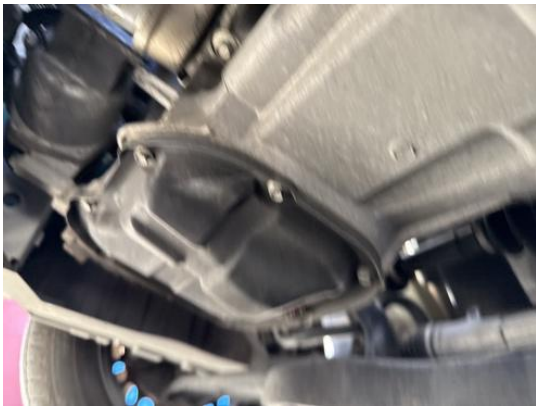
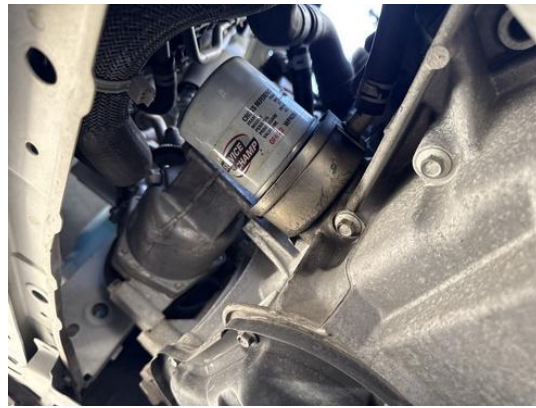
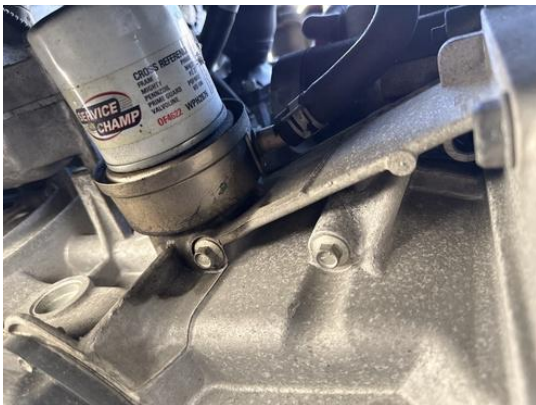
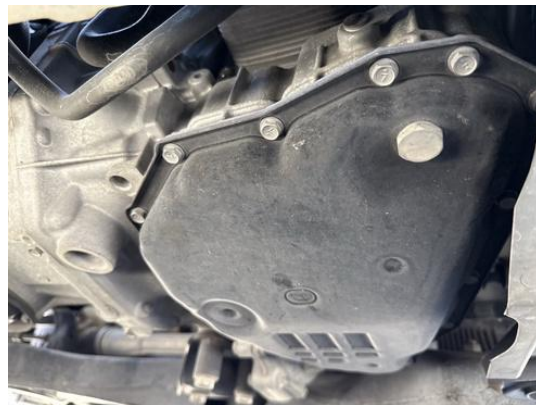
Engine block test	Pass
Coolant mixture test	Pass
Air filter condition	Normal wear
Engine oil condition	Normal wear
Engine oil level	Healthy
Engine oil leaks	None
Coolant level	Healthy
Coolant hoses	Healthy
Radiator condition / function	Healthy
Engine operating temperature	Healthy
Cooling fan function	Healthy
Drive belt condition	Healthy

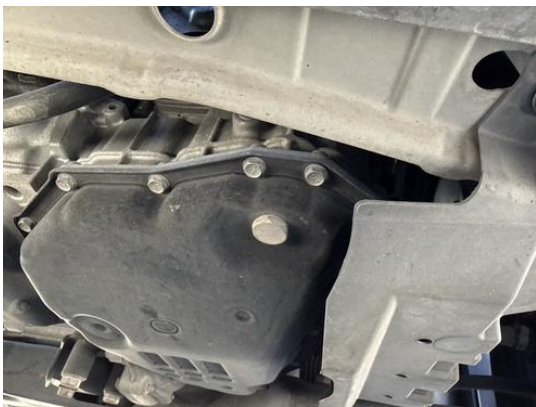
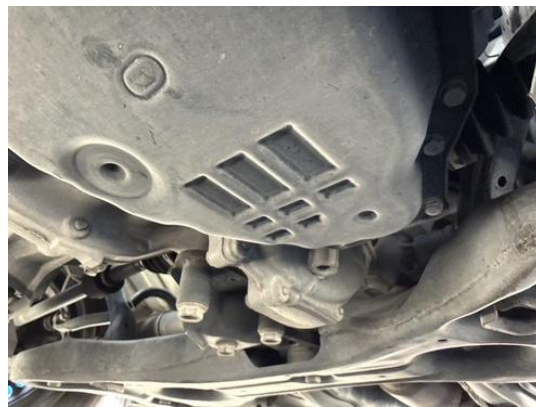
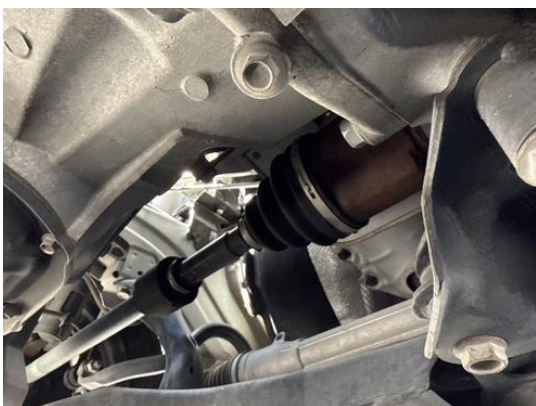
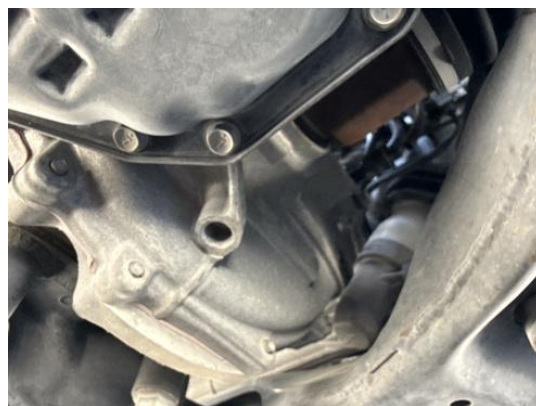
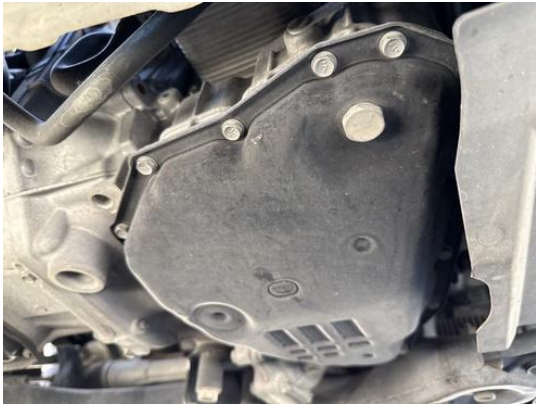
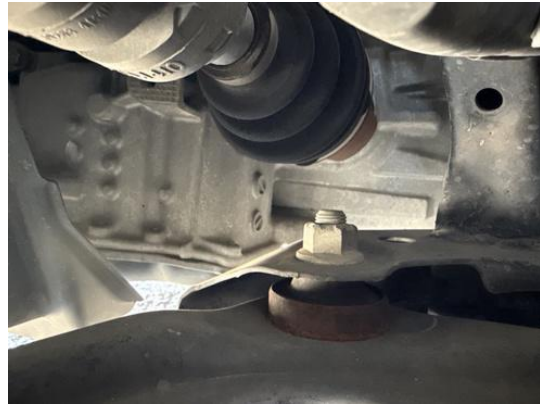
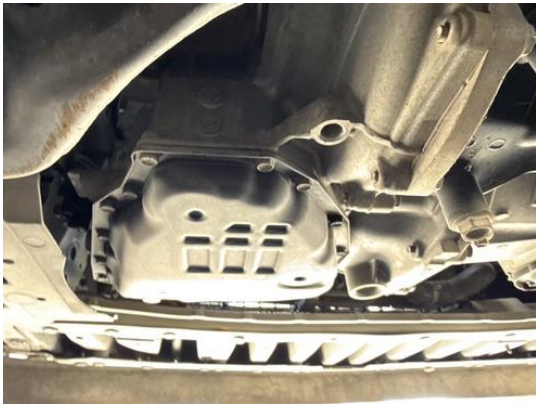
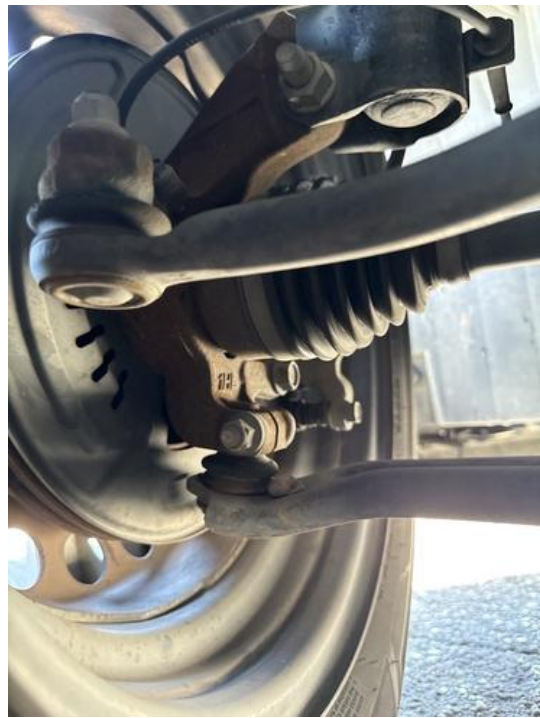
Transmission fluid level	Healthy
Transmission fluid condition	Healthy
Transmission fluid leaks	None

No transmission fluid leaks from the transmission casing or the transmission pan area. Both left and right side CV axle are in healthy condition. Both left and right side axle seals are free of any fluid leaks. Shift transitions out on the road are correct across the board.

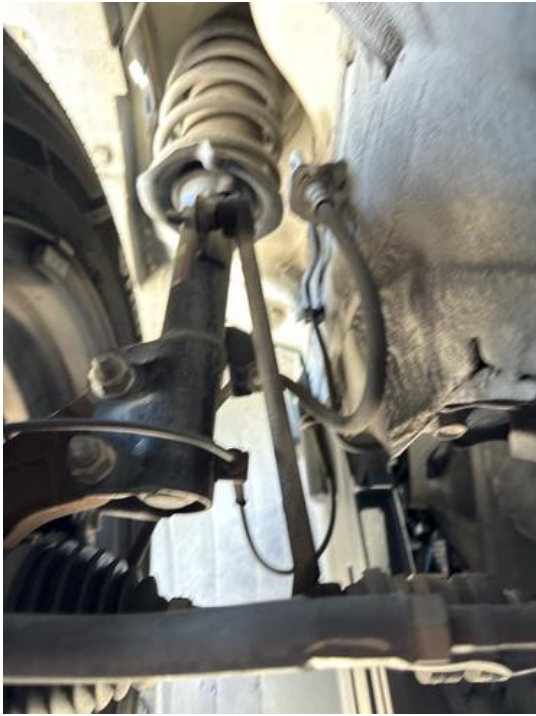
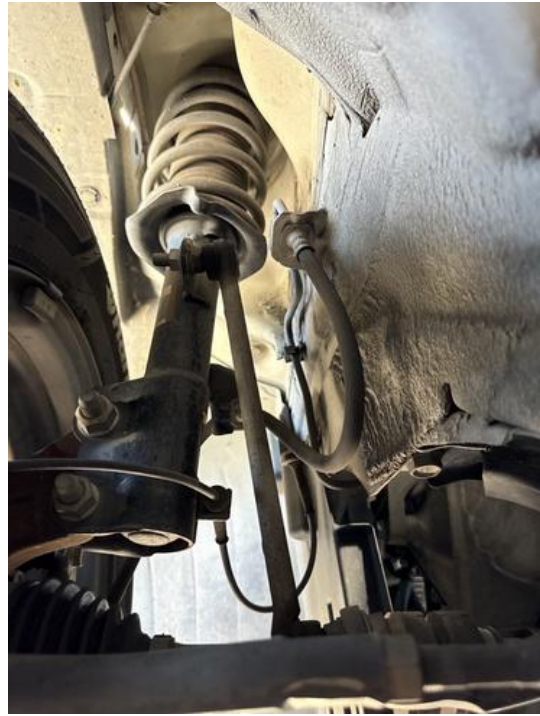
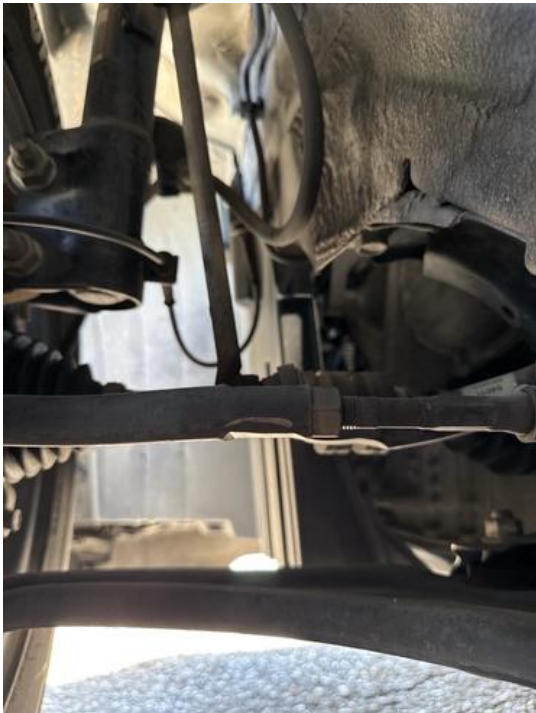
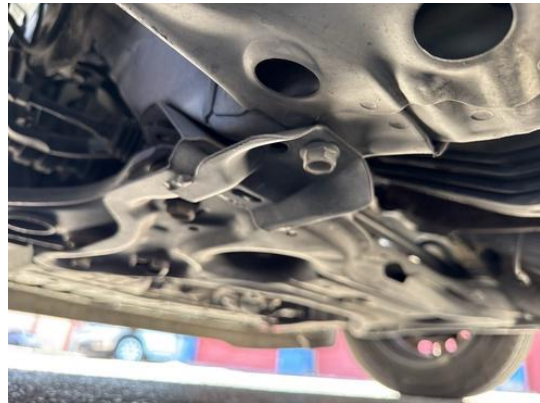
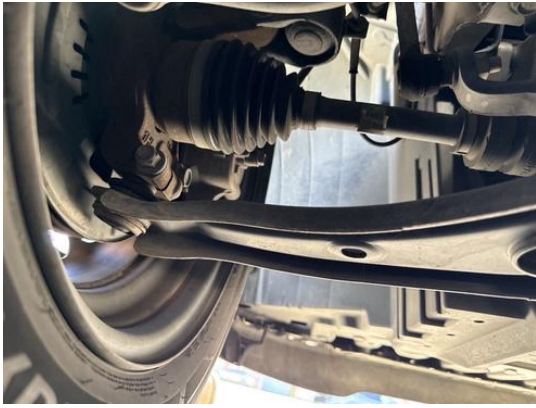
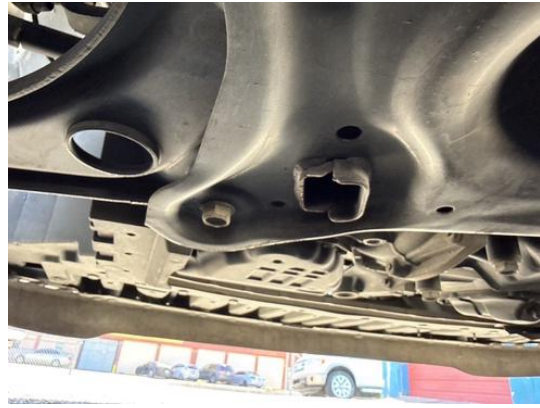
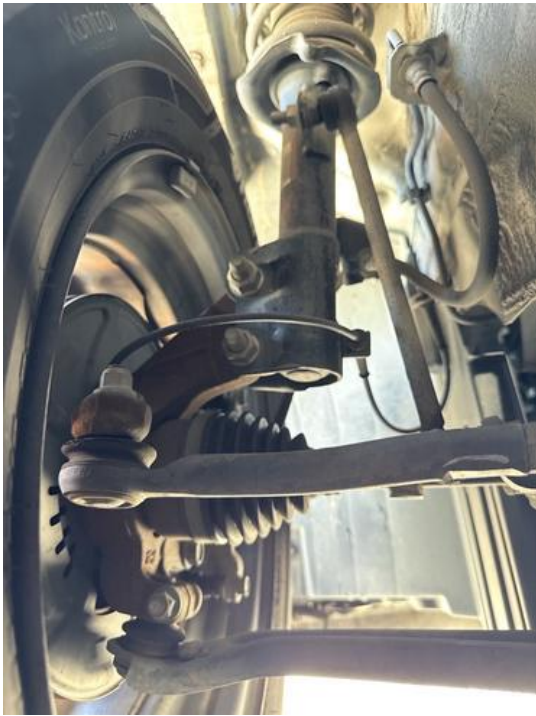
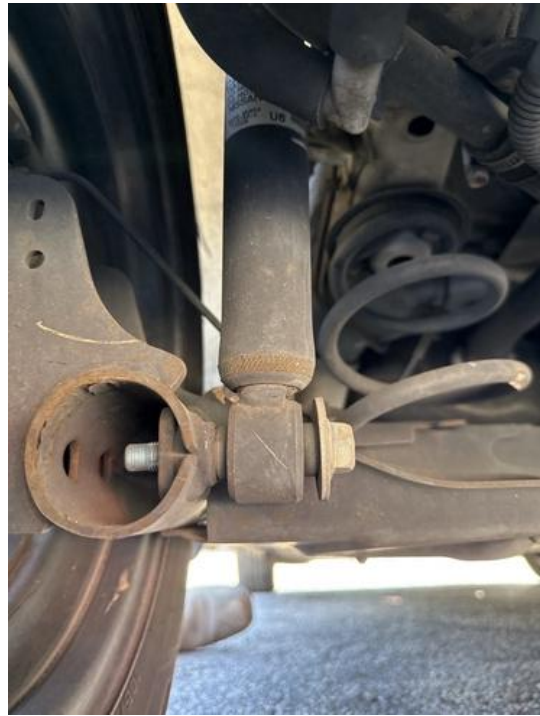
Normal fatigue notice to the suspension components. All of the suspension components seem to be original. None of the suspension components are blown out and due form the replacement. The No excessive surface rust on the exposed metal. No abnormal noise or feedback from the suspension while out on the road. All of the rubber in relation to the mounts, joints and bushings has decent texture.

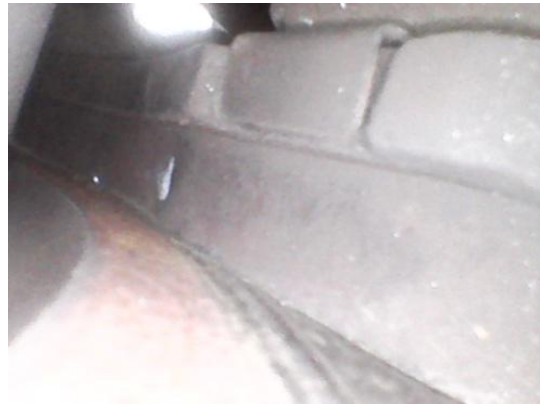
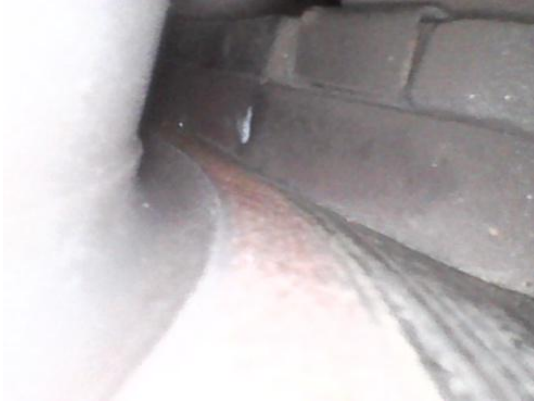
Braking system condition	
Brake fluid condition	Healthy
Brake fluid level	Healthy
Brake fluid leaks	None
Moisture content in brake fluid	None
Brake lines	Healthy
Brake calipers front	Healthy
Brake calipers rear	N/A
Brake drums rear	Healthy
Brake rotors front	Healthy
Brake rotors rear	N/A
Front brake pad life remaining Over 80% brake pad life remaining

Photo 153 Photo 154 Photo 155	75-100% remaining
Rear brake pad life remaining	
E-brake function	Healthy
