Peace of Mind Automotive Inspection Report.

Score	4 / 4 (100%)	Flagged items	1	Actions	0
Site conducted				Unanswered	
Customer name				Luis LMJ auto motor sales	
Date / Time				Jan 21st	
Payment method				Invoice	
Inspection cost				199	
Vehicle Year / Make / Model / Color				2017 dodge ram 1500	
VIN				14562 last 5

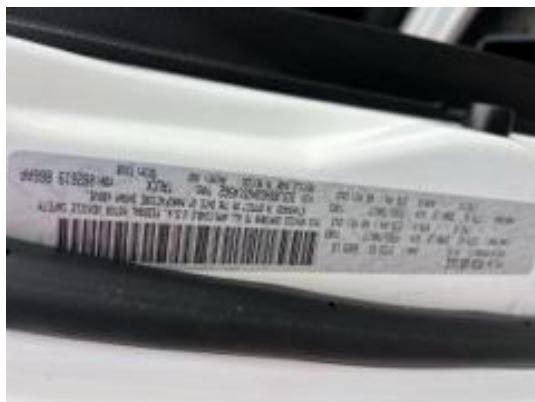
Photo 1	
license plate				Dealer	
Mileage				106427	
Color				White

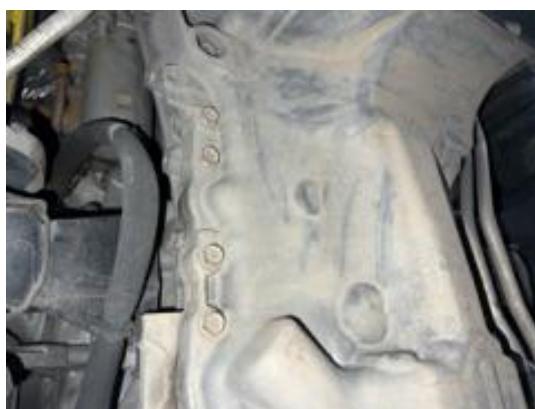
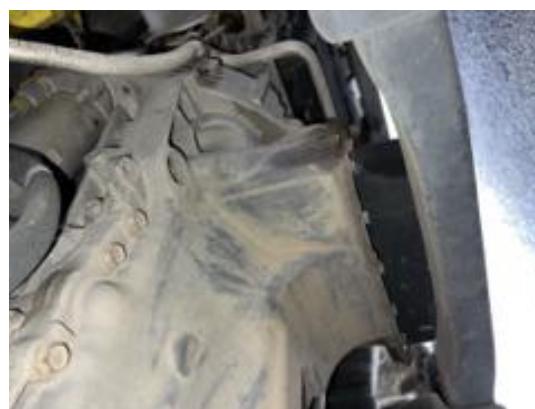
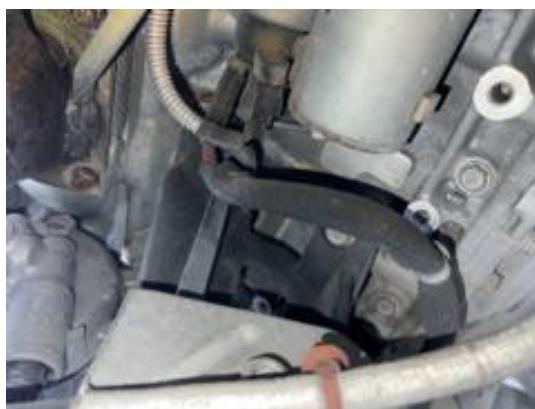
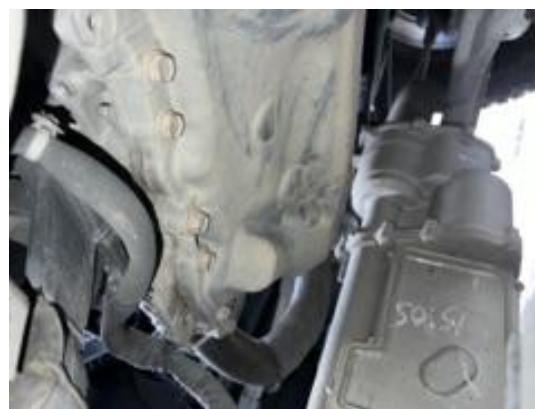
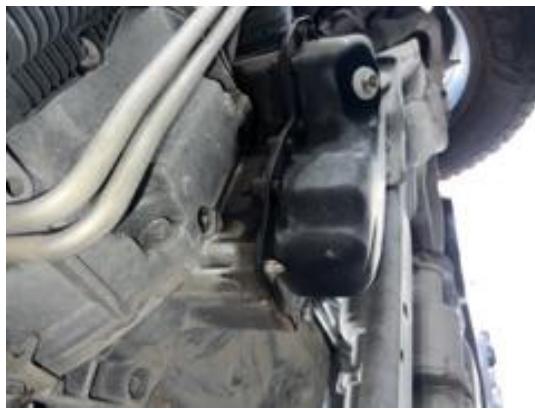
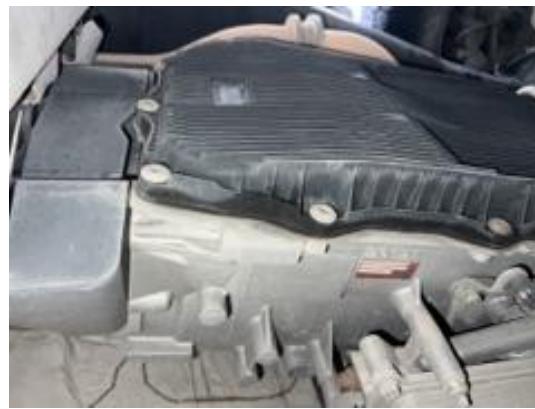
Engine clean internally, no gunk or sludge presents. Proper signs of maintenance present. Block test passed, no internal combustion leak out. Coolant mixture correct and cooling system functionality is healthy. All external engine accessories in good working. No leaks or seepage from anywhere on the engine. External drive belts in decent condition. Currently no concern in mechanical issues present in relation to the engine or related accessories.

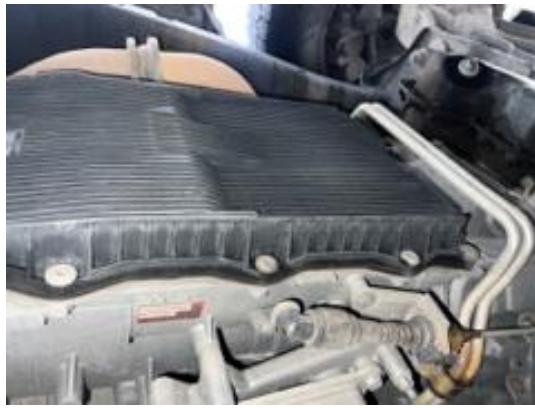
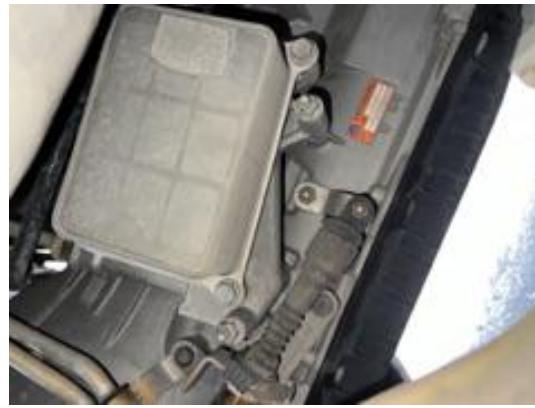
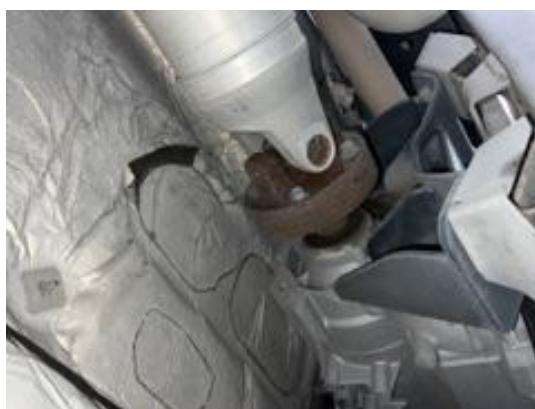
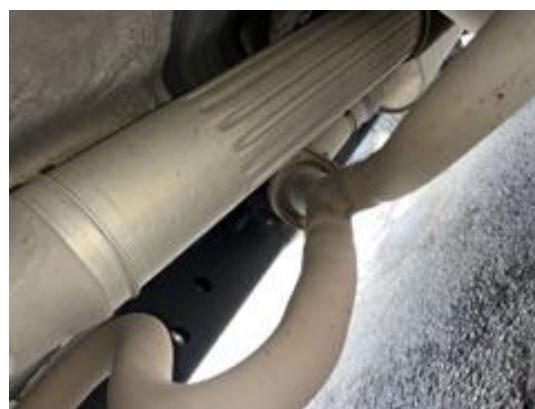
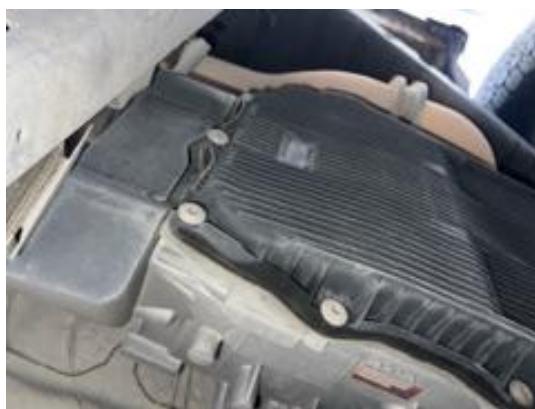
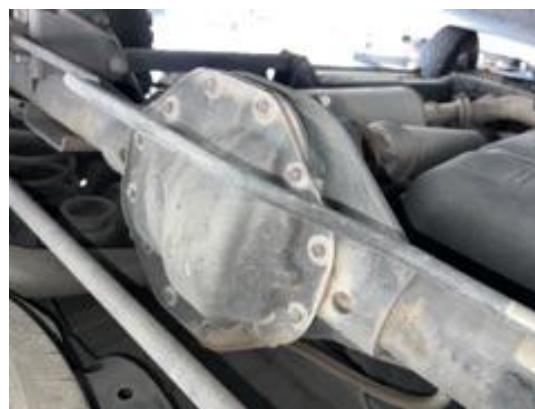
No transmission fluid leak out from the transmission casing or the transmission pan area. Drive shaft and seal is free of any fluid leaks. The rear differential is free of any fluid leak out. Shift transitions out on the road are correct across the board.

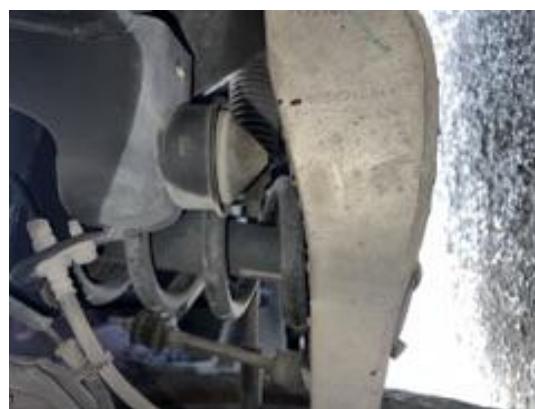
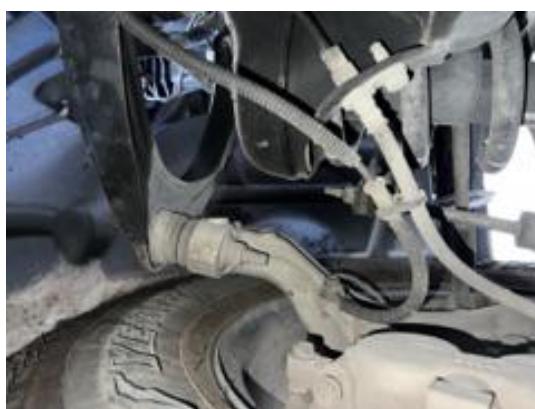
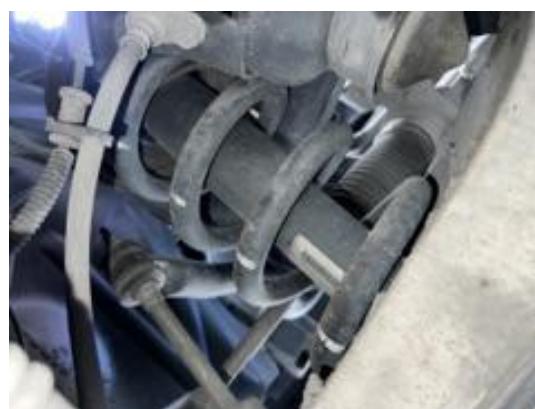
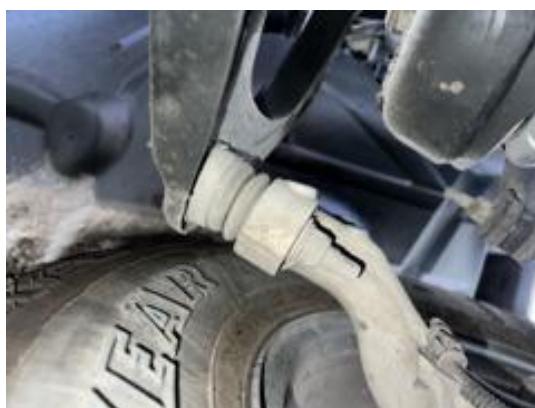
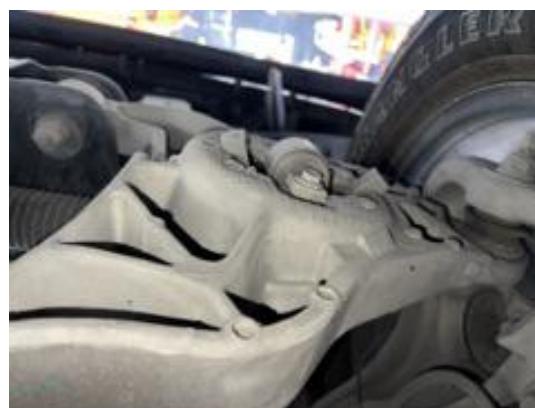
Normal fatigue notice to the suspension components. All of the suspension components seem to be original. None of the suspension components are blown out and due form the replacement. The No excessive surface rust on the exposed metal. No abnormal noise or feedback from the suspension while out on the road. All of the rubber in relation to the mounts, joints and bushings has decent texture.
