## Peace of Mind Automotive Inspection Report.

<b>Site conducted</b>	Unanswered
<b>Customer name</b>	Luis LMJ Auto motor sales
<b>Date / Time</b>	Jan 21st
<b>Payment method</b>	Invoice
<b>Inspection cost</b>	199
<b>Vehicle Year / Make / Model / Color</b>	2017 dodge ram 1500

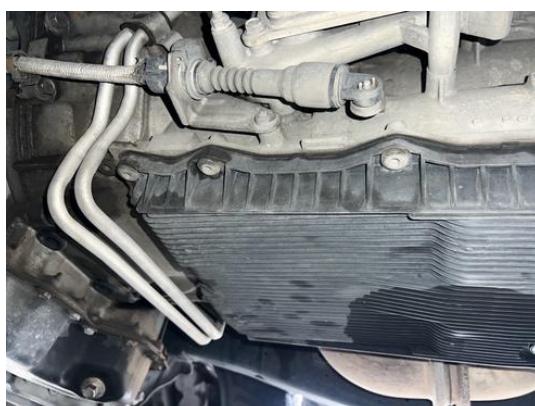
Photo 162

No transmission fluid leak out from the transmission casing or the transmission pan area. Drive shaft and seal is free of any fluid leaks. The rear differential is free of any fluid leak out. Shift transitions out on the road are correct across the board.

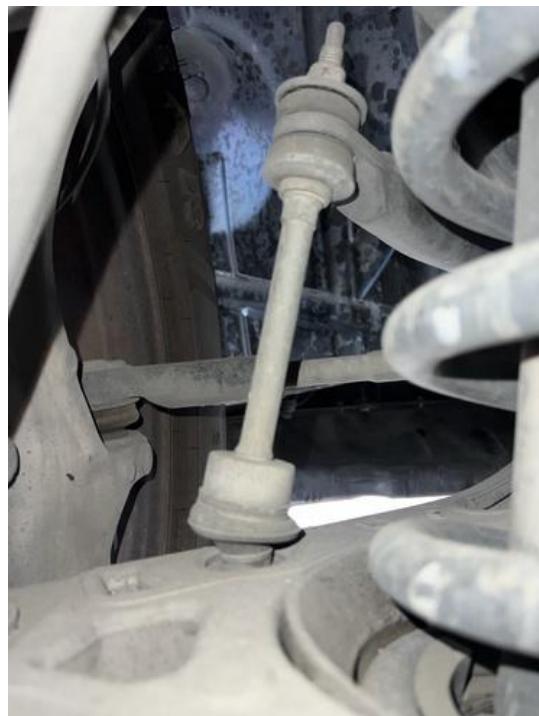
Photo 177

Normal fatigue notice to the suspension components. All of the suspension components seem to be original. None of the suspension components are blown out and due form the replacement. The No excessive surface rust on the exposed metal. No abnormal noise or feedback from the suspension while out on the road. All of the rubber in relation to the mounts, joints and bushings has decent texture.

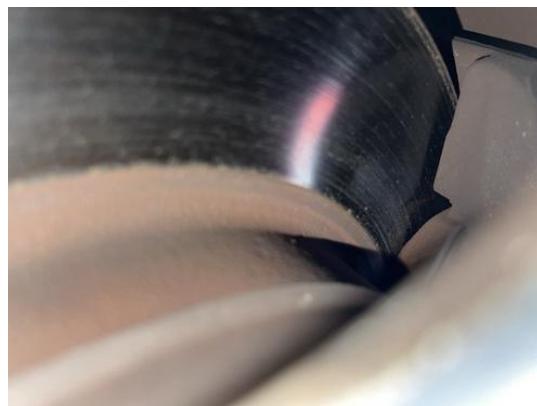
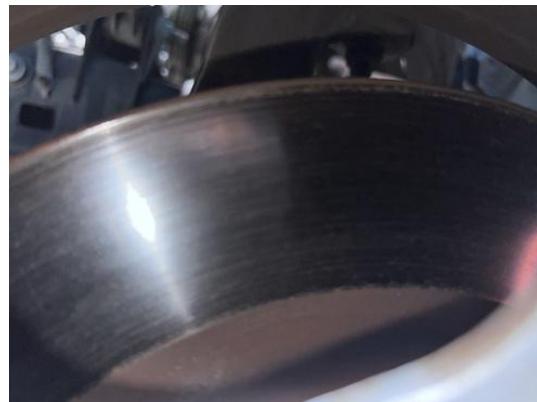
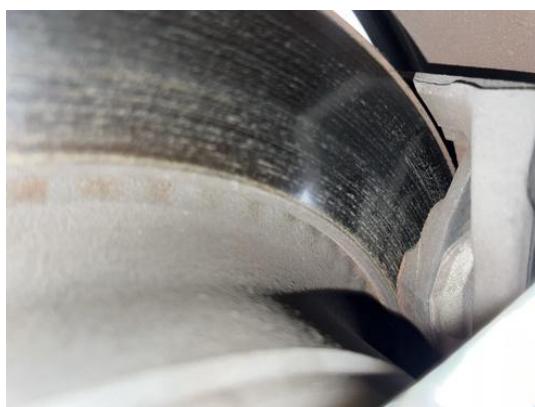
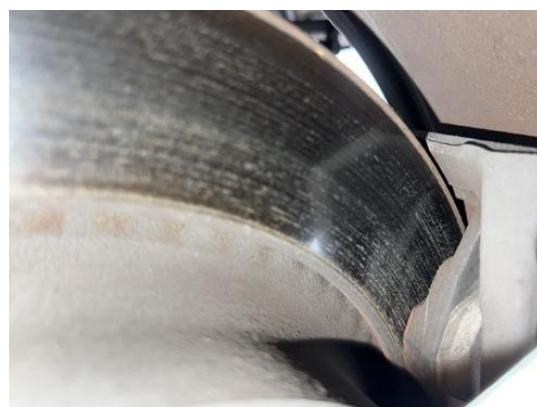
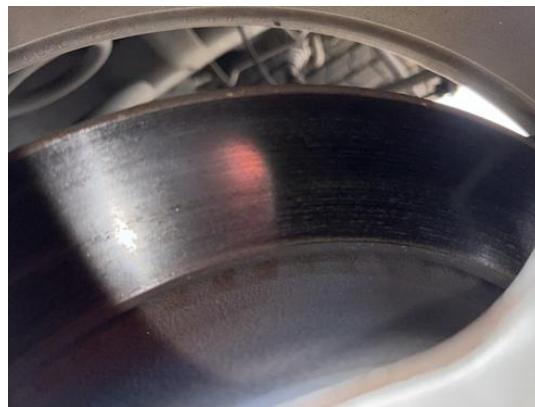
<b>Brake fluid condition</b>	Healthy
<b>Brake fluid level</b>	Healthy
<b>Brake fluid leaks</b>	None
<b>Moisture content in brake fluid</b>	None
<b>Brake lines</b>	Healthy
<b>Brake calipers front</b>	Healthy
<b>Brake calipers rear</b>	Healthy
<b>Brake drums rear</b>	N/A
<b>Brake rotors front</b>	Healthy
<b>Brake rotors rear</b>	Healthy
<b>Front brake pad life remaining</b>	50-75% remaining
