Peace of Mind Automotive Inspection Report.

Score	4 / 4 (100%)	Flagged items	0	Actions	0
Site conducted					Unanswered
Customer name					Lmj auto motor sales
Date / Time					May 19th
Payment method					Invoice
Inspection cost					199
Vehicle Year / Make / Model / Color					2018 jeep wrangler sport
VIN					76442 last 5

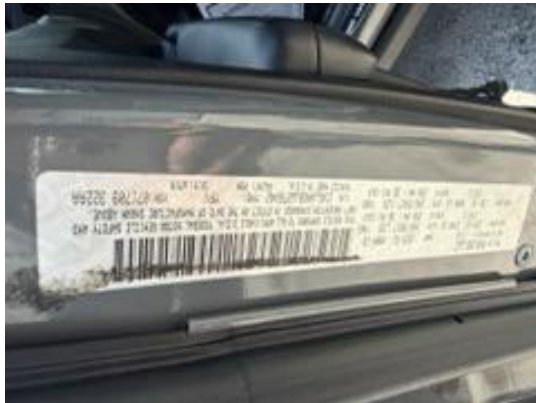
Photo 1					
license plate					Dealer
Mileage					57777
Color					Grey

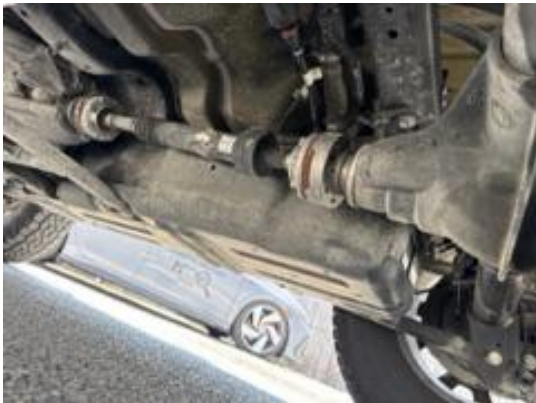
Photo 136

<p>Photo 138</p> </div> </div>	
Differential leaks	None
4x4 function / engagement	Healthy
Clutch engagement	Healthy
Gear engagement	Healthy
Shift transitions	Healthy

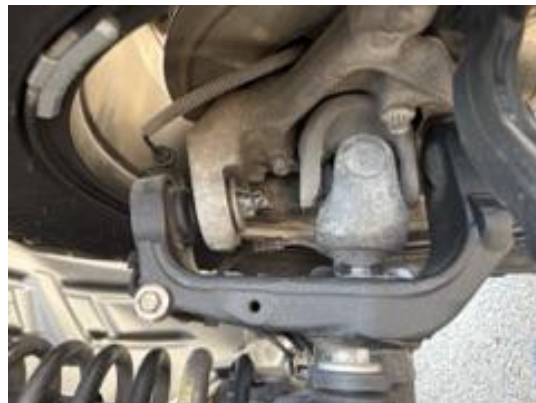
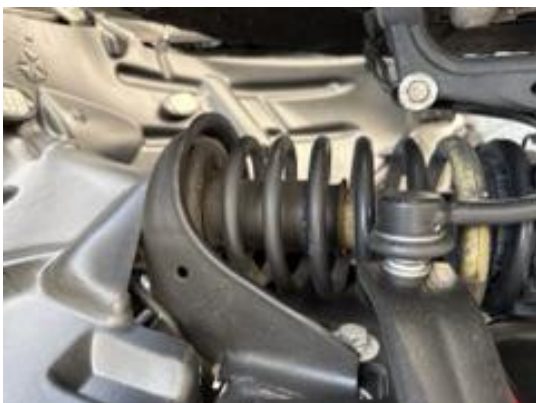
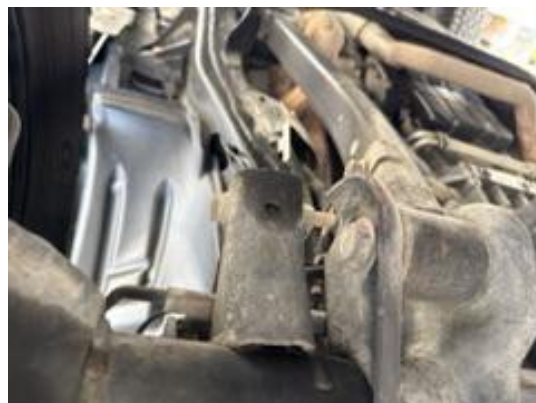
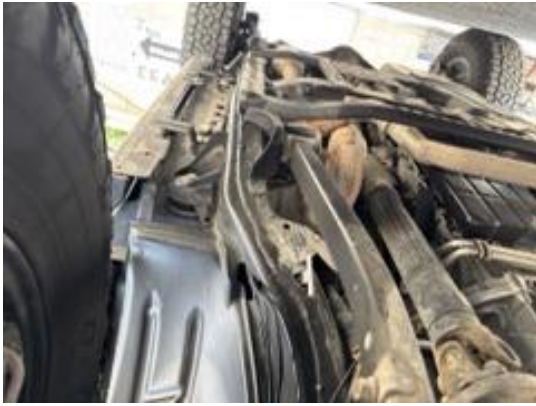
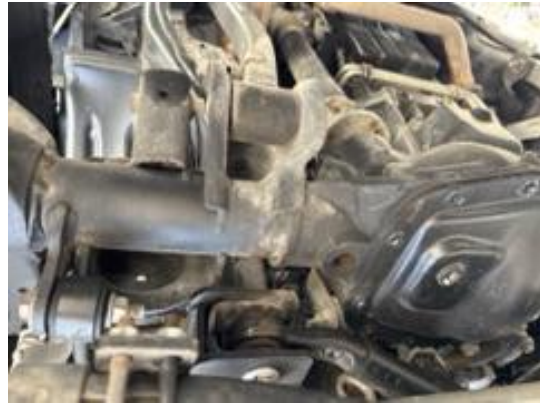
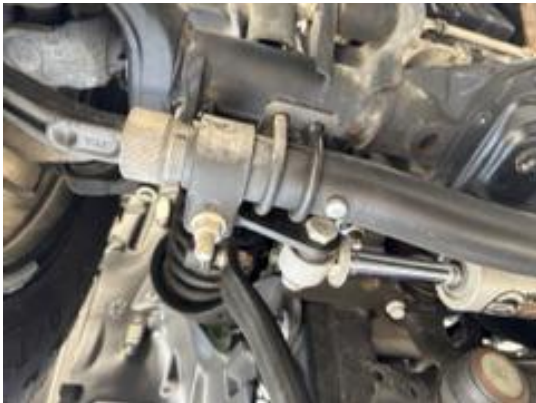
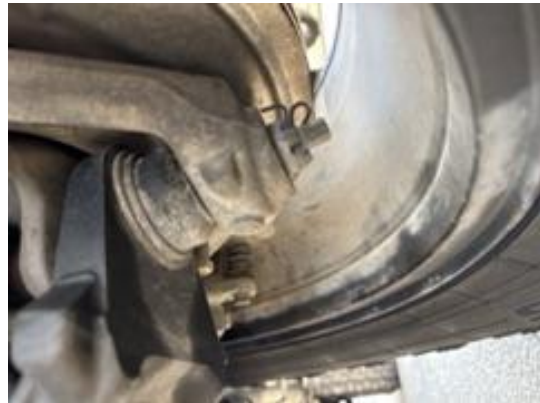
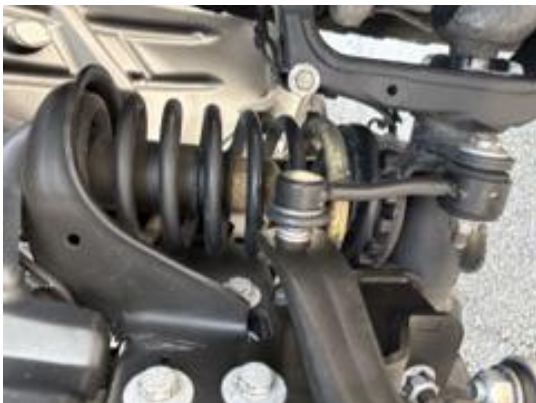
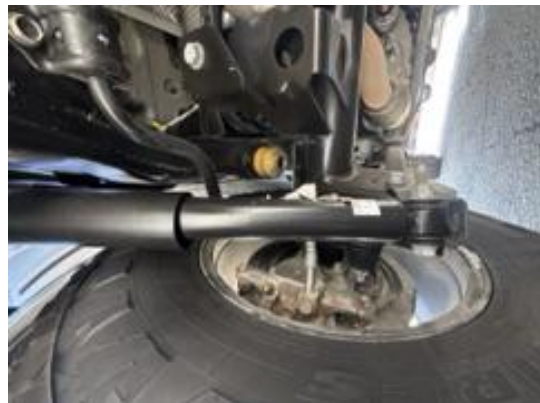
Normal fatigue notice to the suspension components. All of the suspension components seem to be original. None of the suspension components are blown out and due form the replacement. The No excessive surface rust on the exposed metal. No abnormal noise or feedback from the suspension while out on the road. All of the rubber in relation to the mounts, joints and bushings has decent texture.
