## Peace of Mind Automotive Inspection Report.

<b>Site conducted</b>	Unanswered
<b>Customer name</b>	LMJ Auto motor sales
<b>Date / Time</b>	Dec 10th
<b>Payment method</b>	Invoice
<b>Inspection cost</b>	199
<b>Vehicle Year / Make / Model / Color</b>	2019 Chevy Colorado

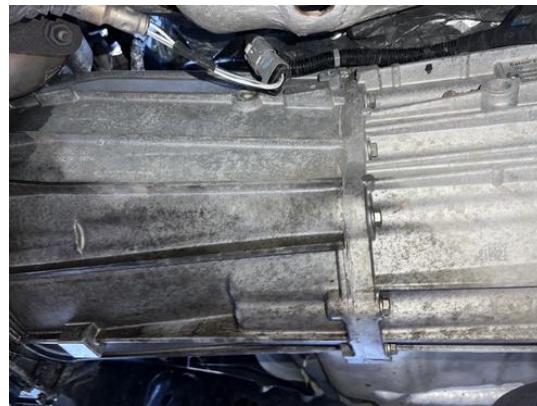
Photo 147

Small amount of oil residue/oil seepage noticed at the backside of the oil pan gasket area, a future repair to expect will be a replacement of the oil pan gasket

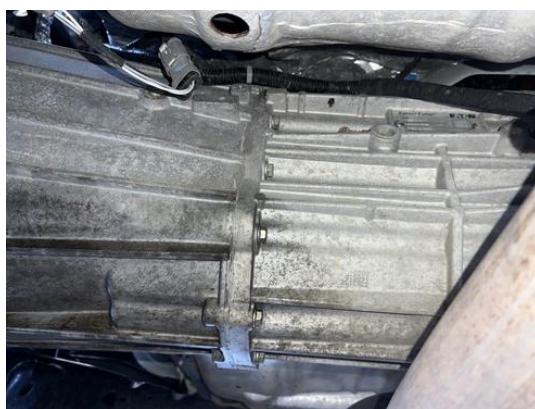
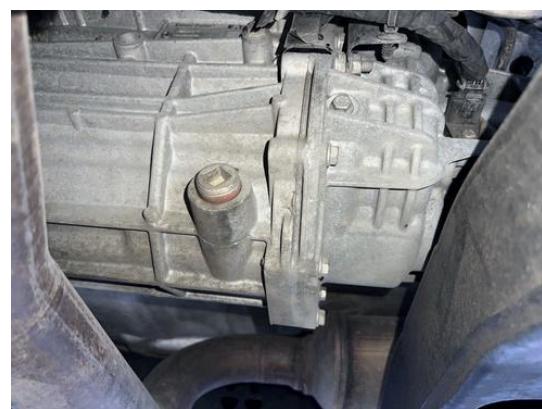
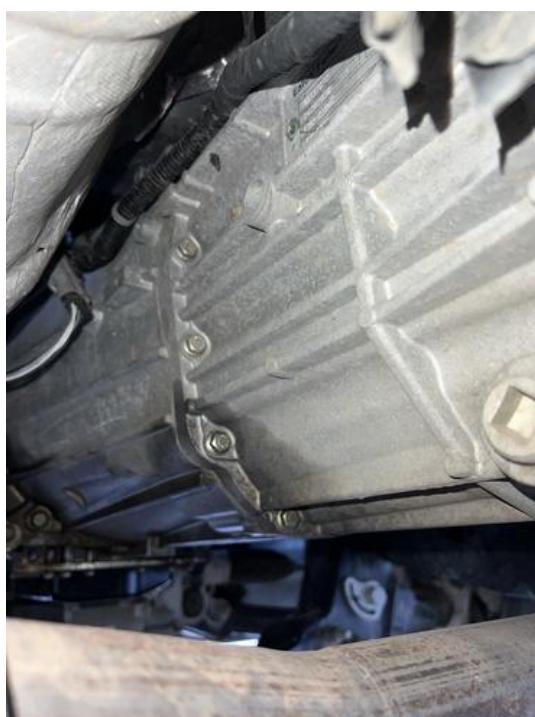
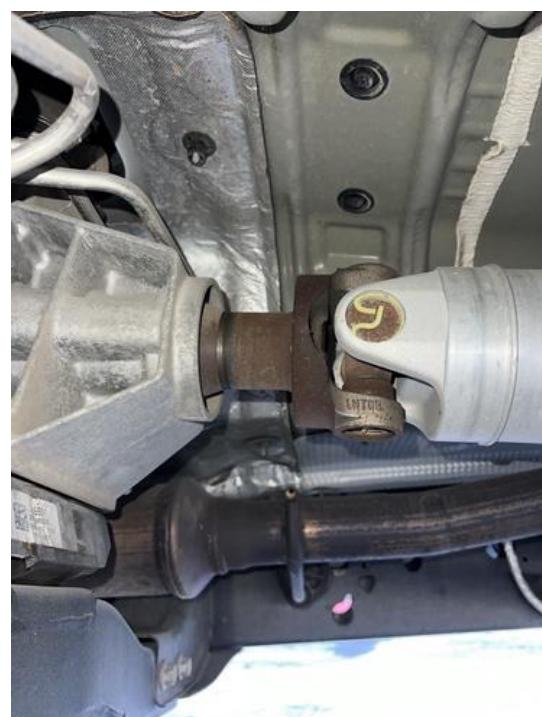
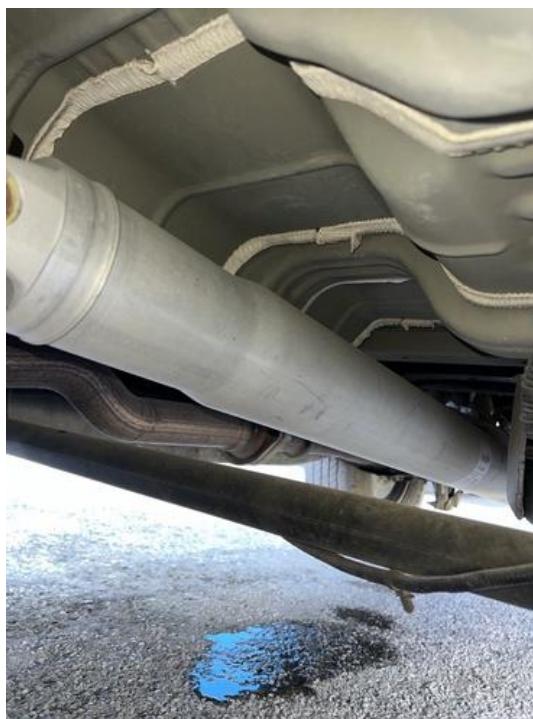
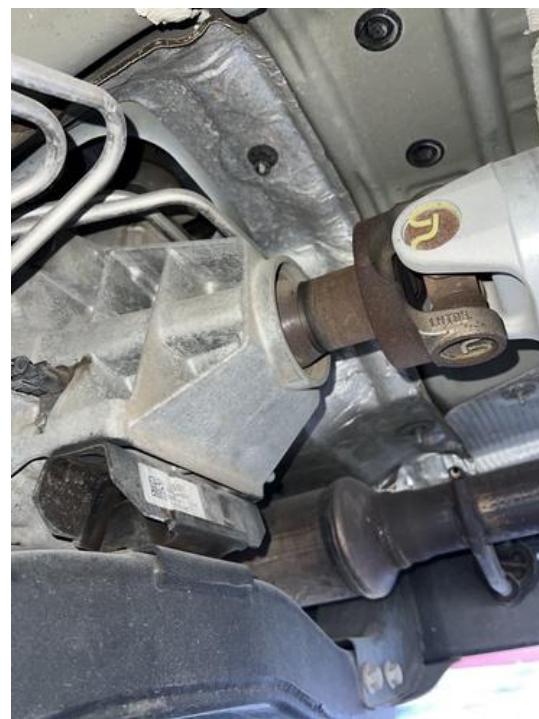
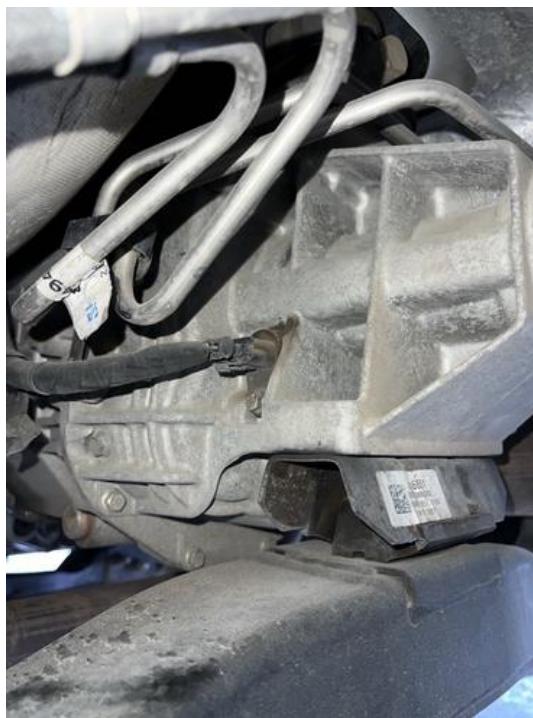
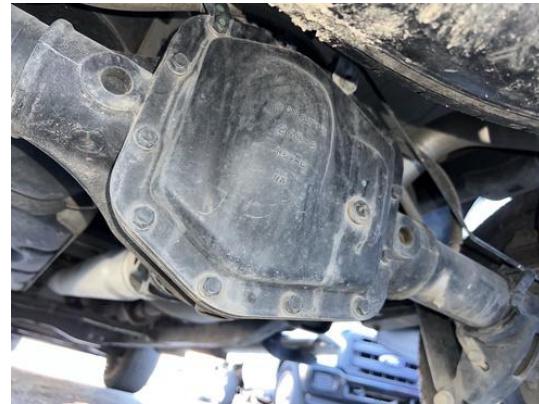
No transmission fluid leak out from the transmission casing or the transmission pan area. Drive shaft and seal is free of any fluid leaks. The rear differential is free of any fluid leak out. Shift transitions out on the road are correct across the board. Clutch engagement is correct.

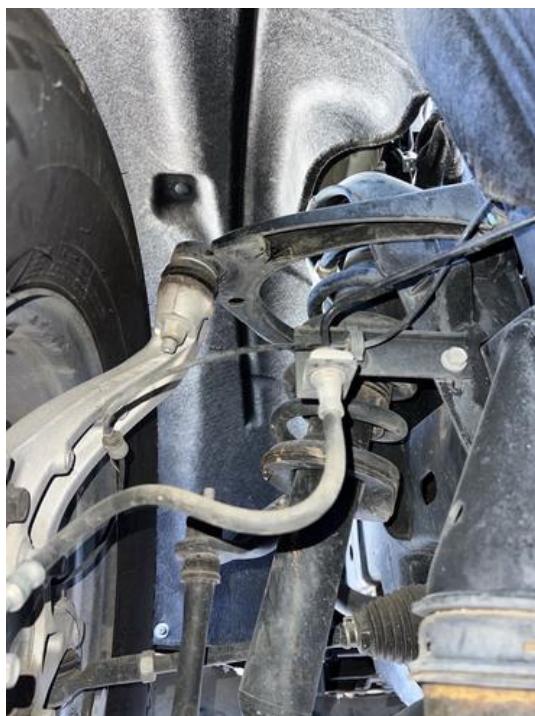
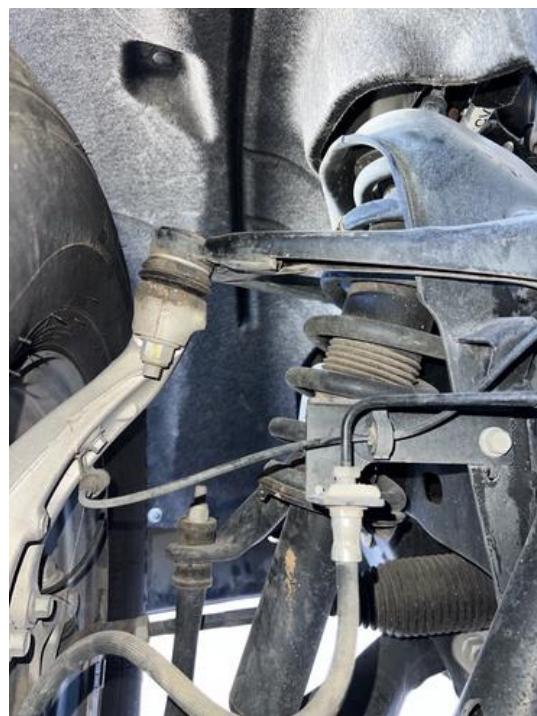
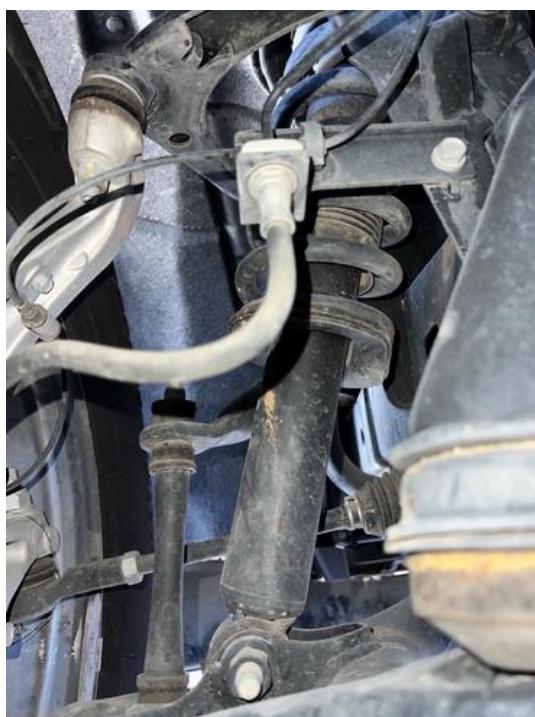
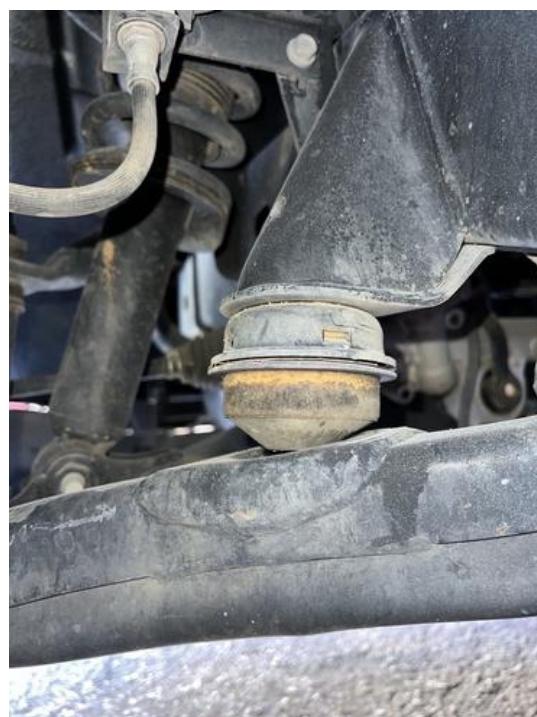
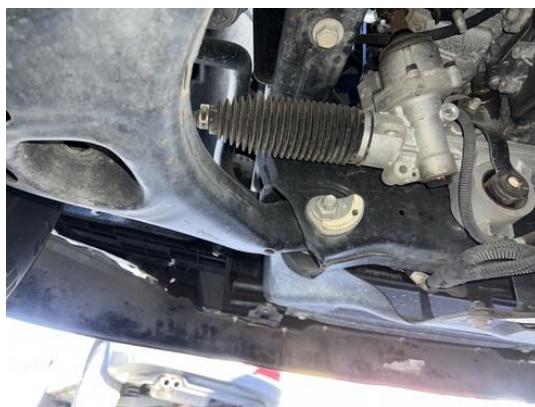
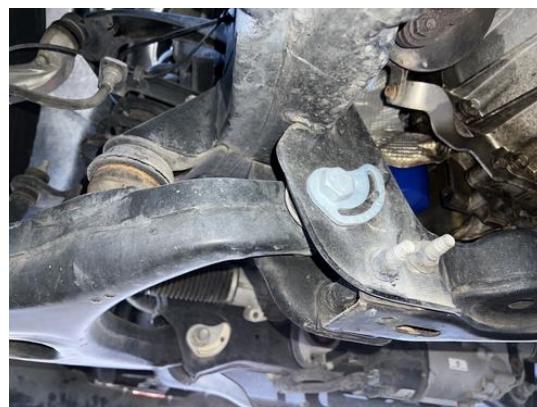
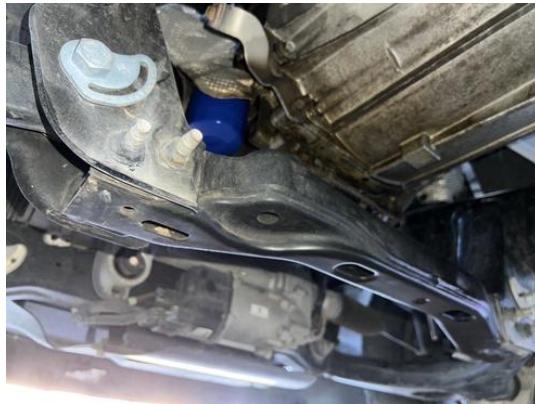
Normal fatigue notice to the suspension components. All of the suspension components seem to be original. None of the suspension components are blown out and due form the replacement. The No excessive surface rust on the exposed metal. No abnormal noise or feedback from the suspension while out on the road. All of the rubber in relation to the mounts, joints and bushings has decent texture.

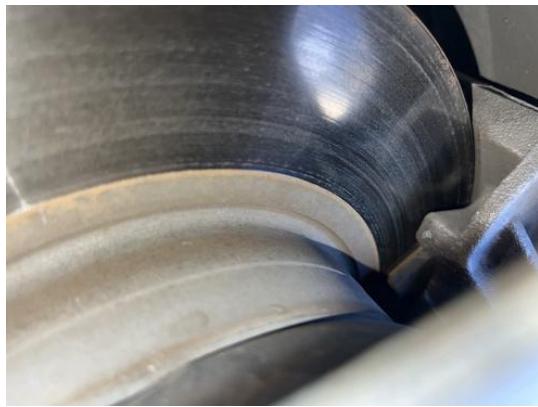
Photo 180

There is right about 50% brake pad life remaining on both the front and rear brake system. Brake rotors both front and rear are in healthy condition.
