## Peace of Mind Automotive Inspection Report.

| Score | 4 / 4 (100%) | Flagged items | 0 | Actions | 0 |
|---|---|---|---|---|---|
| Vehicle Year / Make / Model / Color | | | | | 2019 ford fiesta |
| Mileage | | | | | 99824 |

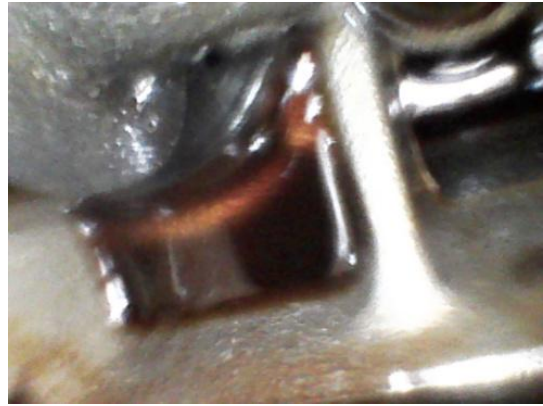
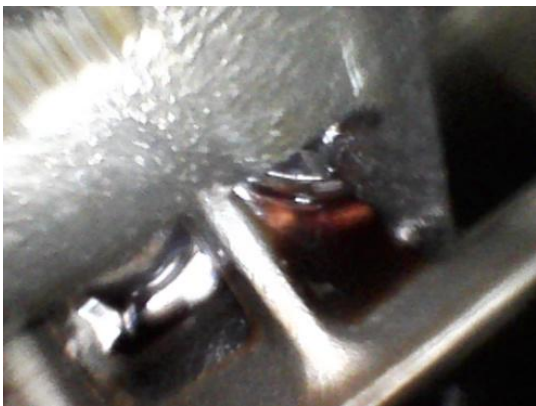
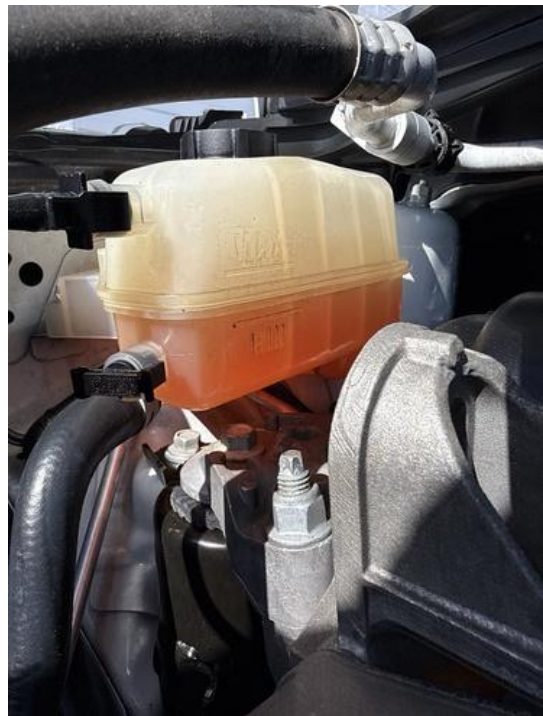
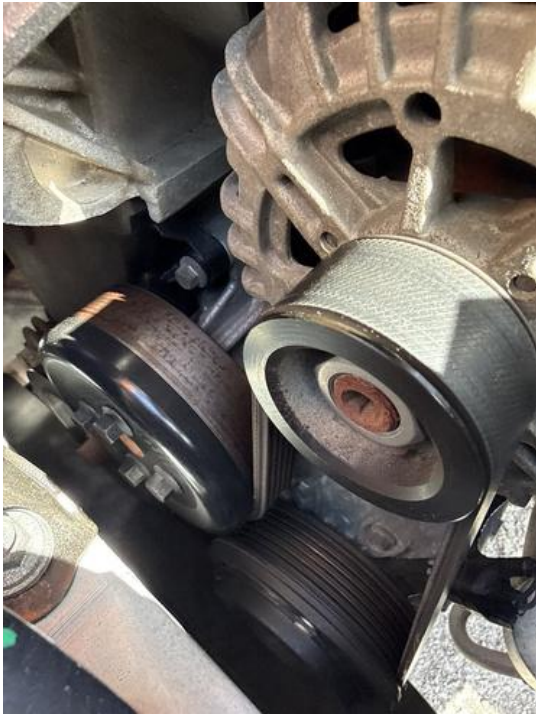
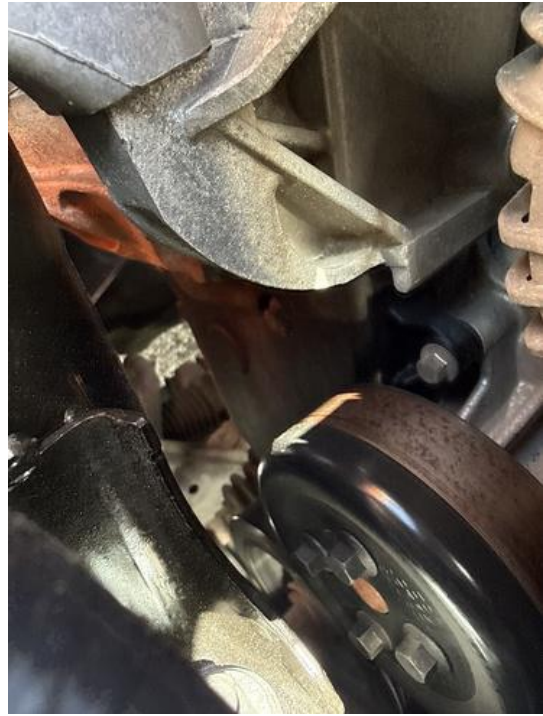
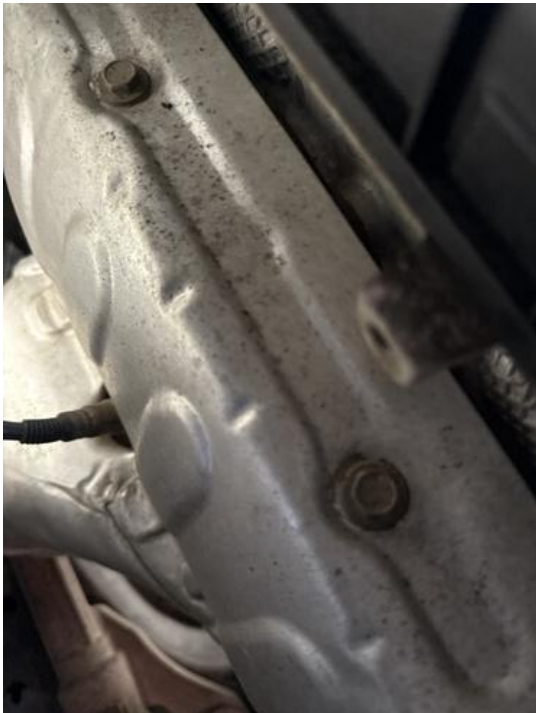
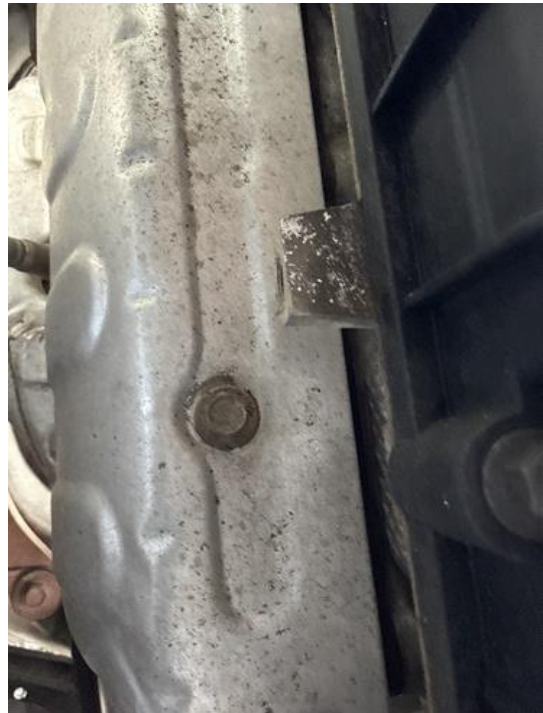
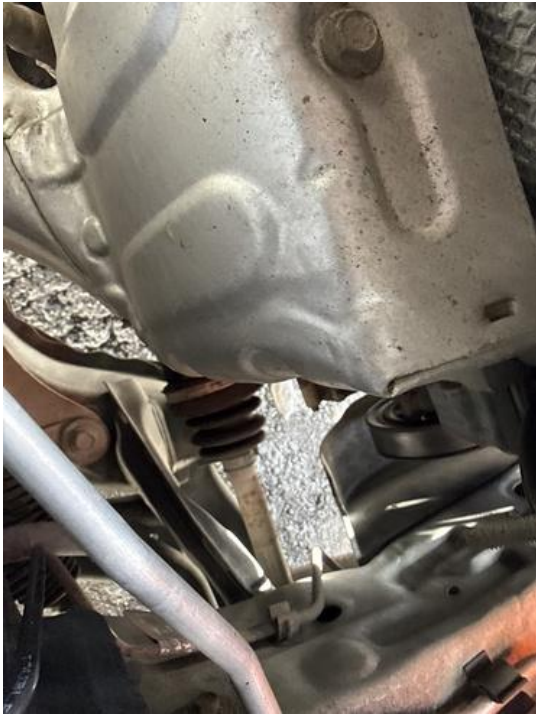
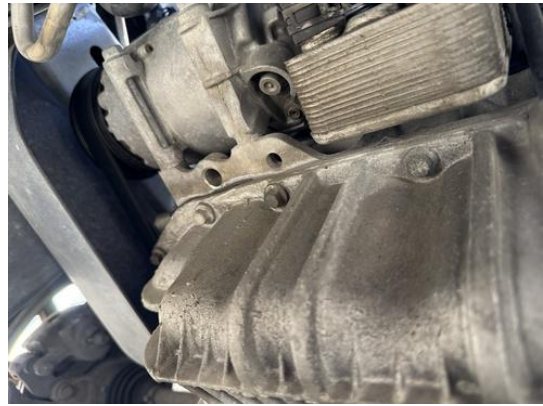
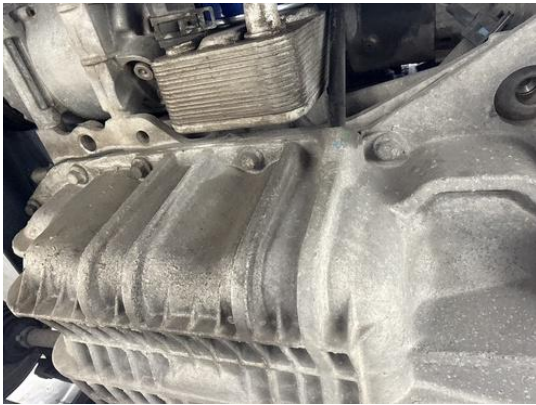
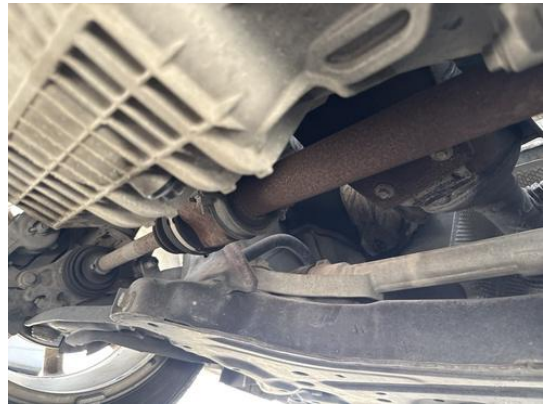
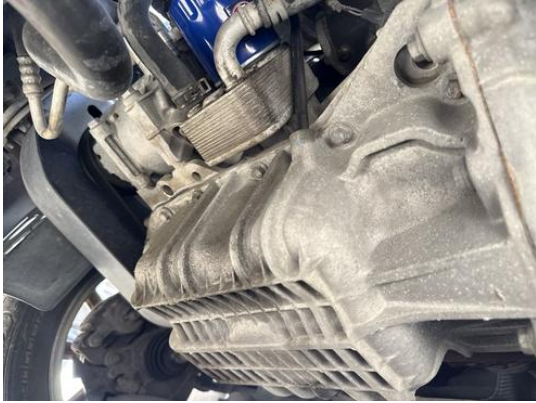
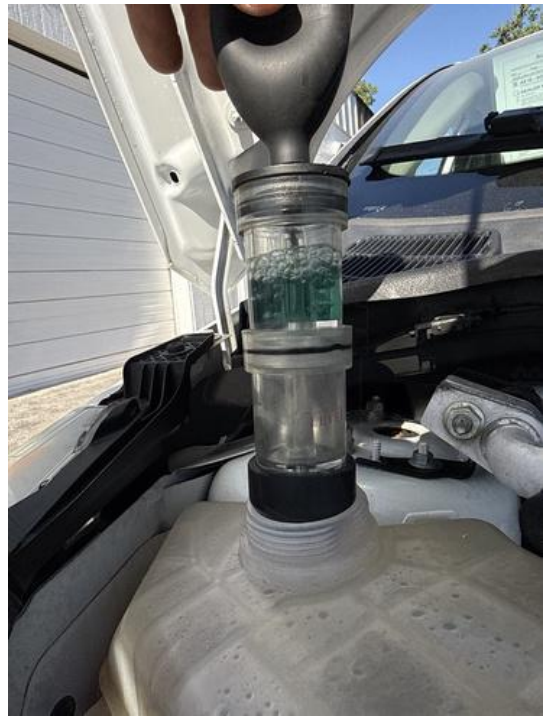
Engine clean internally, no gunk or sludge presents. Proper signs of maintenance present. Block test passed, no internal combustion leak out. Coolant mixture correct and cooling system functionality is healthy. All external engine accessories in good working. No leaks or seepage from anywhere on the engine. External drive belts in decent condition. Currently no concern in mechanical issues present in relation to the engine or related accessories.

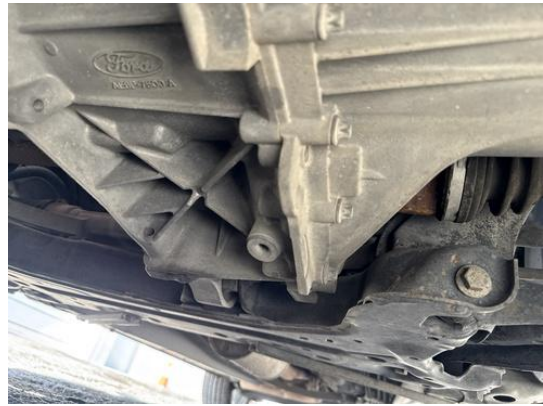
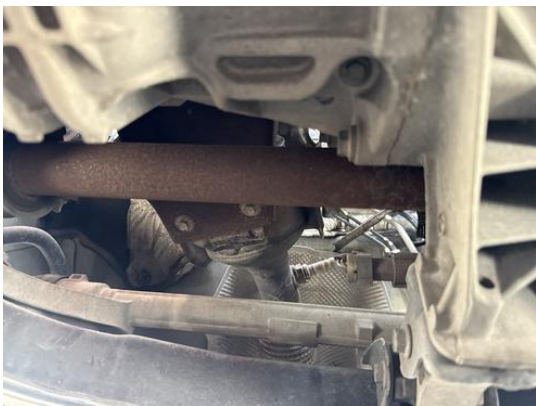
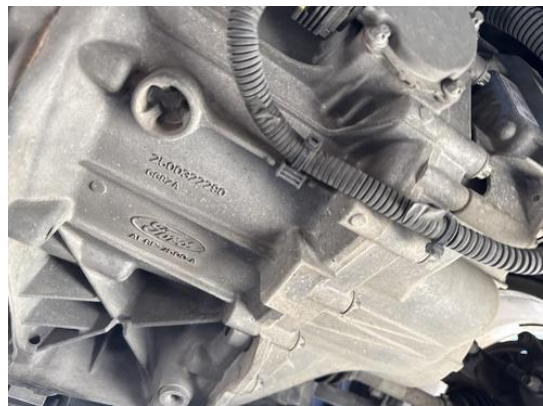
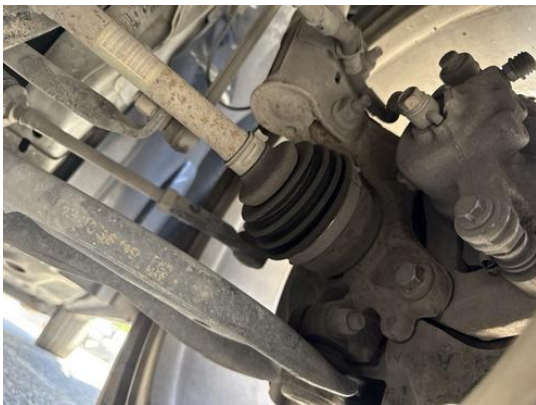
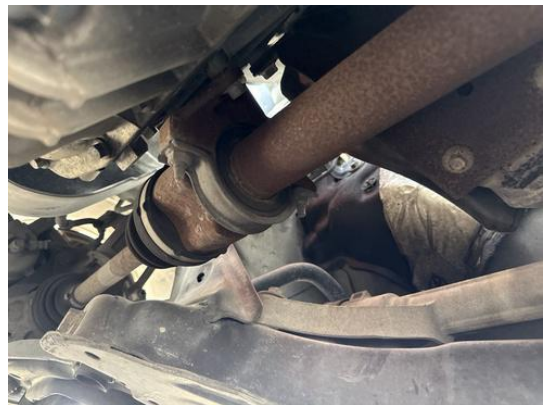
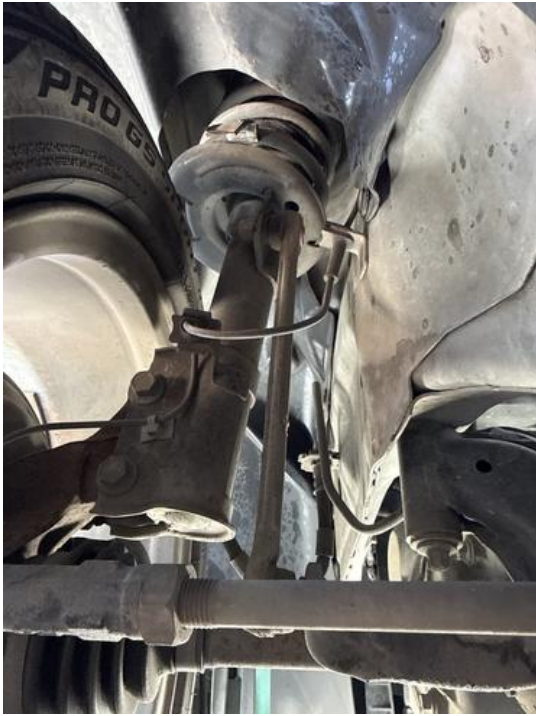
No transmission fluid leaks from the transmission casing. Both the left and right side axle seals are free of any fluid leaks. Both the left and right side CV axle are in healthy condition. Shift transitions out on the road are correct across the board.

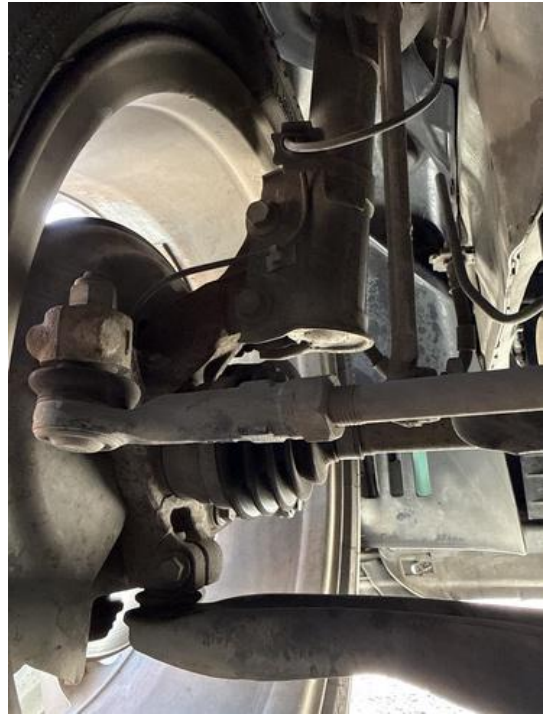
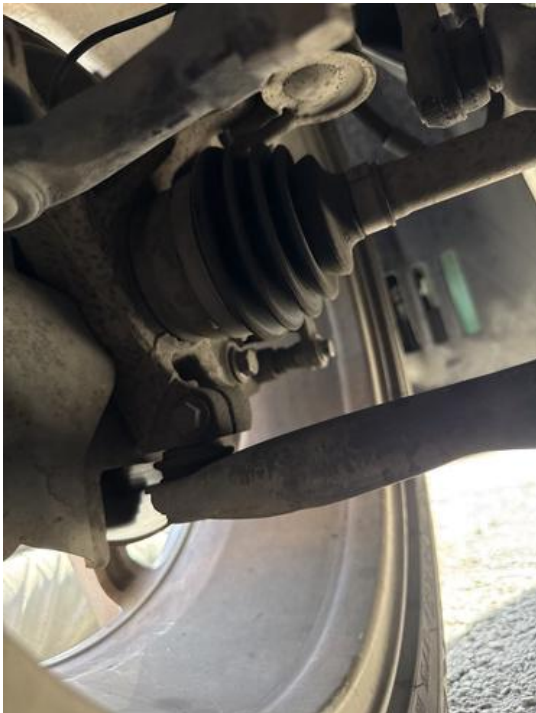
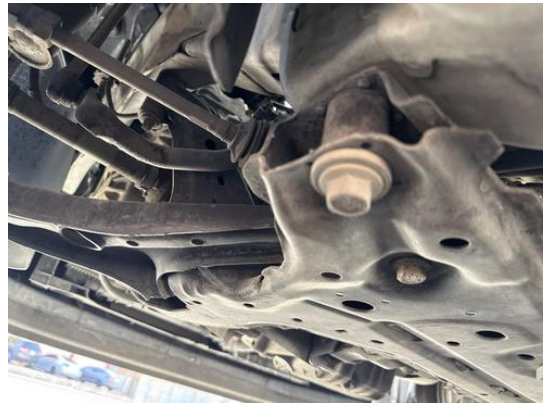
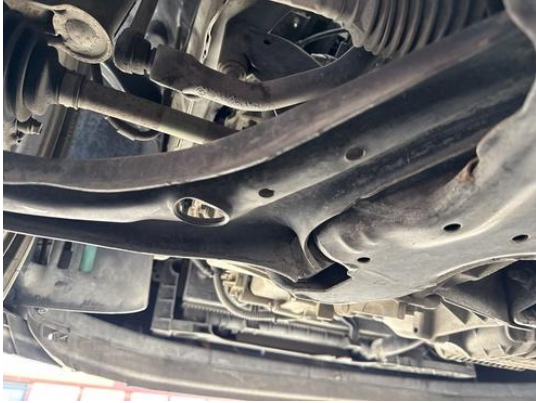
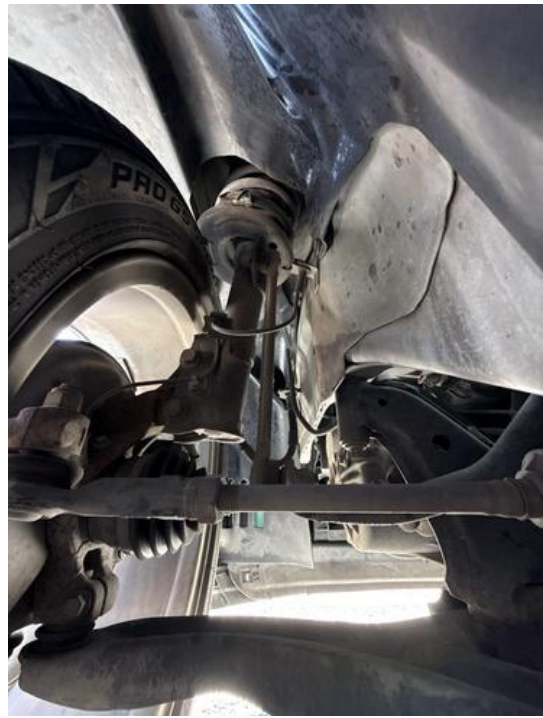
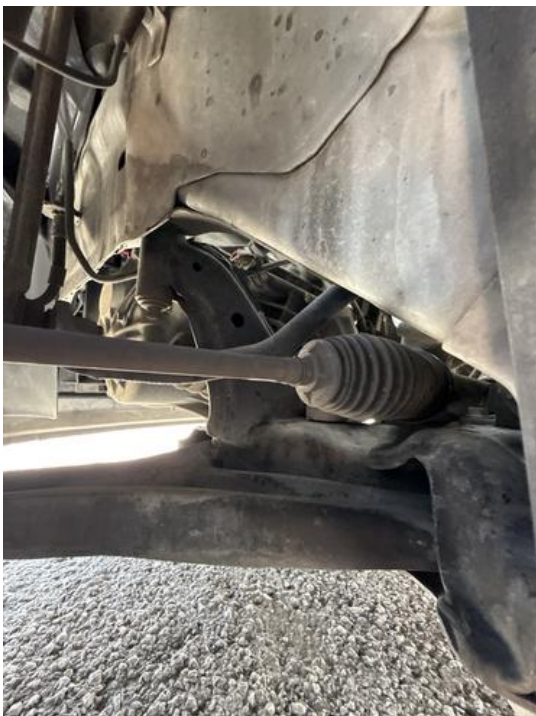
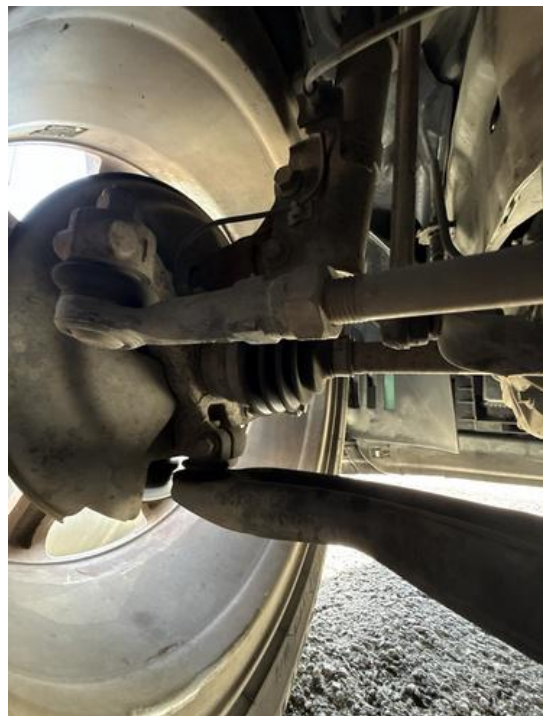
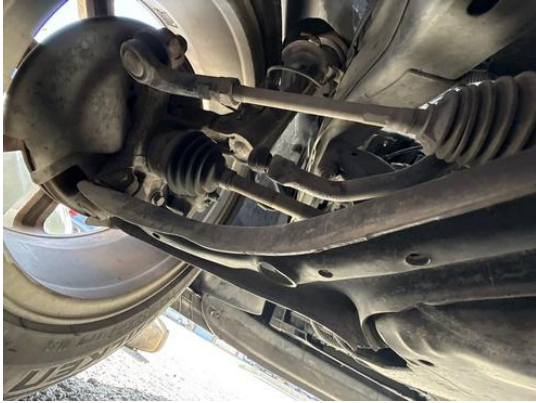
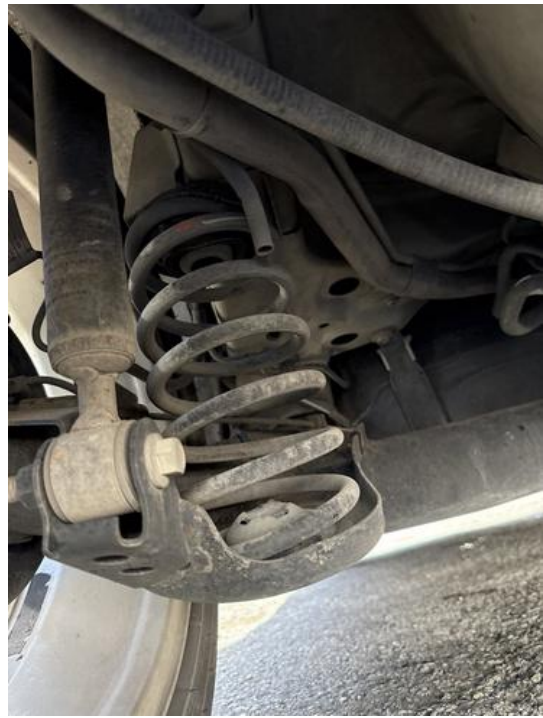
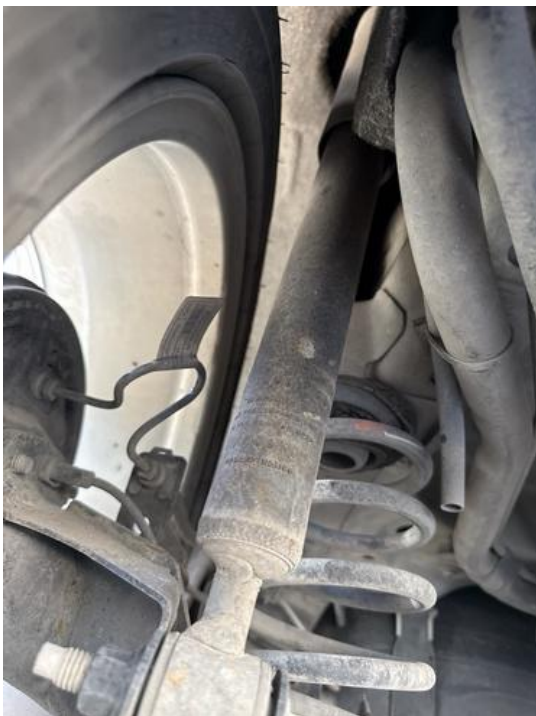
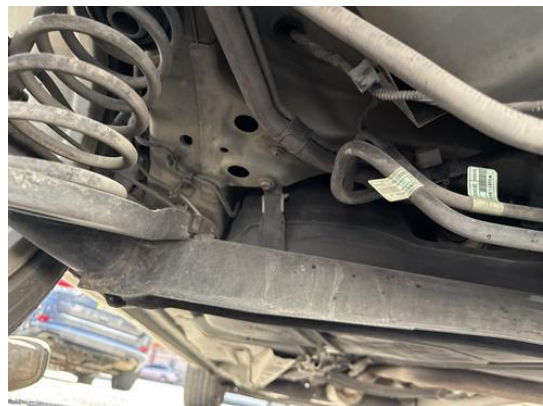
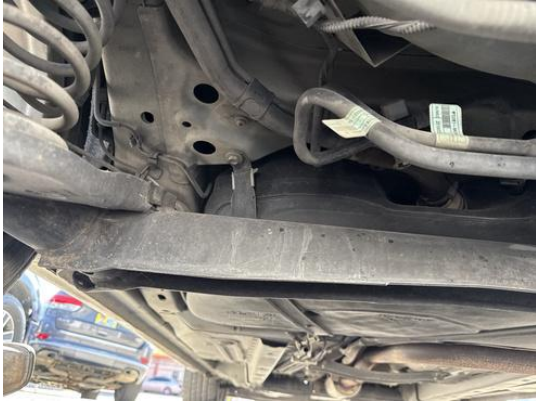
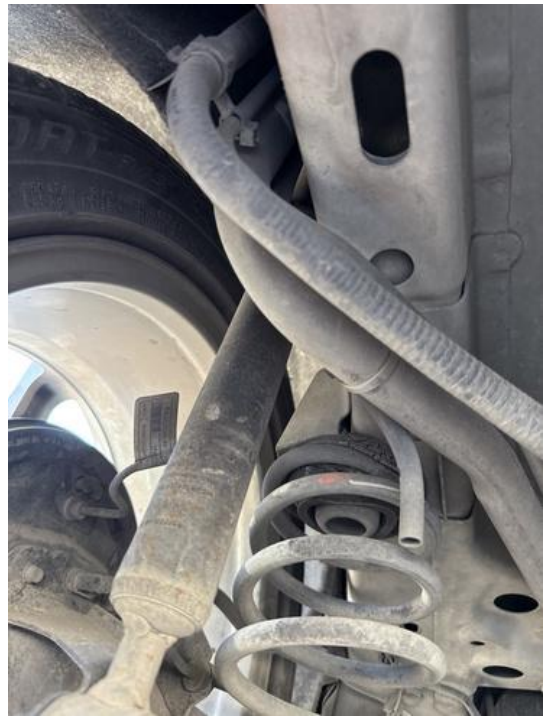
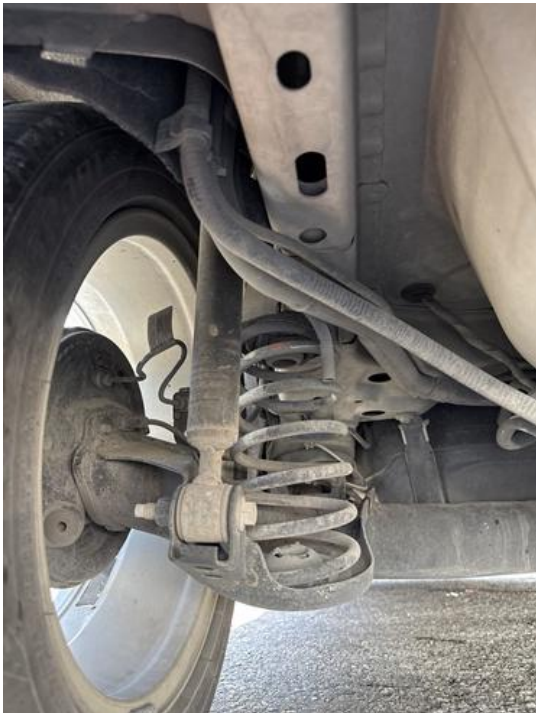
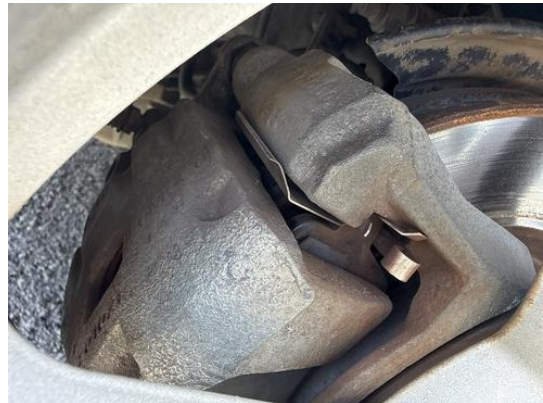
Normal fatigue notice to the suspension components. All of the suspension components seem to be original. None of the suspension components are blown out and due form the replacement. The No excessive surface rust on the exposed metal. No abnormal noise or feedback from the suspension while out on the road. All of the rubber in relation to the mounts, joints and bushings has decent texture.
