Peace of Mind Automotive Inspection Report.

Score	3 / 4 (75%)	Flagged items	1	Actions	0
Site conducted					Unanswered
Customer name					Lmj auto motor sales
Date / Time					May 19th
Payment method					Invoice
Inspection cost					199
Vehicle Year / Make / Model / Color					2019 ford expedition max
VIN					22443 last 5

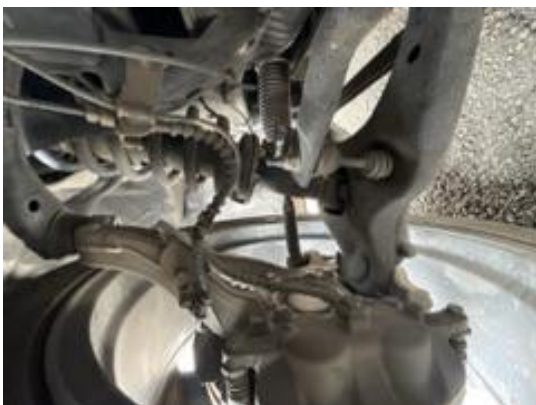
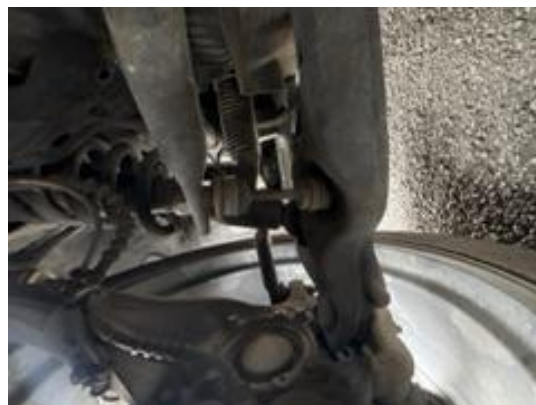
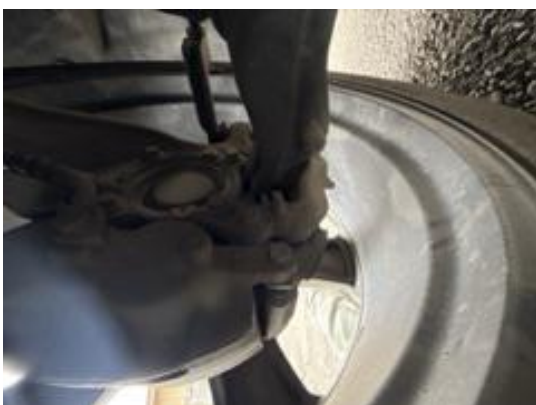
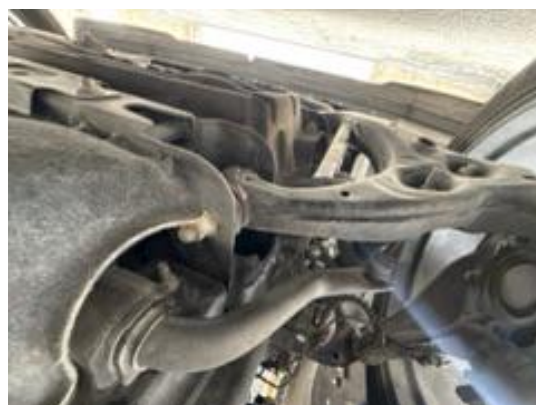
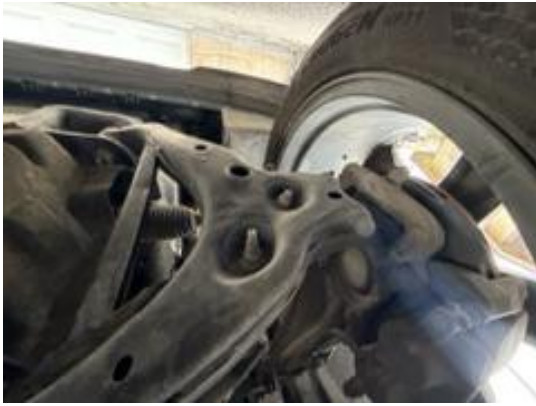
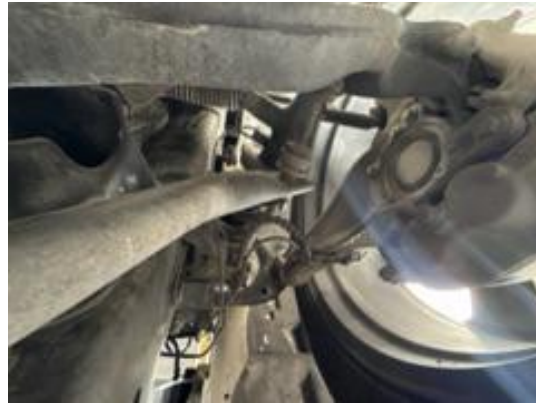
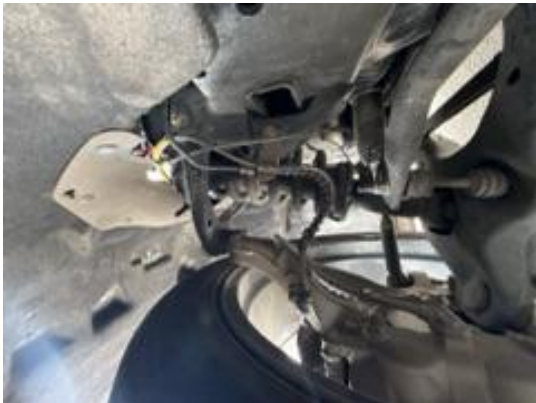
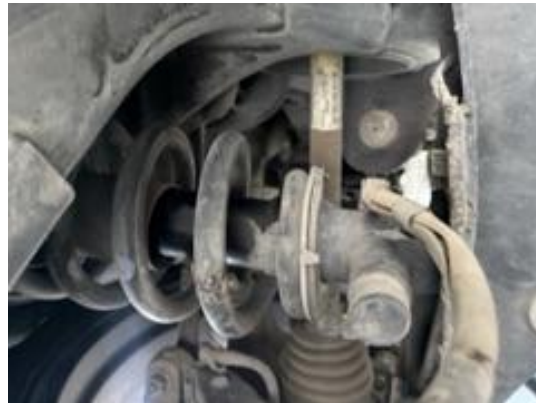
Normal fatigue notice to the suspension components. All of the suspension components seem to be original. None of the suspension components are blown out and due form the replacement. The No excessive surface rust on the exposed metal. No abnormal noise or feedback from the suspension while out on the road. All of the rubber in relation to the mounts, joints and bushings has decent texture.

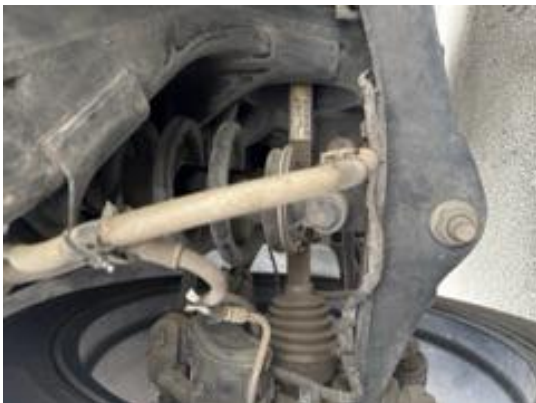
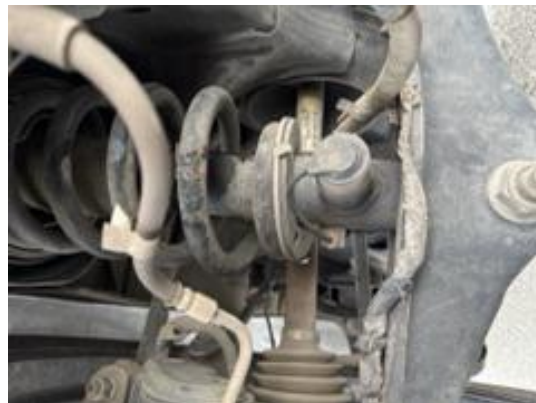
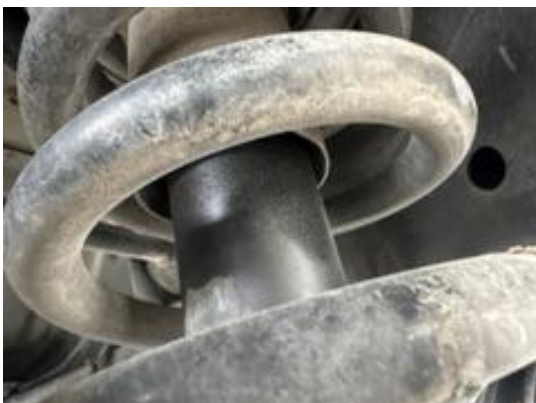
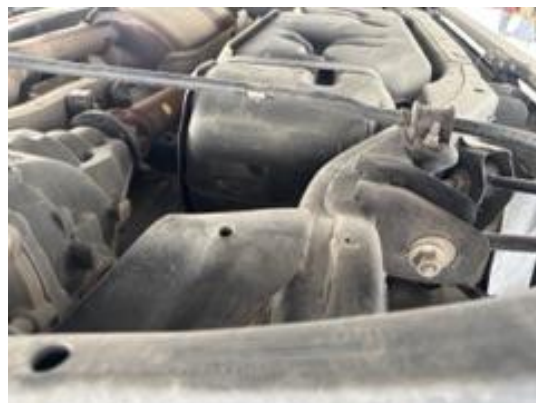
Small amount of leak out notice from the rear driver, side strut, no immediate attention is needed however, eventually the strut may need to be replaced
