# Peace of Mind Automotive Inspection Report.

Score	4 / 4 (100%)	Flagged items	0	Actions	0
<b>Site conducted</b>					Unanswered
<b>Customer name</b>					Lmj auto motor sales
<b>Date / Time</b>					May 19th
<b>Payment method</b>					Invoice
<b>Inspection cost</b>					199
<b>Vehicle Year / Make / Model / Color</b>					2019 ford expedition max
<b>VIN</b>					22443 last 5

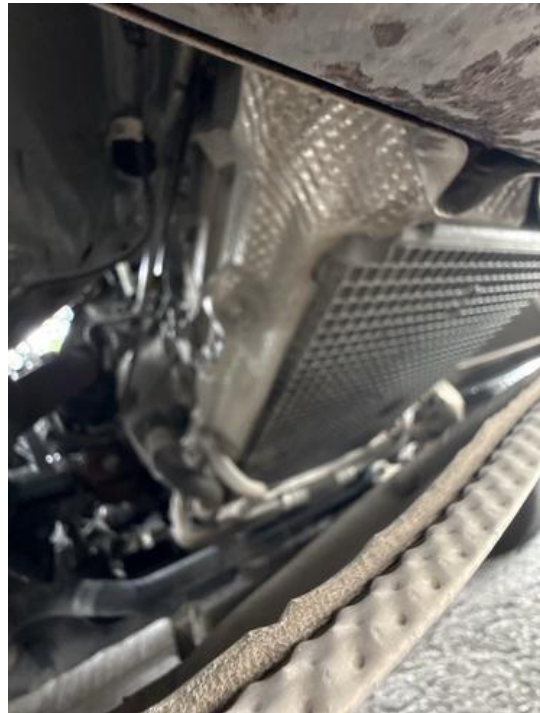
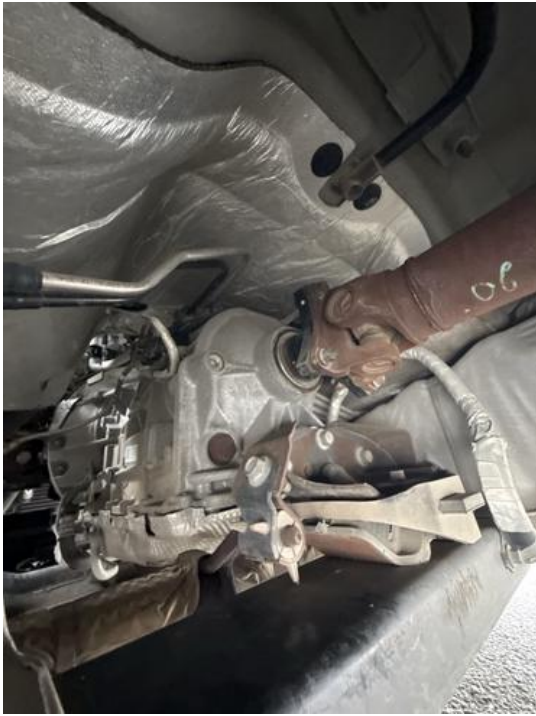
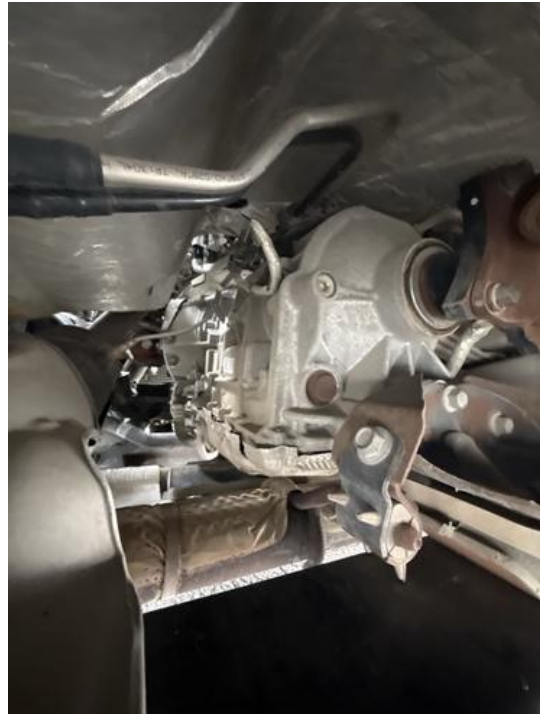
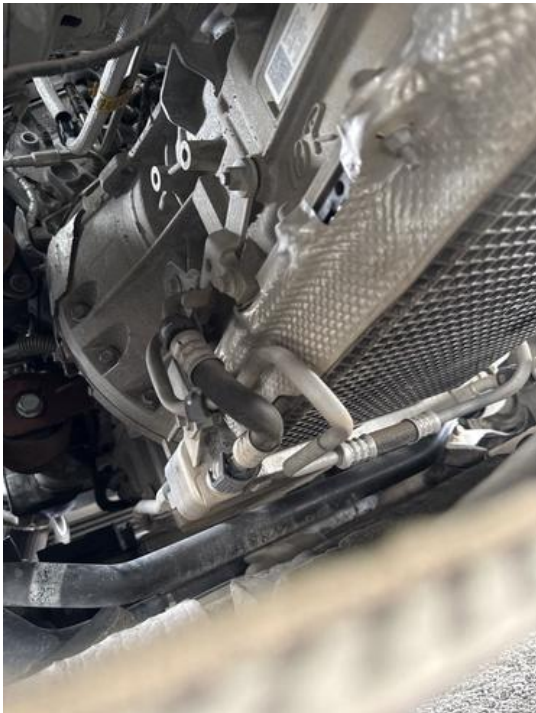
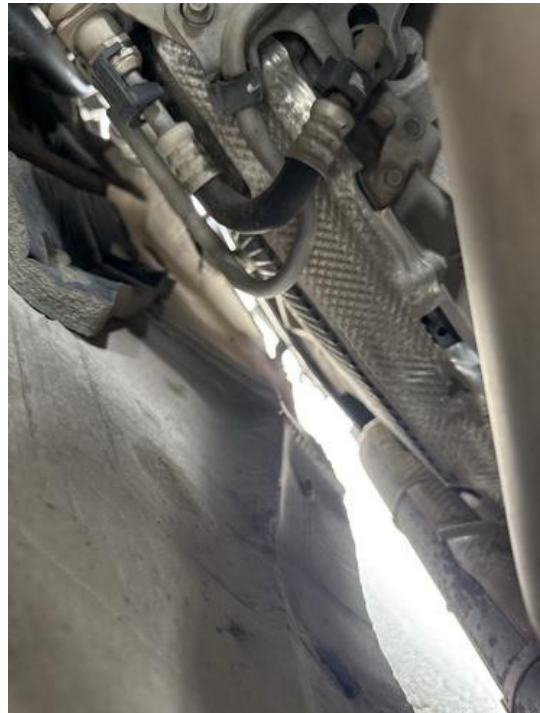
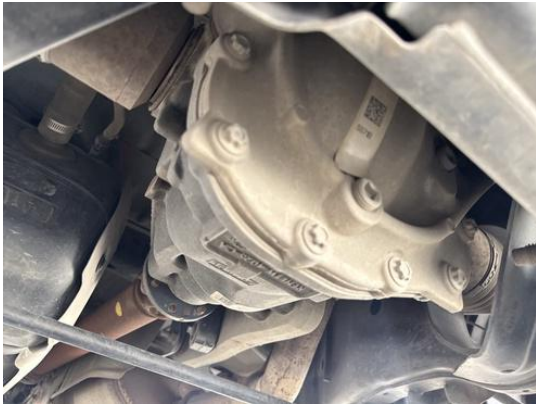
Transmission / Differentials					
<b>Transmission fluid level</b>	Healthy				
<b>Transmission fluid condition</b>	Healthy				
<b>Transmission fluid leaks</b>	None				
<p>No transmission fluid leaks from the transmission casing or the transmission pan area. The tail shaft seal is free of any fluid leaks. The driveshaft is in healthy condition. Shift transitions out on the road are correct across the board. No fluid leak out from the rear differential.</p>

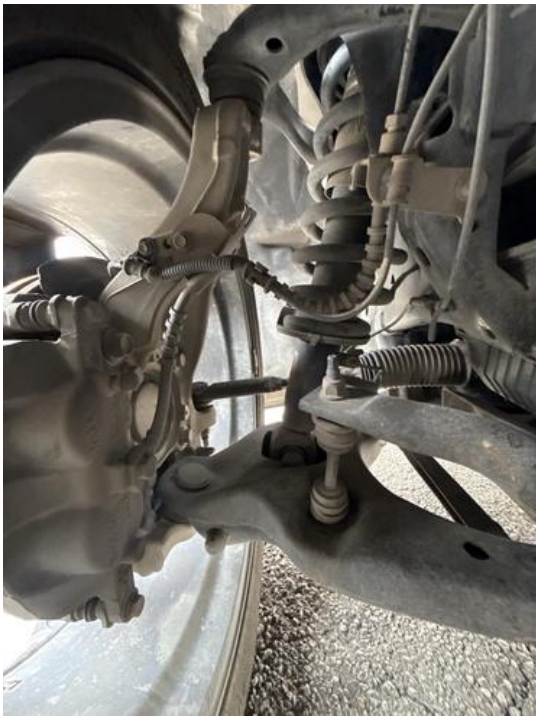
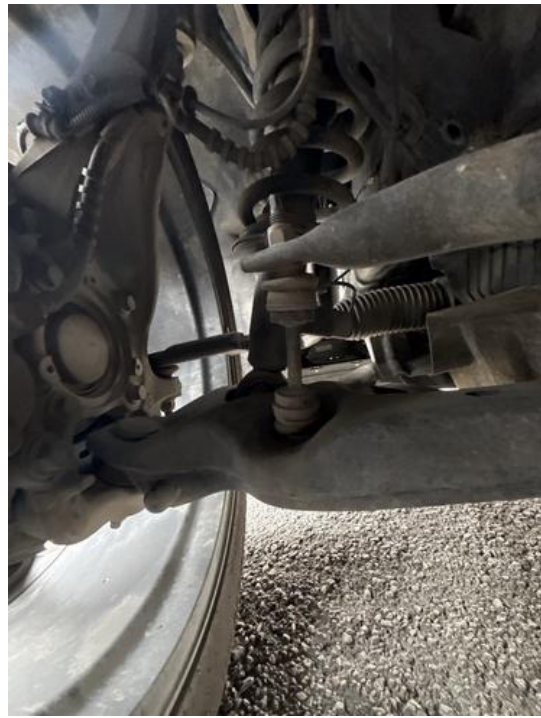
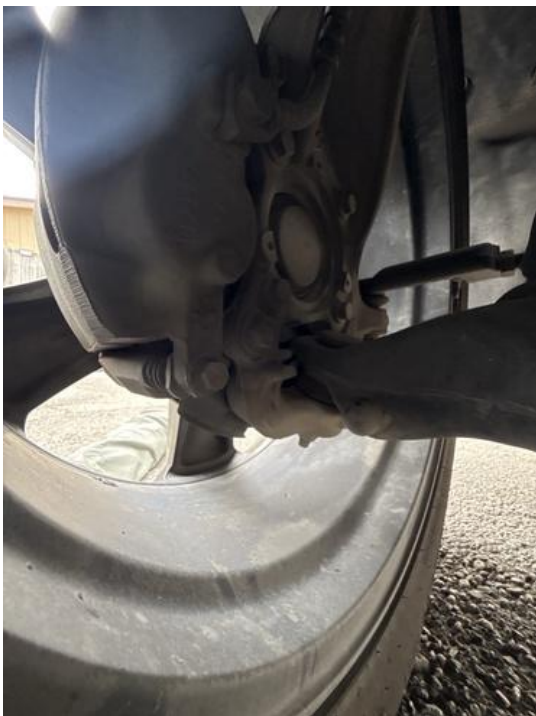
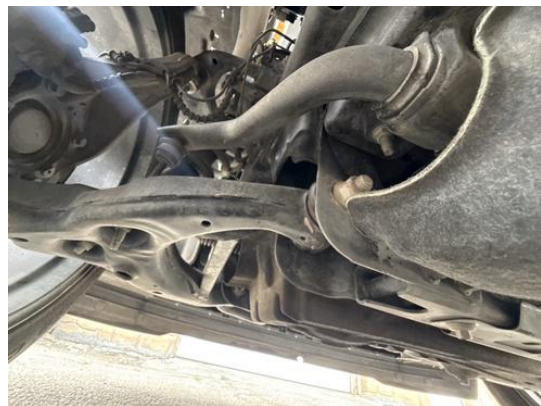
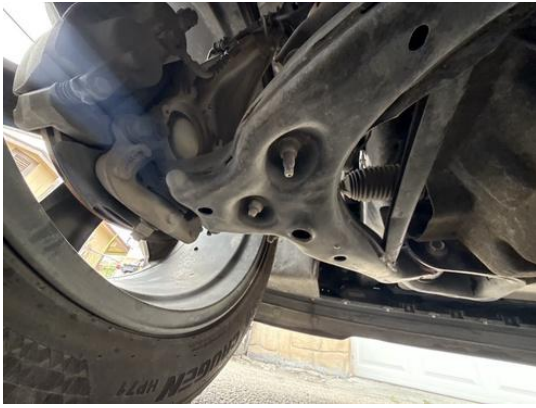
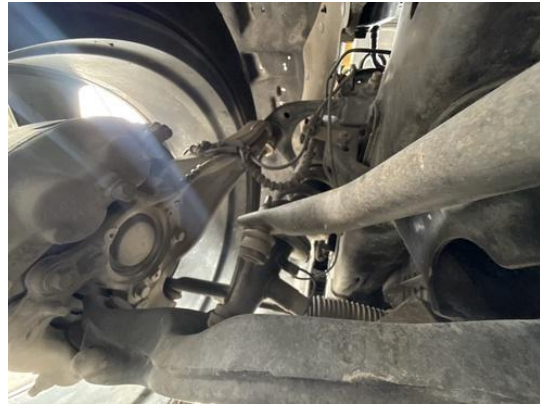
Normal fatigue notice to the suspension components. All of the suspension components seem to be original. None of the suspension components are blown out and due form the replacement. The No excessive surface rust on the exposed metal. No abnormal noise or feedback from the suspension while out on the road. All of the rubber in relation to the mounts, joints and bushings has decent texture.

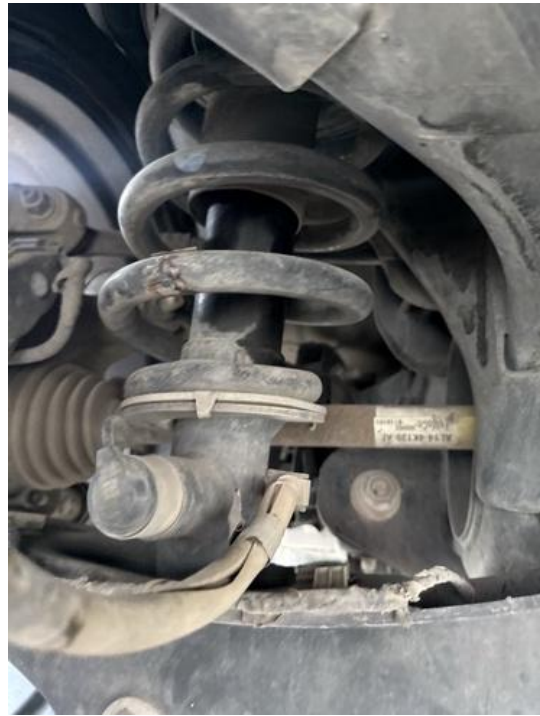
Photo 161

Small amount of leak out notice from the rear driver, side strut, no immediate attention is needed however, eventually the strut may need to be replaced

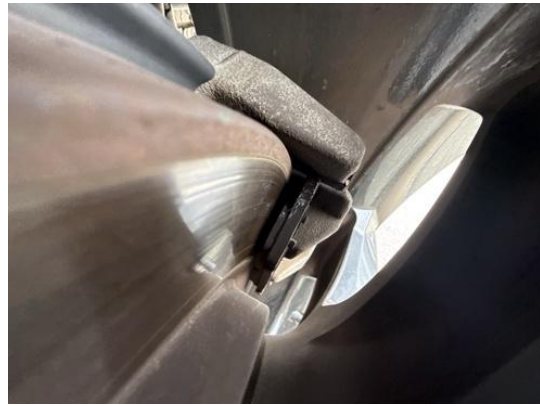
Photo 173

Braking system condition		
Brake fluid condition	Healthy	
Brake fluid level	Healthy	
Brake fluid leaks	None	
Moisture content in brake fluid	None	
Brake lines	Healthy	
Brake calipers front	Healthy	
Brake calipers rear	Healthy	
Brake drums rear	N/A	
Brake rotors front	Healthy	
Brake rotors rear	Healthy	
<b>Front brake pad life remaining</b>	<b>25-50% remaining</b>	
Only around 35% brake pad life remaining

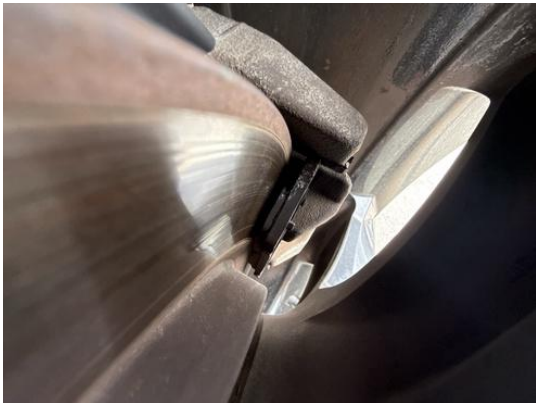
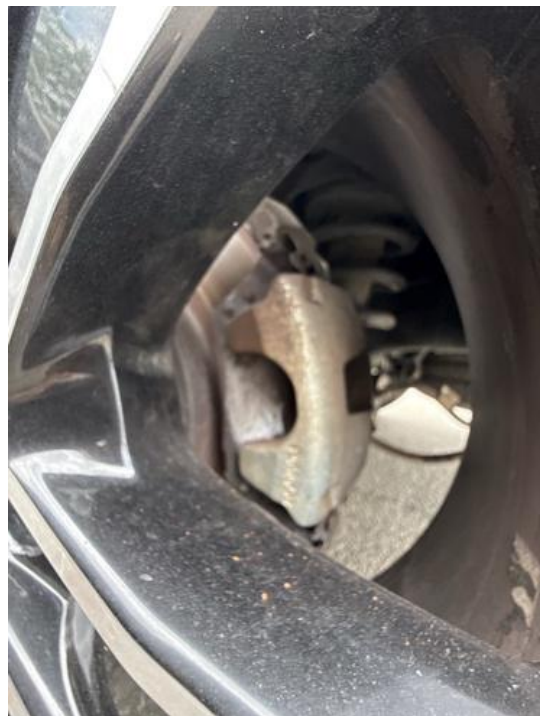
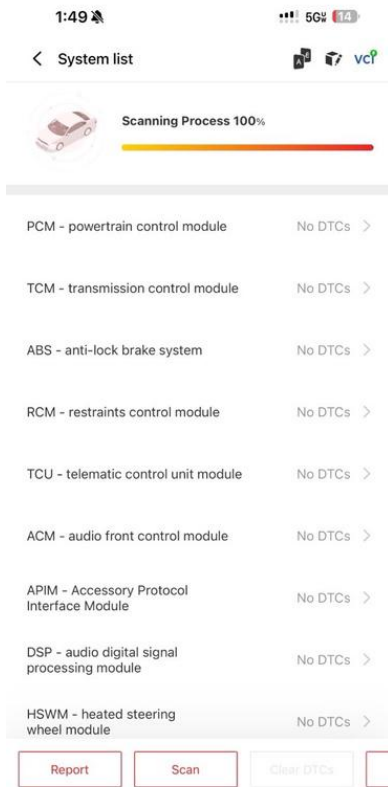
Photo 171	Photo 172	Photo 173
<b>Rear brake pad life remaining</b>	<b>50-75% remaining</b>	
Write about 55% brake pad life remaining
