Lighthouse Home Inspections, LLC Home Inspection Report

1234 Happy Street, Cleveland, OH 44000 Inspection prepared for: I.M. Client Date of Inspection: 1/1/2020 Time: 1:00 PM Age of Home: 1915 Size: 1020 Order ID: XXX

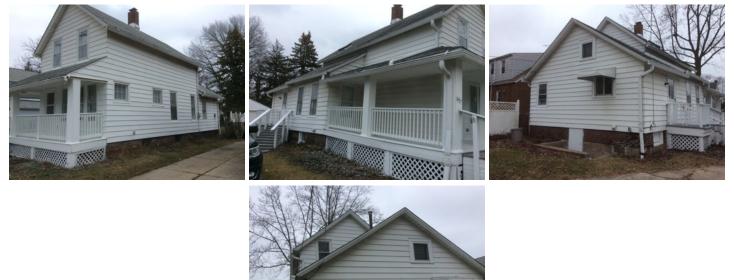
2.1. The exterior siding appeared in serviceable condition.

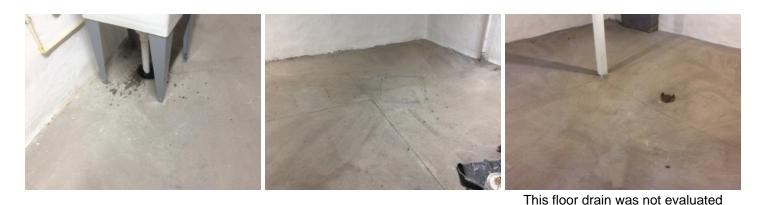
4.1. Dirty floor but good shape for age. All concrete floor slabs experience some degree of cracking due to shrinkage in the drying process. In most instances floor coverings prevent recognition of cracks or settlement in all but the most severe cases. Where carpeting and other floor coverings are installed, the materials and condition of the flooring underneath cannot be determined.

4.2. Floor drain present. I recommend obtaining a Drain Backup Rider, often called a <u>Sewage Backup Rider</u>, and discuss proper coverage amounts with your insurance carrier.
