Inspection

██████████ Dr, Houston, TX ██████████

Date of Inspection: 6/3/2020 Time: 9:00 AM

PROPERTY INSPECTION REPORT

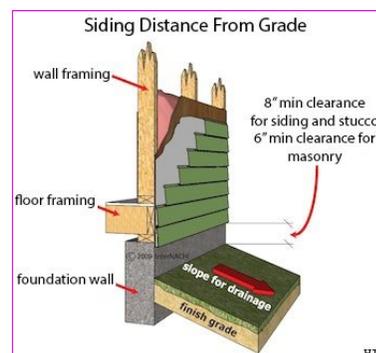
Soil height close to the exterior facade on part of the structure. This is a path for insects & moisture to travel to enter the home.

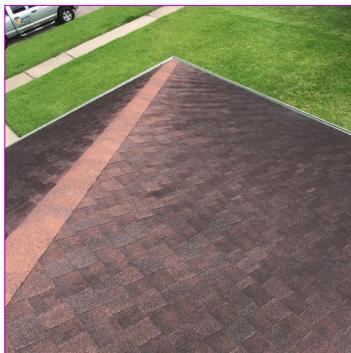
- Evidence of patching and/or repair at time of inspection. Monitor these areas. Keep up with proper maintenance & corrective measures when needed.
- The flashings were generally serviceable. Attention to the items noted, together with routine maintenance, will keep the flashings functional & maximize their expected useful life
- General Images:
 - At the time of the inspection, composition shingles covering the roof exhibited minor granule deterioration & there are minor surface cracks developing
 - There were exposed fasteners at the time of inspection
 - Some flashings were incorrectly installed & do not fully serve their intended purpose.
 - One or more flashing were not properly sealed at the time of inspection

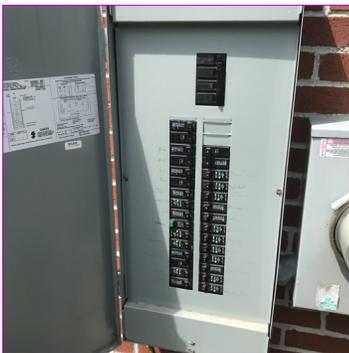
- Main disconnect was part of the service panel
- Unable to view the earth ground rod system to confirm proper installation
- General Images:
 - There is room for additional breakers
 - **Afc**i protection present. Not tested
 - All knockouts in place
 - All required trip ties were in place
- Some of the breaker labeling is unreadable
- Breaker panel was not labeled or was partially labeled. This is a deficiency
- The breaker(s) pictured appear to be rated for greater amperage then allowed by the wire size present. The HVAC listed the breakers at 30amp & 35 amp but the breakers in the electrical box are 40amp & 45 amp
- Aluminum wiring lacks anti oxidant coating. This is a deficiency

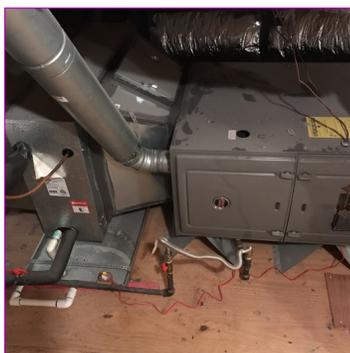
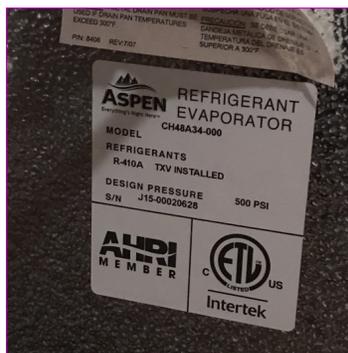
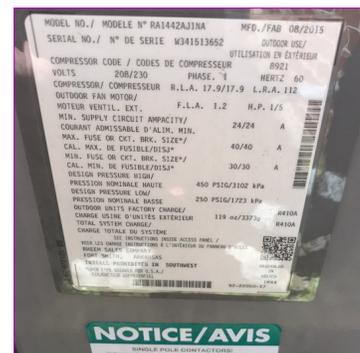
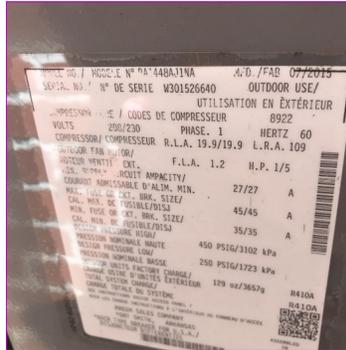
- Upstairs left bedroom & bathroom hvac registrars - Both blew air hotter then the rest of the house. 66° & 68°. I recommend correction by a qualified hvac technician.

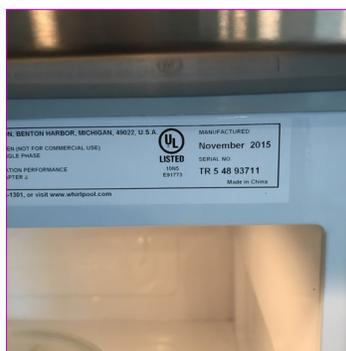
Comments:
 • General image & Manufacturers tag:
 • Functioned properly. Orange light seen inside is a microwave tester which indicated functionality
 • Microwave not fully secured to the frame
