Town of Holden Beach Draft Summary Report

Town Pier Preliminary Reconstruction

HDR Engineering, Inc. of the Carolinas
Project No. 10426190

July 2, 2025

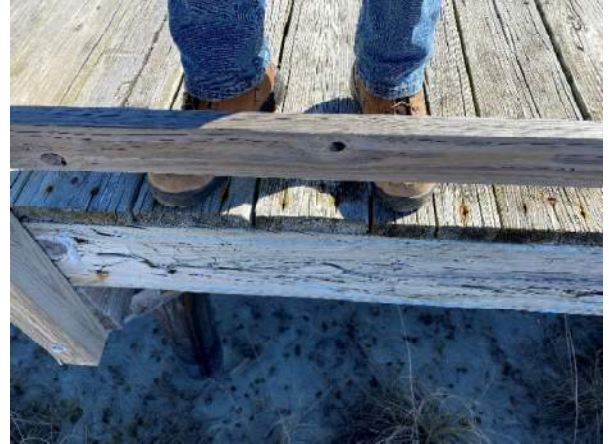
As shown in Photo 1 of Appendix C, the typical side rails, toe boards, and chain link fencing are in POOR condition. There are over 12 locations where the toe boards, midrails, rail posts, and top rails are disconnected and/or split. The chain link fence has also been cut or disconnected in at least 3 locations. Structurally, the railings are POOR, and the deck boards appear SATISFACTORY. However, it was noted that the ramp does NOT meet federal ADA requirements for pedestrian access and would require to be reconfigured and/or replaced.

Photo 1: Typical Railing and Fence Damage near station 0+10
