Project #: HLD-2601

Reference: Holden Beach Fishing Pier – 2026 Underwater Inspection Report  
Holden Beach, North Carolina

## **INTRODUCTION**

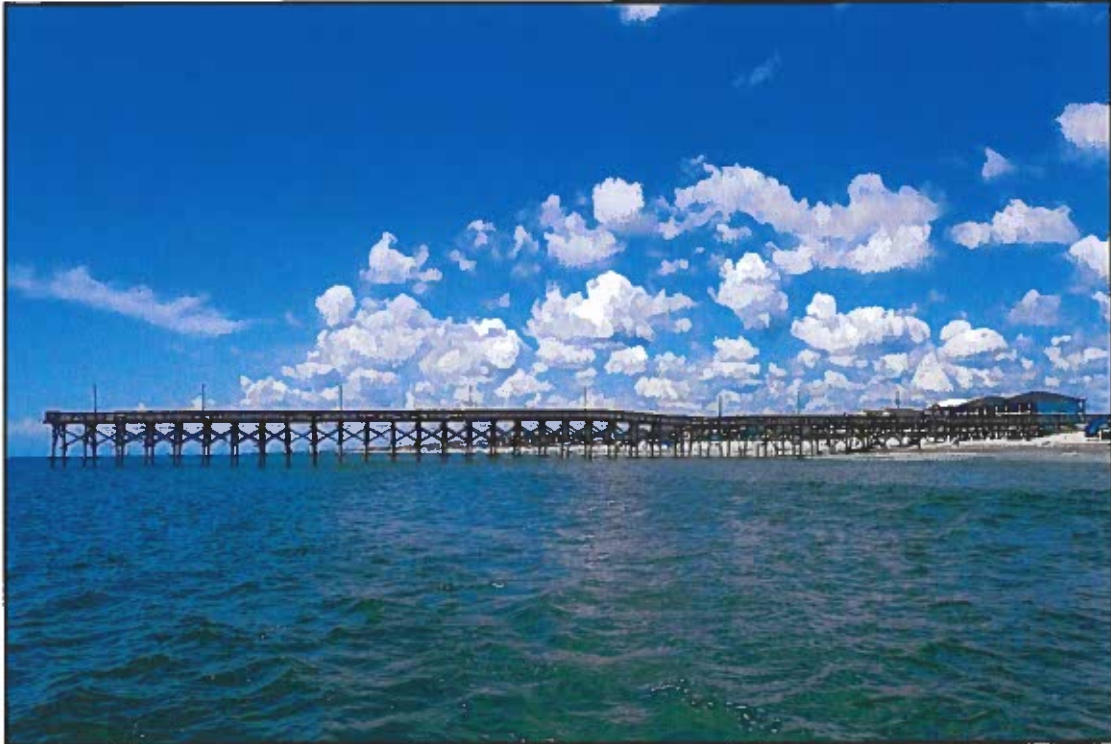
**Photograph 1: Overall of Holden Beach Pier.**

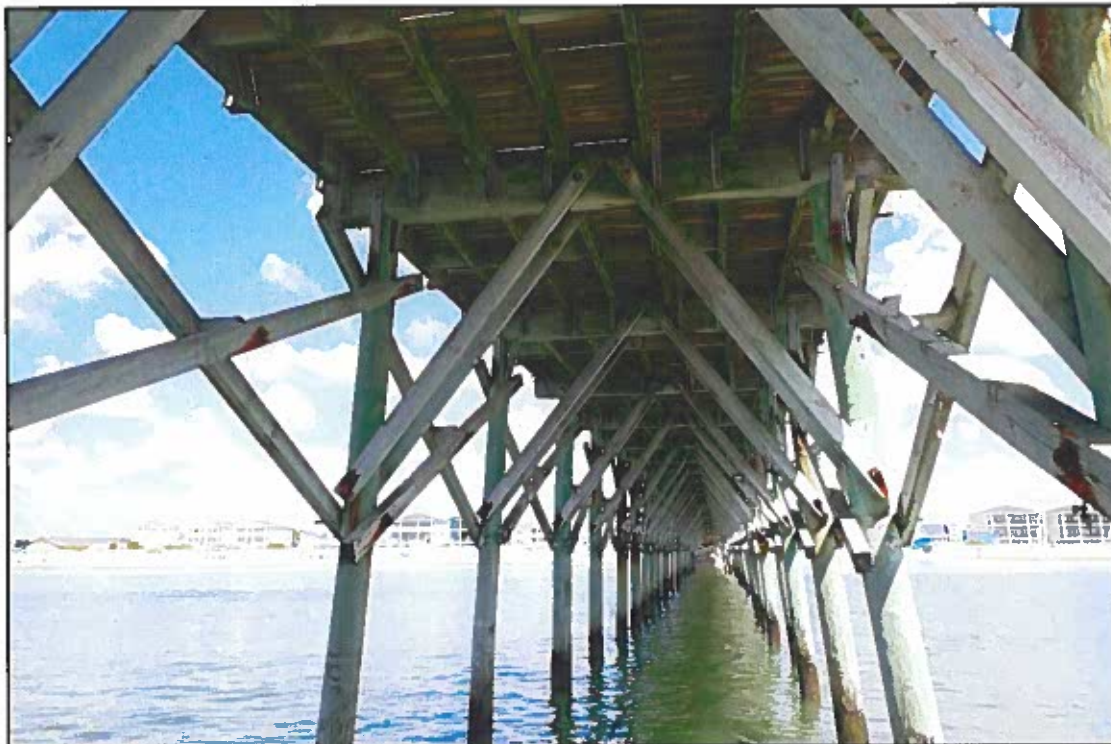
**Photograph 2: Typical bent configuration, looking north.**

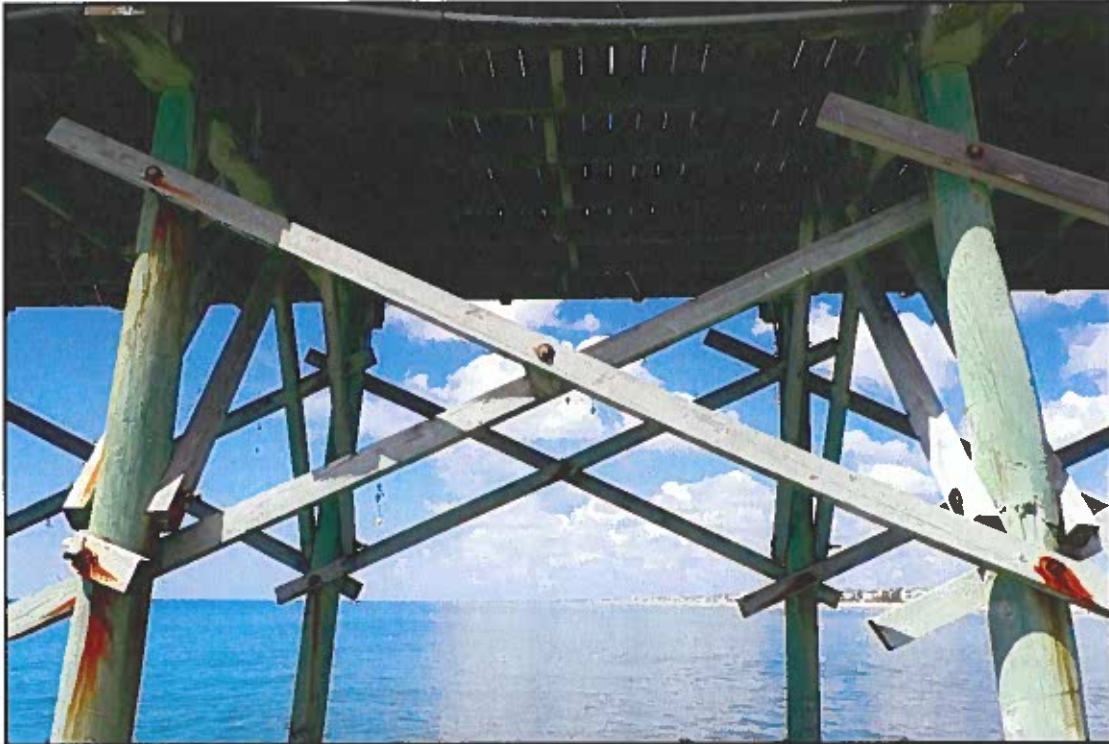
**Photograph 3: Typical bent configuration, looking west.**

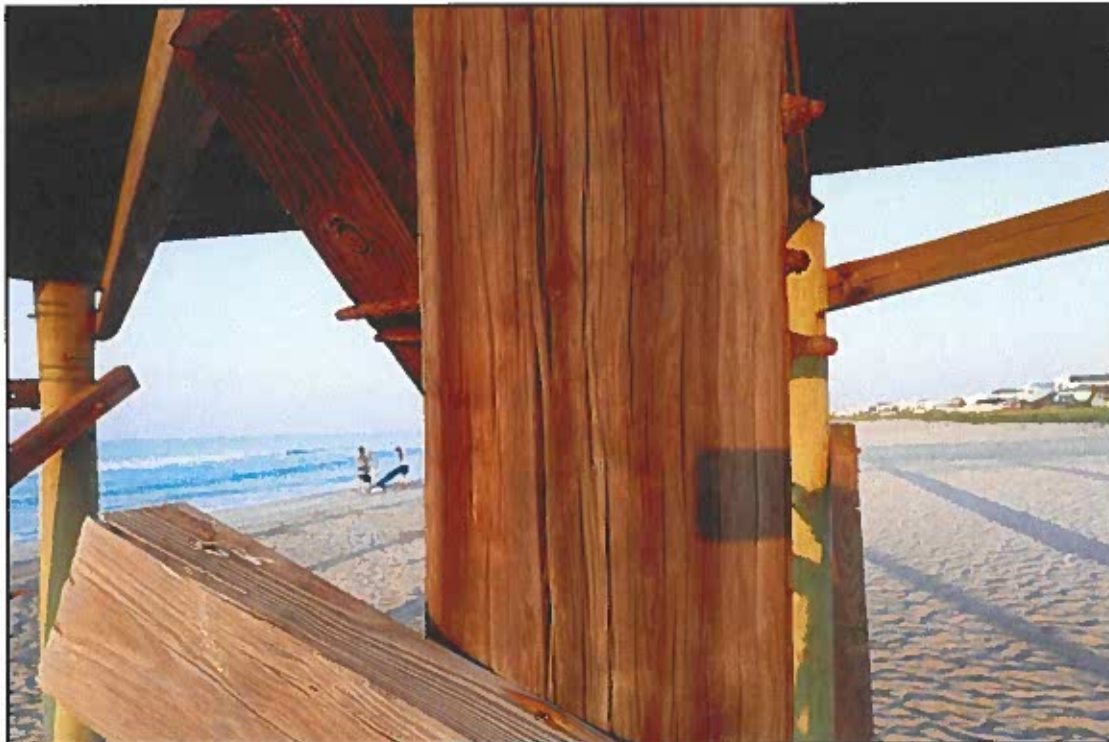
The inshore timber piles associated with Bents -6 through 14 exhibited light checking and weathering (Photograph 4). The piles located between Bents 23 through 52 exhibited light marine growth consisting primarily of barnacles below Mean Low Water (MLW) (Photograph 5) and typically exhibited no defects above MLW. Isolated defects were identified in some of the piles and are summarized in Table 2.

**Photograph 4: Pile 12A – Typical light weathering and checking.**

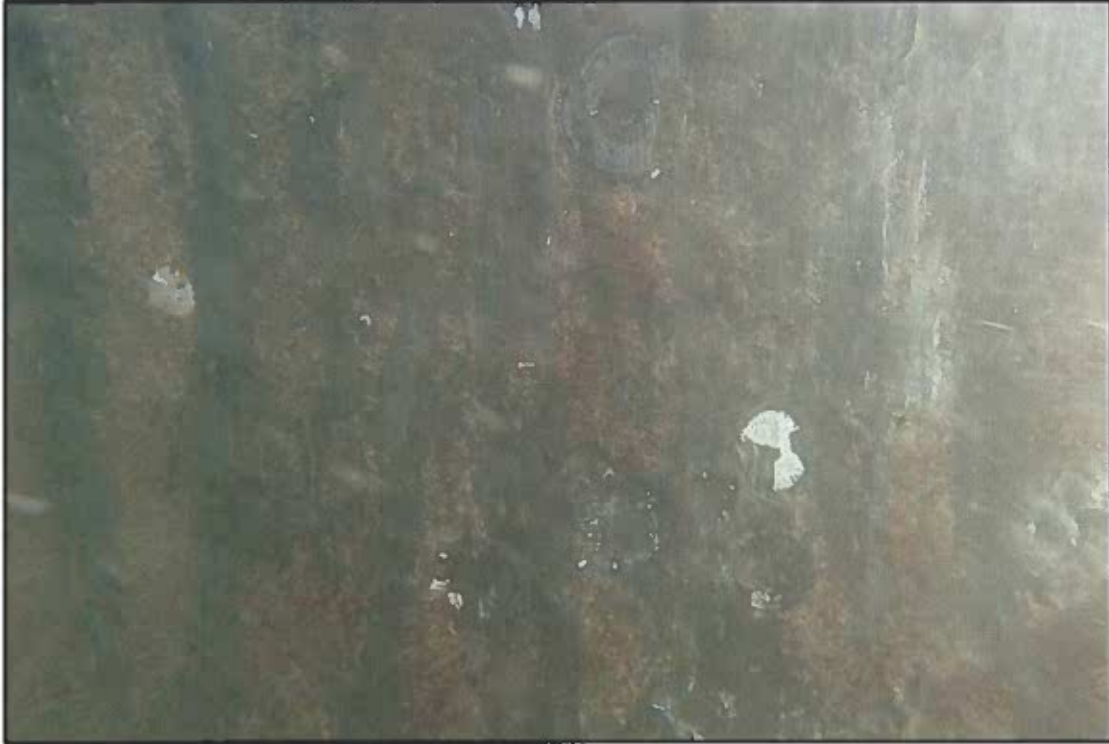
**Photograph 5: Typical light marine growth below water.**

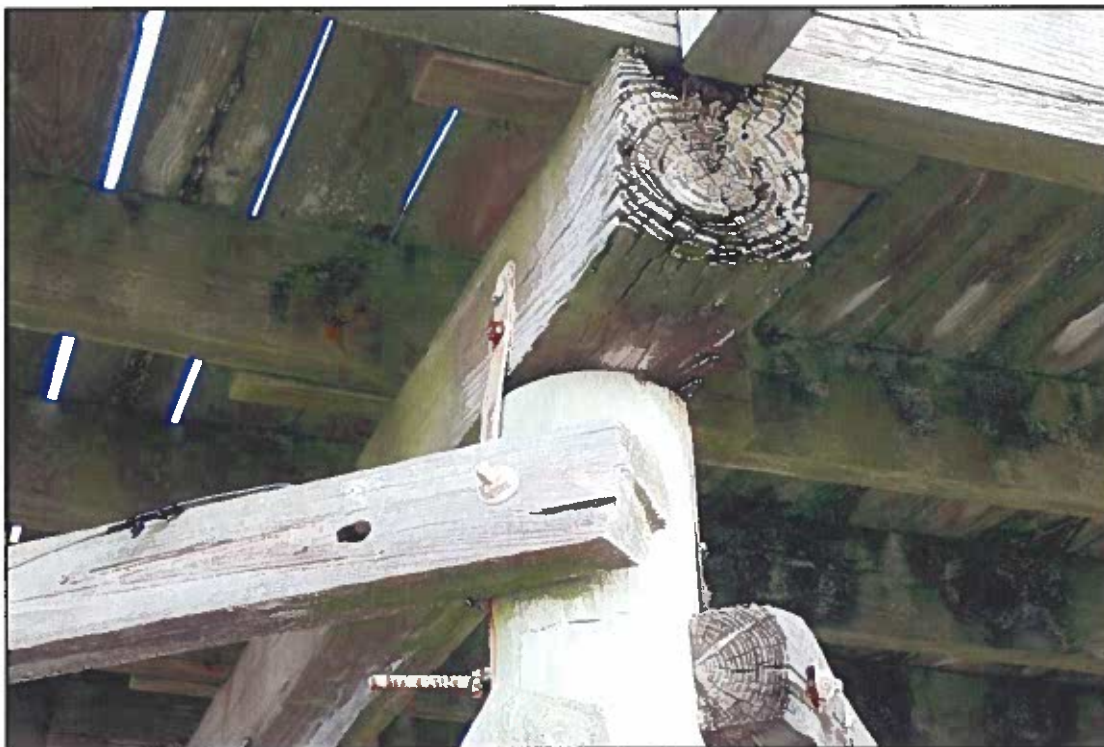
| PILE LOCATION | DAMAGE RATING | REASON FOR RATING |
|---|---|---|
| 17A | Severe | 100% non-bearing pile; cap supported by fishplates only (Photograph 9). |

**Photograph 9: Pile 17A – 100% non-bearing pile being supported by fishplates.**

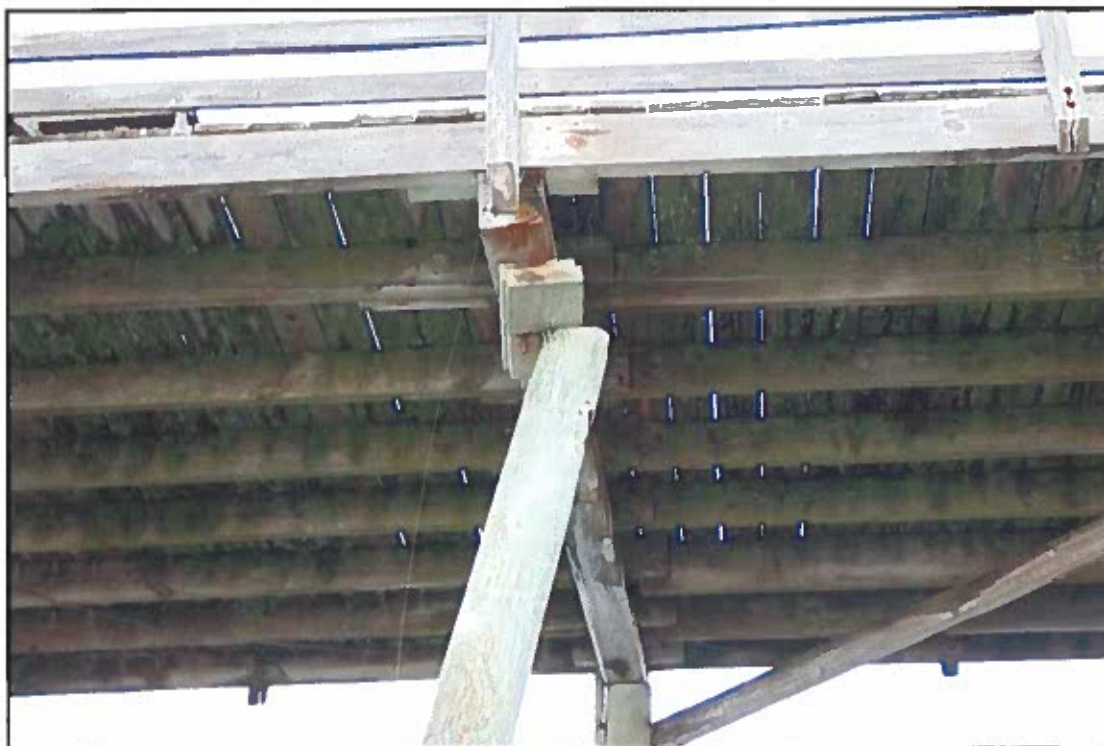
| PILE LOCATION | DAMAGE RATING | REASON FOR RATING |
|---|---|---|
| 24A | Major | 50% non-bearing due to pile displacement from beneath cap (Photograph 10). |

**Photograph 10: Pile 24A – 50% non-bearing pile due to being displaced.**

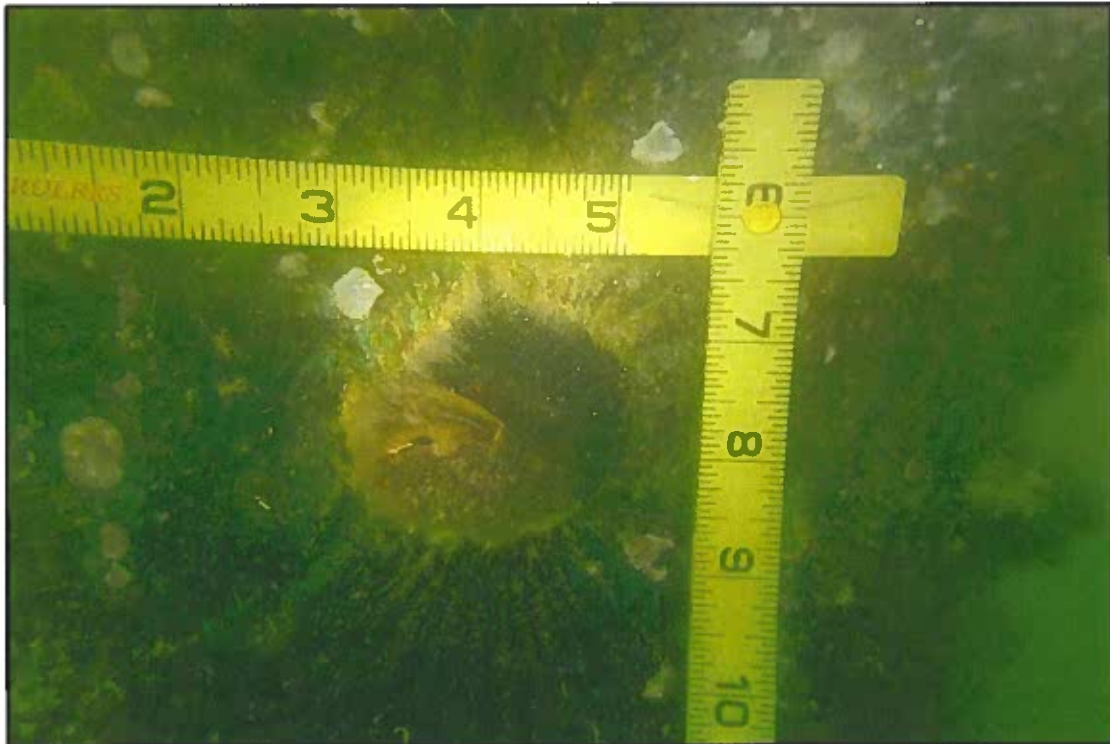
| PILE LOCATION | DAMAGE RATING | REASON FOR RATING |
|---|---|---|
| 47A | Moderate | 2-inch-diameter hole with hollowing due to marine borer, 7 feet above mudline; 10–15% section loss (Photograph 11). |

**Photograph 11: Pile 47A - Hole in pile with section loss due to marine borer.**

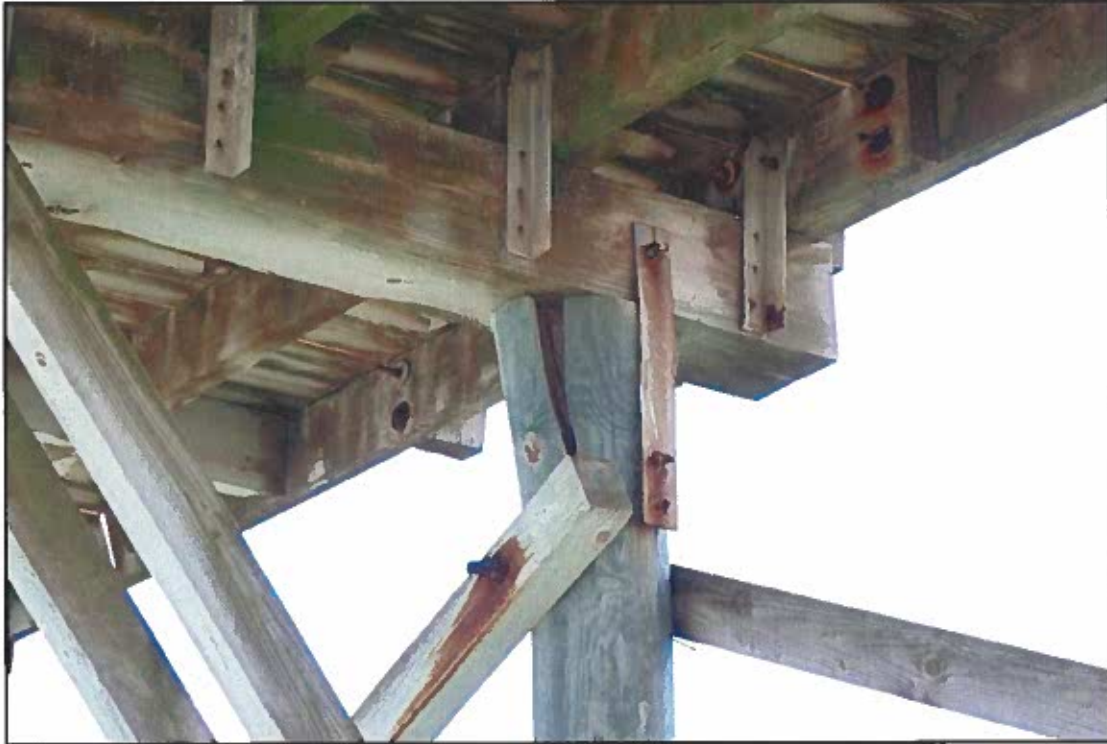
| PILE LOCATION | DAMAGE RATING | REASON FOR RATING |
|---|---|---|
| 50B | Major | Split in top 18 inches of pile (Photograph 13). |

**Photograph 13: Pile 50B – Typical split in top 18” of pile.**

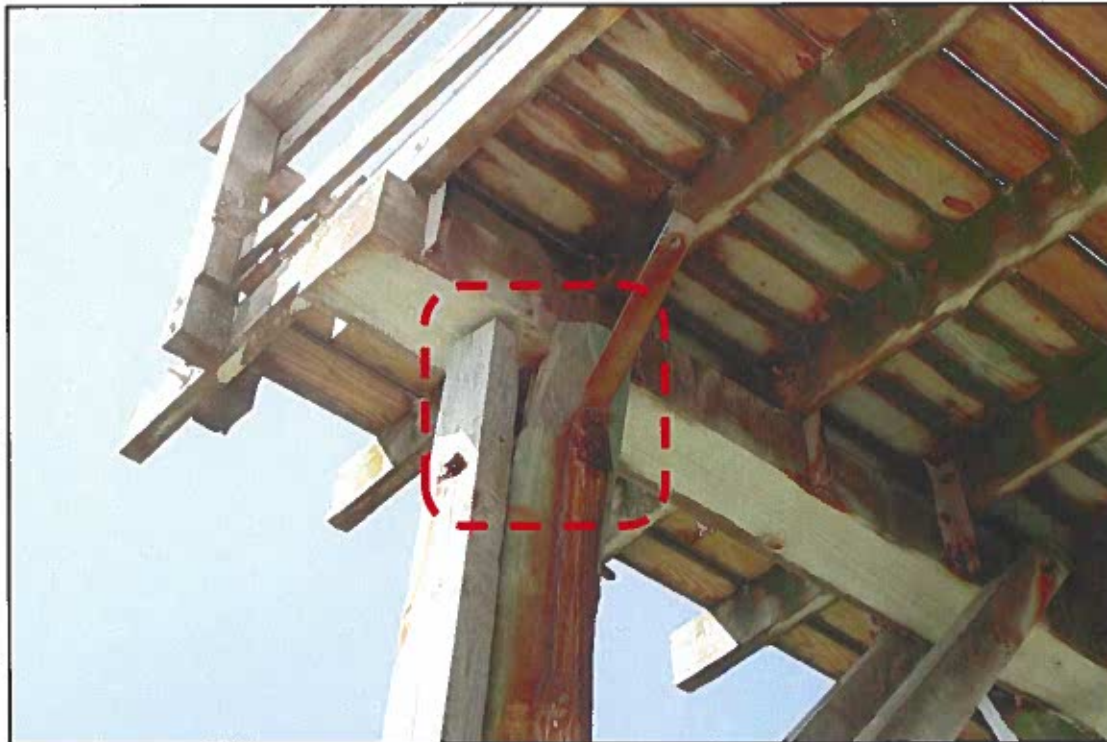
| PILE LOCATION | DAMAGE RATING | REASON FOR RATING |
|---|---|---|
| 52A | Severe | Split in top 18 inches of pile, 75% non-bearing (Photograph 14). |

**Photograph 14: Pile 52A – Split in top 18” of pile with 75% non-bearing.**

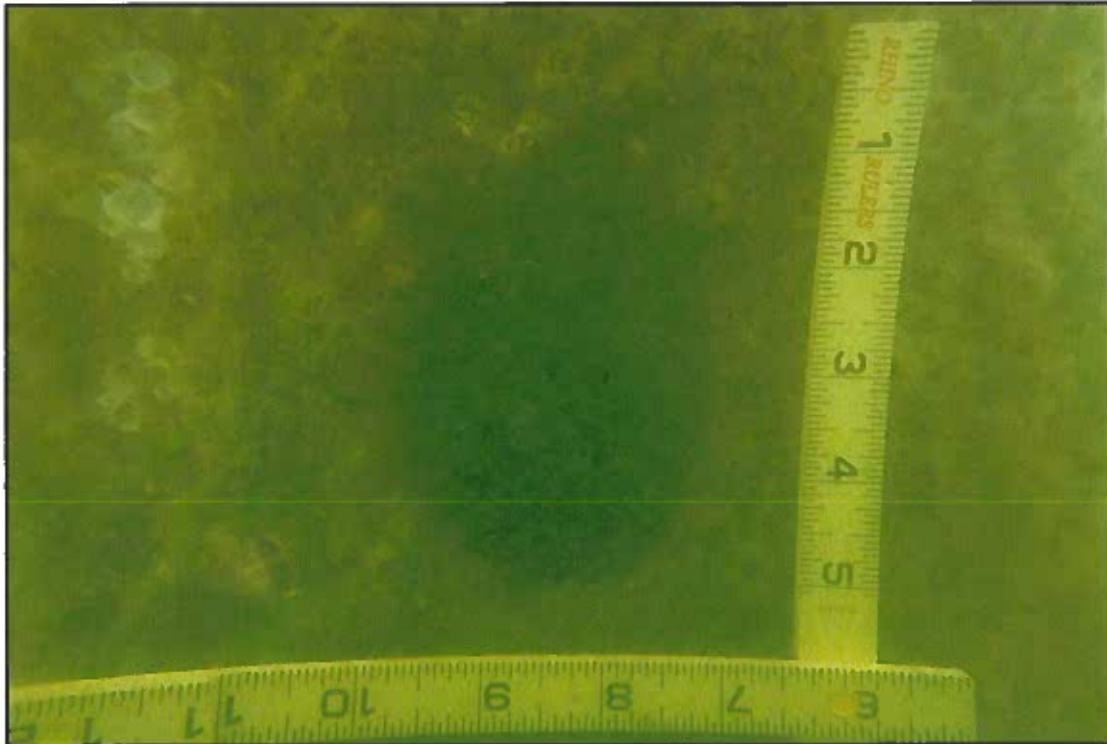
| PILE LOCATION | DAMAGE RATING | REASON FOR RATING |
|---|---|---|
| 52B | Severe | 3-inch by 5-inch hole with hollowing due to marine borer, 6 feet above ML; >75% section loss extending 2 feet above and below the hole (Photograph 15). |

**Photograph 15: Pile 52B – Hole in pile with section loss and hollowing due to marine borer.**

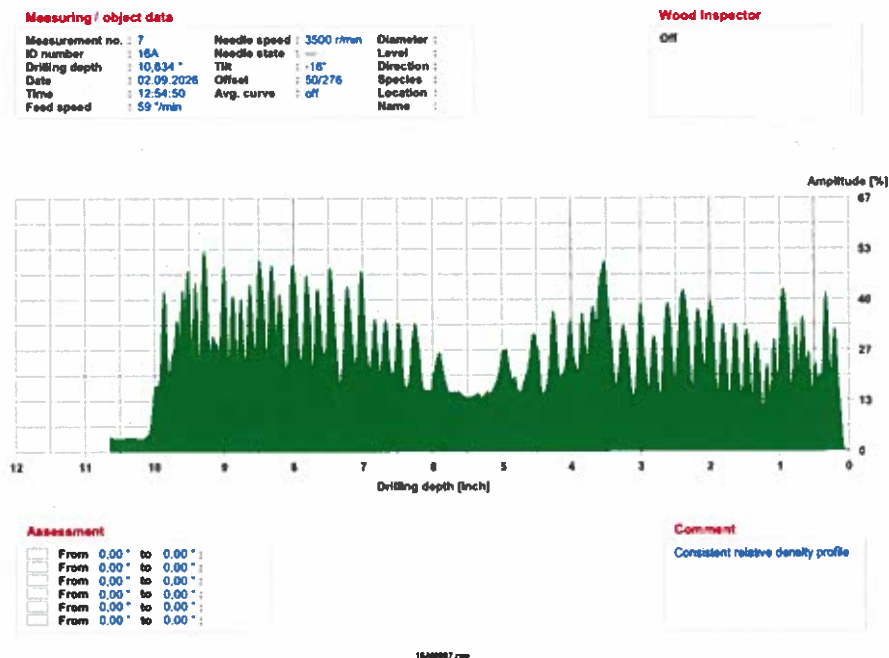
In summary, no internal wood decay or voids were observed in any of the piles tested. All drillings were classified as “Consistent Relative Density” profiles (See Figure 1). A consistent profile typically illustrates a density variation within the annual rings of the pile. As the needle encounters each annual ring the earlywood, or spring growth, of an has low relative density, while the late wood, or summer growth of an annual ring, is much denser. Therefore, when drilling a sound pile a consistent profile has regular peaks (i.e. dense latewood) and troughs (i.e. less dense earlywood) such as that shown in Figure 1. Also shown in Figure 1 is the center of the pile which has the lowest relative density in the cross section of a wood pile. That is the approximate center of the pile which represents the juvenile growth of a tree and is generally less dense than the remainder of the cross section.

**Figure 1 – Pole 16A. Consistent relative densith profile. Low region in center is representative of the pith, or center, of a pile which has the lowest density in the cross section of a pile.**

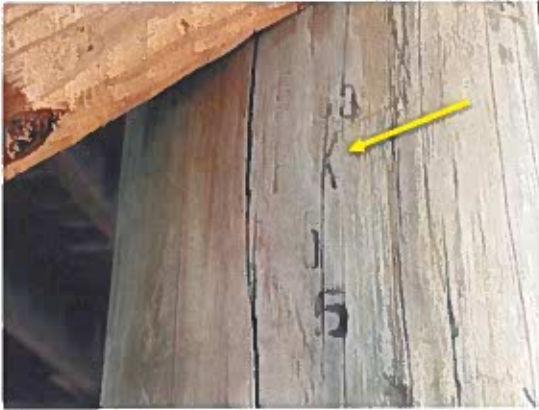
Samples were not collected for species identification as they were not included in the scope of work. However, the species of the piles appeared to be consistent with southern pine and the piles were likely treated with copper chromated arsenic (CCA) based on the green color. This was confirmed on one pile that exhibited a pole brand as shown in Photo 1.

Photo 1 - Brand on pile indicating southern pine and CCA treatment (i.e. "SPSK").
