DOT US Department of Transportation
PHMSA Pipeline and Hazardous Materials Safety Administration
OPS Office of Pipeline Safety – Accident Investigation Division

Principal Investigator Wesley Mathews
Acting Accident Investigation Director Chris Ruhl
Date of Report May 26, 2022
Subject Failure Investigation Report - Denbury Gulf Coast Pipelines, LLC – Pipeline Rupture/ Natural Force Damage

Failure Investigation Report – Denbury Gulf Coast Pipelines LLC
Pipeline Rupture/Natural Force Damage
February 22, 2020

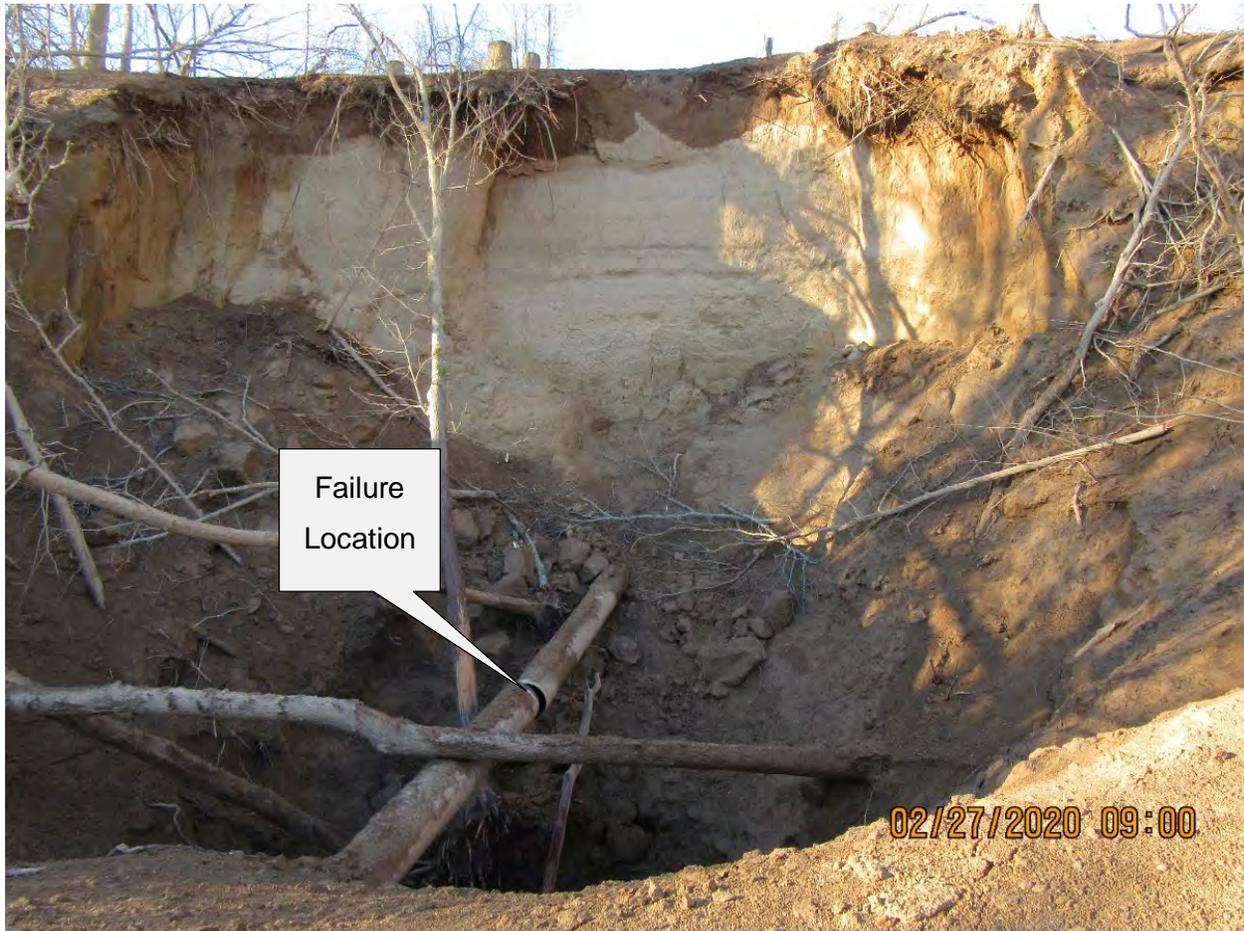
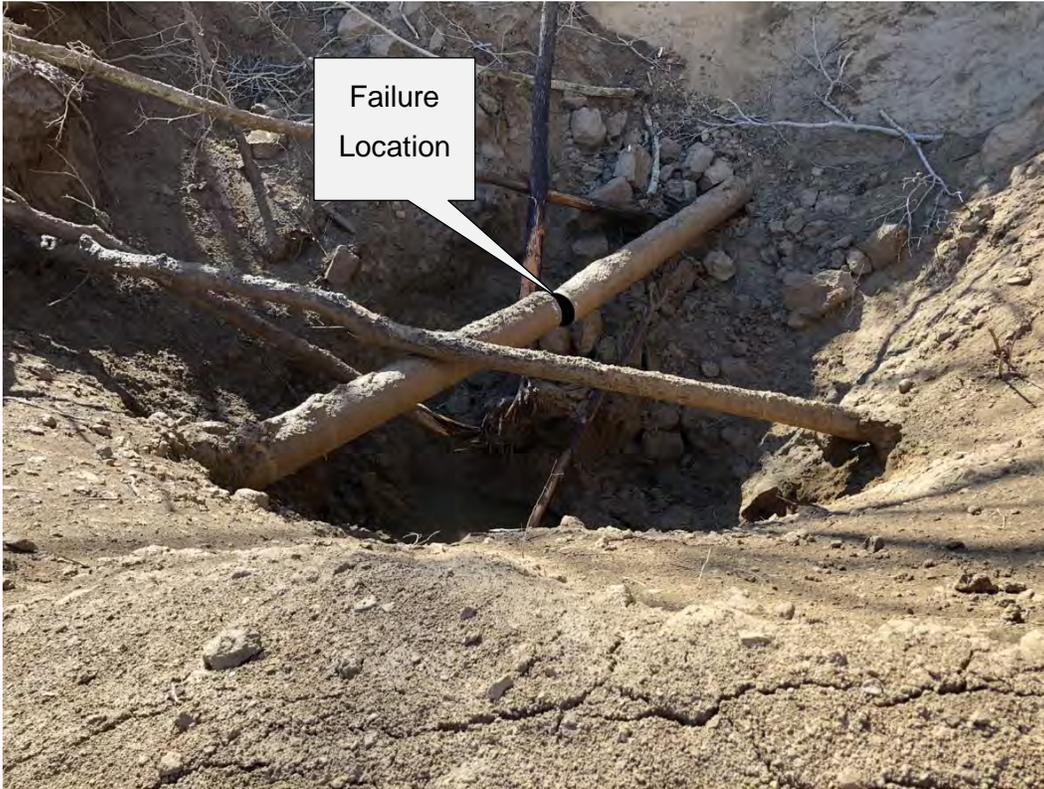
Figure 6. Failure Location (Upstream to Downstream)

From initial visual examination, the failure appeared to have occurred at least 40 feet in elevation below the roadway, with indications of soil subsidence in the vicinity of the failure. The release crater included trees and root debris, but based on the pipeline alignment sheet elevation profile, a significant volume of soil in the slick bore section between the failure and MS Highway 433 had collapsed. The soil in the vicinity of the failure appeared to be extremely wet.

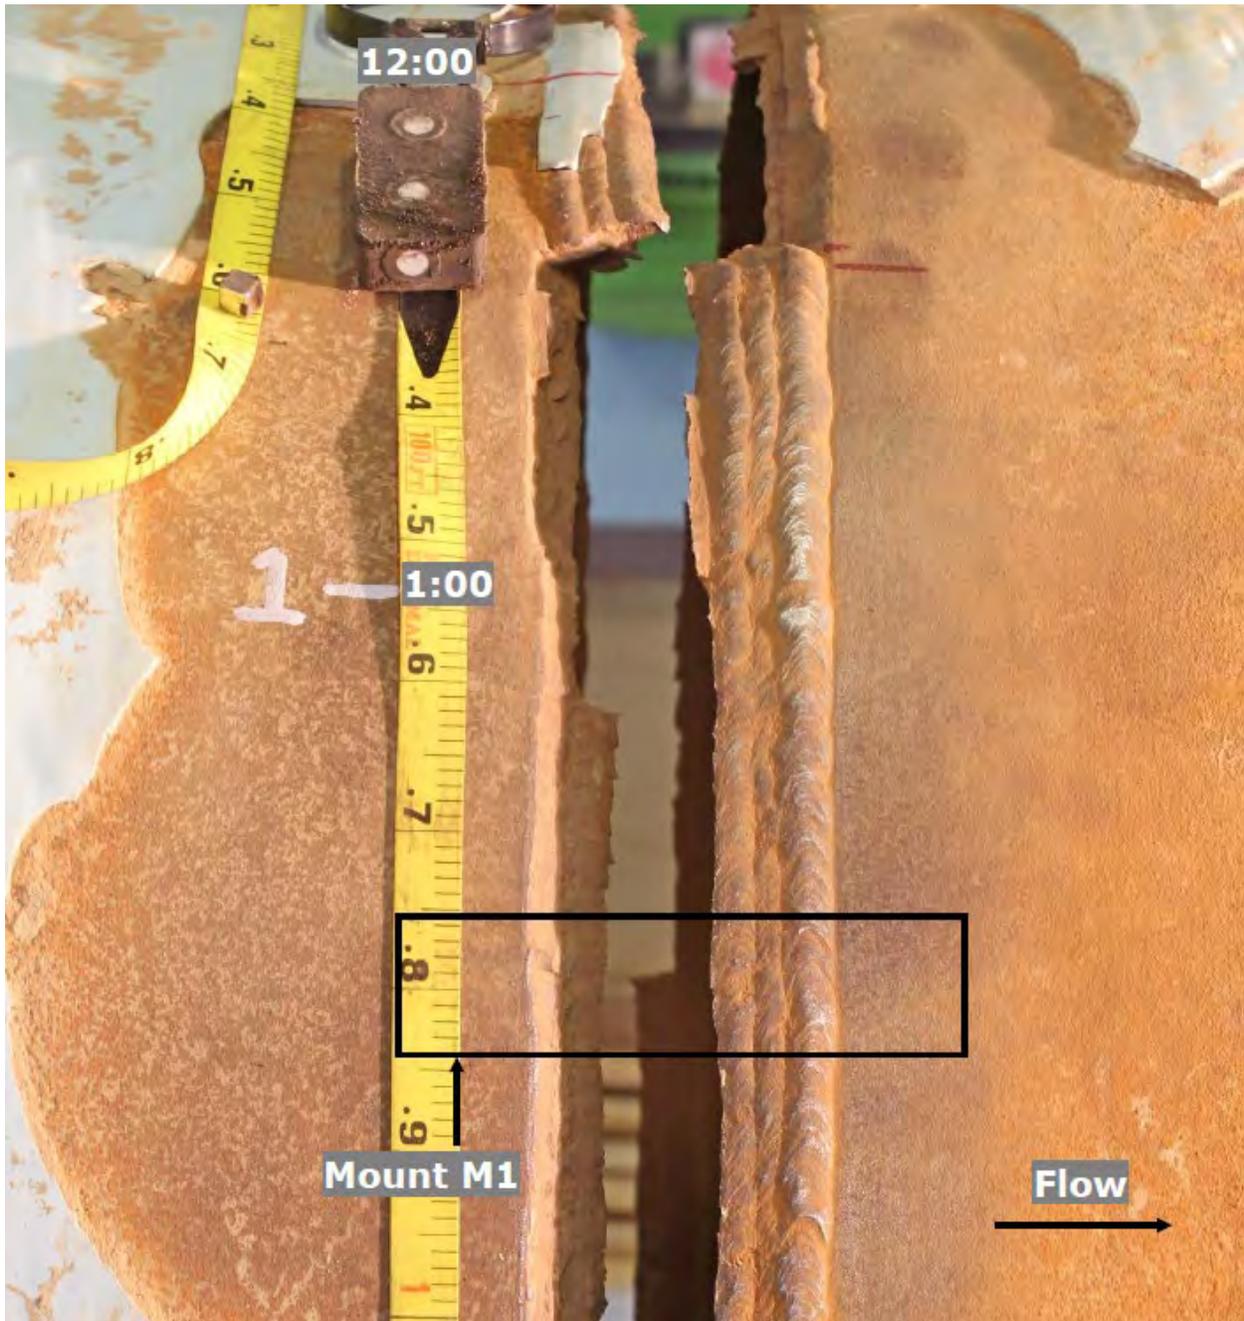
Figure 19. Overview of Mount M1

Sample M1 contains a fracture path at a shear angle. This sample was removed from the girth weld at the 1:35 o'clock orientation (see Figure 19).

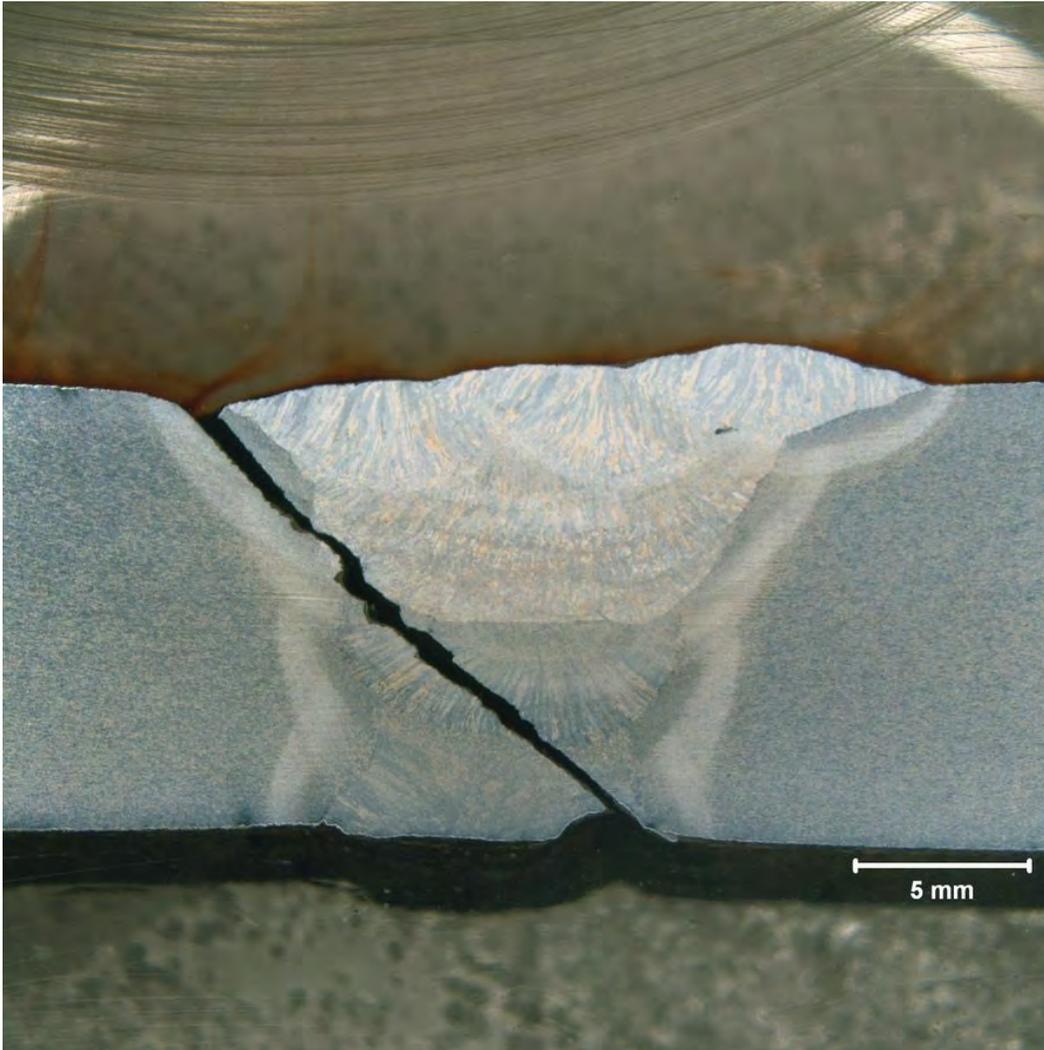
Figure 20. Representative Cross-Section from Sample M1

The fracture path of this sample is located in the HAZ near the toe of the weld at the OD surface. An image of the cross section of sample M1 is provided in Figure 20.

There is no indication of excessive porosity and/or inclusions. It shows a slight misalignment of the high-low weld of approximately 4.3% of the NWT. Higher magnifications are provided in the laboratory report which show grain elongation due to the cold work that took place during the rupture process. This is consistent with ductile overloading. The microstructure is typical of modern X80 line pipe. A close-up of sample M1 is provided in Figure 21.

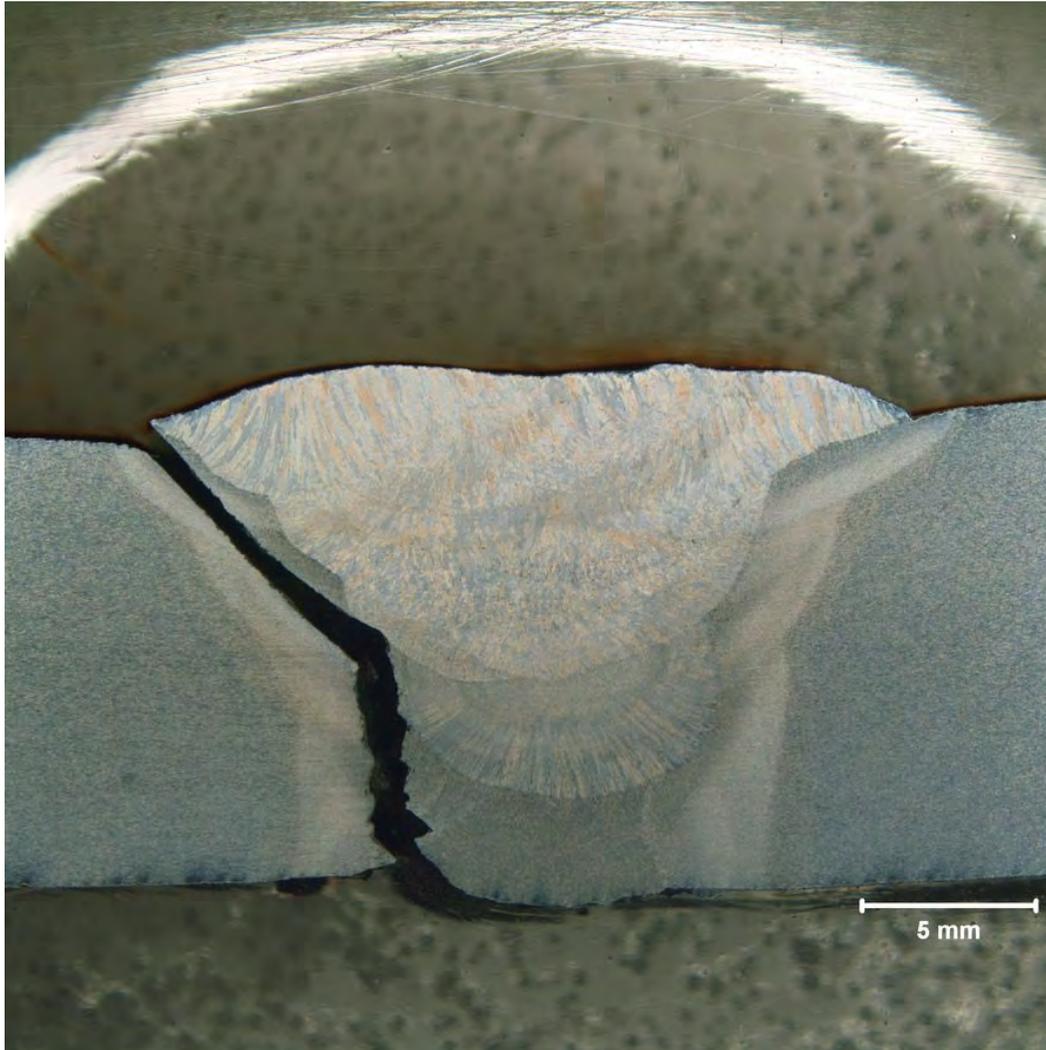
Figure 23. Representative Cross-Section from Sample M2

There are both smooth and rough regions in this sample. The high-low weld misalignment at this location is approximately 6.9% of the NWT. The fracture path at this location was mainly located at the HAZ. Fractography in the SEM shows the presence of a smooth region containing dimples (typical of ductile behavior) and cleavage facets (typical of brittle behavior) in the rough region. Some fissures were also found in the area where cleavage facets were located. These fissures are usually seen in girth weld overload areas (see Figure 24).

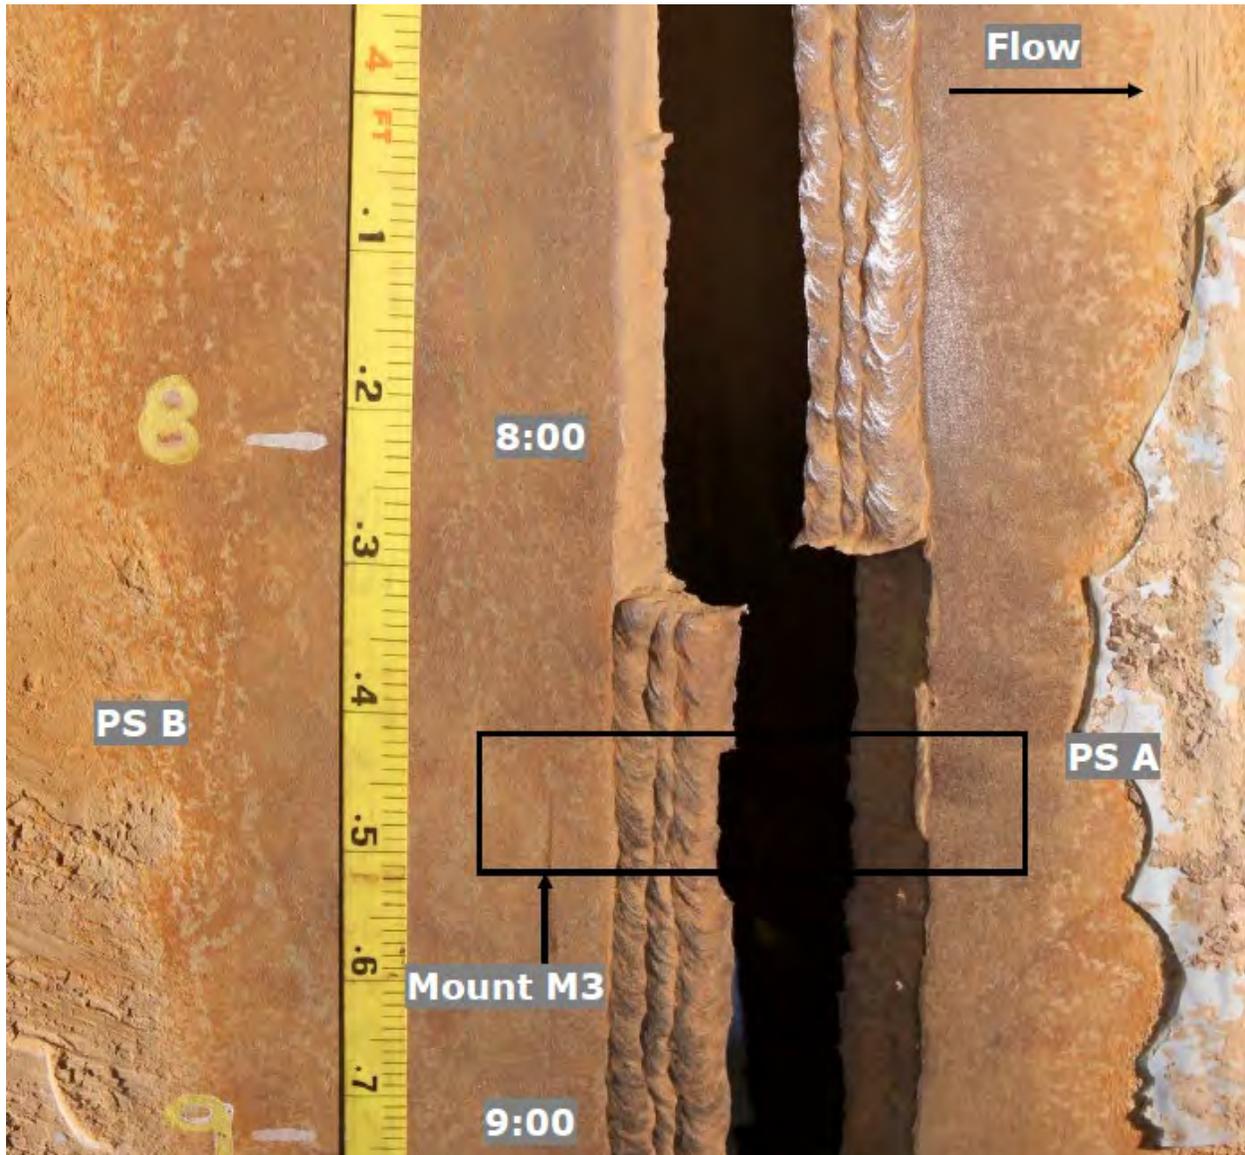
Figure 25. Overview of Mount M3

The fracture path is at a shear angle and mainly located in the weld metal. The morphology of the weld is similar to samples M1 and M2. The high-low weld misalignment at this location was approximately 2.6% of the NWT. The microstructure is consistent with the findings in samples M1 and M2 (see Figure 26 and Figure 27).

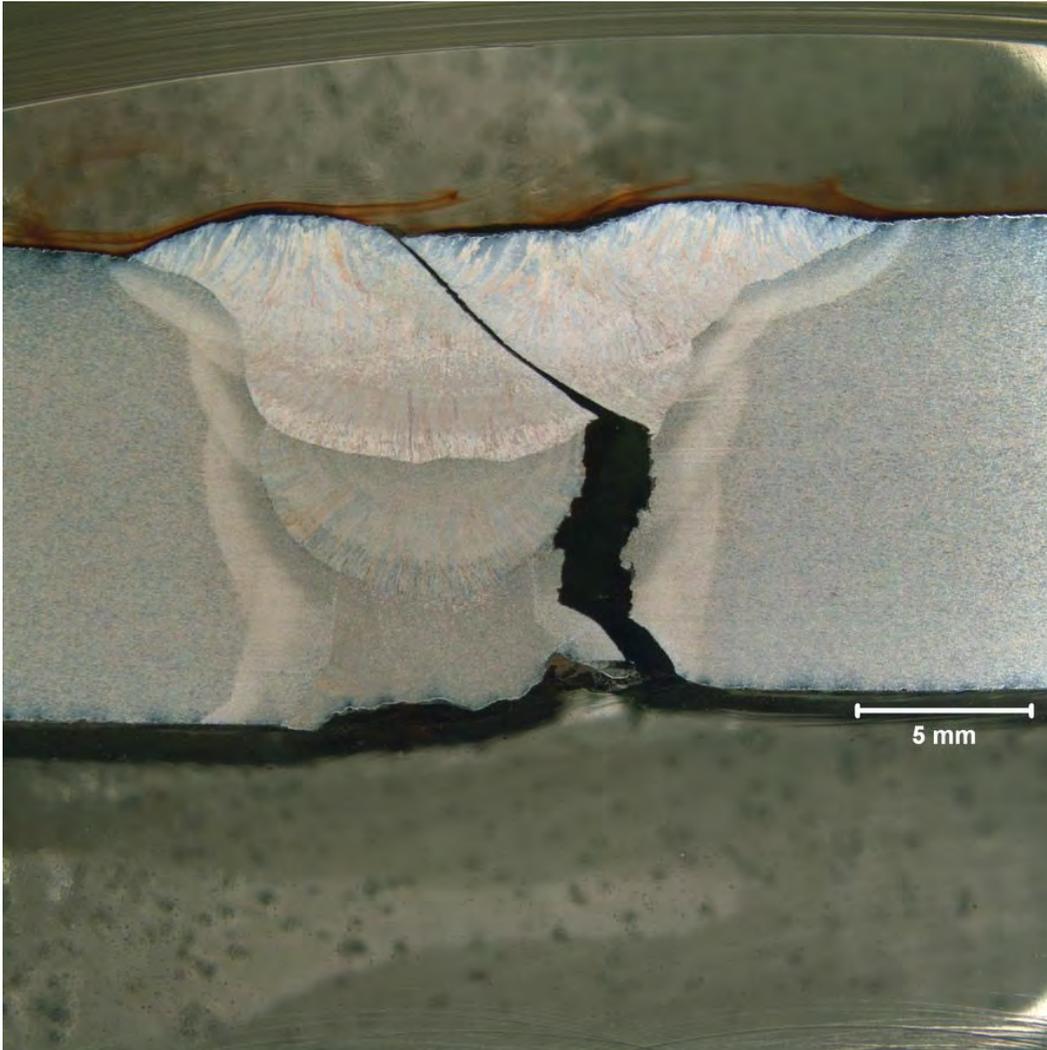
Figure 29. Representative Cross-Section from Sample M4

There is a smooth shear angle region and a rough region. The fracture path at this location is mainly in the HAZ. (see Figure 29).

The sample shows grain elongation and an inclusion orientated parallel to the fracture surface which is consistent with ductile overload. There are also fissures in this sample that have the same morphology shown in M2 sample. A close-up of the M4 sample is provided in Figure 30.

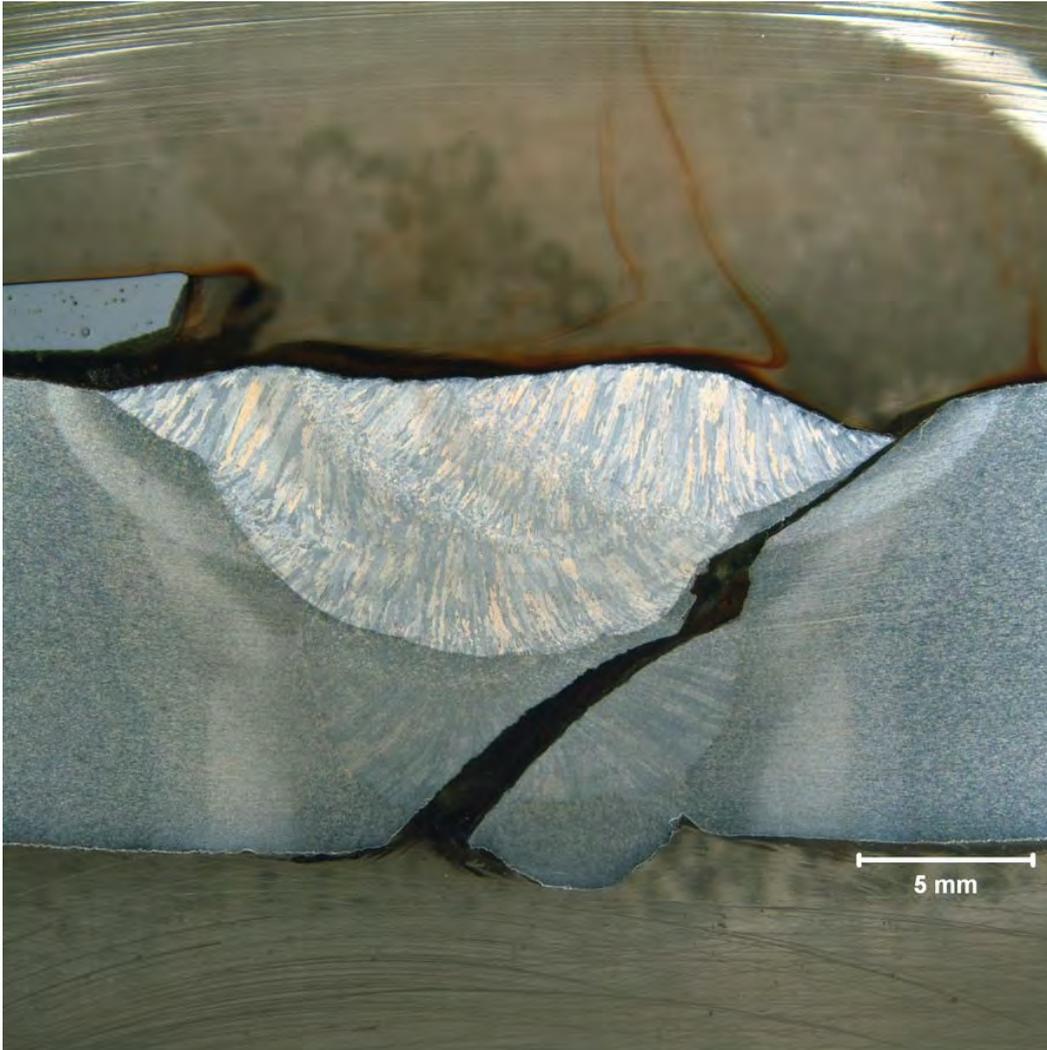
Figure 32. Representative Cross-Section from Sample M5

This sample has a smooth shear region on most of the fracture surface, located in both the weld metal and base metal. There is a shallow flaw between the weld metal and HAZ which is consistent with incomplete fusion. The high-low weld misalignment at this location was approximately 4.6% of the NWT. There is no evidence of crack extension at the flaw in this sample. A view of the cross section of sample M5 is provided in Figure 32.

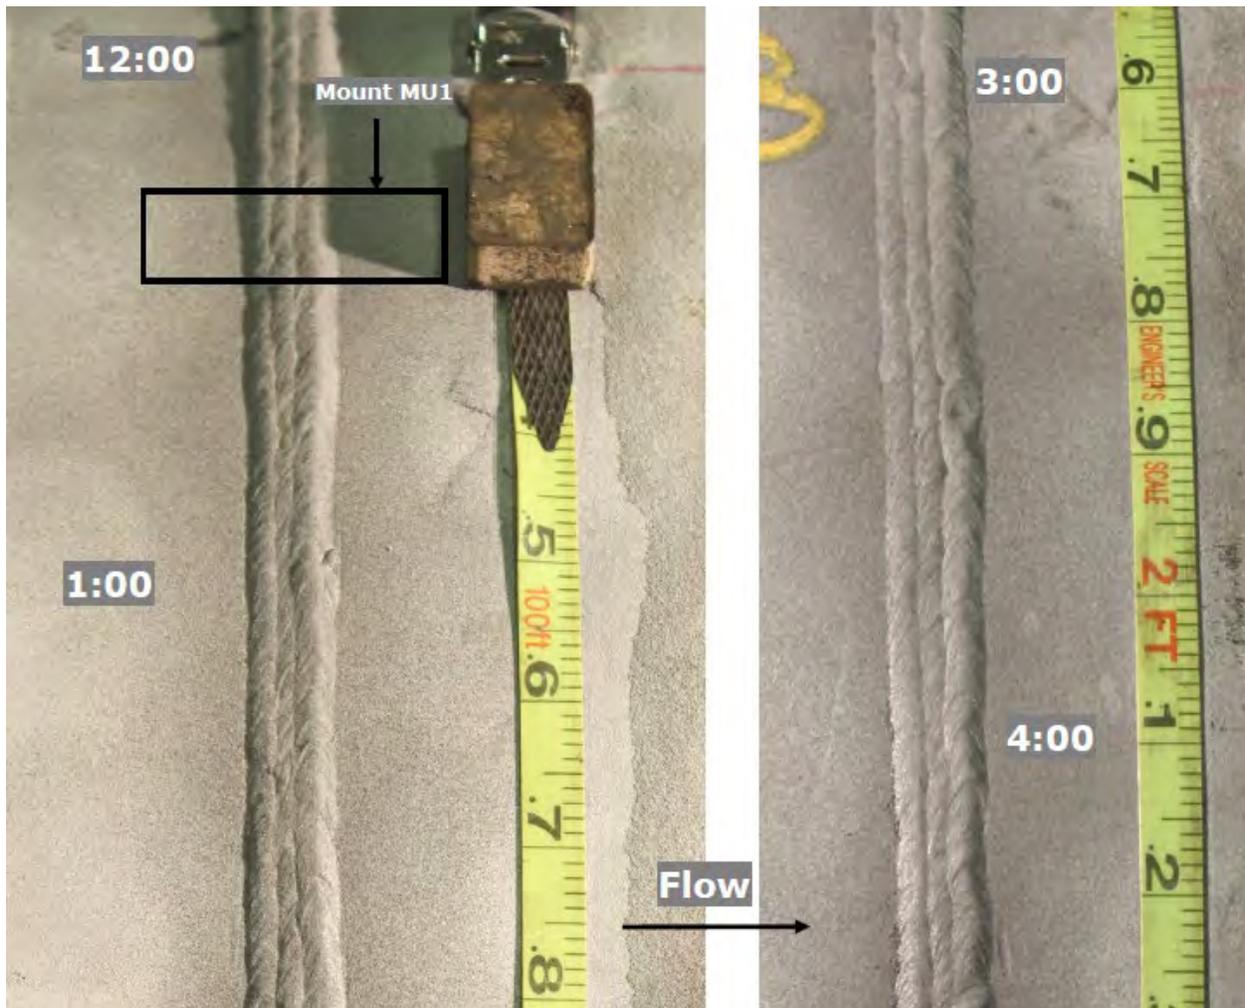
Figure 33. Overview of Mount MU1

This sample was removed from the intact GW at the 12:24 o'clock position. The morphology is similar to the previous mounts. The high-low weld misalignment at this location is approximately 4.6% of the NWT. The figure shows a shallow incomplete fusion flaw (1.9% of the NWT) between the weld metal and the HAZ. An image of the cross section of sample MU1 is provided in Figure 34.

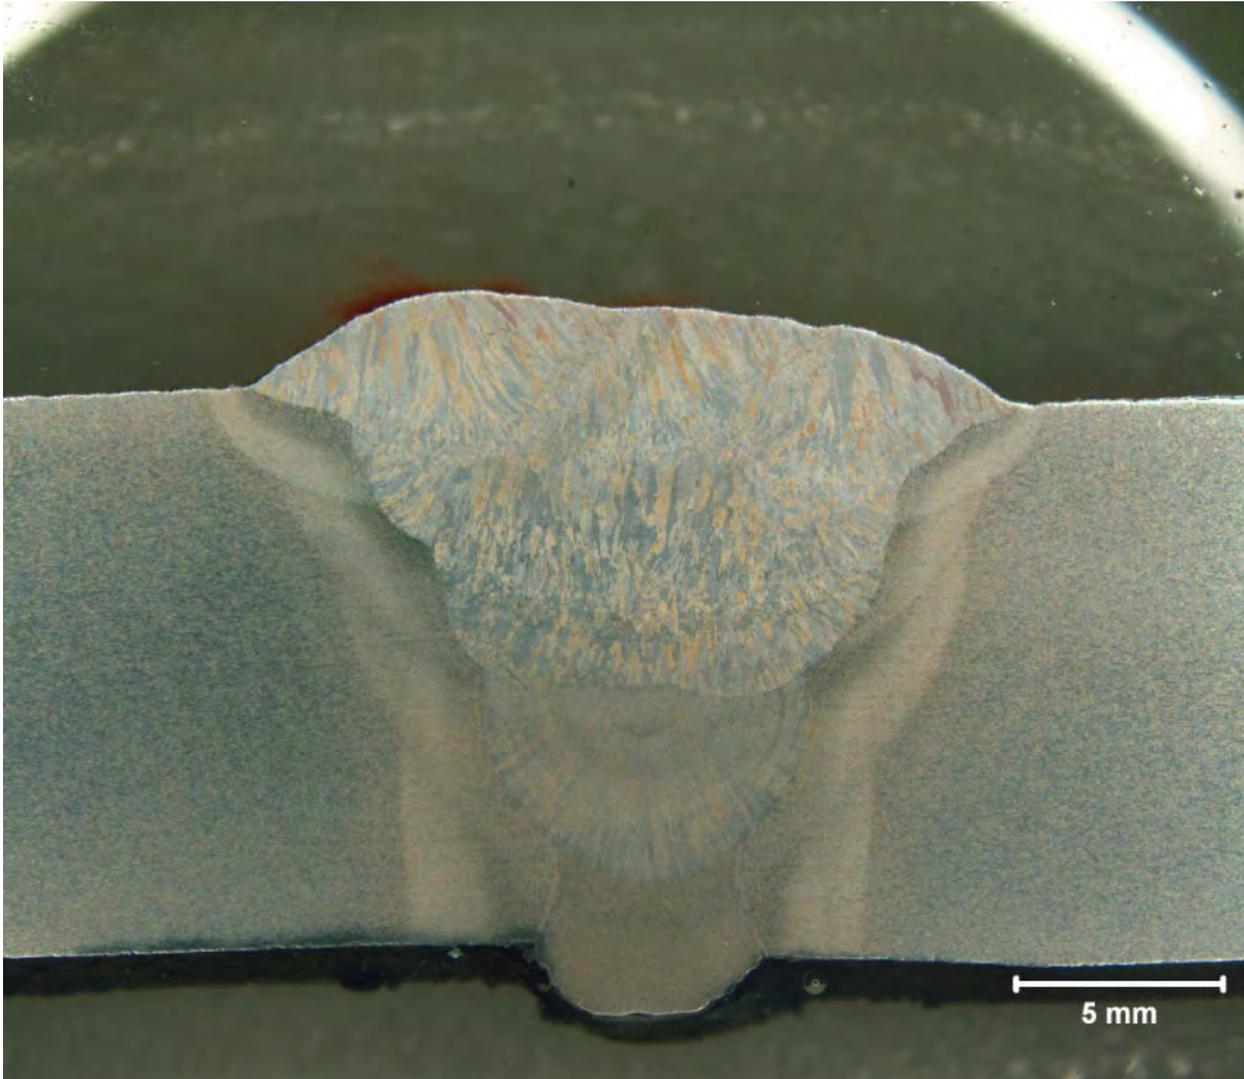
Figure 34. Cross Section of Mount MU1

A shallow flaw was identified between the weld metal and HAZ, with no evidence of cracking or extension of the flaw. A close up view of the flaw is provided in Figure 35.

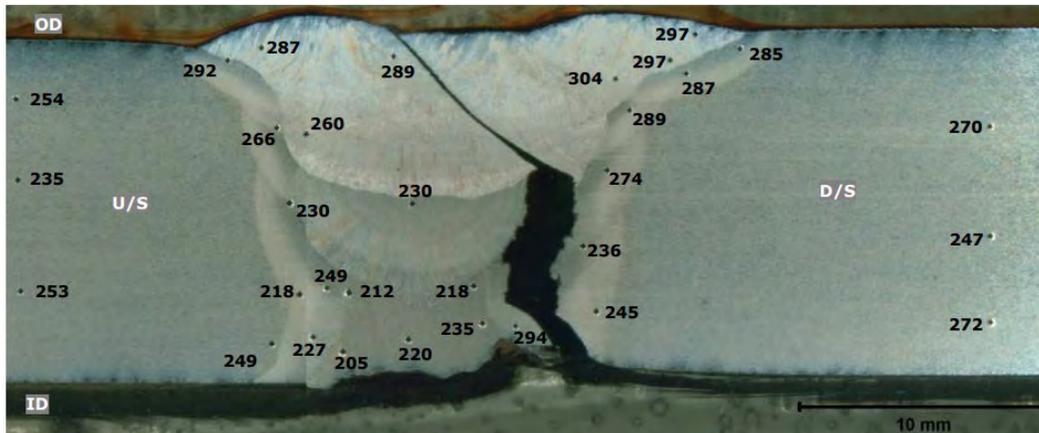
Figure 39: Light Photomicrograph of M2 Axial Cross-Section Showing Hardness Levels in HV

Vickers hardness testing was conducted on all six metallographic cross sections. No areas of unusually high hardness were identified. Hardness testing of the failed girth weld exhibit variability that is likely associated with cold work sustained during the failure. The hardness testing of the intact weld are the best representation of the base hardness of the welds preceding the failure. The results indicate a lower hardness of the weld metal compared to the pipe metal, which indicating that the weld metal is softer than the parent metal. Typically, the parent metal

is harder than the weld metal. The axial tensile tests on the intact girth weld show similar failure to the actual fracture, further indicating that the lower hardness typical of the weld was the preferred location for the overload failure under applied axial stress. Hardness levels at varying points on sample M2 from the failed girth weld are shown in Figure 39.

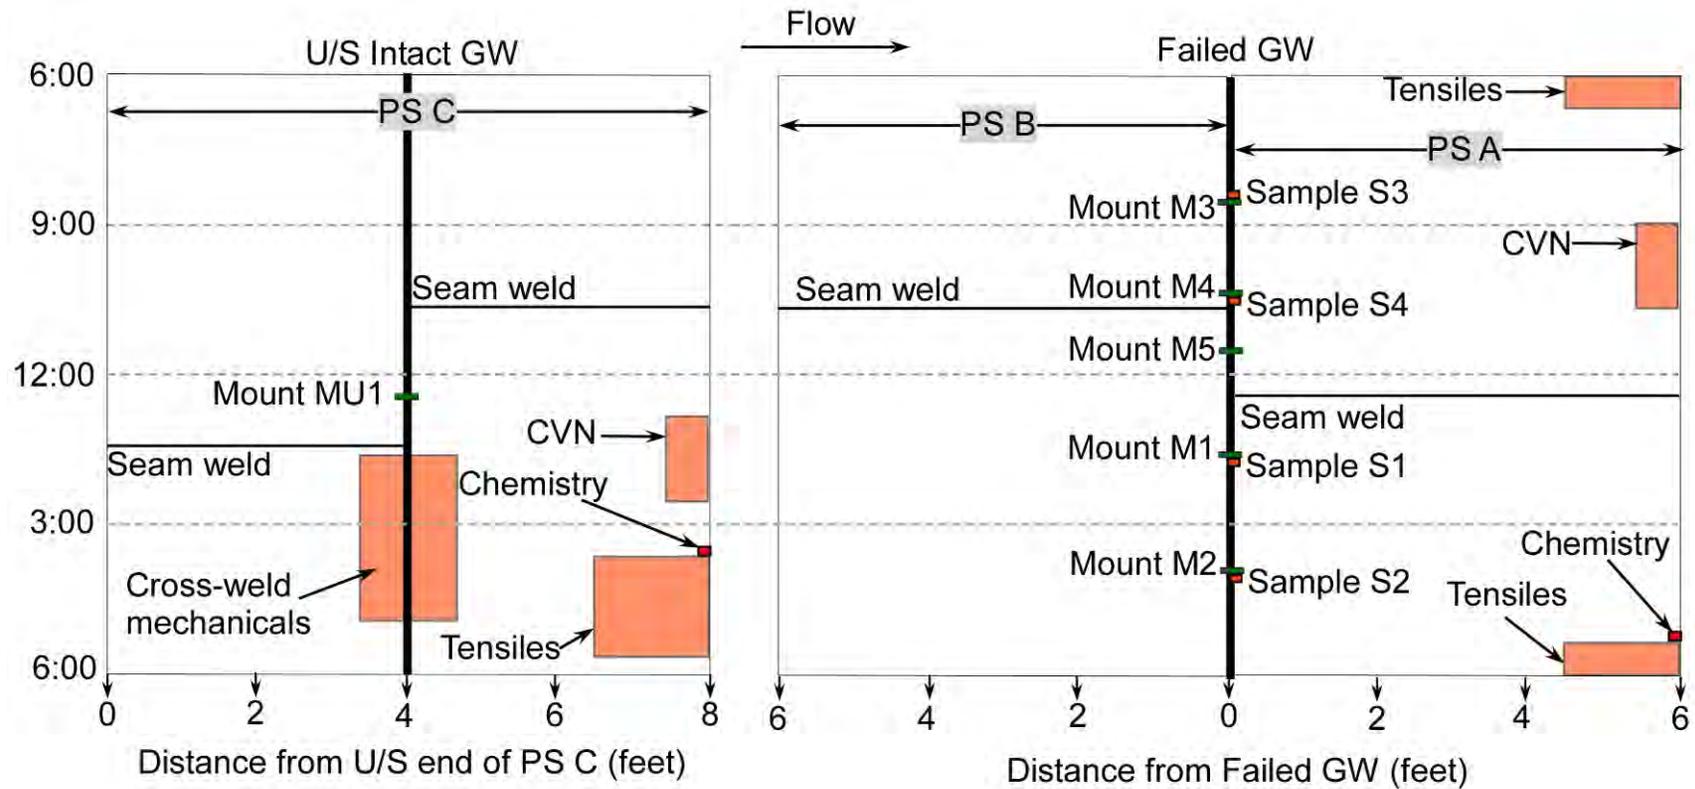
Figure 1. Schematic of Pipe Sections (PSs) A, B, and C showing the locations of the girth welds and seam welds, and where samples for metallography (Mounts M1, M2, M3, M4, M5, and MU1), fractography (Sample S1, S2, S3, and S4), mechanical testing (CVN, cross-weld mechanicals, and tensiles), and chemical analyses (chemistry) were removed.

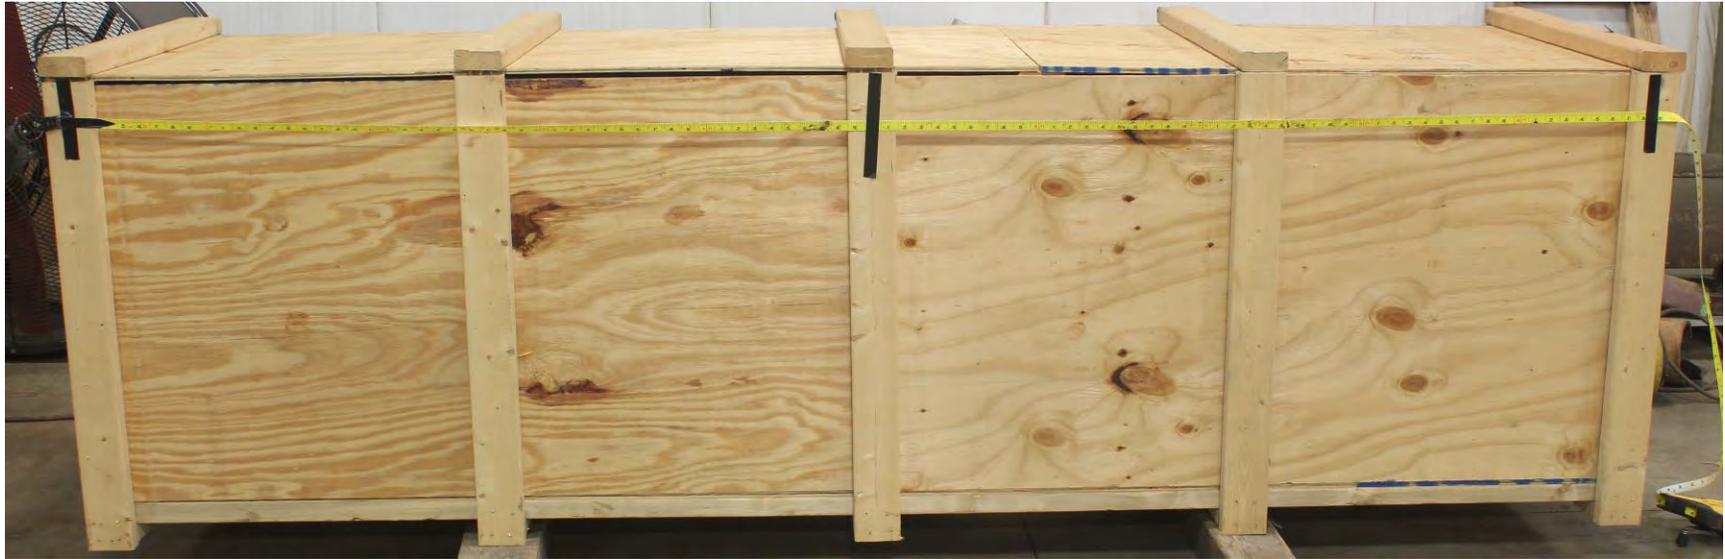
Figure 2. Photograph of the wooden crate that contained PS A, as received at DNV GL.

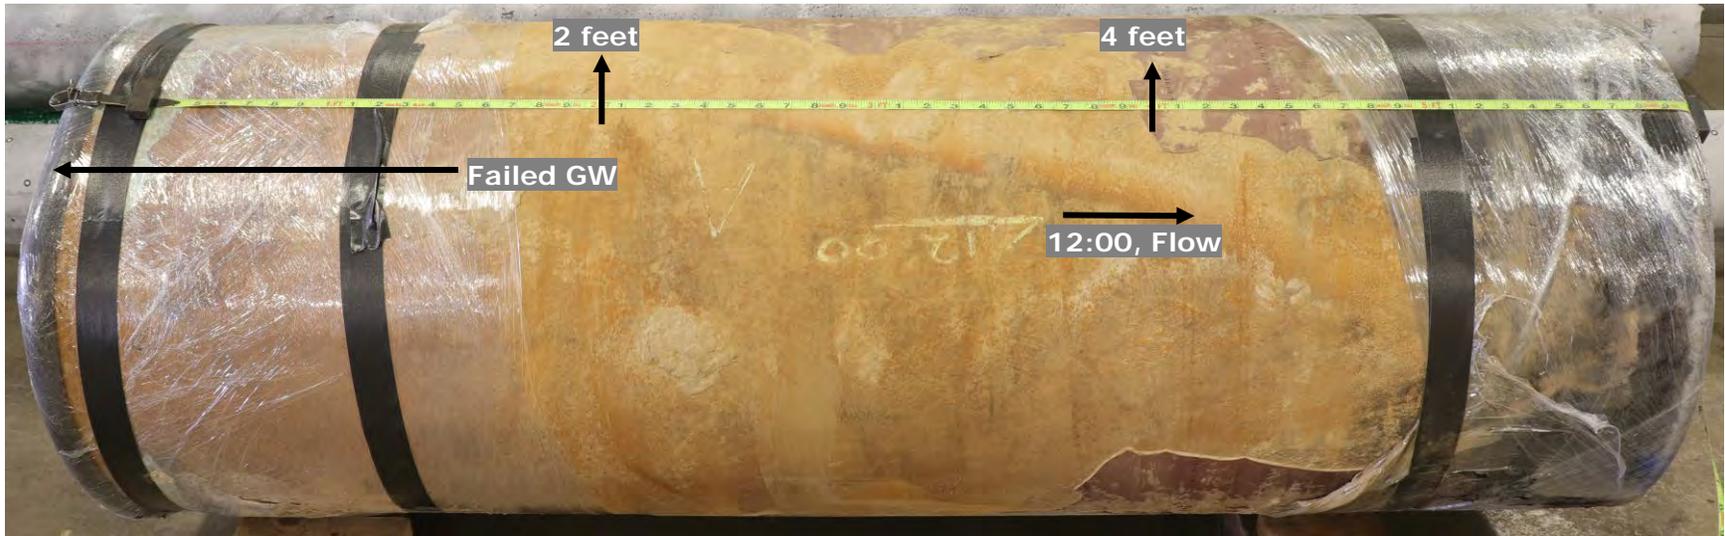
Figure 3. Photograph of PS A after removal from the wooden crate. The tape measure indicates the distance from the U/S end of PS A.

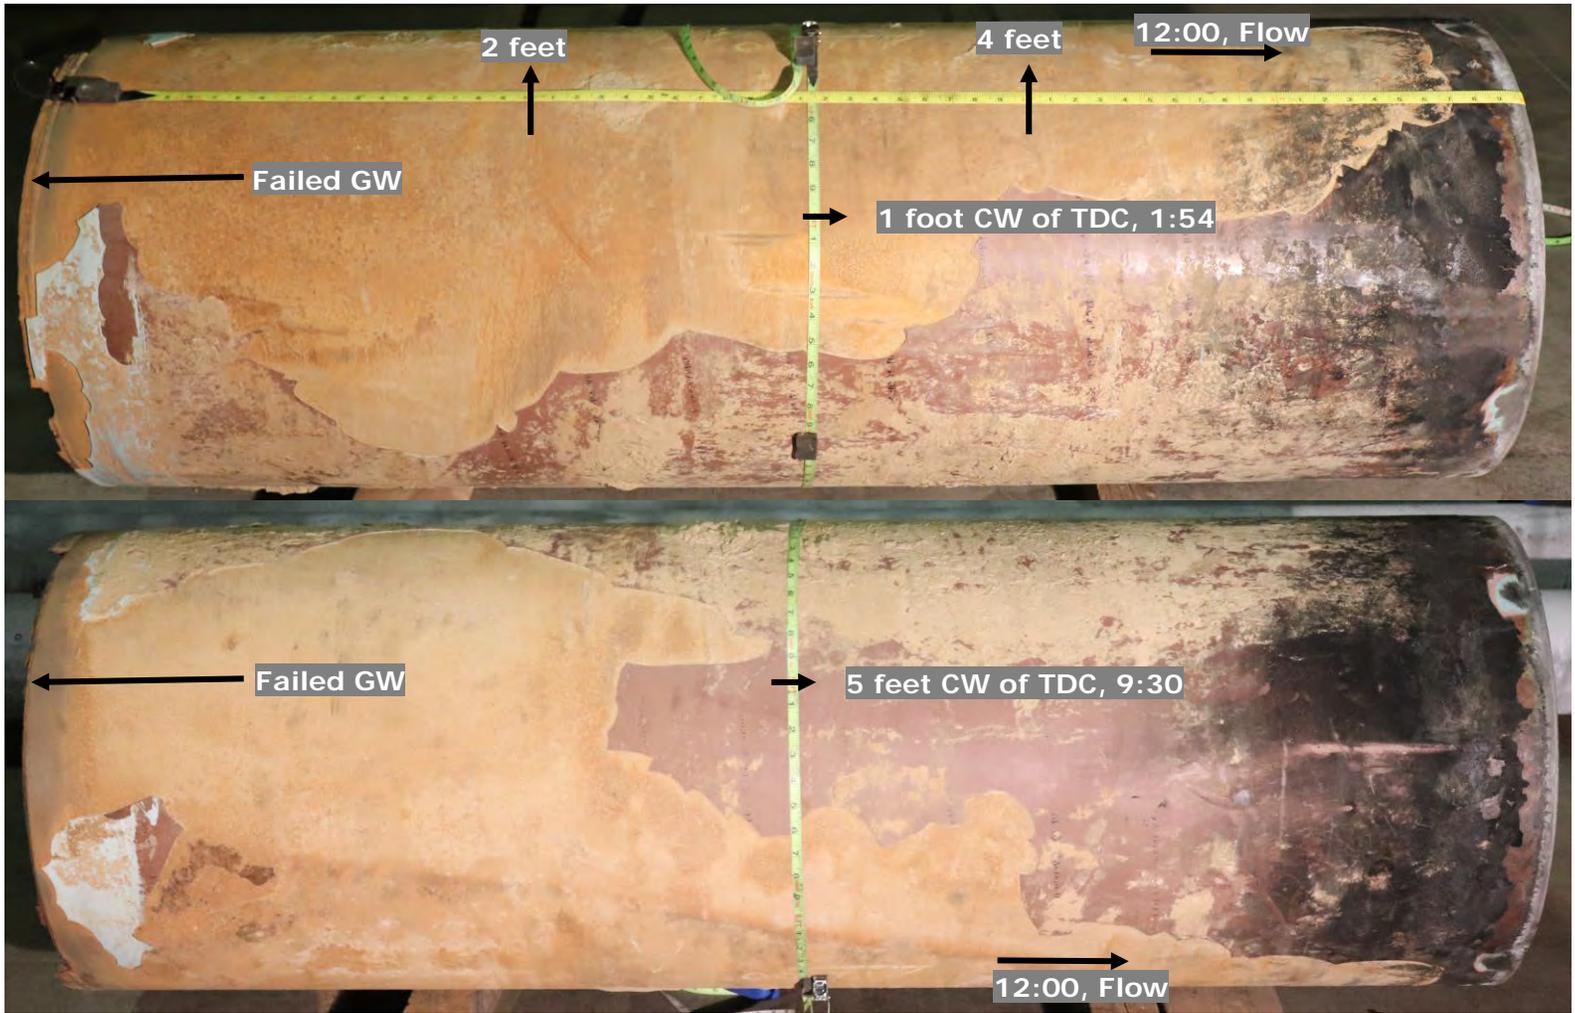
Figure 4. Photographs of PS A after removal of the protective wrappings. The horizontal tape measure indicates the distance from the U/S end of PS A, and circumferential tape measure indicates the distance clockwise (CW) of top-dead-center (TDC) looking downstream (D/S).

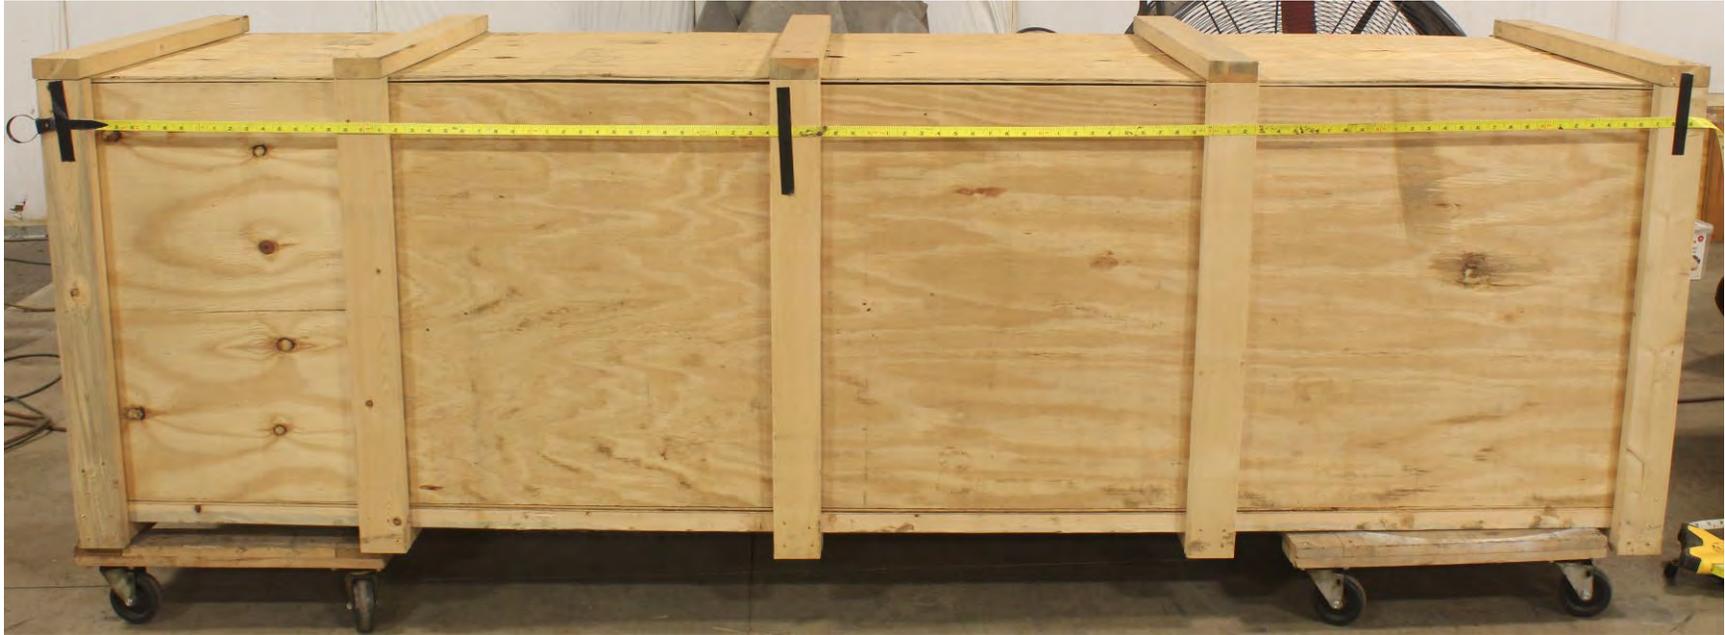
Figure 5. Photograph of the wooden crate that contained PS B, as received at DNV GL.

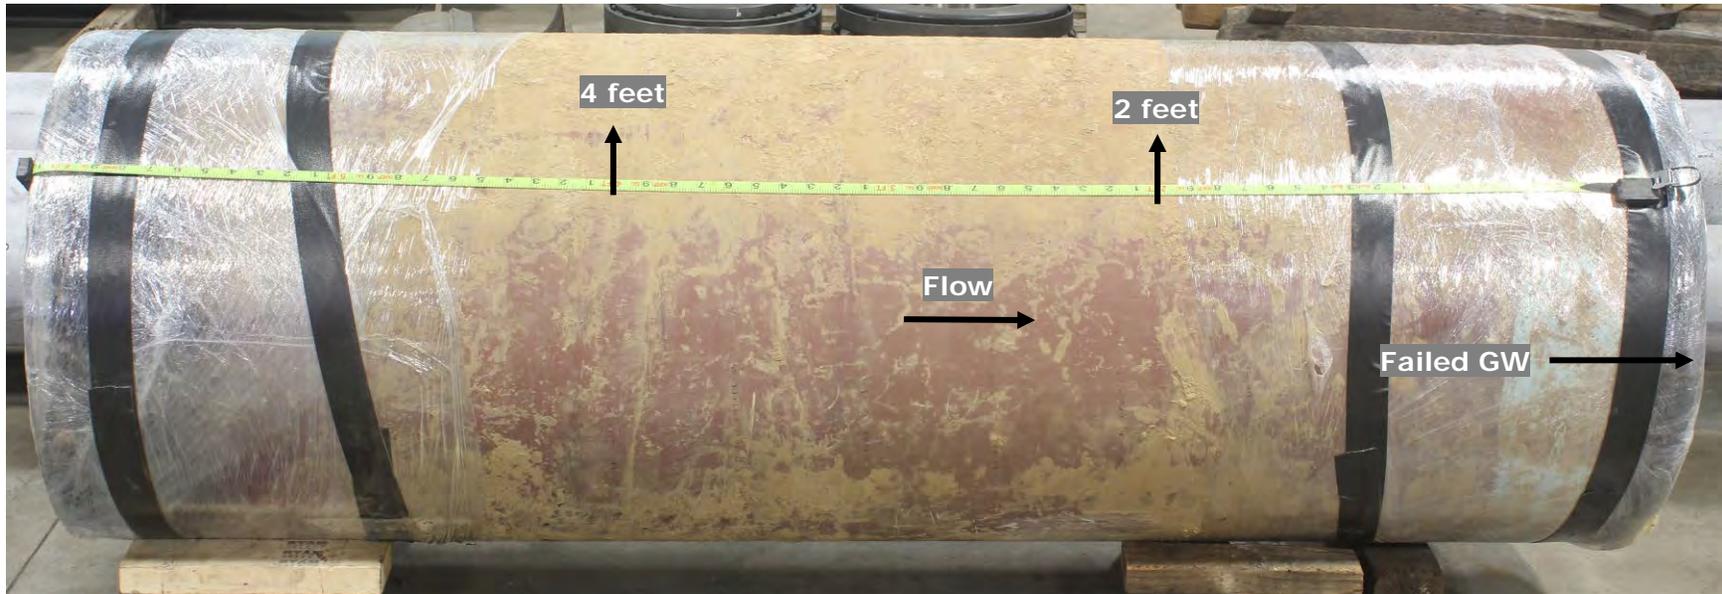
Figure 6. Photograph of PS B after removal from the wooden crate. The tape measure indicates the distance from the D/S end of PS B.

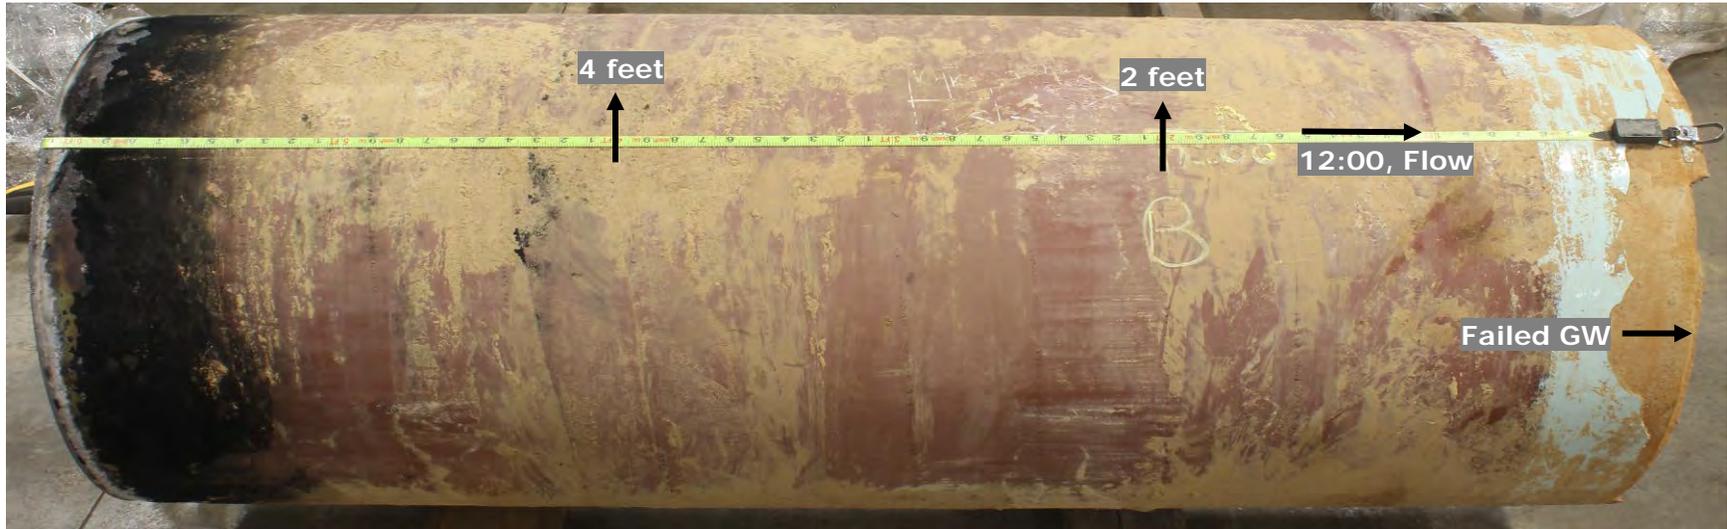
Figure 7. Photograph of PS B after removal of the protective wrappings. The tape measure indicates the distance from the D/S end of PS B.
