DOT US Department of Transportation
PHMSA Pipeline and Hazardous Materials Safety Administration
OPS Office of Pipeline Safety – Accident Investigation Division

Principal Investigator Wesley Mathews
Acting Accident Investigation Director Chris Ruhl
Date of Report May 26, 2022
Subject Failure Investigation Report - Denbury Gulf Coast Pipelines, LLC – Pipeline Rupture/ Natural Force Damage

Failure Investigation Report – Denbury Gulf Coast Pipelines LLC
Pipeline Rupture/Natural Force Damage
February 22, 2020

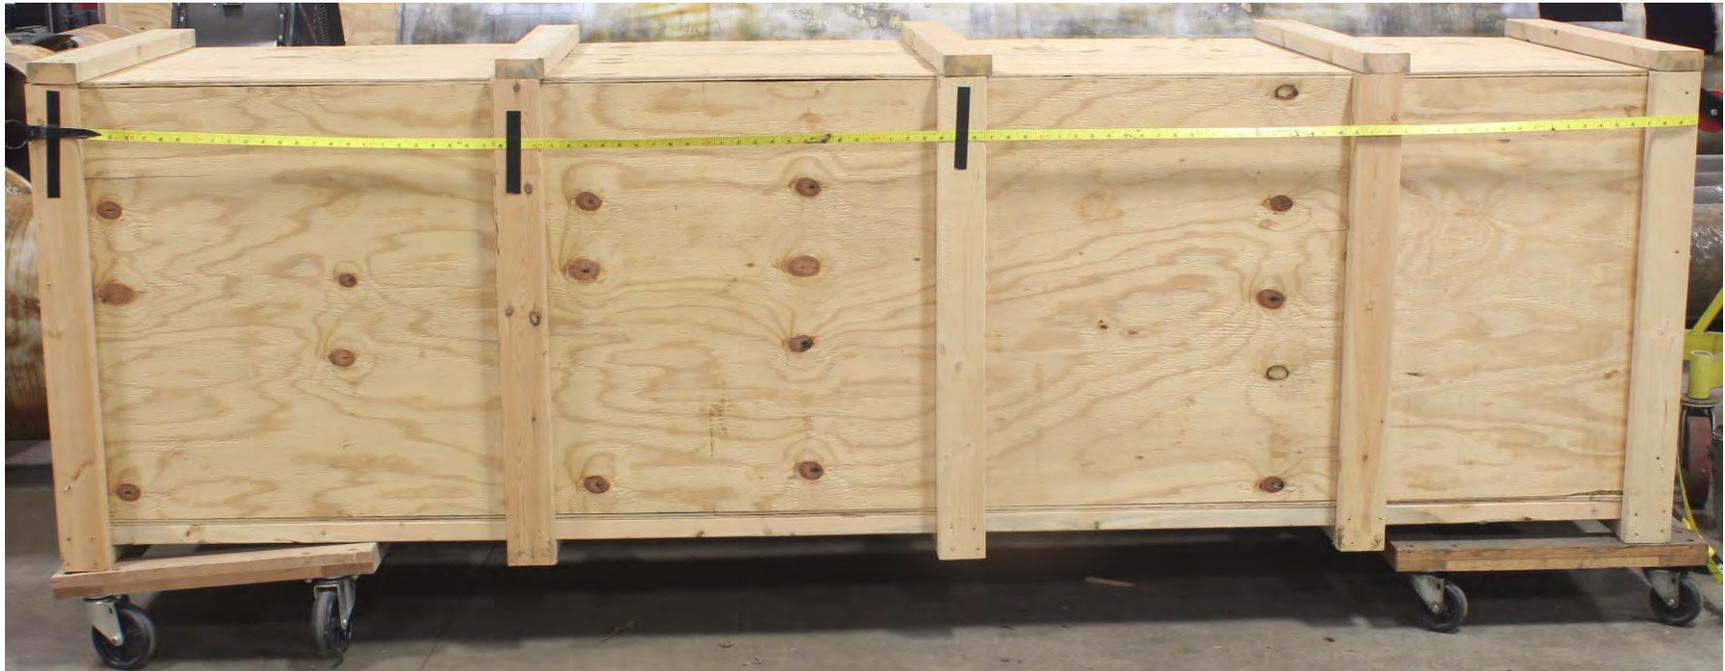
Figure 8. Photograph of the wooden crate that contained PS C, as received at DNV GL.

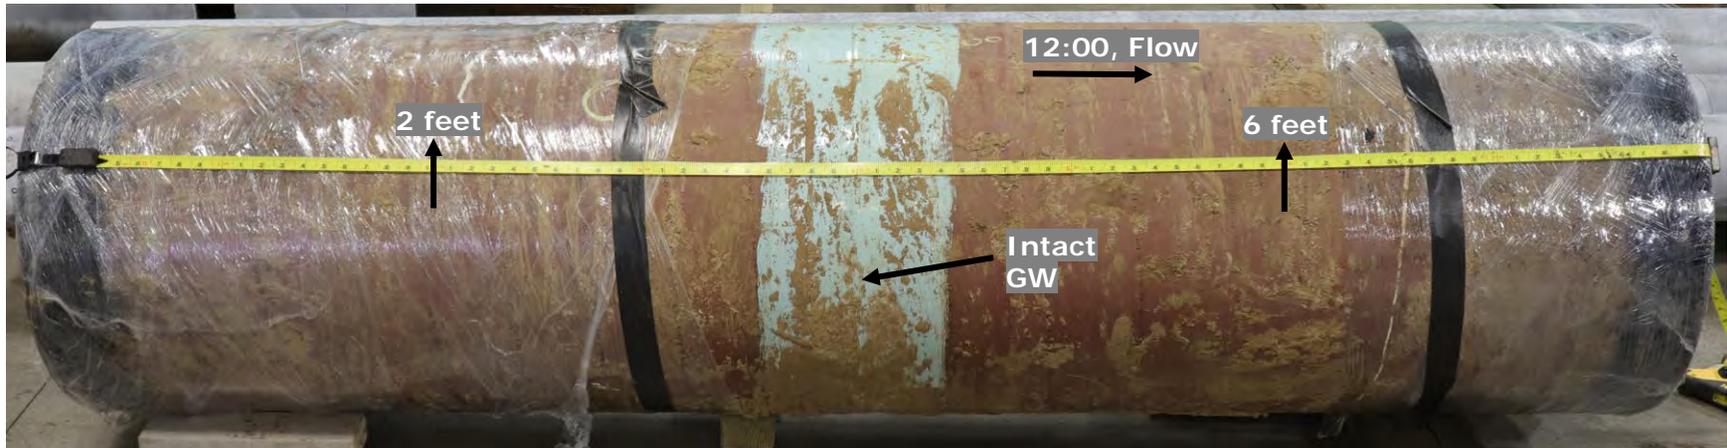
Figure 9. Photograph of PS C after removal from the wooden crate. The tape measure indicates the distance from the U/S end of PS C.

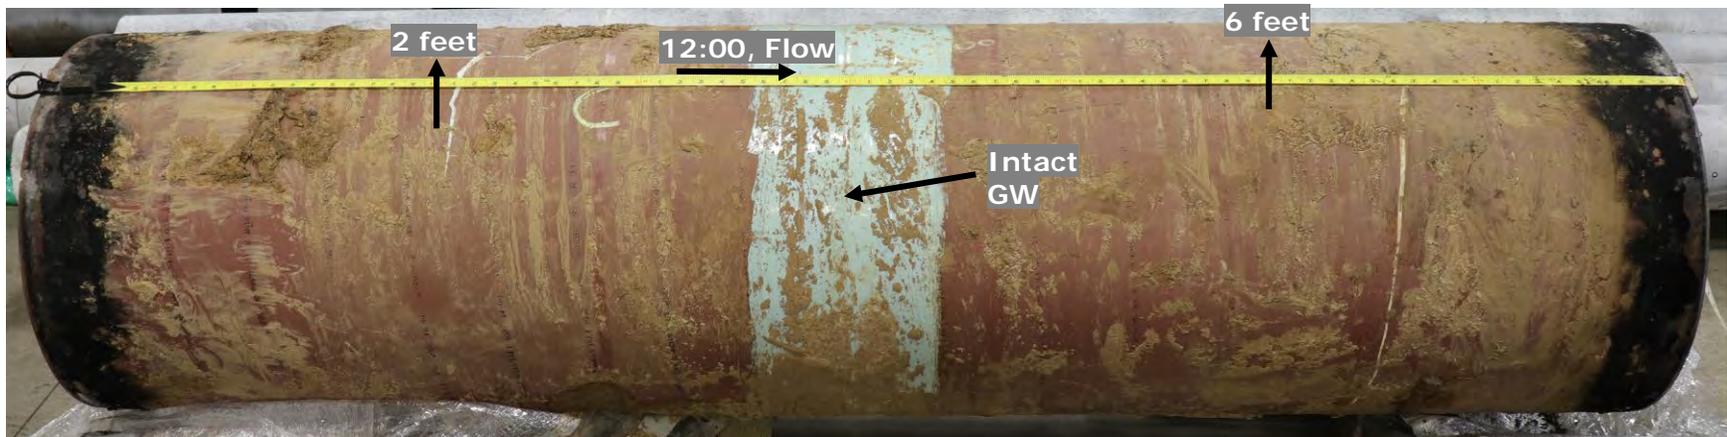
Figure 10. Photograph of PS C after removal of the protective wrappings. The tape measure indicates the distance from the U/S end of PS C.

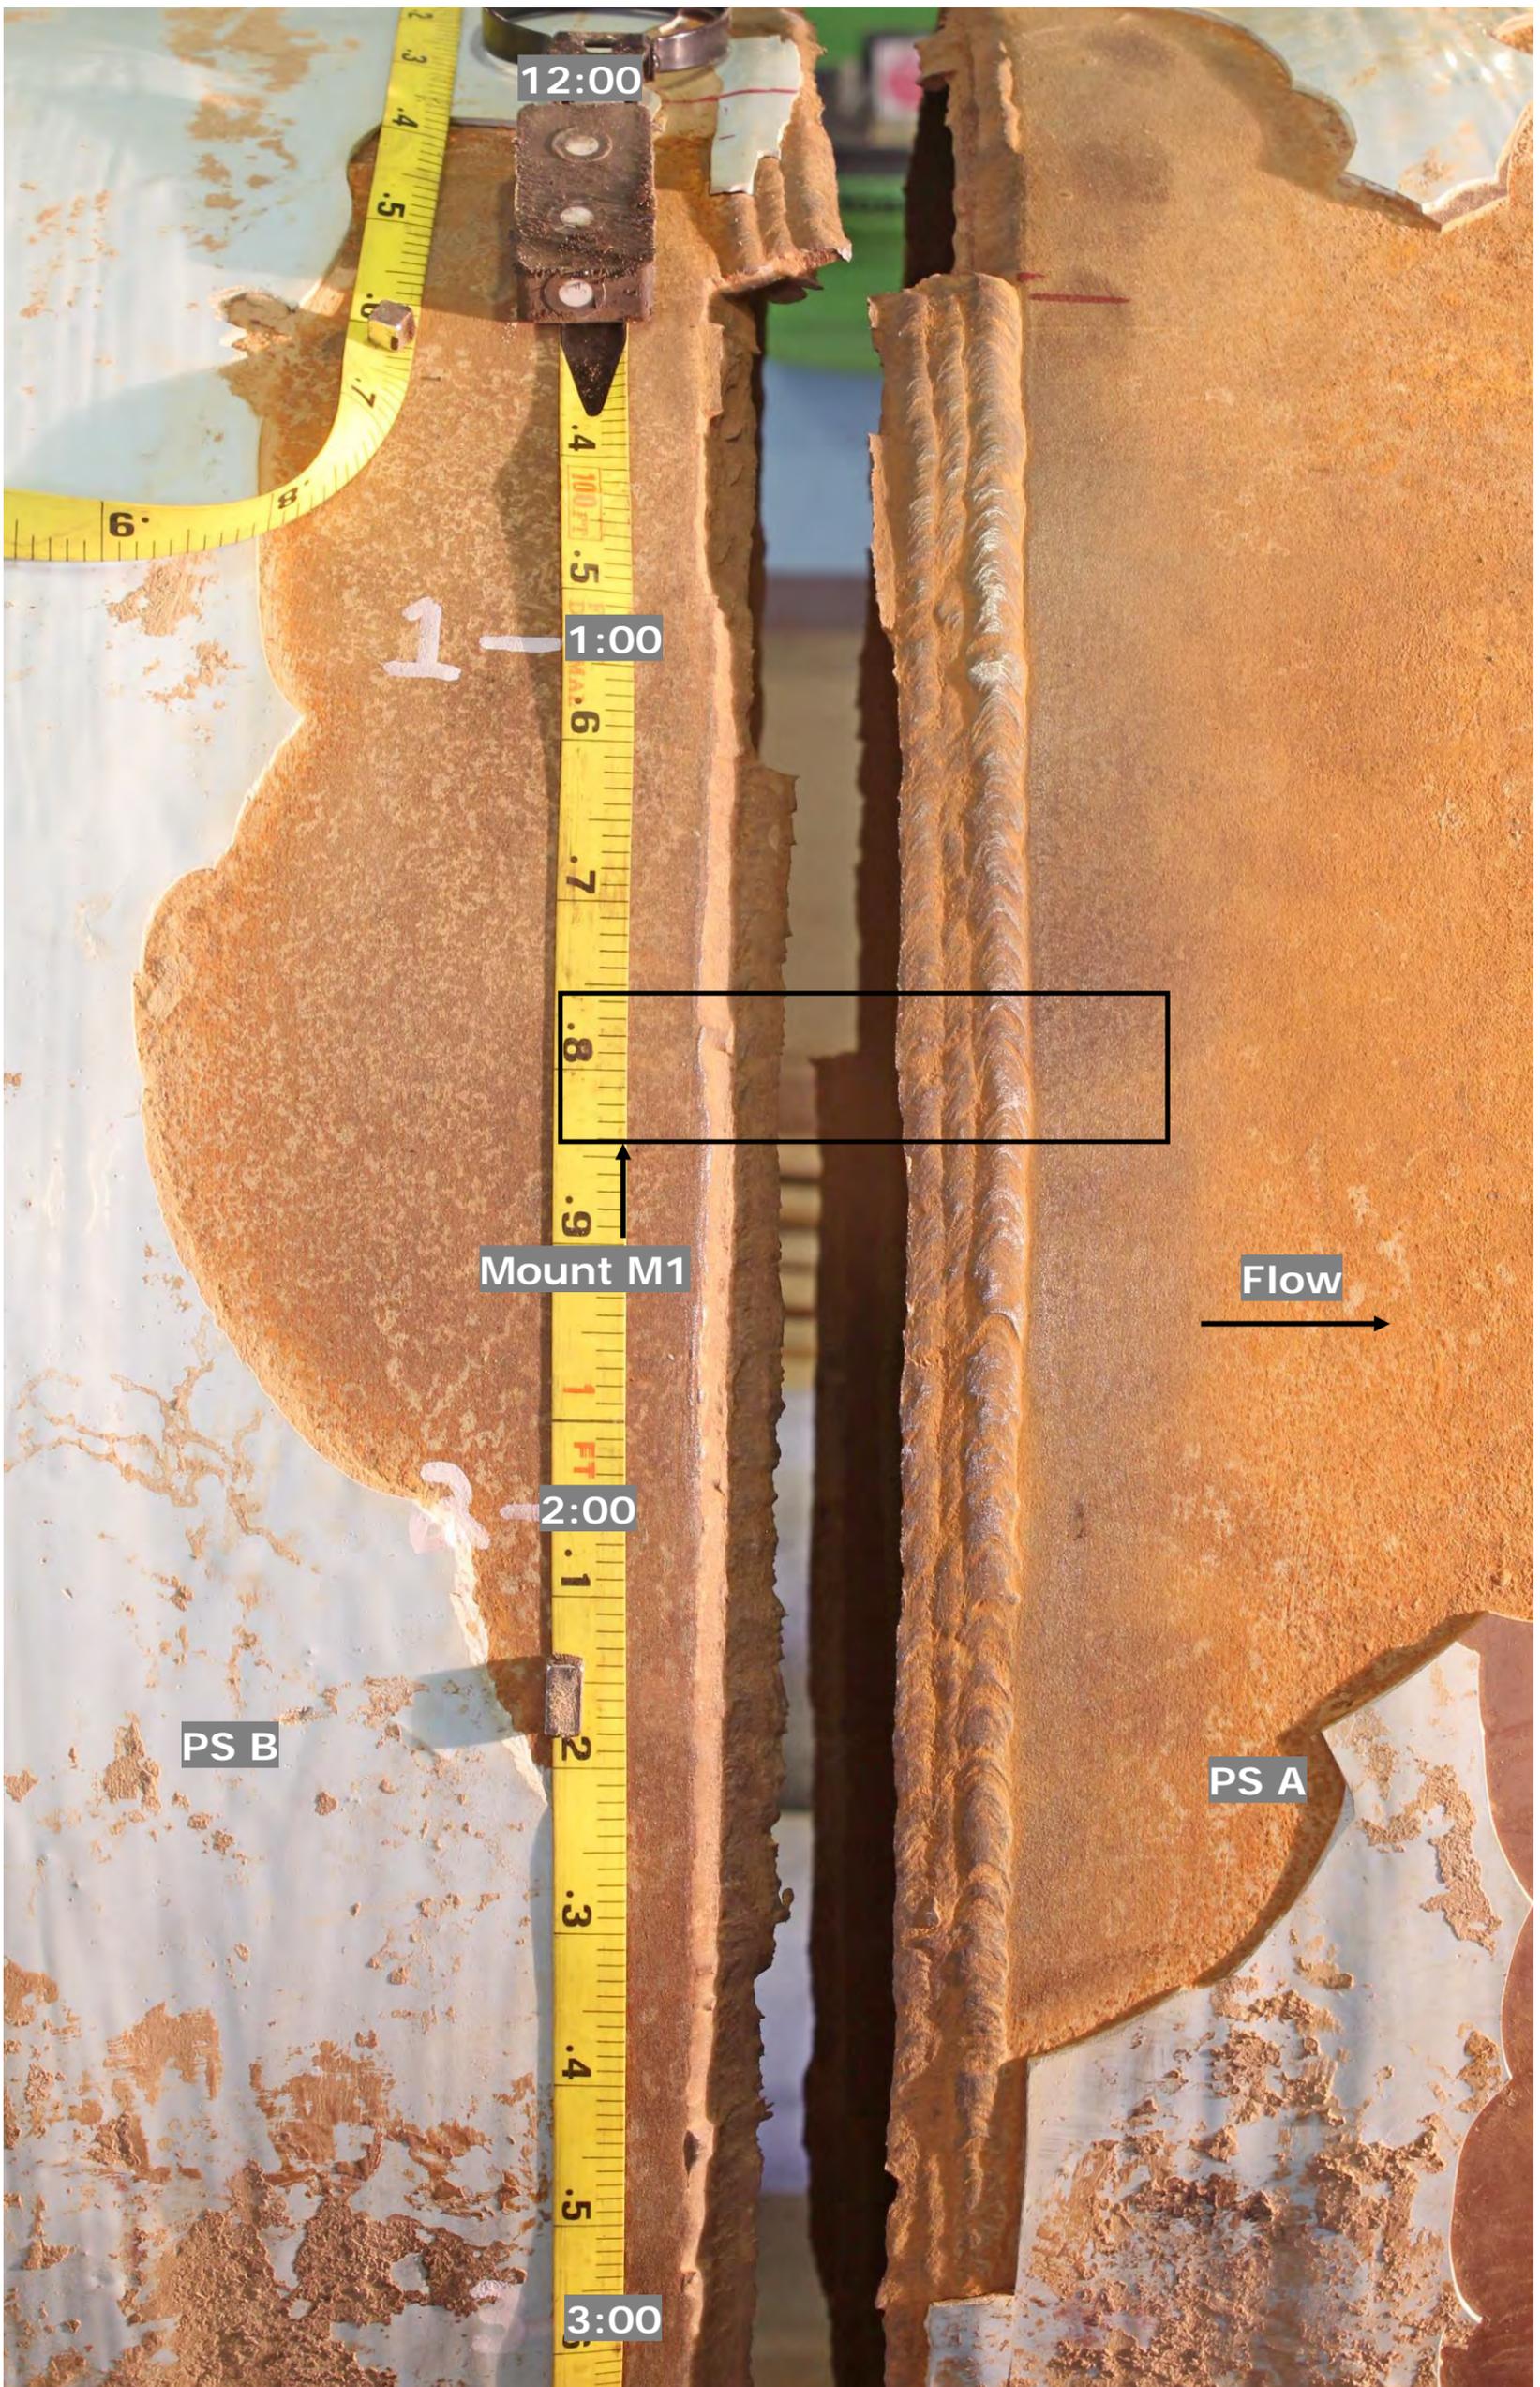
Figure 11. Photograph of the external of surfaces of PSs A and B adjacent to the fracture surfaces, between the 12 and 3 o'clock orientations, showing the failed girth weld and the morphology of the coating. The tape measure indicates the approximate distance CW of TDC (looking D/S convention).

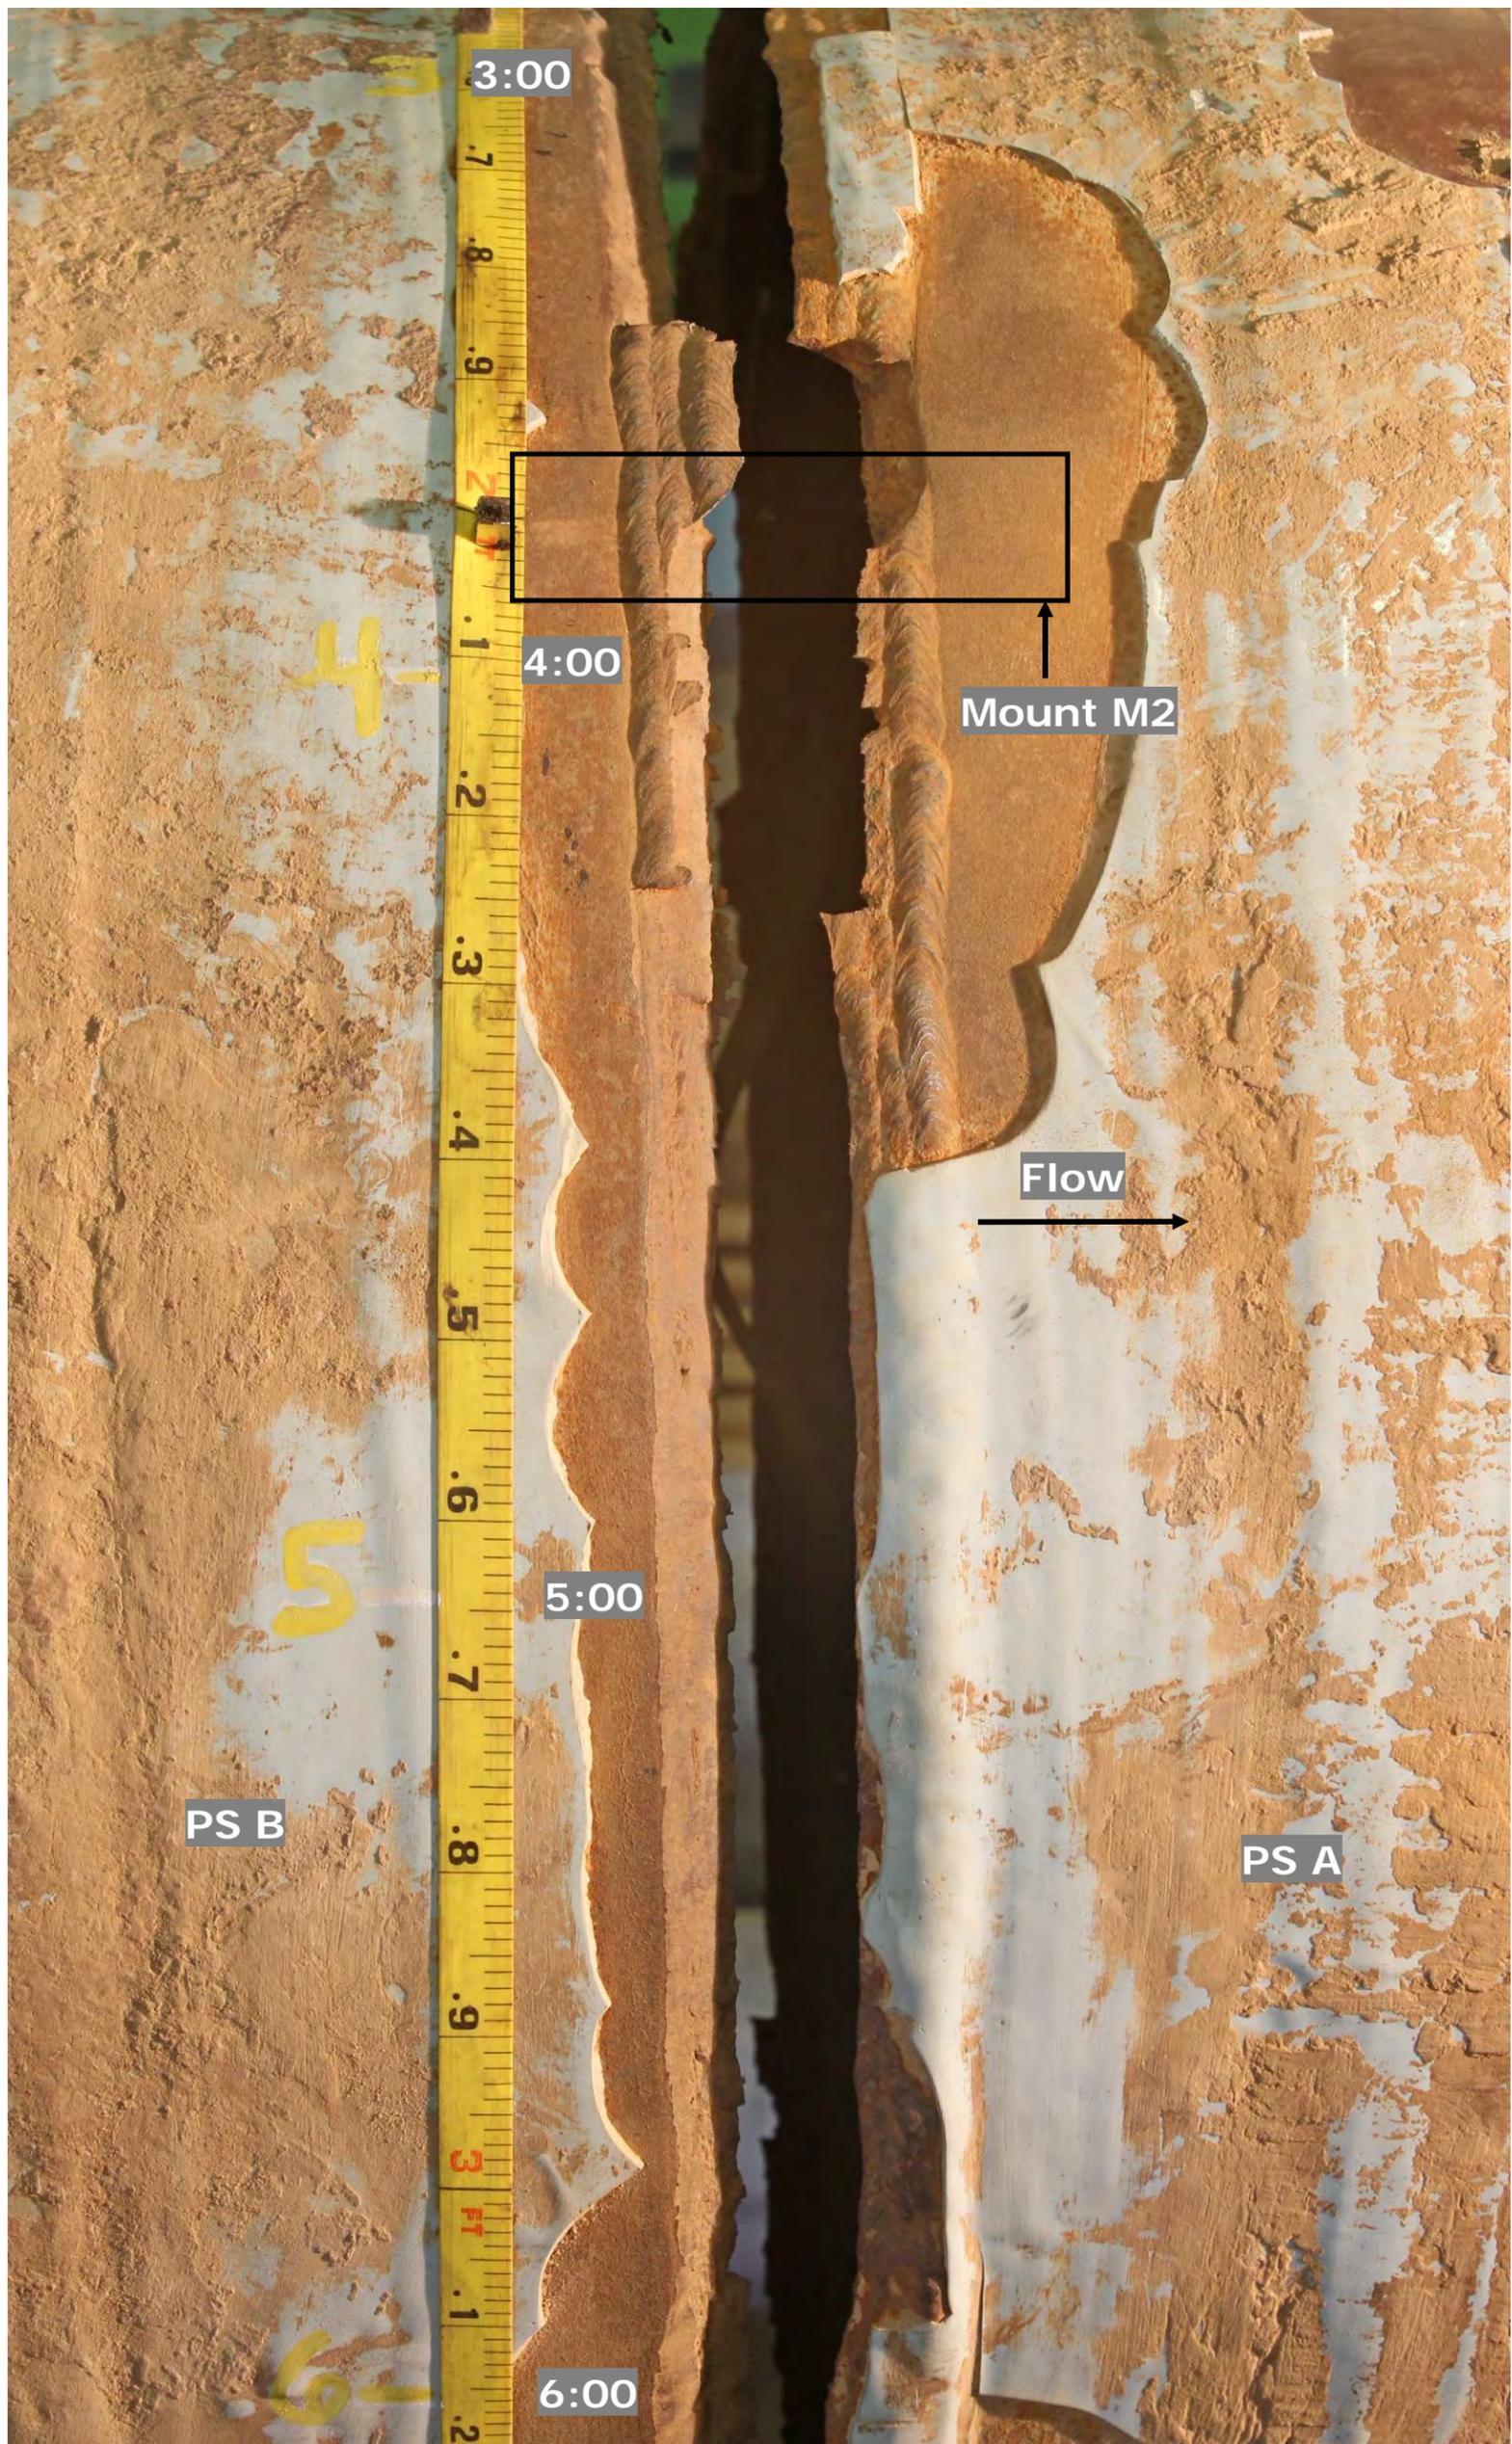
Figure 12. Photograph of the external of surfaces of PSs A and B adjacent to the fracture surfaces, between the 3 and 6 o'clock orientations, showing the failed girth weld and the morphology of the coating. The tape measure indicates the approximate distance CW of TDC (looking D/S convention).

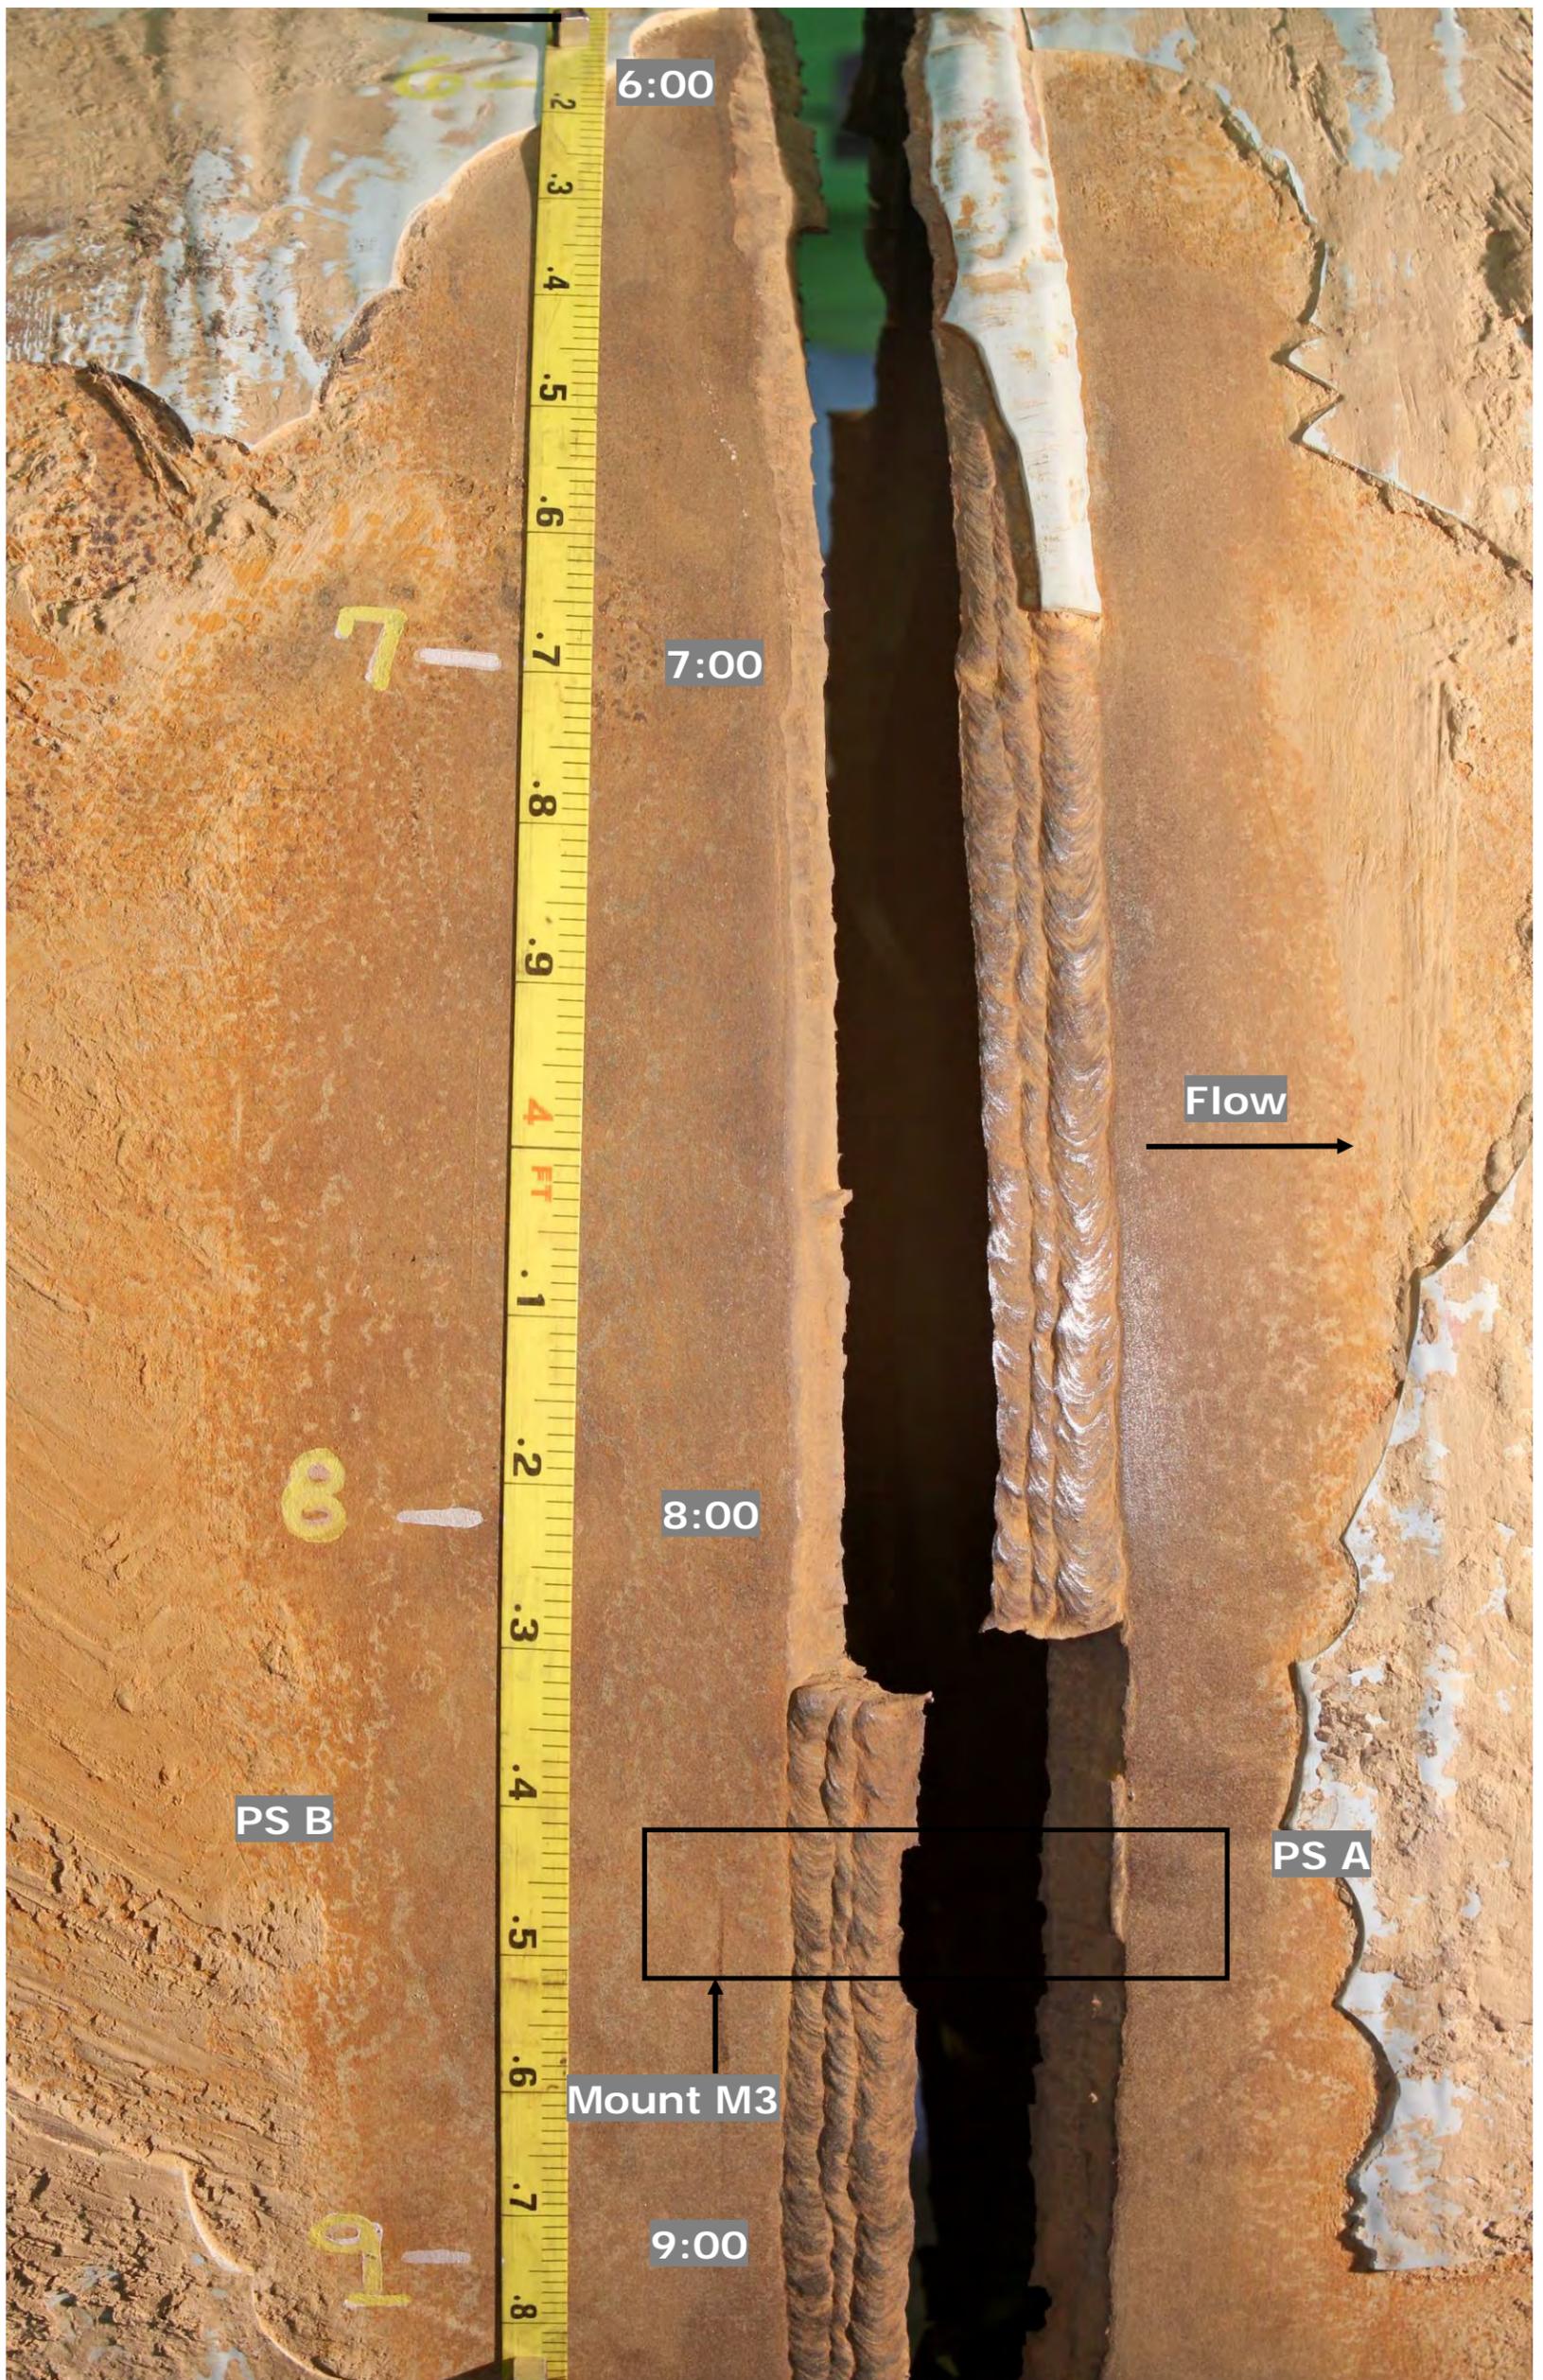
Figure 13. Photograph of the external of surfaces of PSs A and B adjacent to the fracture surfaces, between the 6 and 9 o'clock orientations, showing the failed girth weld and the morphology of the coating. The tape measure indicates the approximate distance CW of TDC (looking D/S convention).

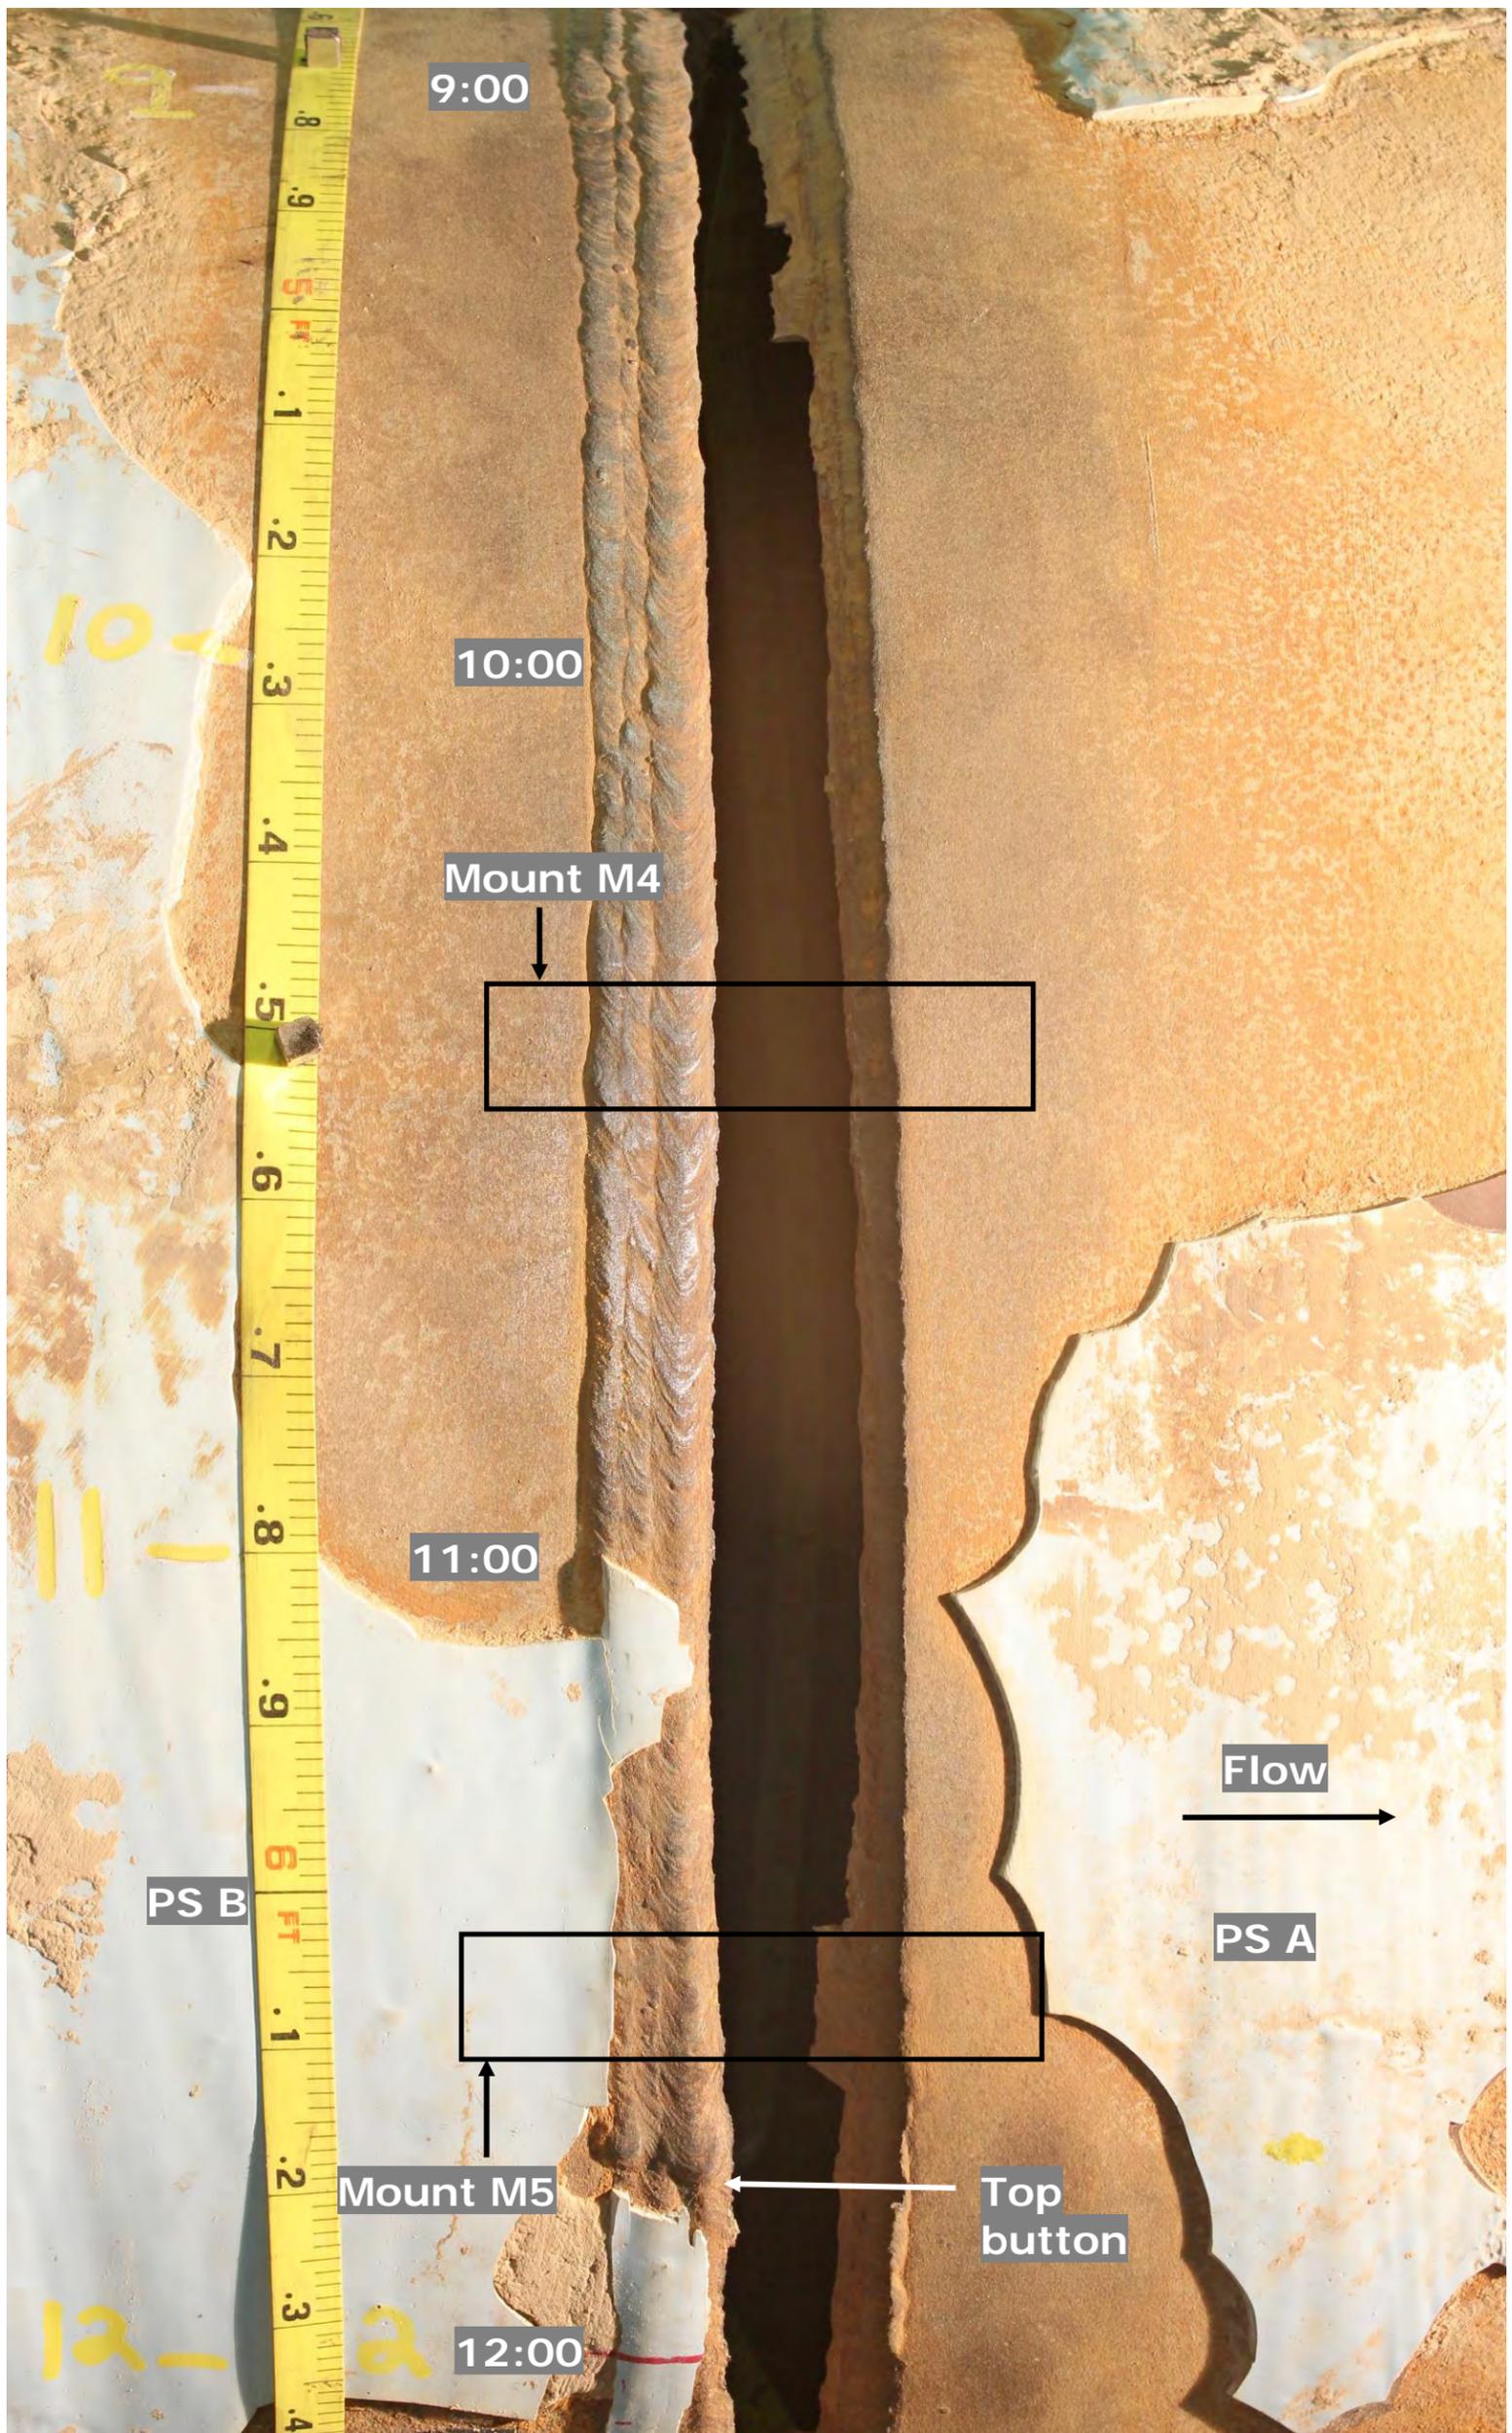
Figure 14. Photograph of the external of surfaces of PSs A and B adjacent to the fracture surfaces, between the 9 and 12 o'clock orientations, showing the failed girth weld and the morphology of the coating. The tape measure indicates the approximate distance CW of TDC (looking D/S convention).

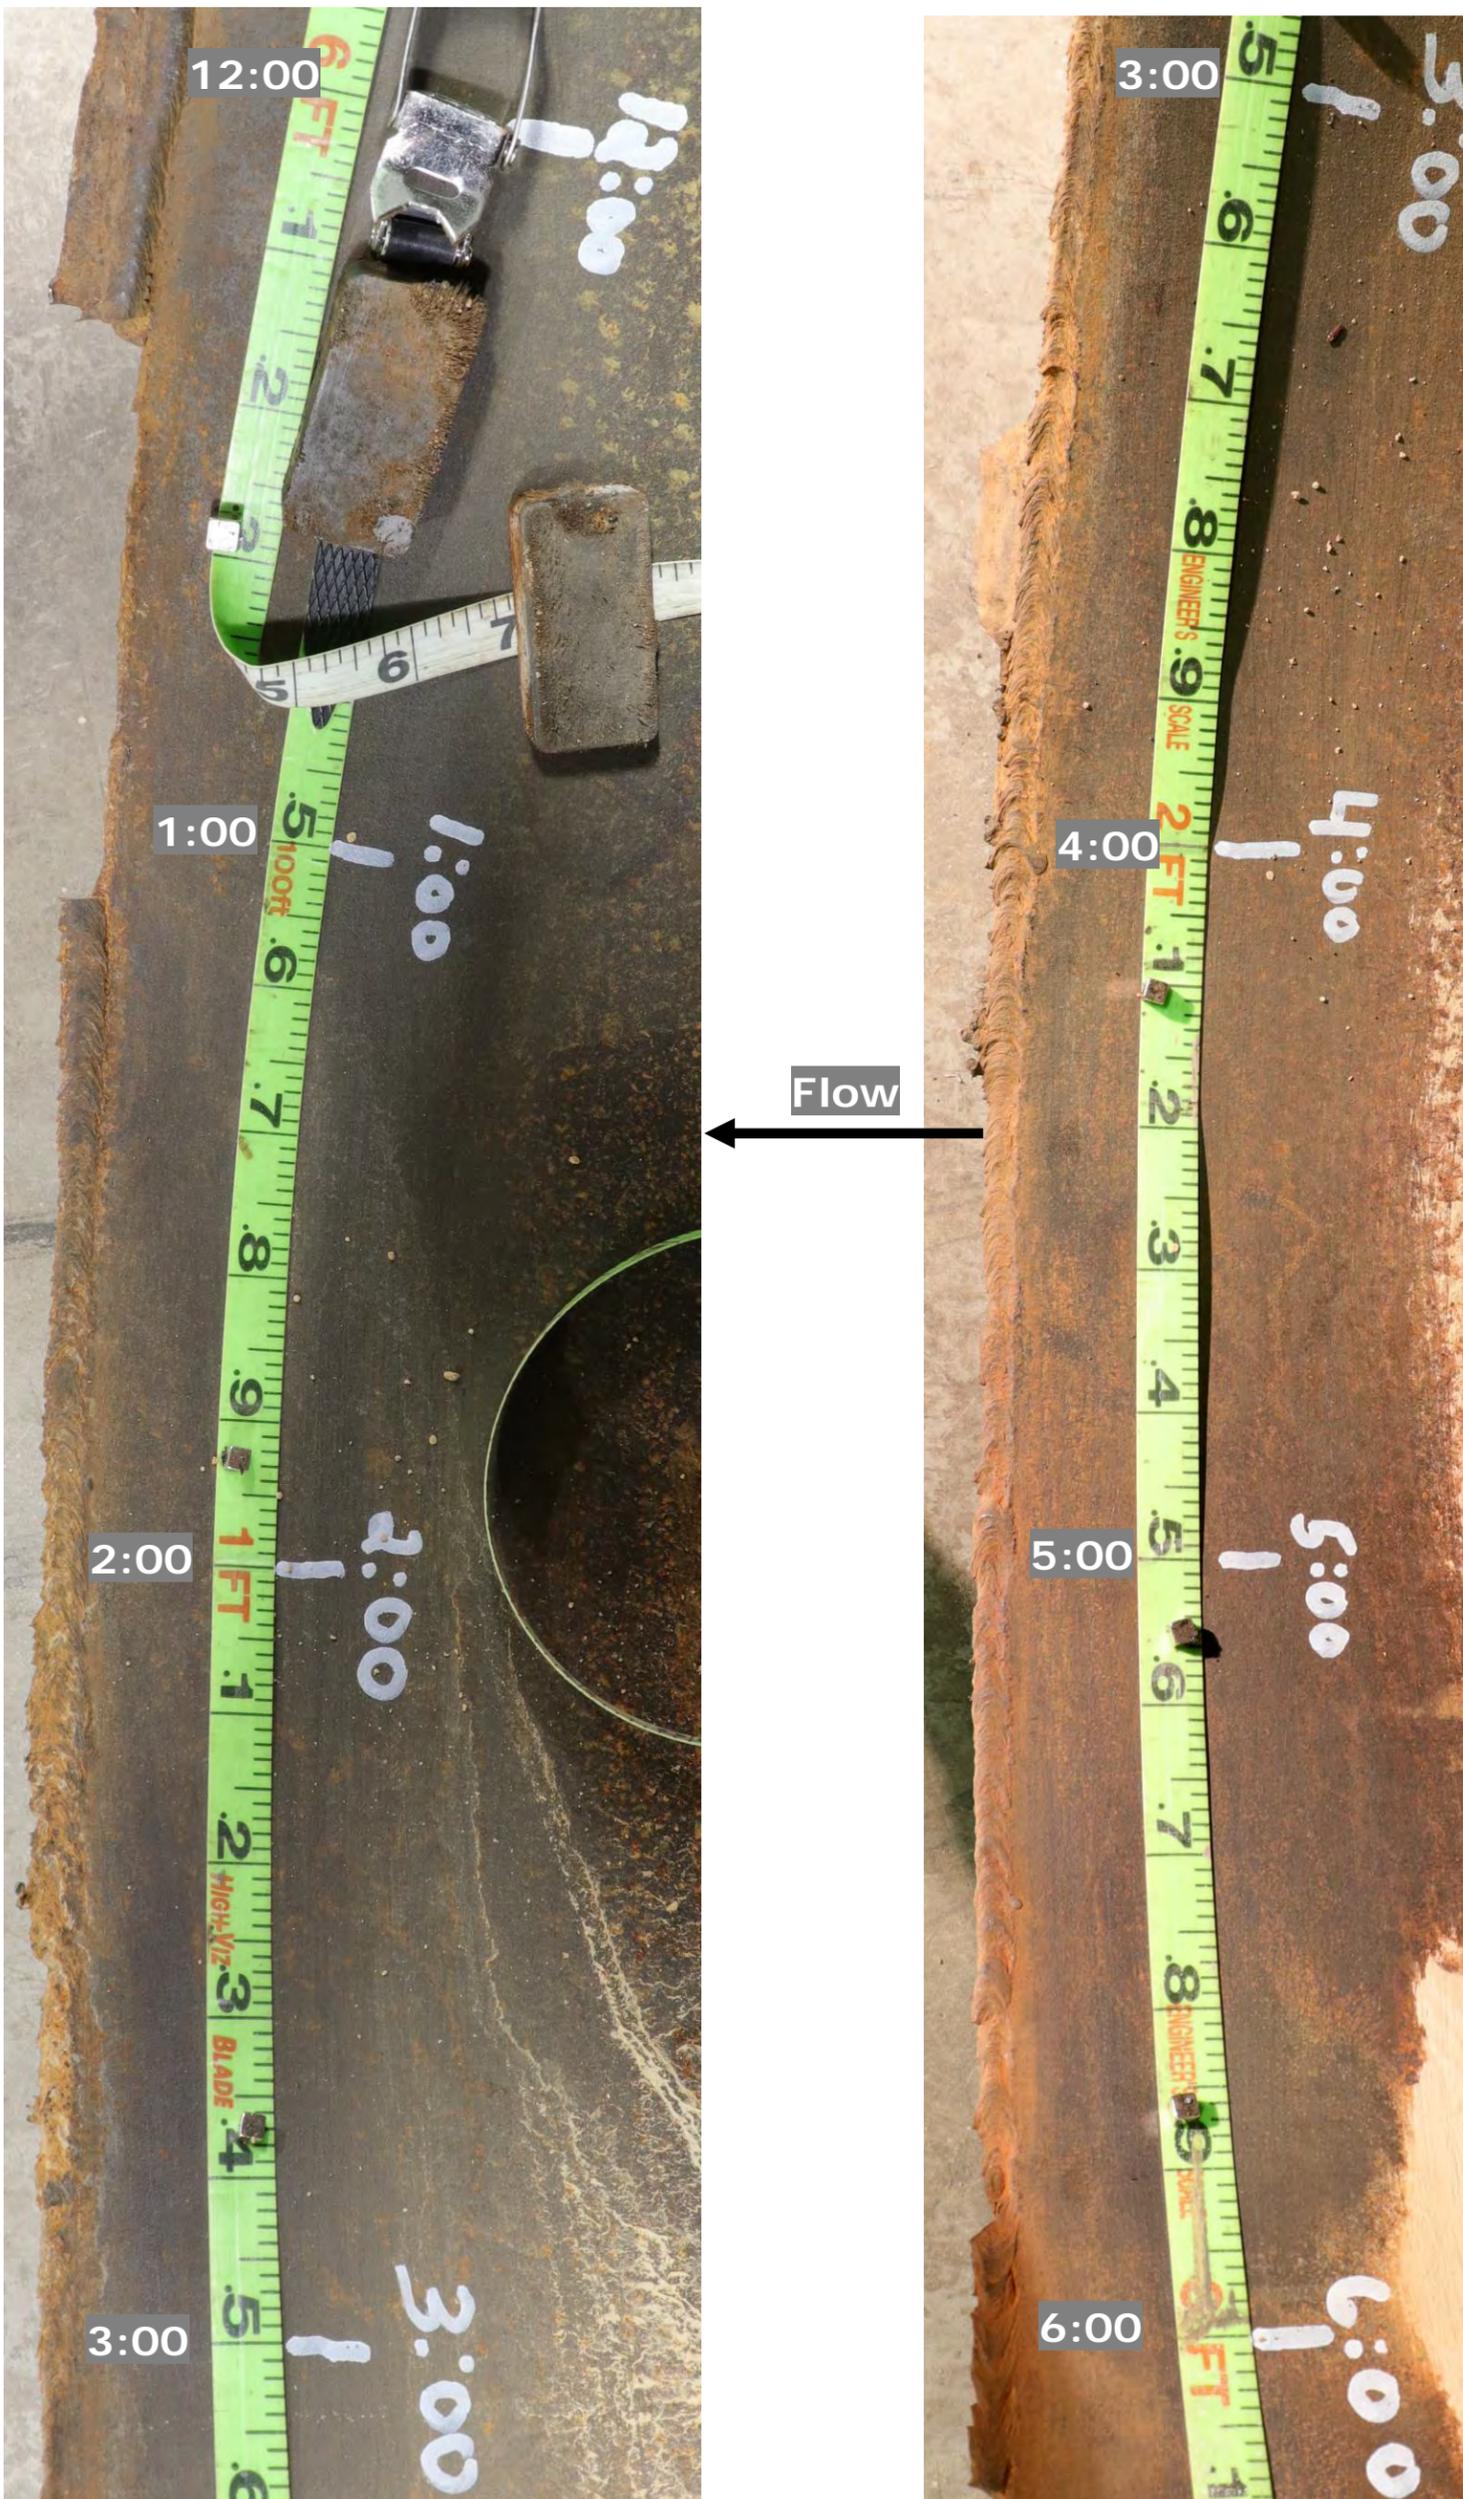
Figure 15. Photograph of the internal pipe surface adjacent to the fracture surface of PS B, between the 12 and 6 o'clock orientations. The tape measure indicates the approximate distance CW of TDC (looking D/S convention).
