DOT US Department of Transportation
PHMSA Pipeline and Hazardous Materials Safety Administration
OPS Office of Pipeline Safety – Accident Investigation Division

Principal Investigator Wesley Mathews
Acting Accident Investigation Director Chris Ruhl
Date of Report May 26, 2022
Subject Failure Investigation Report - Denbury Gulf Coast Pipelines, LLC – Pipeline Rupture/ Natural Force Damage

Failure Investigation Report – Denbury Gulf Coast Pipelines LLC
Pipeline Rupture/Natural Force Damage
February 22, 2020

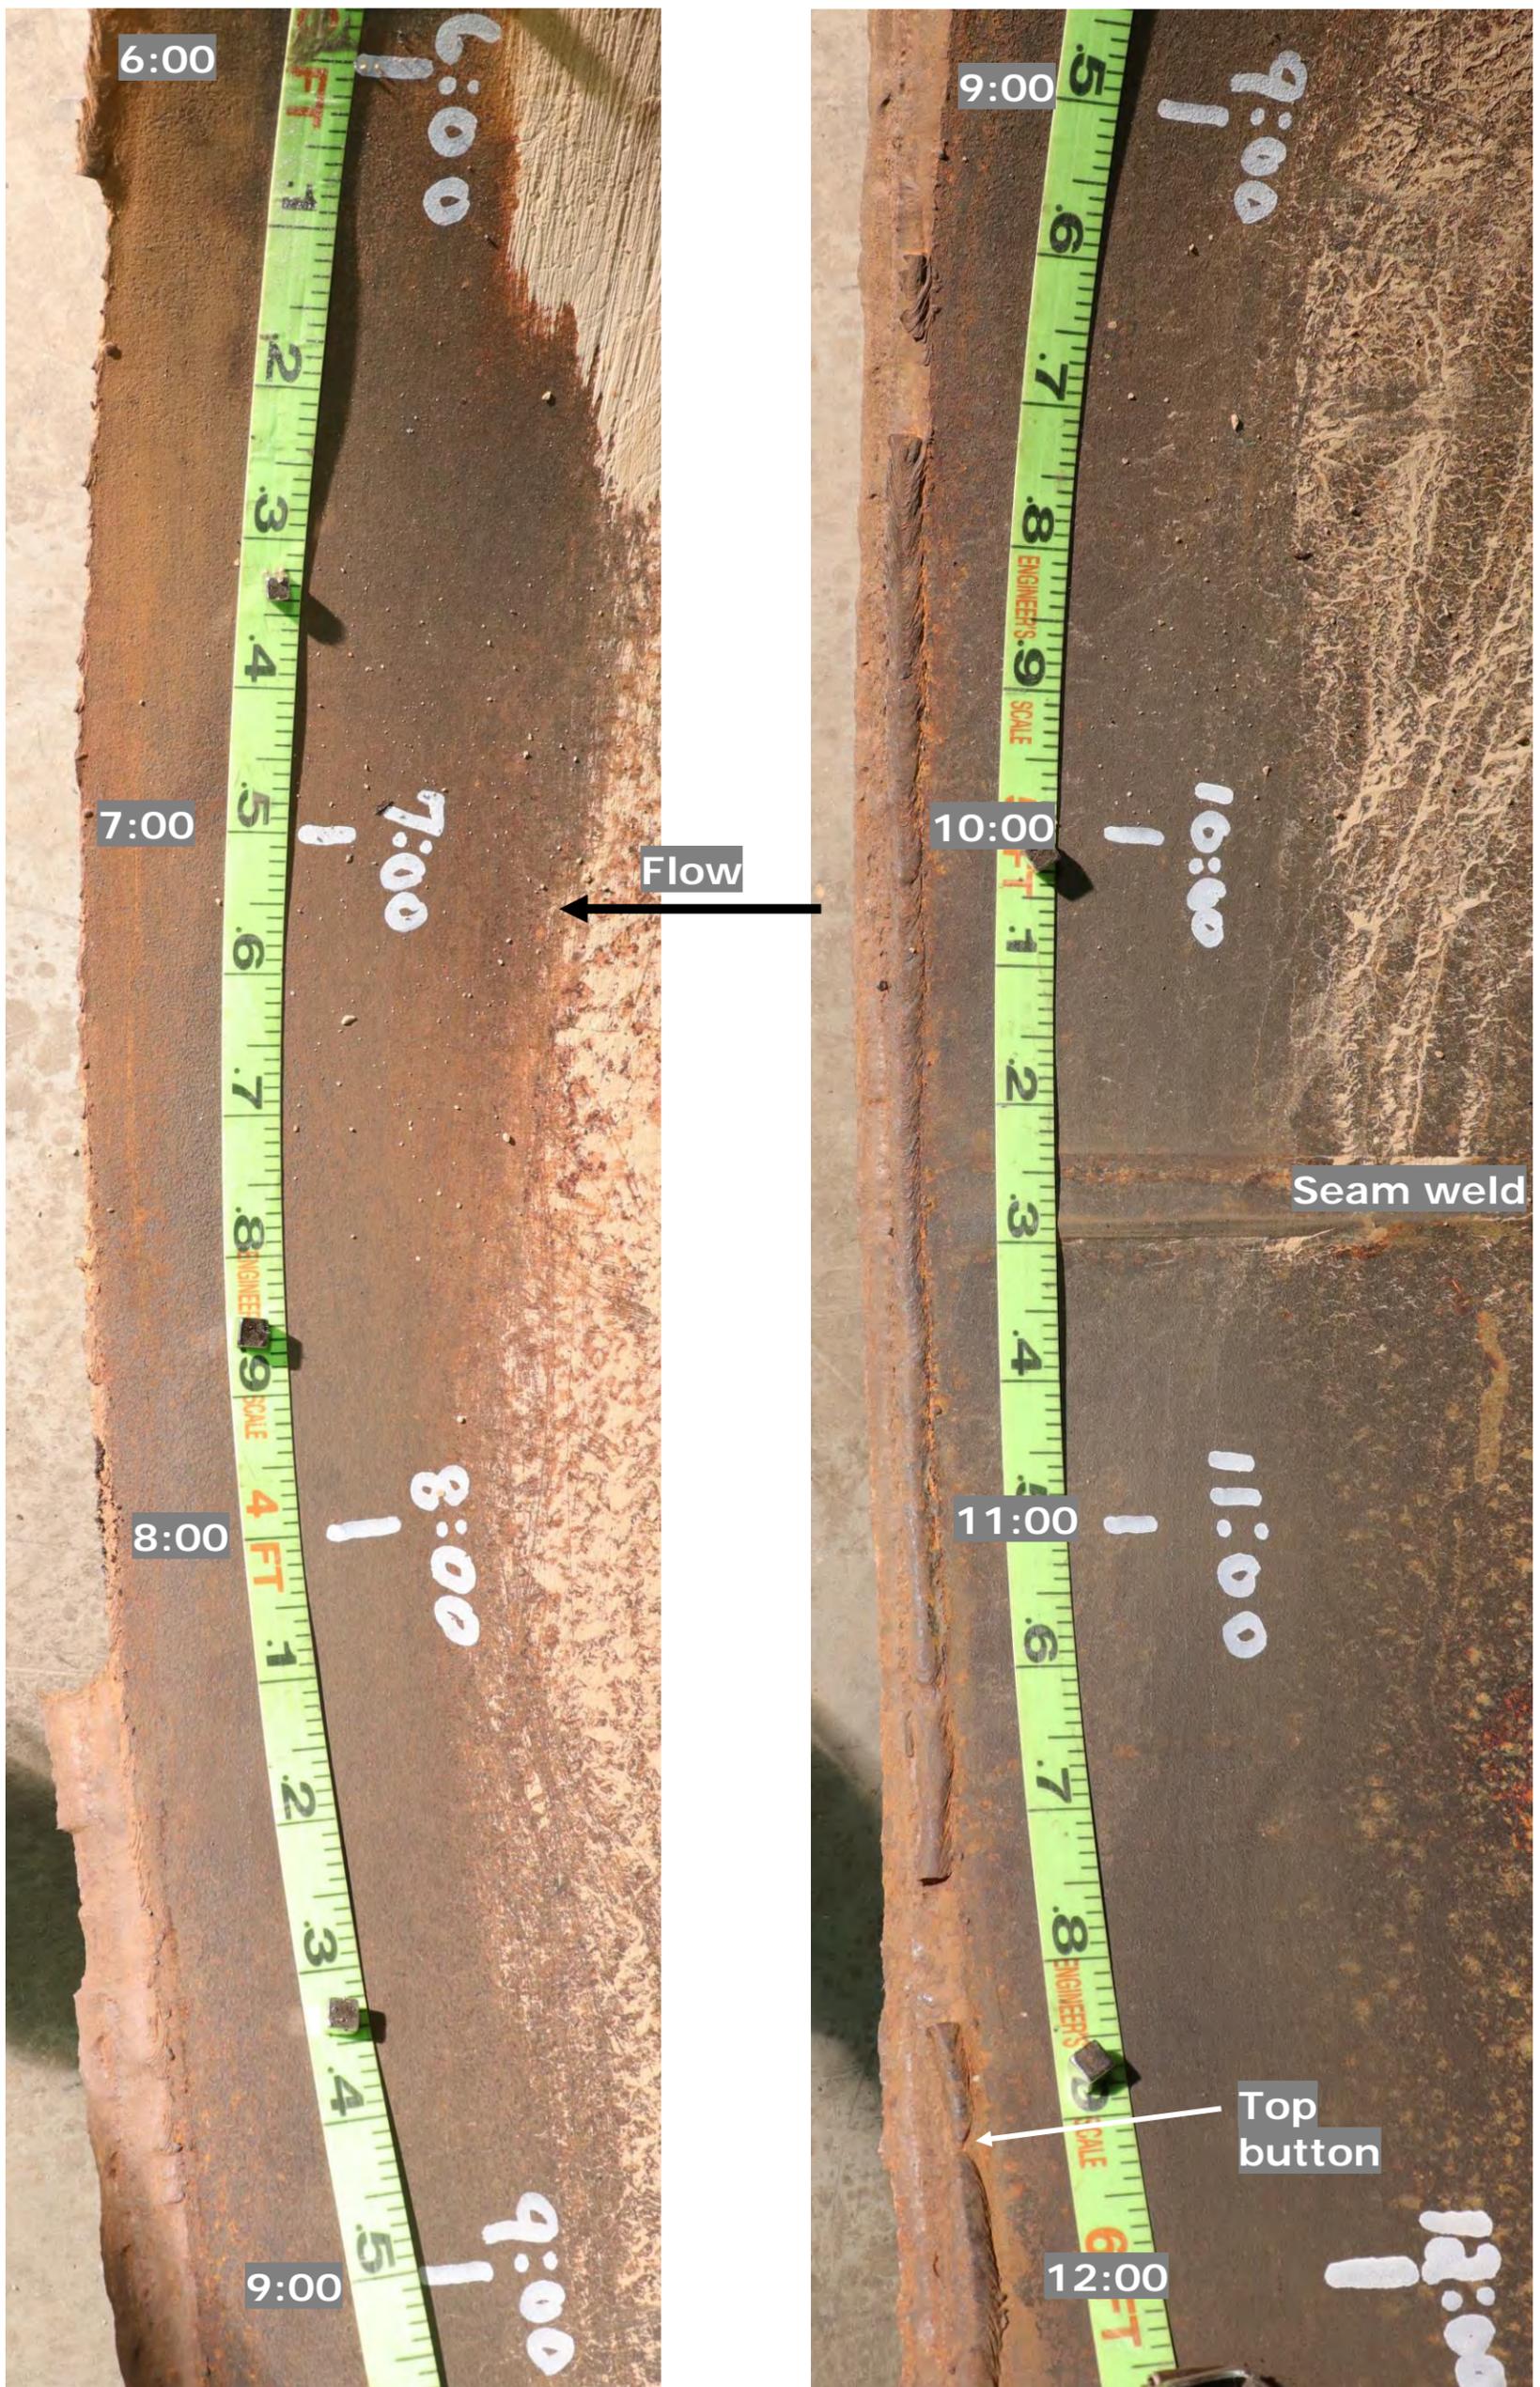
Figure 16. Photographs of the internal pipe surface adjacent to the fracture surface of PS B, between the 6 and 12 o'clock orientations. The tape measure indicates the approximate distance CW of TDC (looking D/S convention).

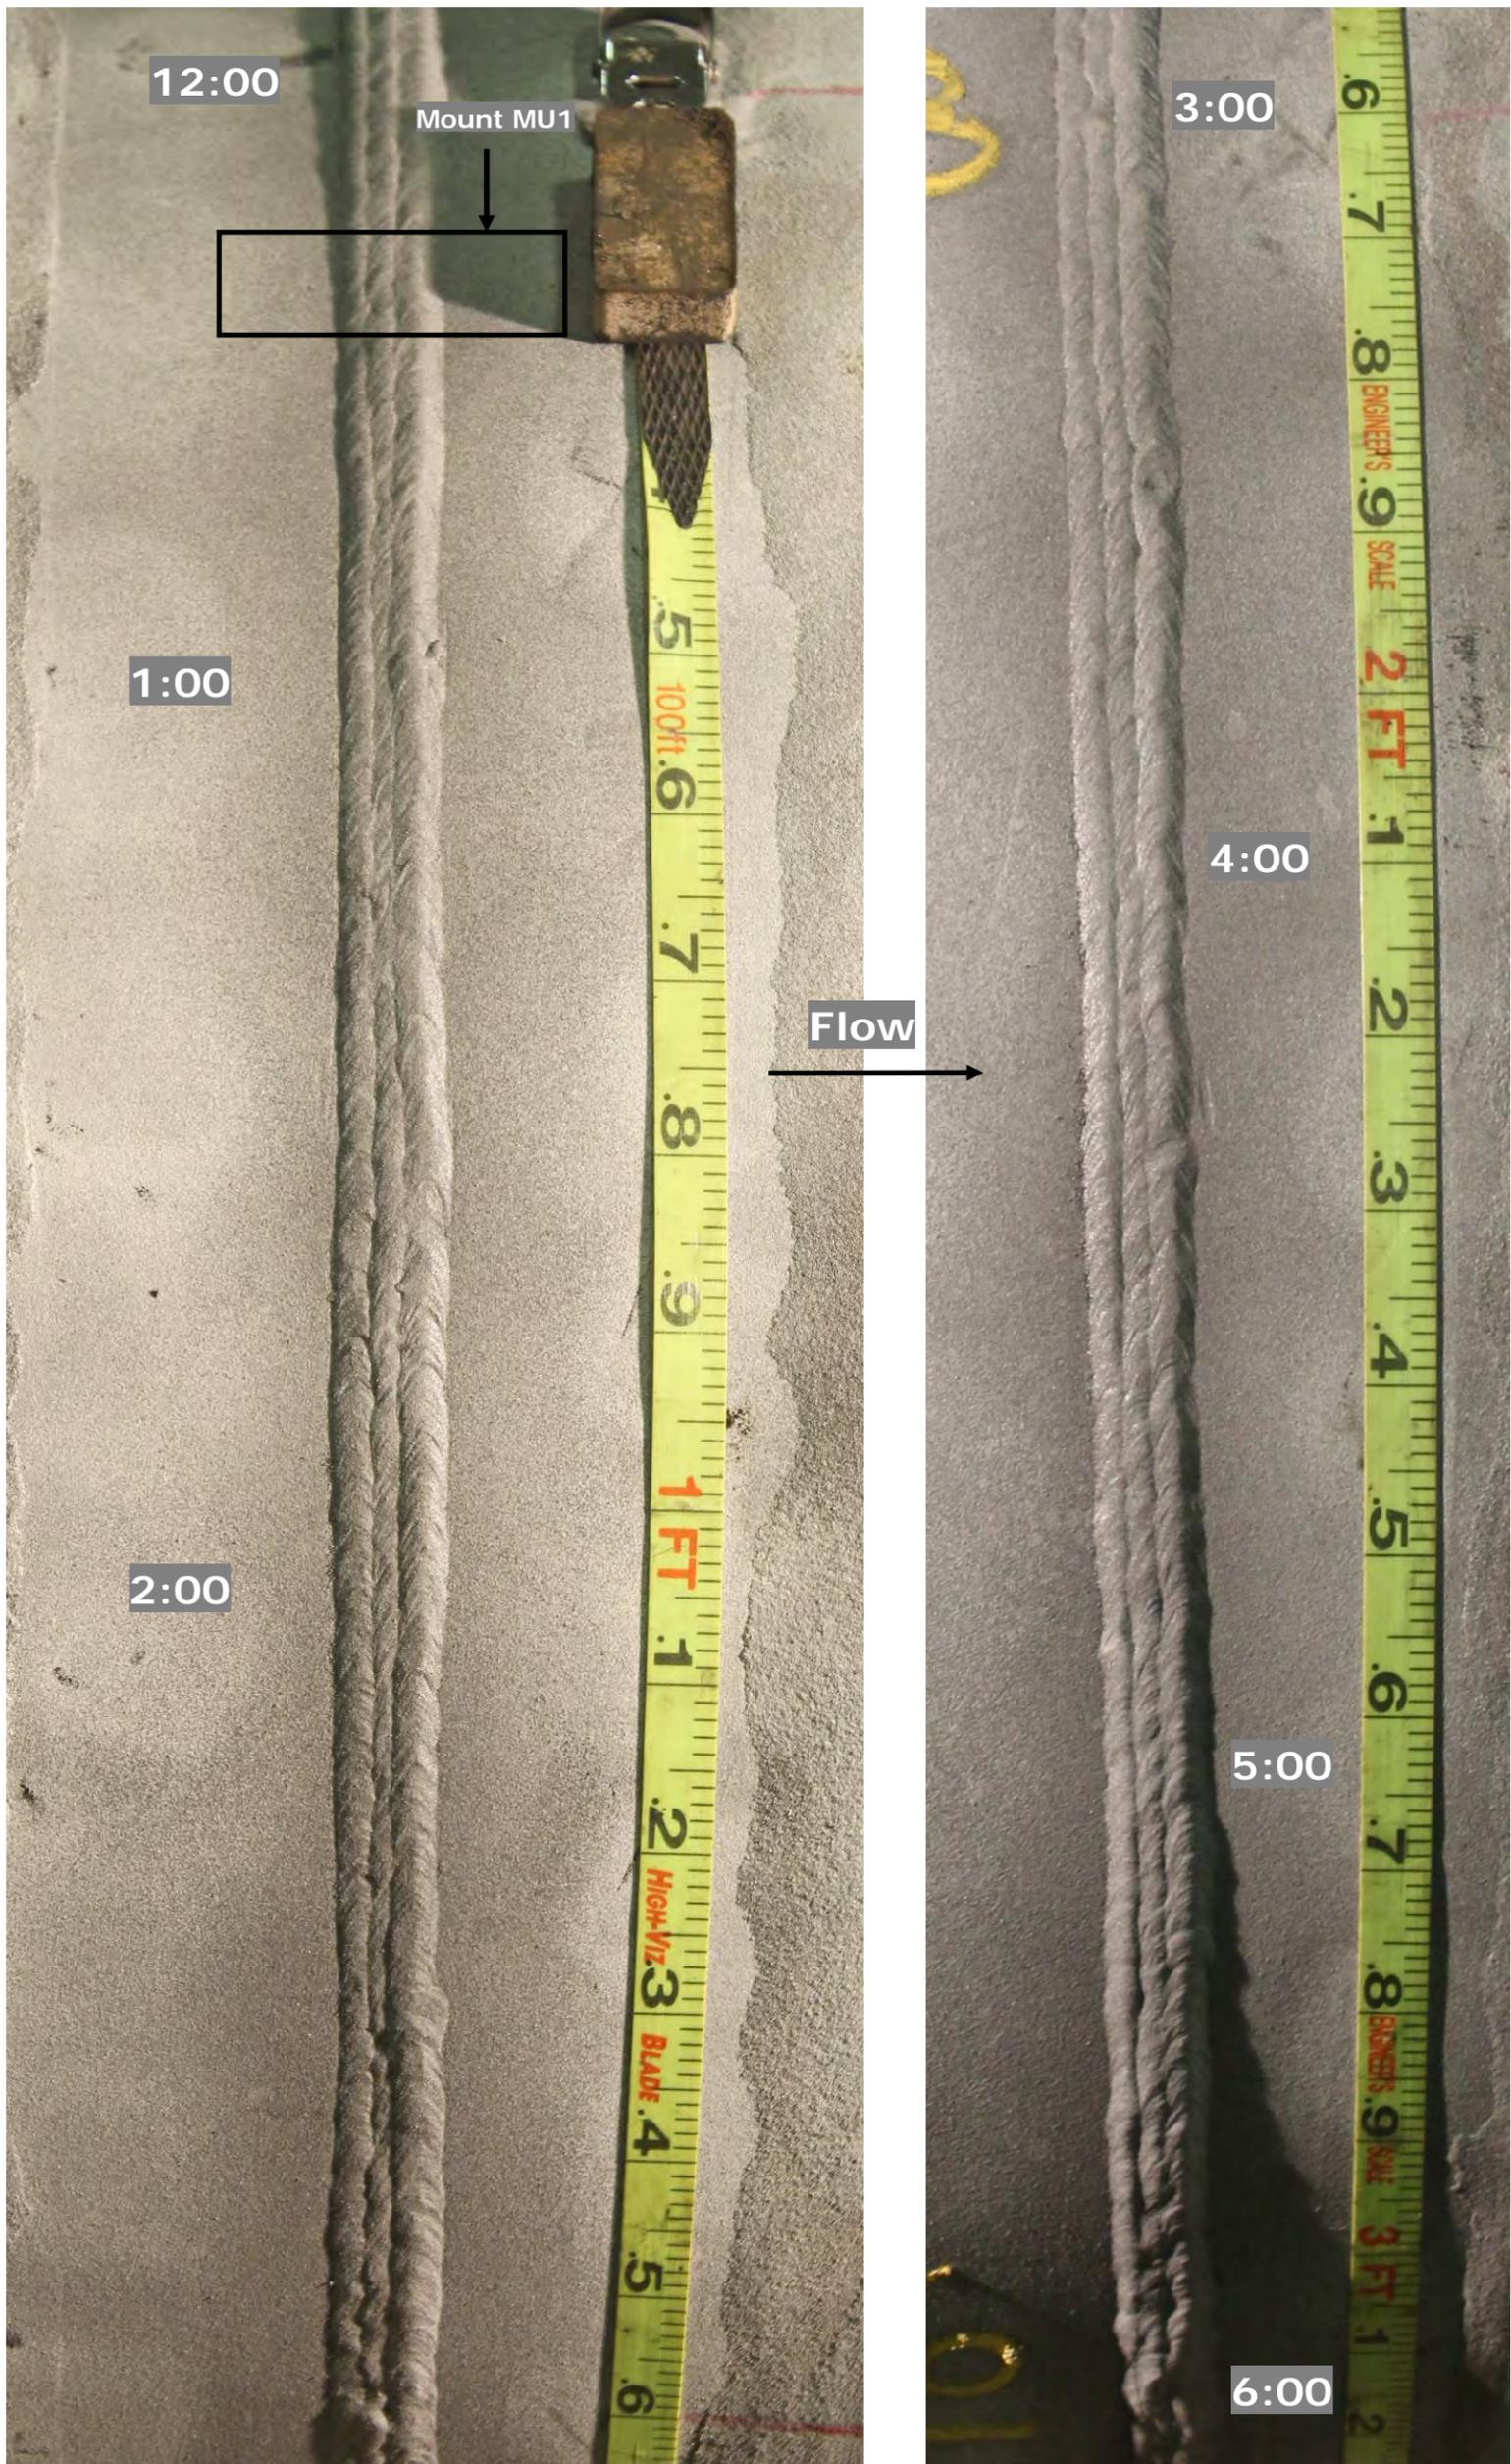
Figure 17. Photograph of the external pipe surface at the intact girth weld following grit blasting and MPI, between the 12:00 and 6:00 orientations. The tape measure indicates the approximate distance CW of TDC (looking D/S convention).

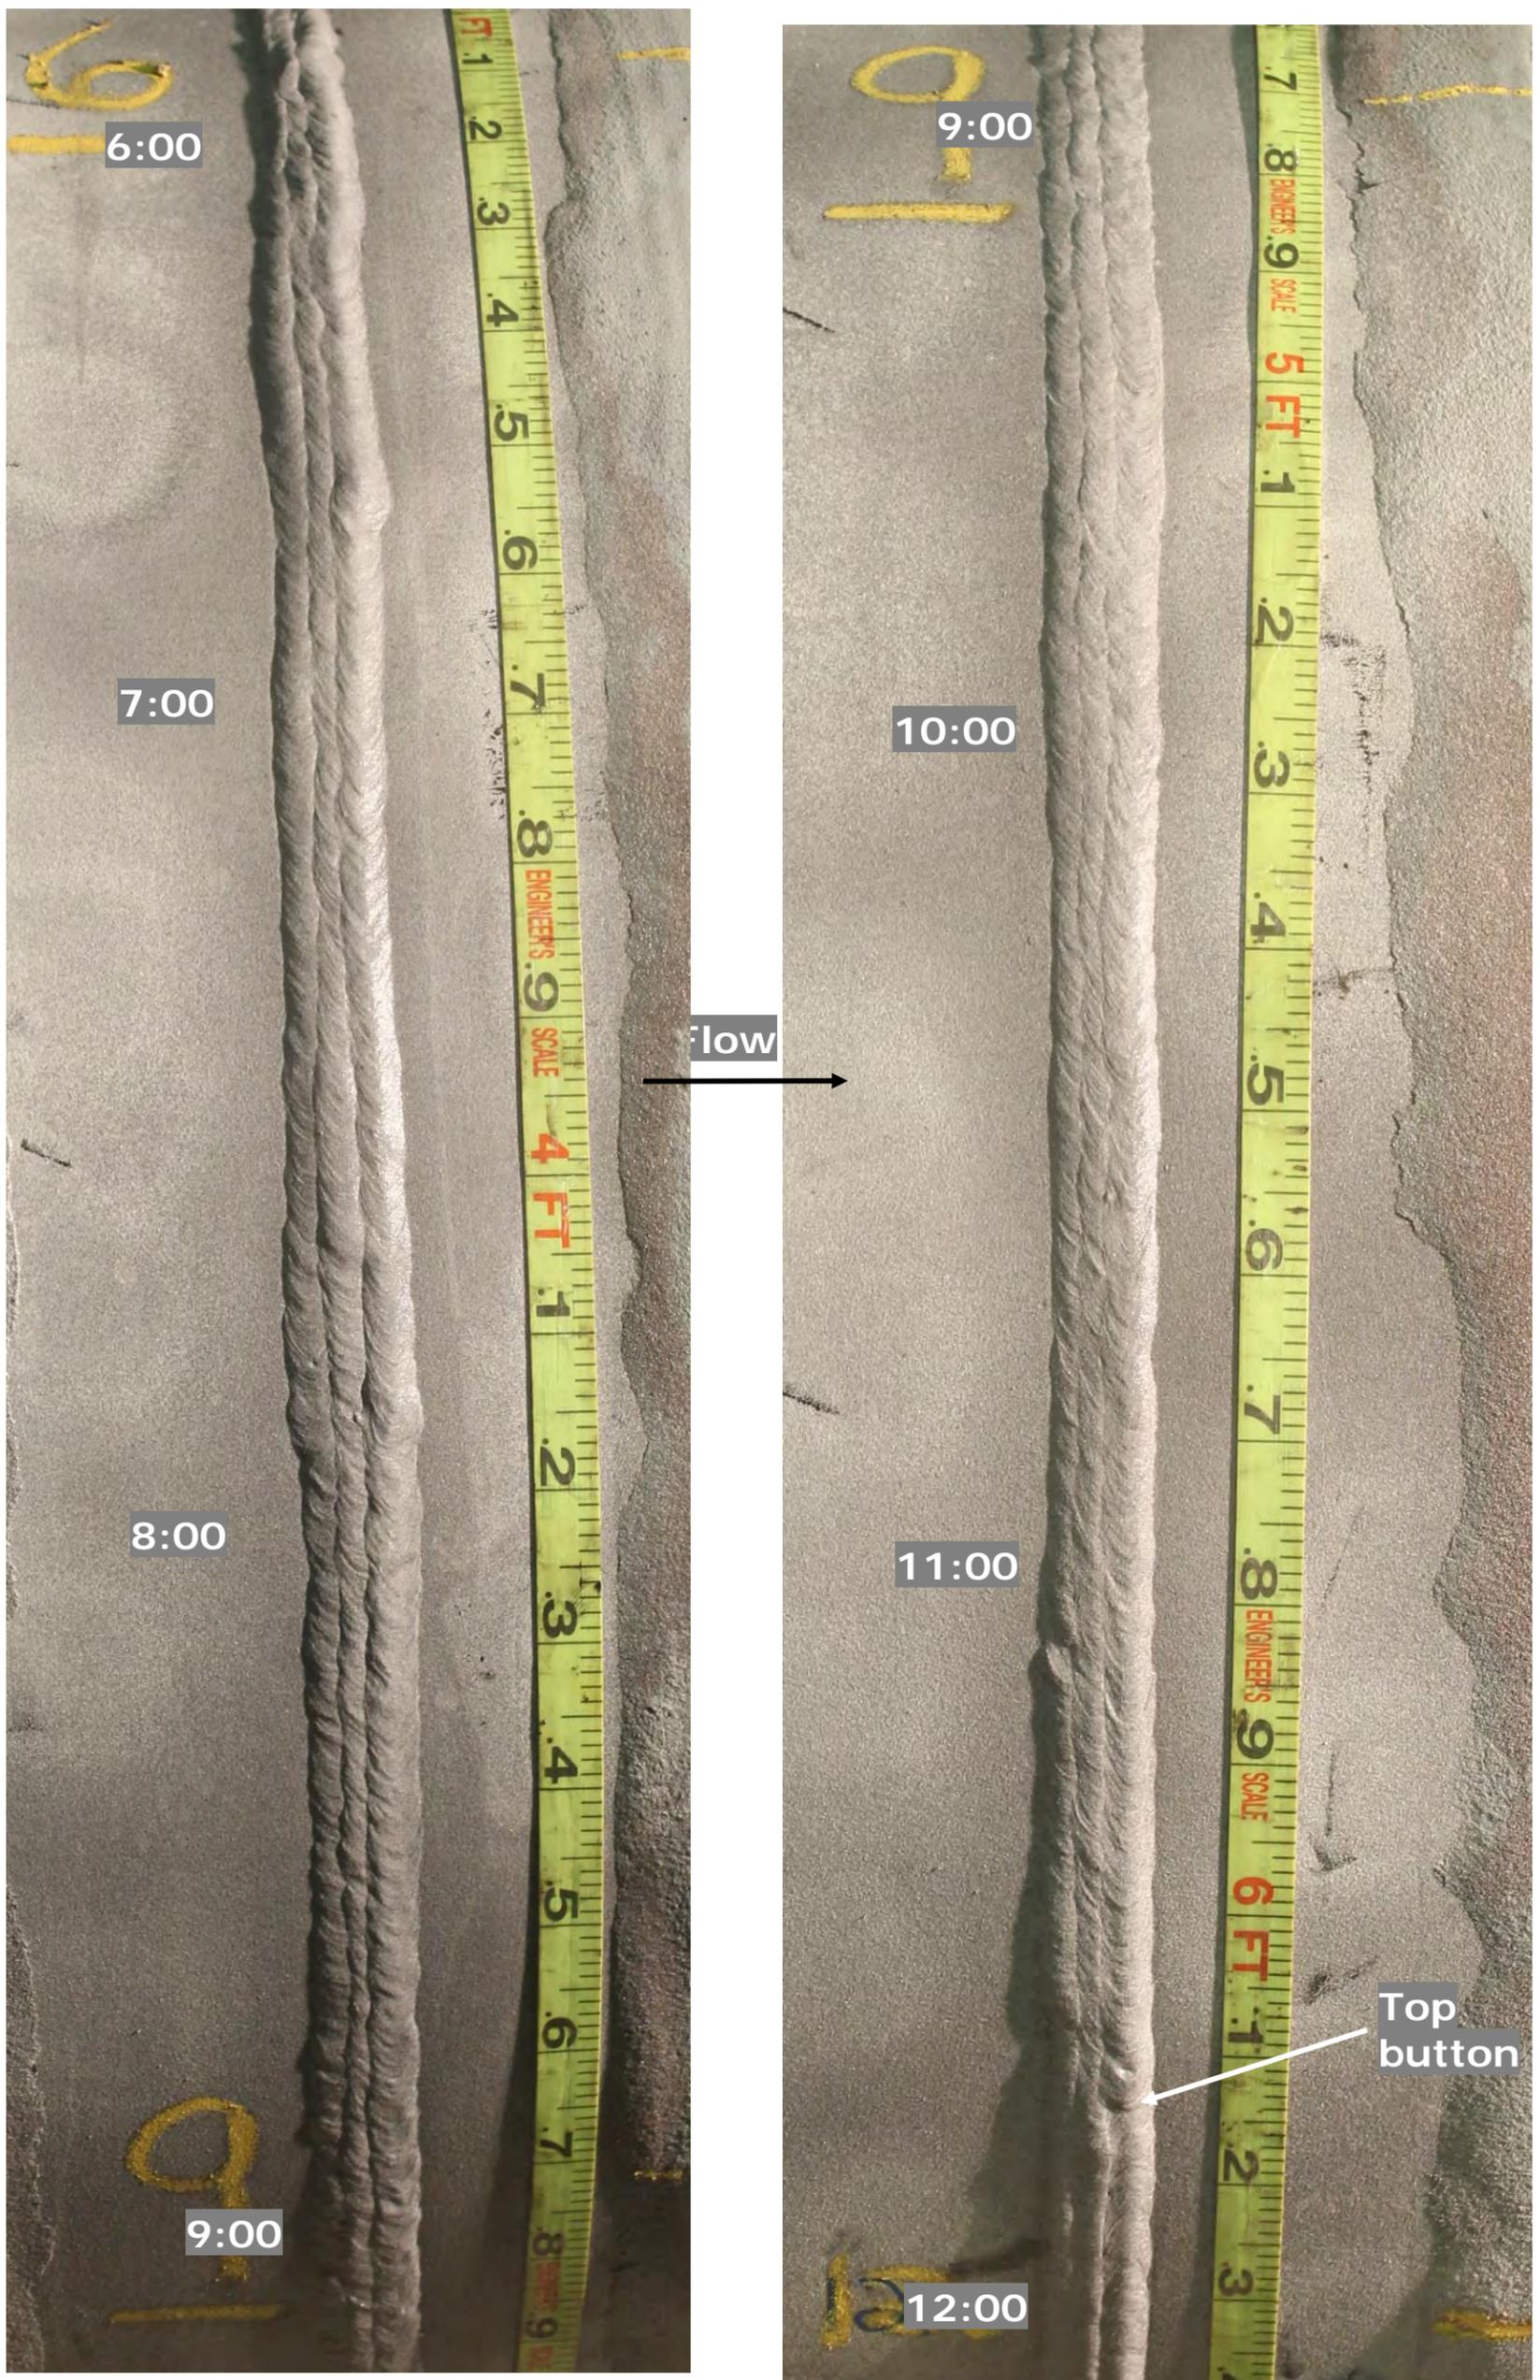
Figure 18. Photograph of the external pipe surface at the intact girth weld following grit blasting and MPI, between the 6:00 and 12:00 orientations. The tape measure indicates the approximate distance CW of TDC (looking D/S convention).

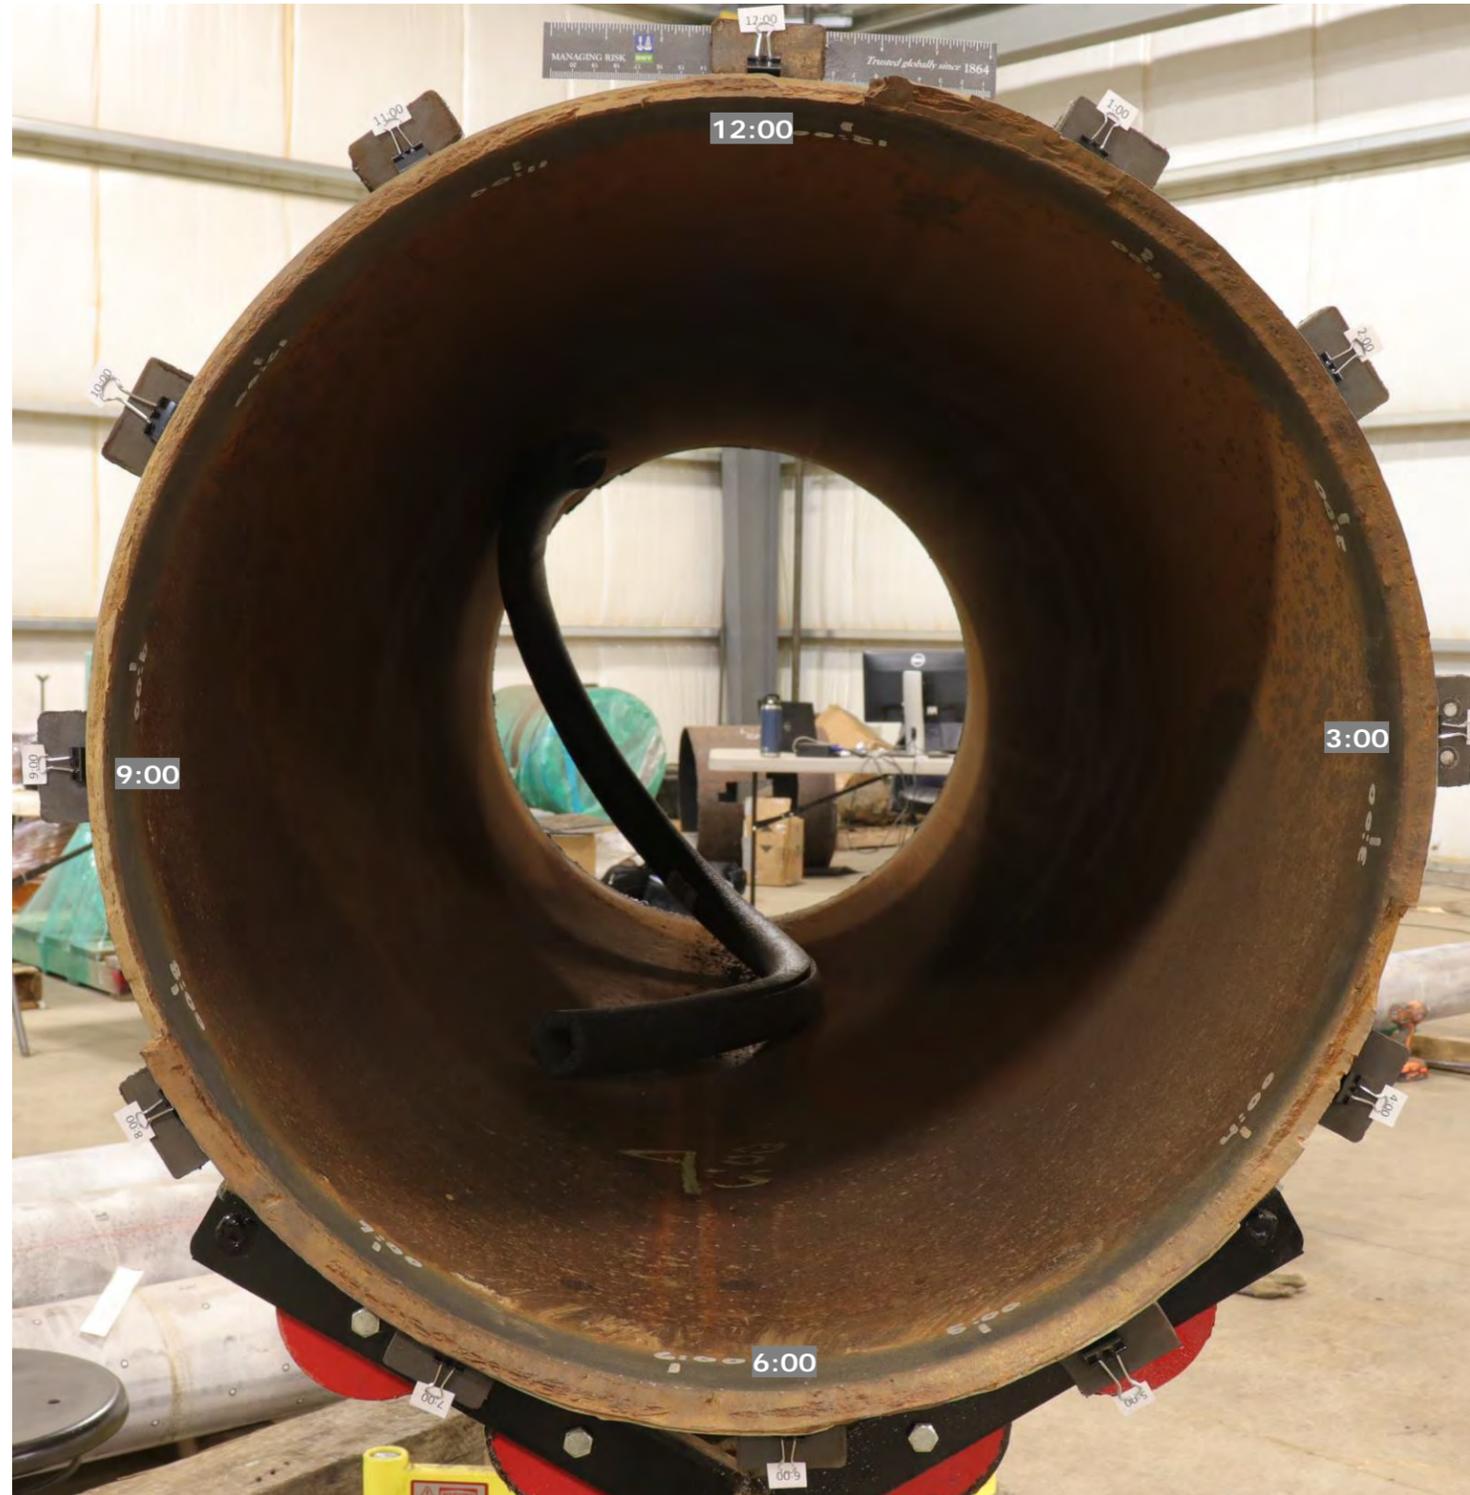
Figure 19. Photograph of the fracture surface and internal pipe surface of PS A. Flow direction is into the photograph. Labels on magnets indicate o'clock orientations.

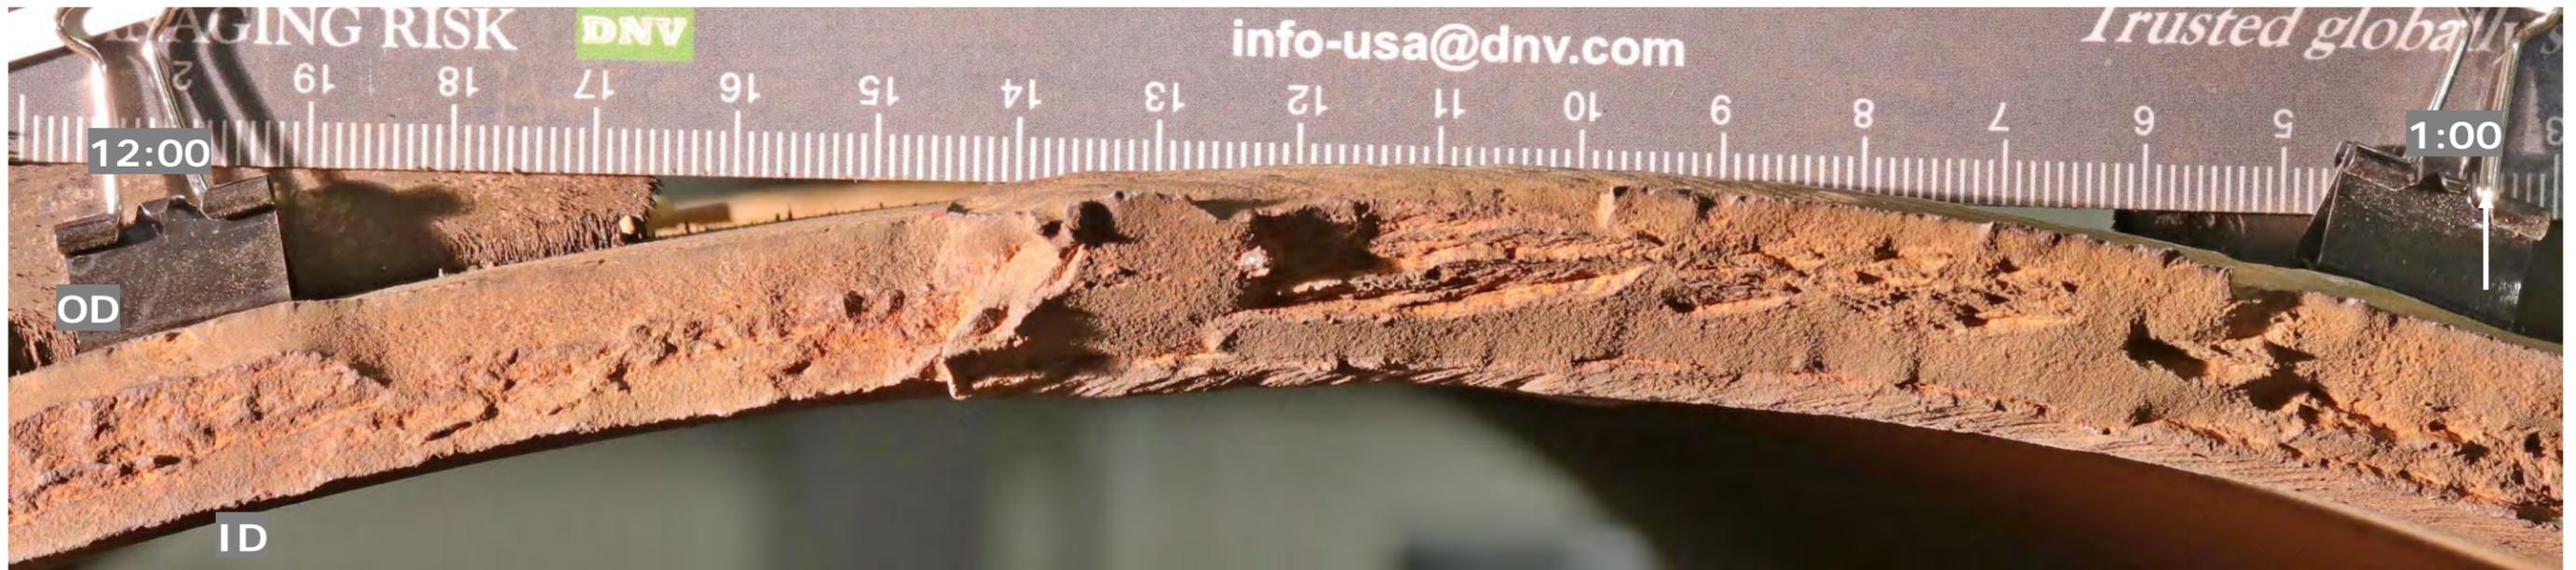
Figure 20. Photograph of the fracture surface of PS A between the 12 and 1 o'clock orientations. Units of ruler are in cm. Flow direction is into the photograph.

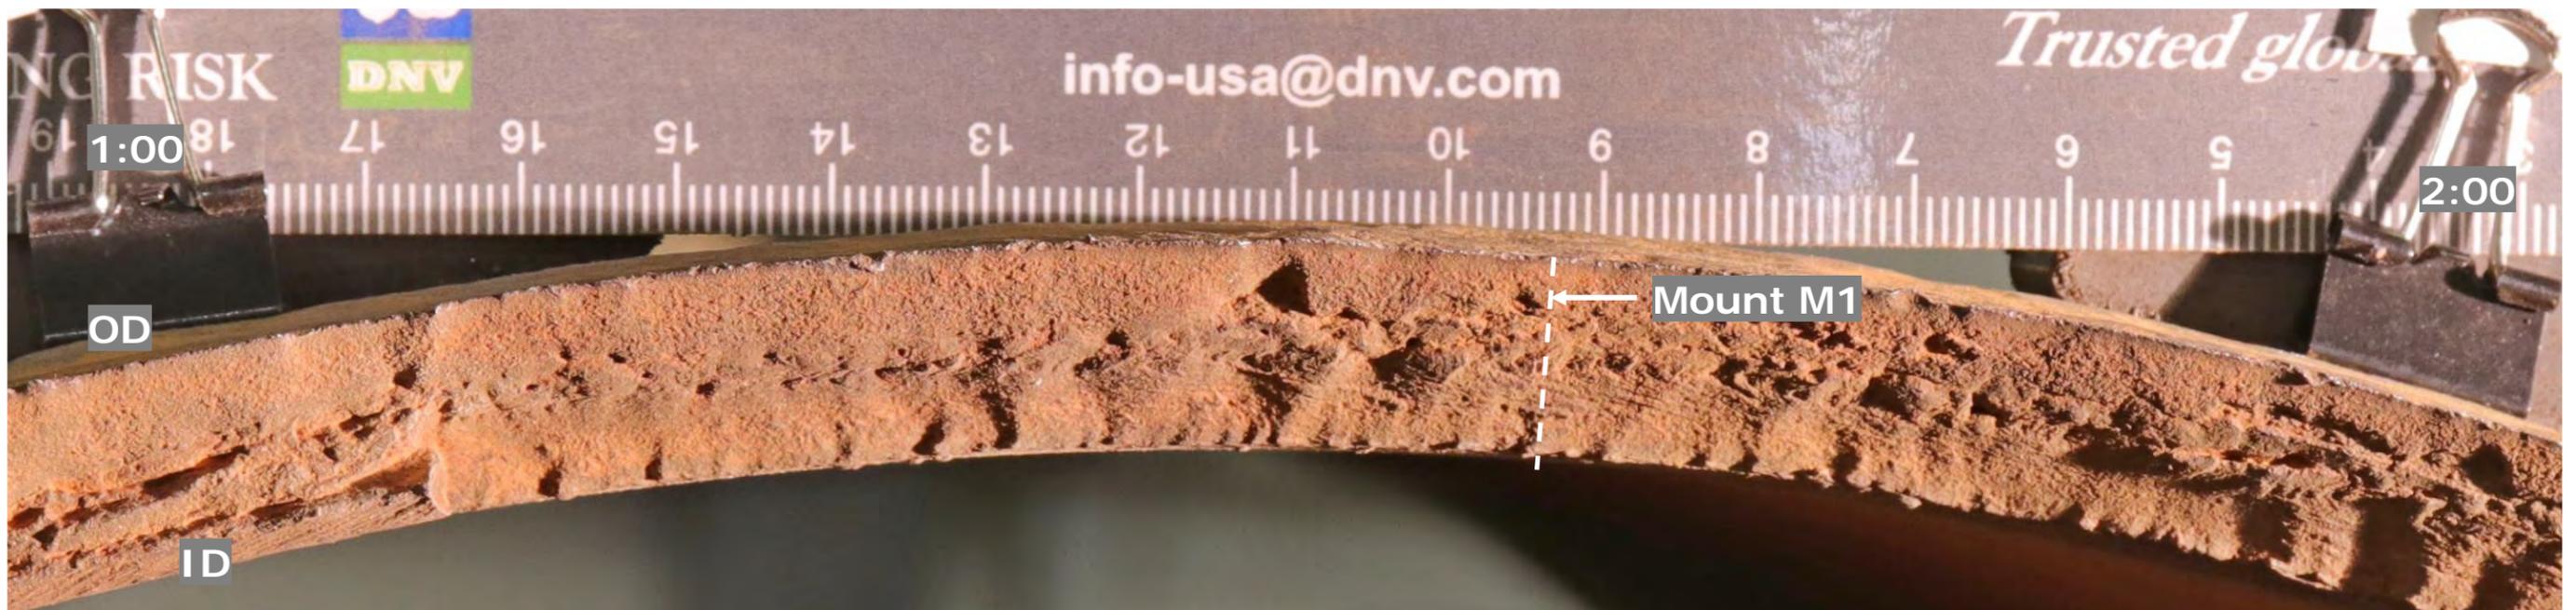
Figure 21. Photograph of the fracture surface of PS A between the 1 and 2 o'clock orientations. Units of ruler are in cm. Flow direction is into the photograph.

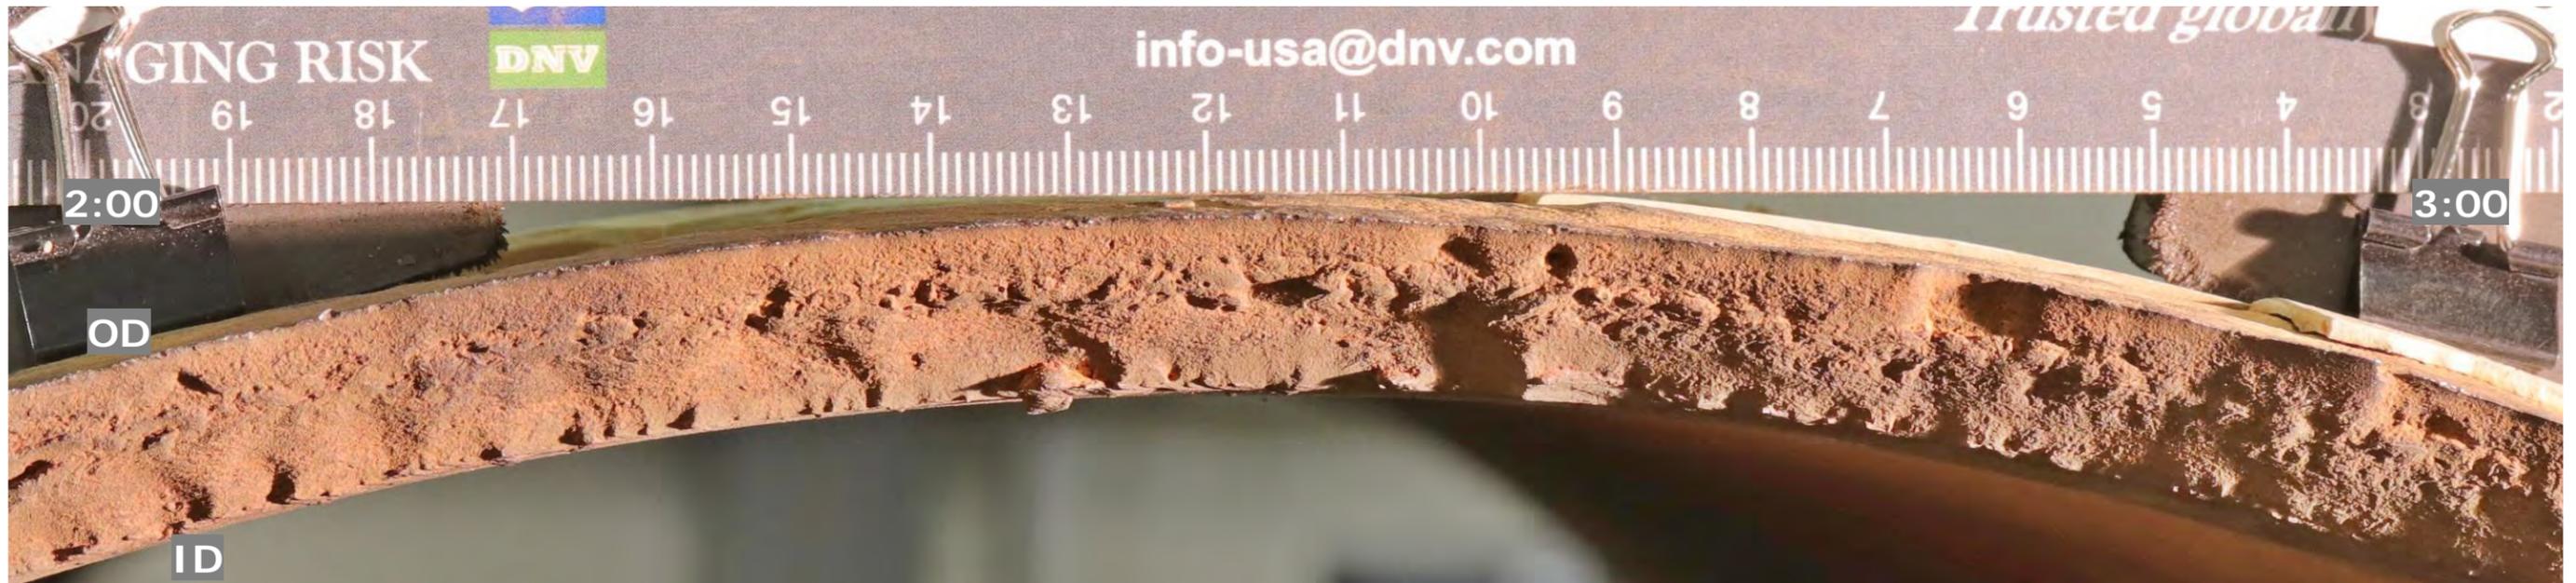
Figure 22. Photograph of the fracture surface of PS A between the 2 and 3 o'clock orientations. Units of ruler are in cm. Flow direction is into the photograph.

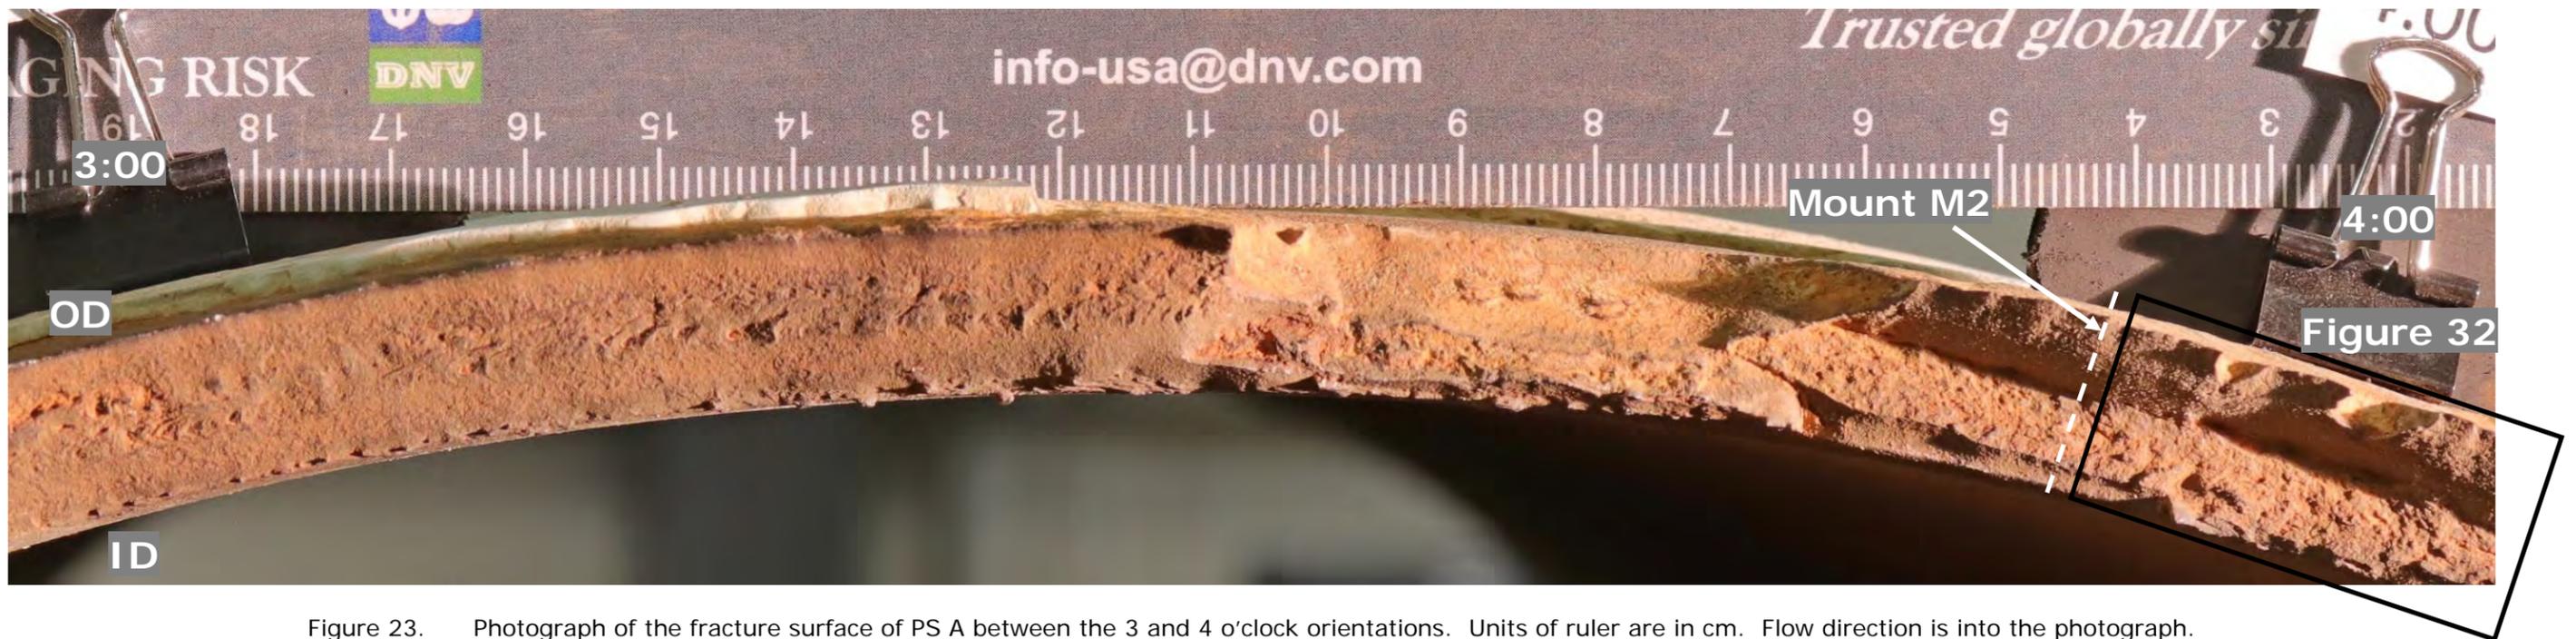
Figure 23. Photograph of the fracture surface of PS A between the 3 and 4 o'clock orientations. Units of ruler are in cm. Flow direction is into the photograph.

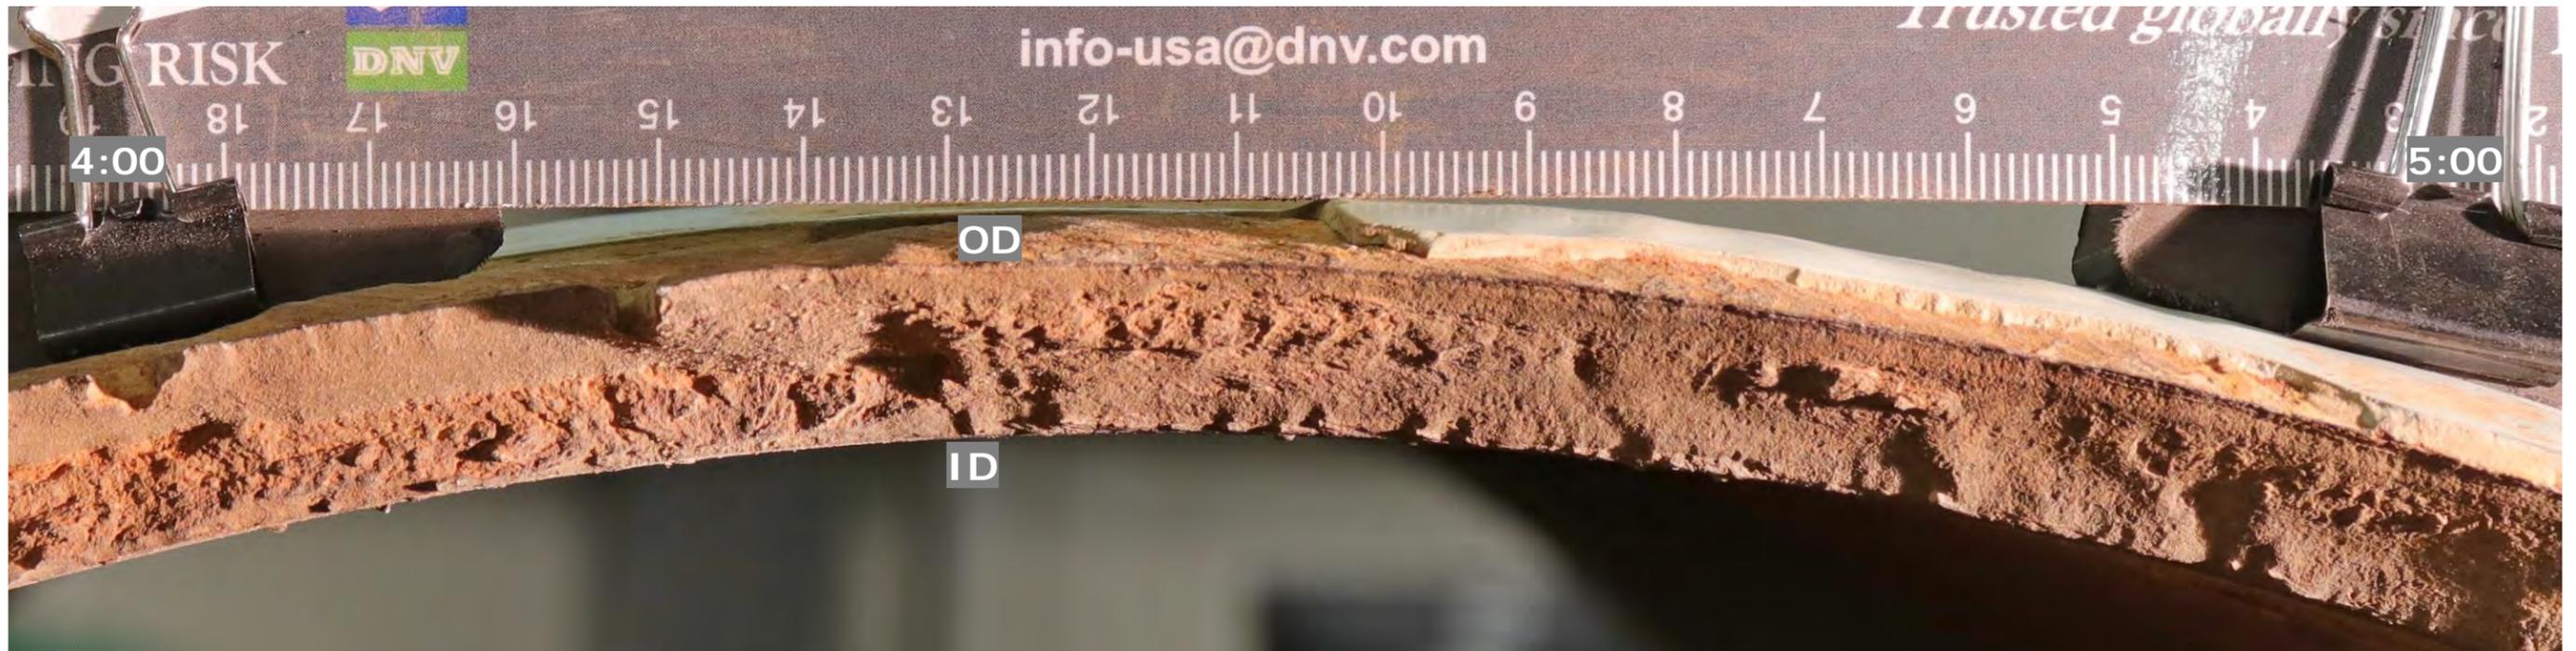
Figure 24. Photograph of the fracture surface of PS A between the 4 and 5 o'clock orientations. Units of ruler are in cm. Flow direction is into the photograph.
