DOT US Department of Transportation
PHMSA Pipeline and Hazardous Materials Safety Administration
OPS Office of Pipeline Safety – Accident Investigation Division

Principal Investigator Wesley Mathews
Acting Accident Investigation Director Chris Ruhl
Date of Report May 26, 2022
Subject Failure Investigation Report - Denbury Gulf Coast Pipelines, LLC – Pipeline Rupture/ Natural Force Damage

Failure Investigation Report – Denbury Gulf Coast Pipelines LLC
Pipeline Rupture/Natural Force Damage
February 22, 2020

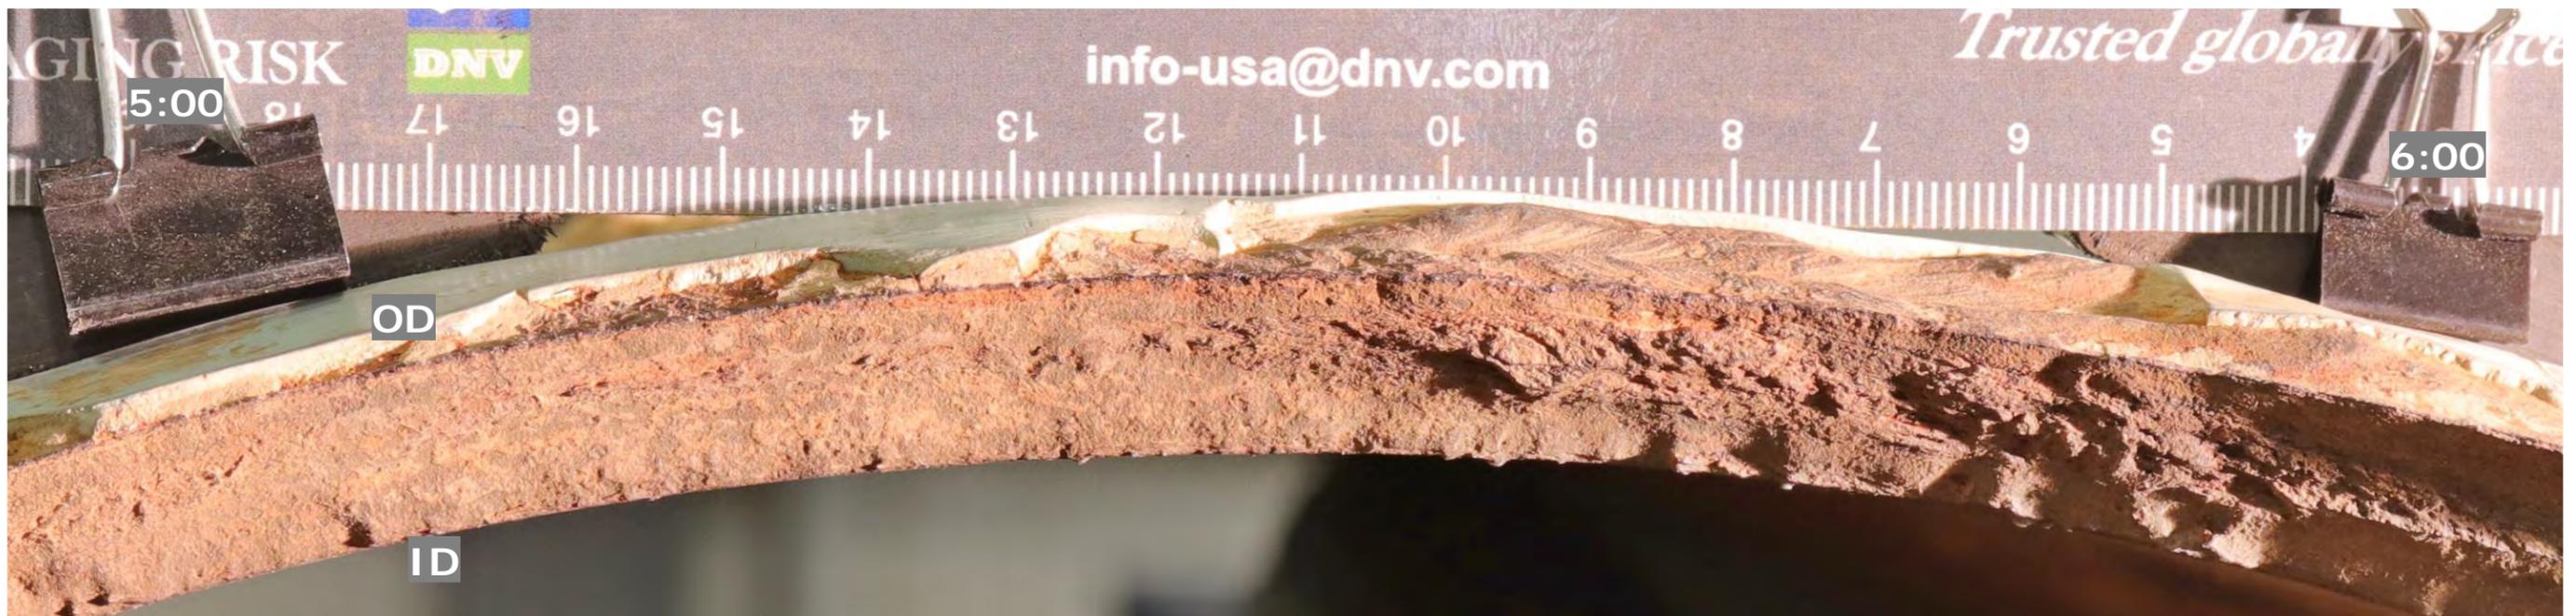
Figure 25. Photograph of the fracture surface of PS A between the 5 and 6 o'clock orientations. Units of ruler are in cm. Flow direction is into the photograph.

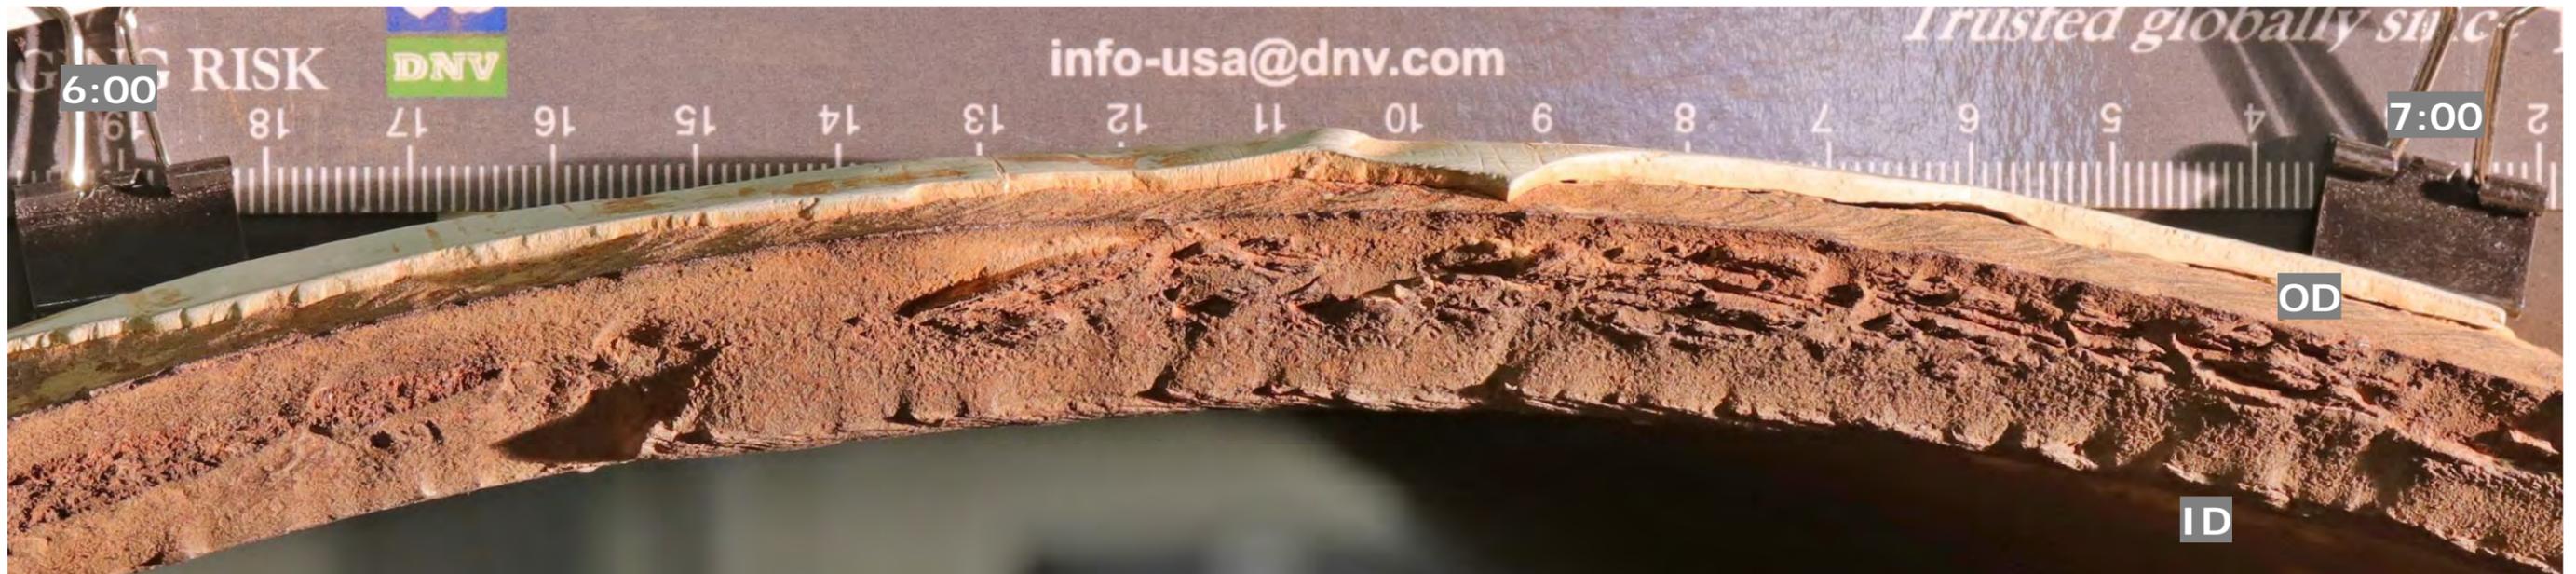
Figure 26. Photograph of the fracture surface of PS A between the 6 and 7 o'clock orientations. Units of ruler are in cm. Flow direction is into the photograph.

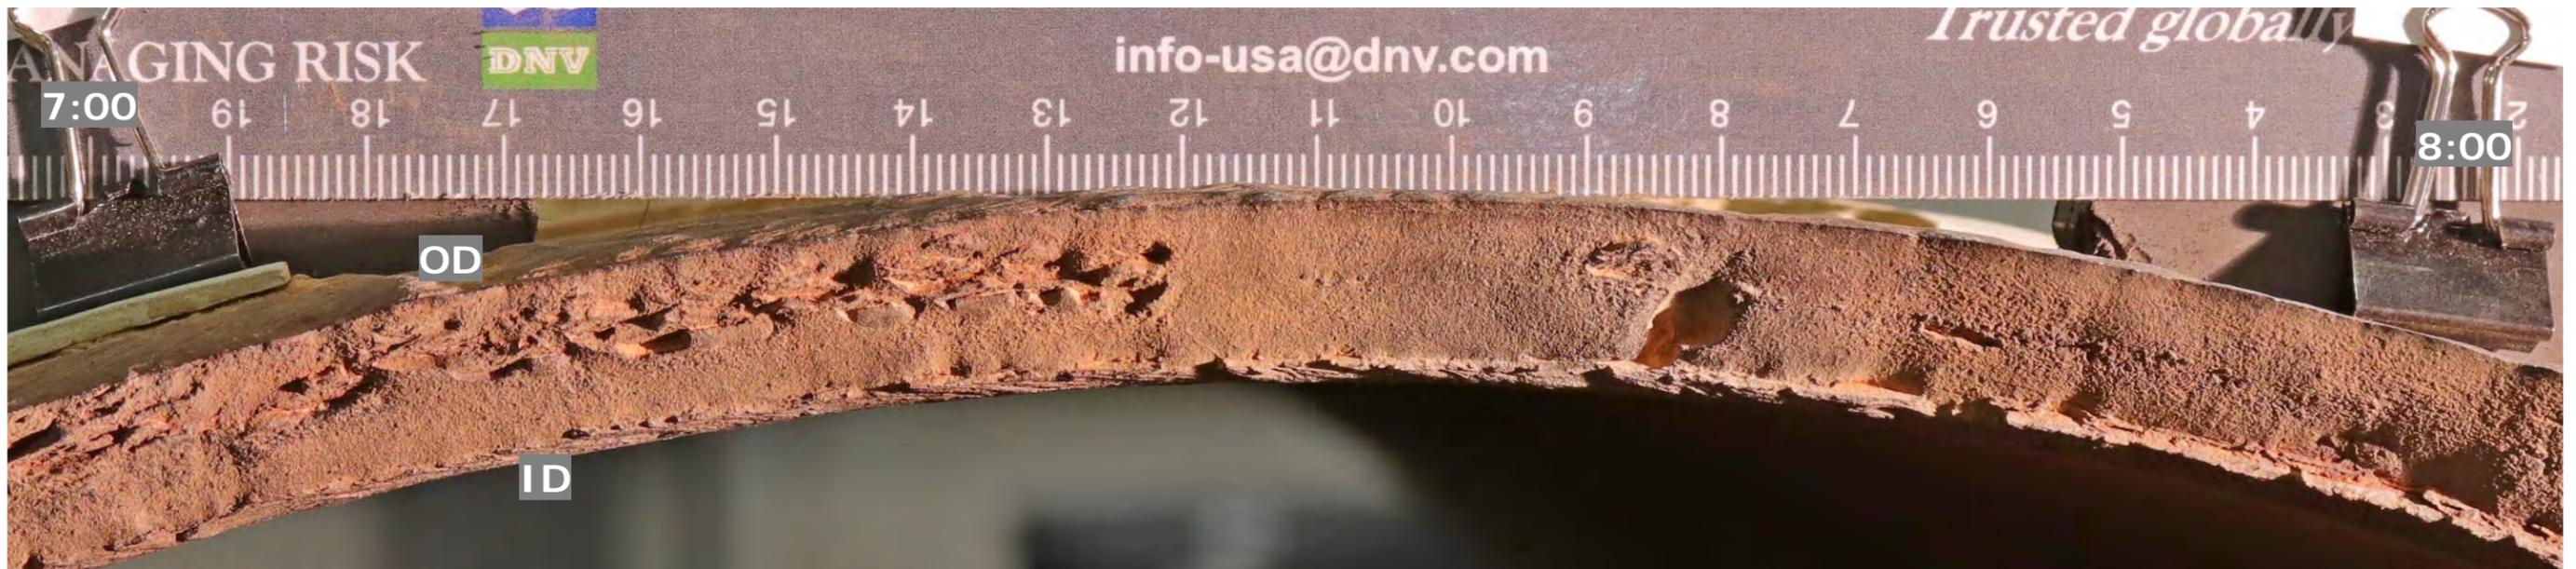
Figure 27. Photograph of the fracture surface of PS A between the 7 and 8 o'clock orientations. Units of ruler are in cm. Flow direction is into the photograph.

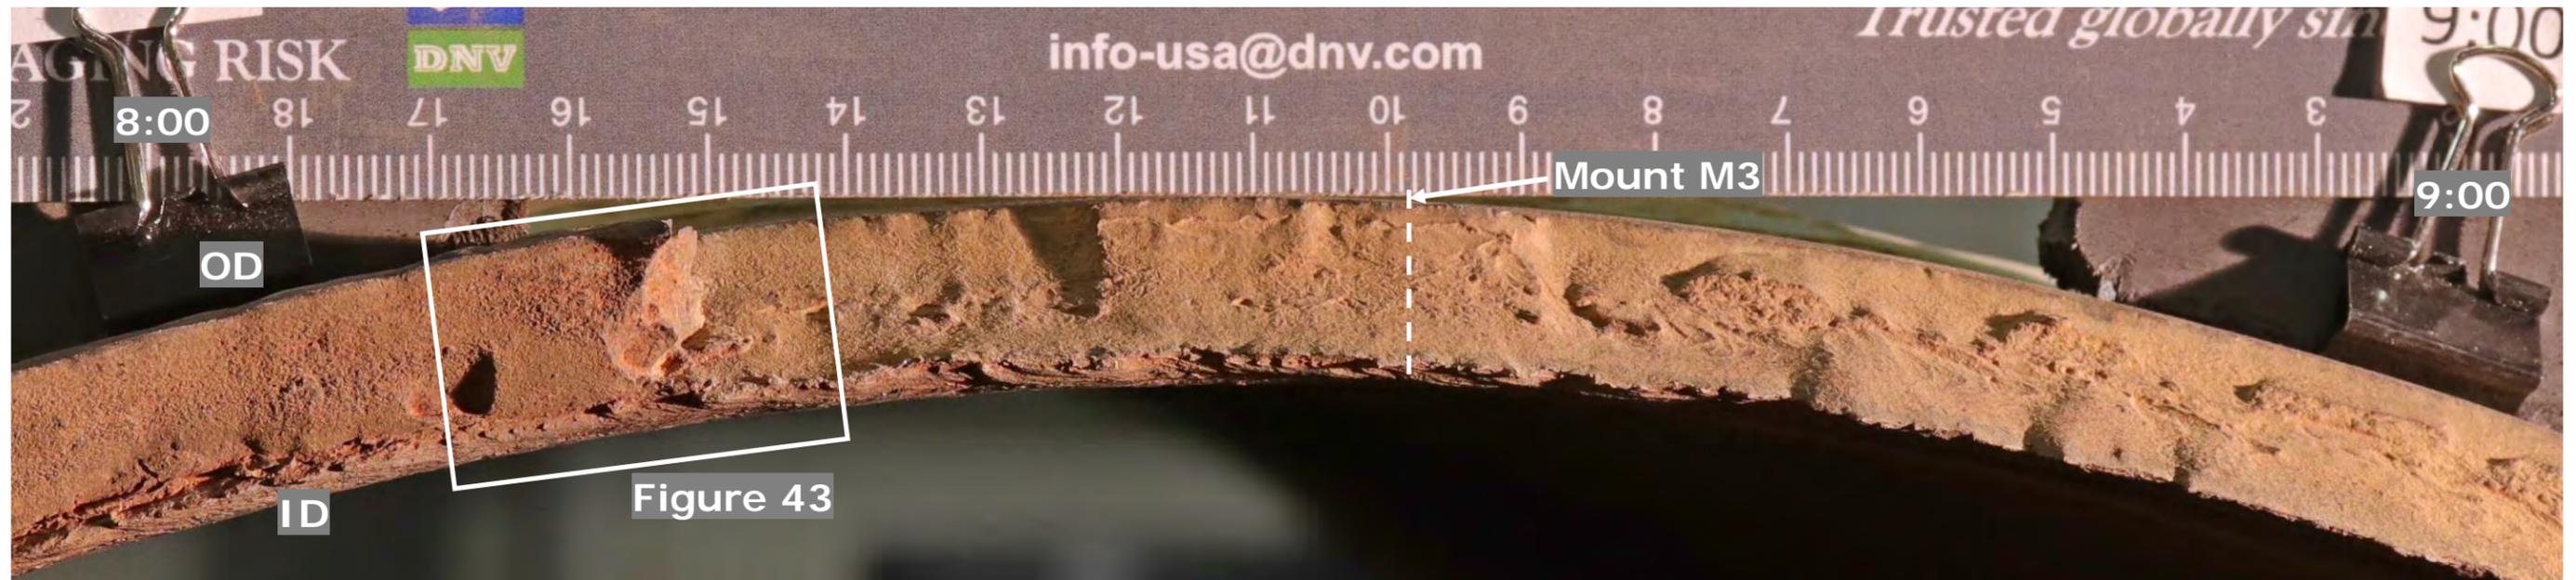
Figure 28. Photograph of the fracture surface of PS A between the 8 and 9 o'clock orientations. Units of ruler are in cm. Flow direction is into the photograph.

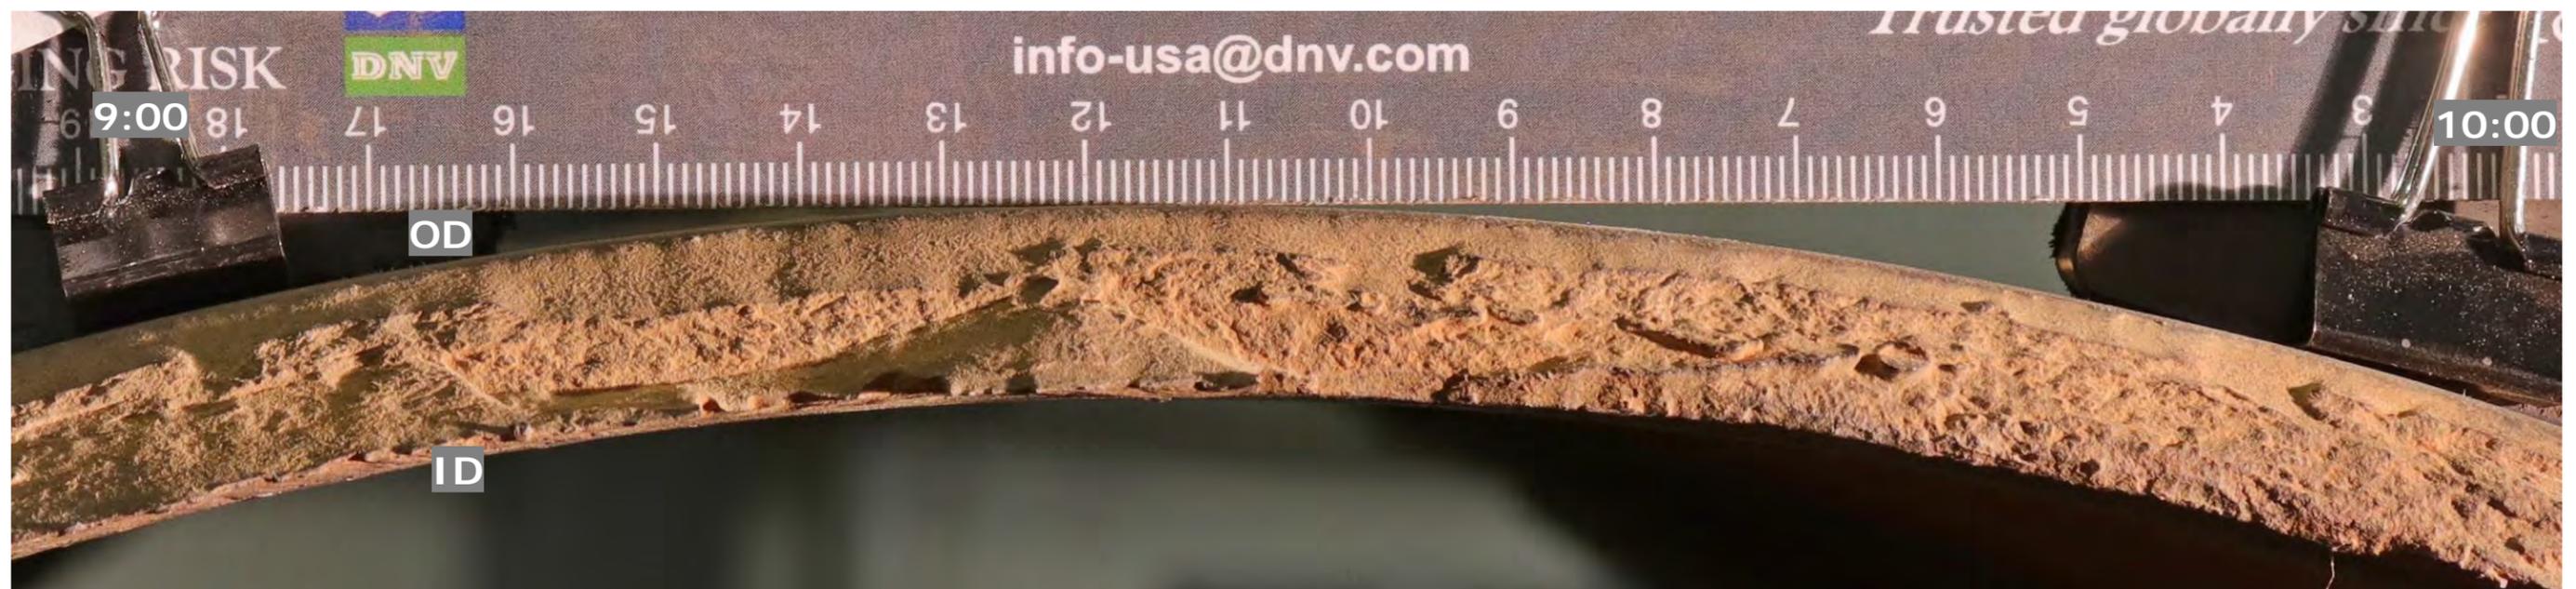
Figure 29. Photograph of the fracture surface of PS A between the 9 and 10 o'clock orientations. Units of ruler are in cm. Flow direction is into the photograph.

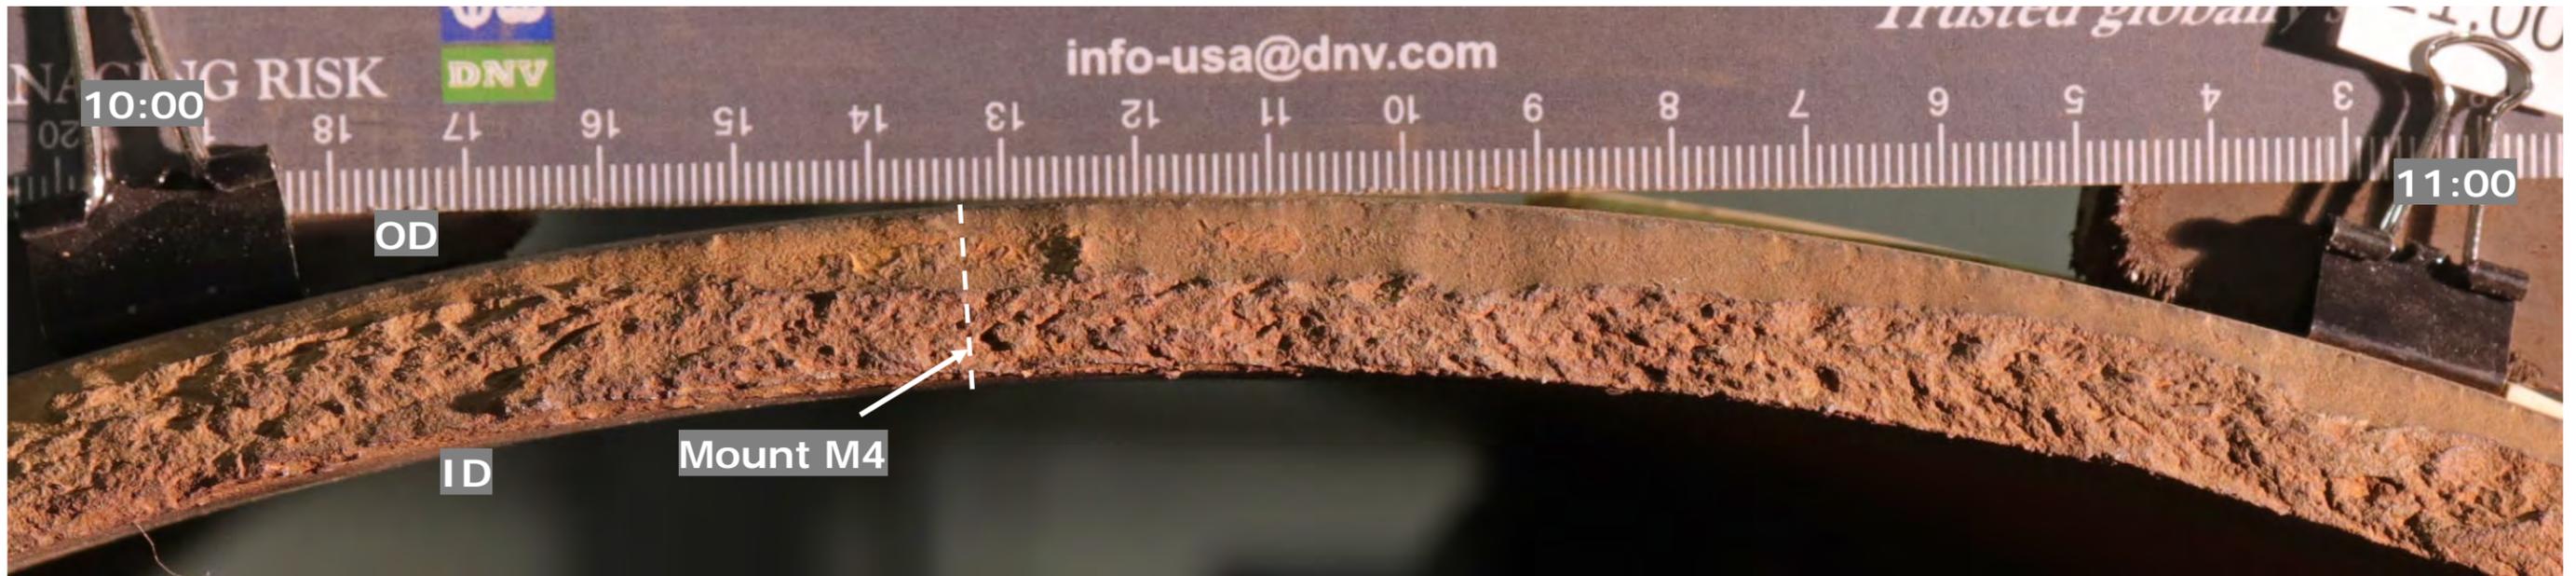
Figure 30. Photograph of the fracture surface of PS A between the 10 and 11 o'clock orientations. Units of ruler are in cm. Flow direction is into the photograph.

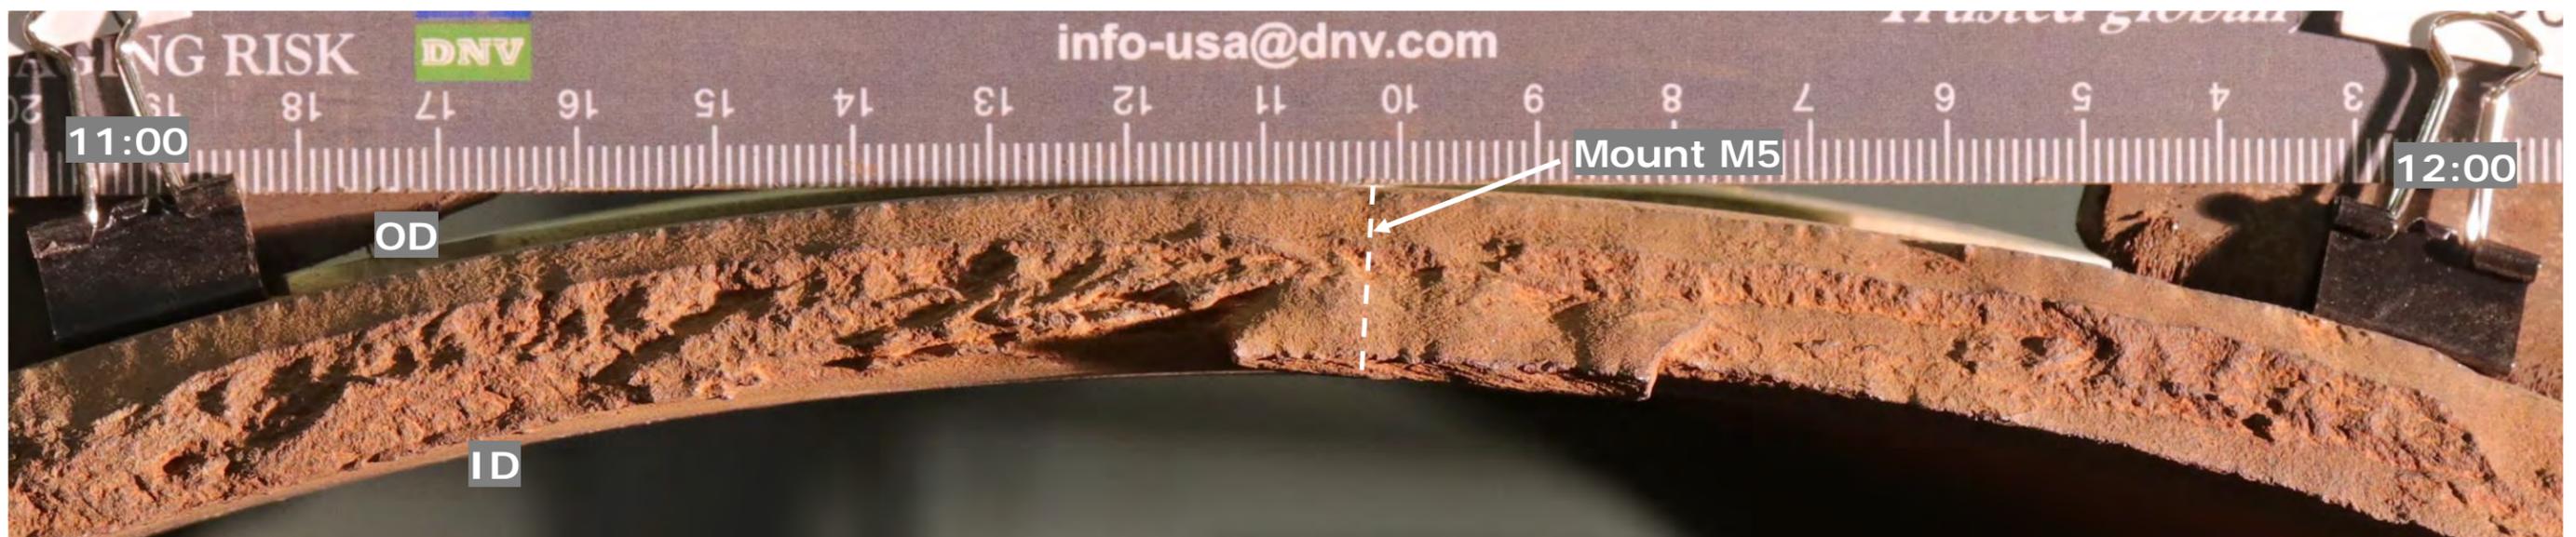
Figure 31. Photograph of the fracture surface of PS A between the 11 and 12 o'clock orientations. Units of ruler are in cm. Flow direction is into the photograph.

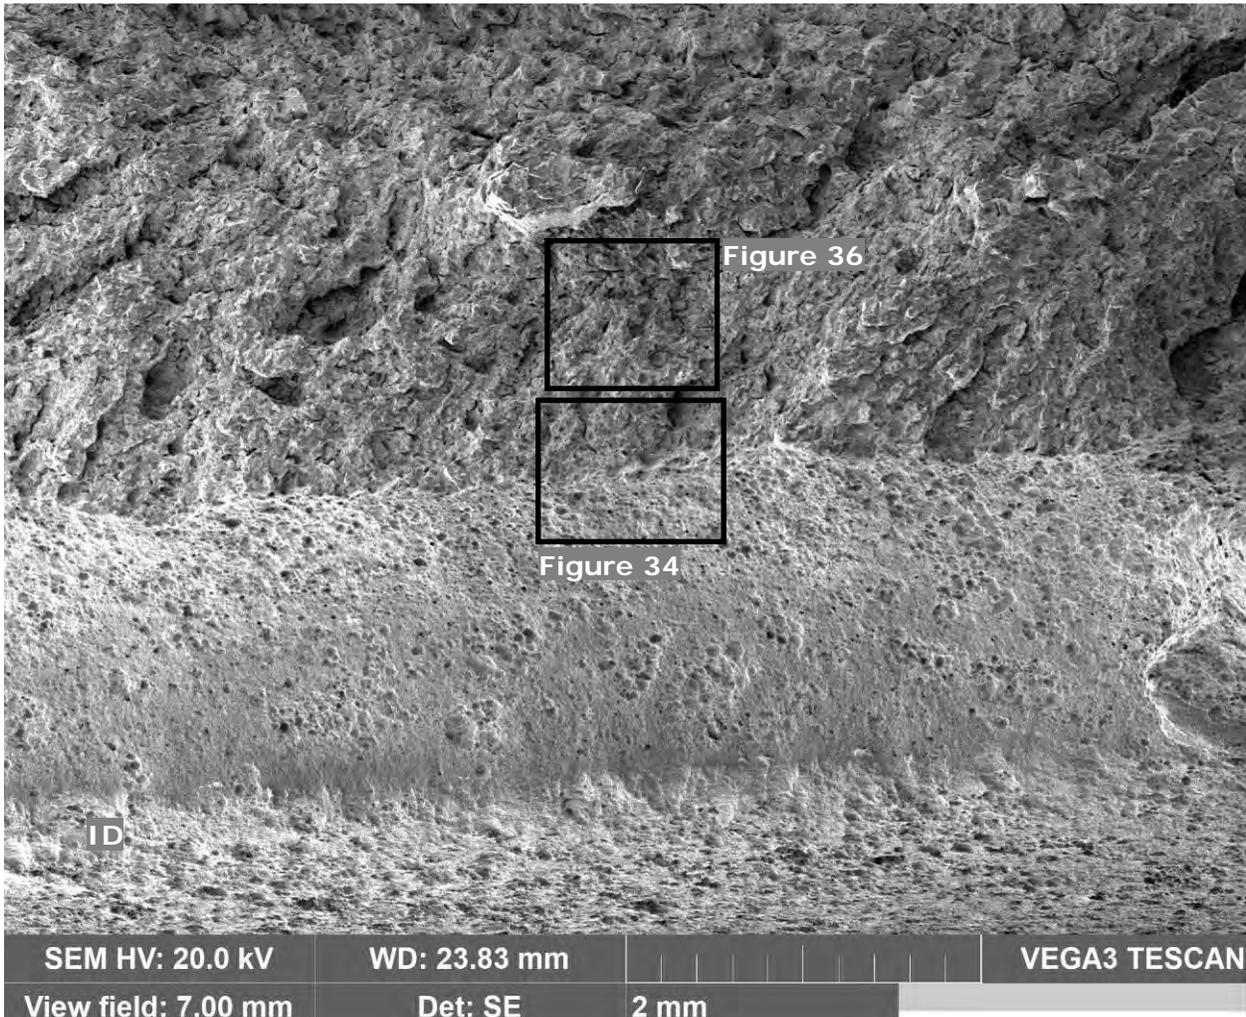
Figure 33. SEM image of Sample S2 adjacent to the ID surface; area indicated in Figure 32.

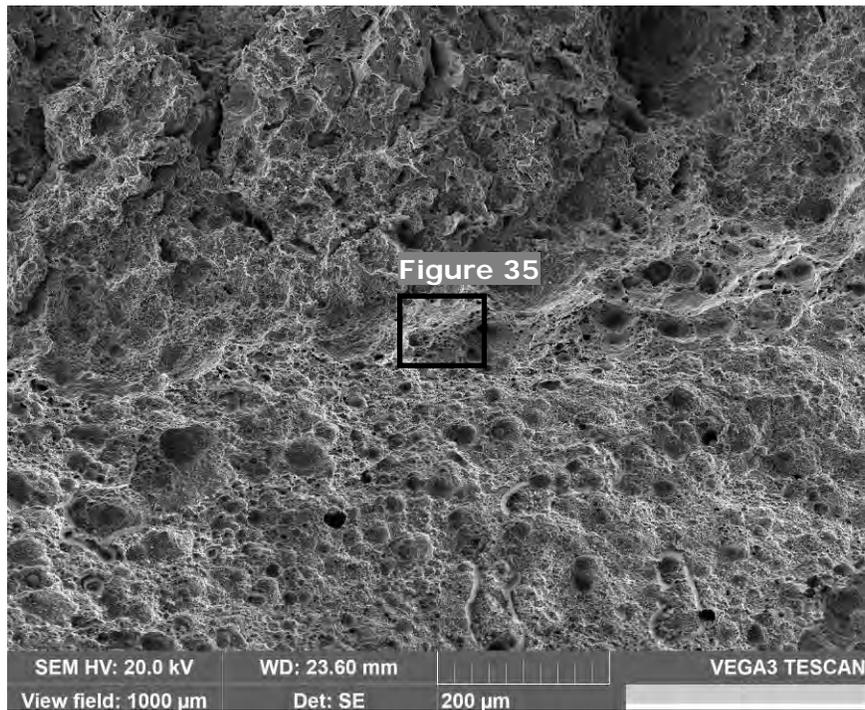
Figure 34. SEM image of Sample S2 at the interface of a macroscopically smooth and rough region; area indicated in Figure 33.

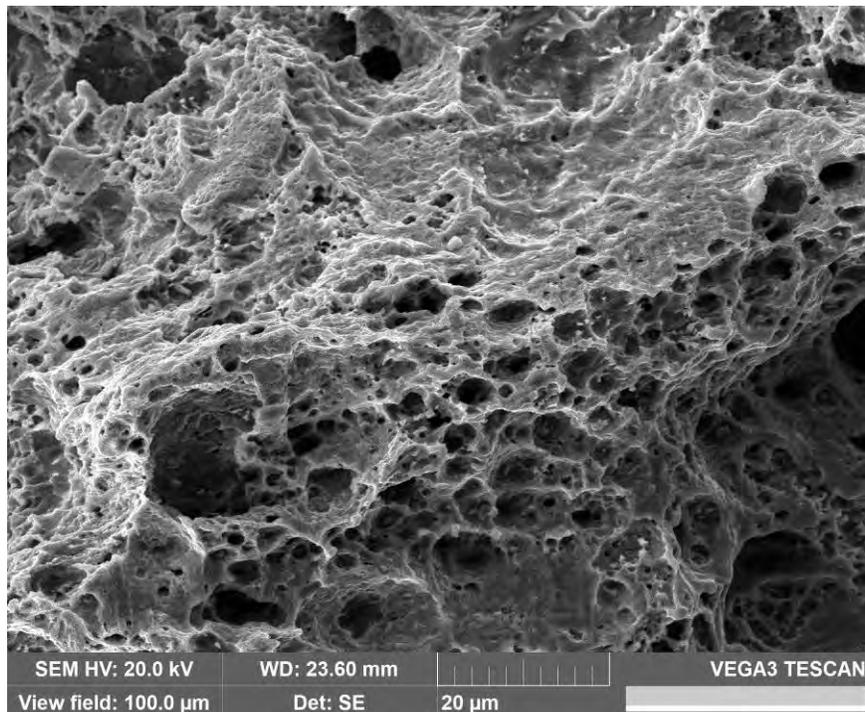
Figure 35. High magnification SEM image of Sample S2 in the macroscopically smooth region; area indicated in Figure 34.

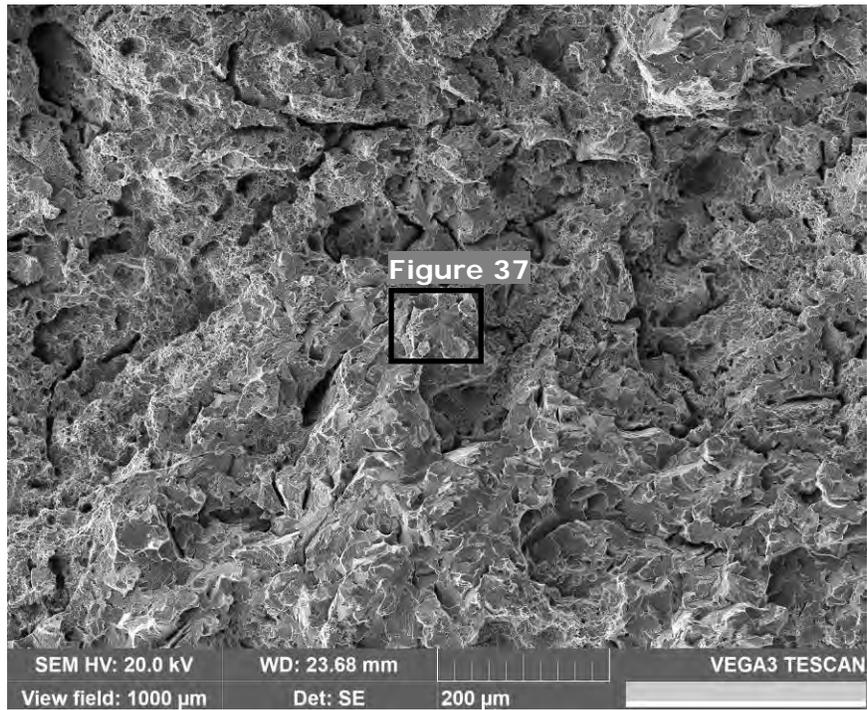
Figure 36. SEM image of Sample S2 in a macroscopically rough region; area indicated in Figure 33.

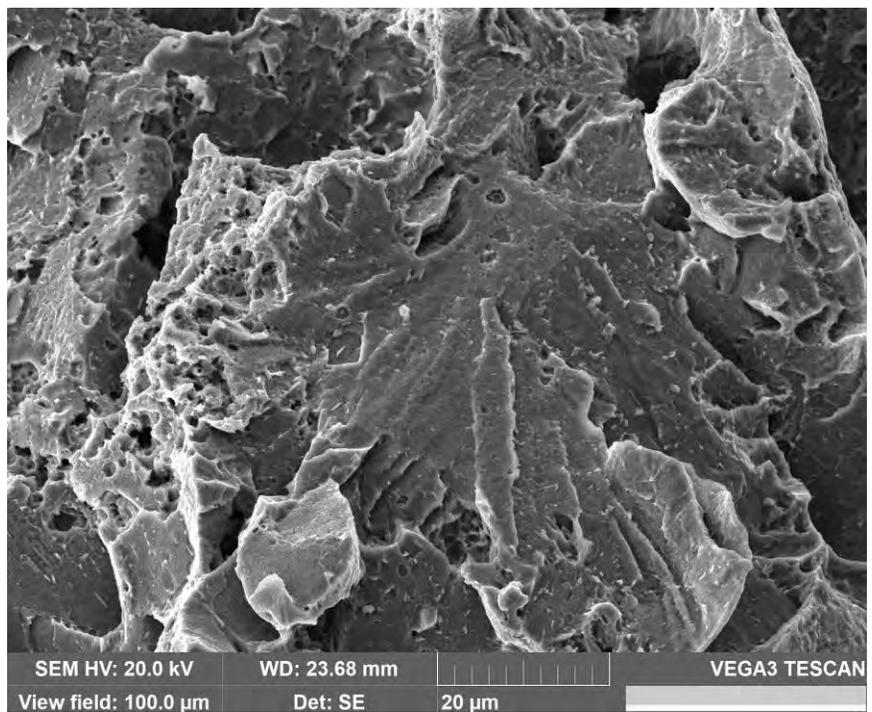
Figure 37. High magnification SEM image of Sample S2 in a macroscopically rough region; area indicated in Figure 36.

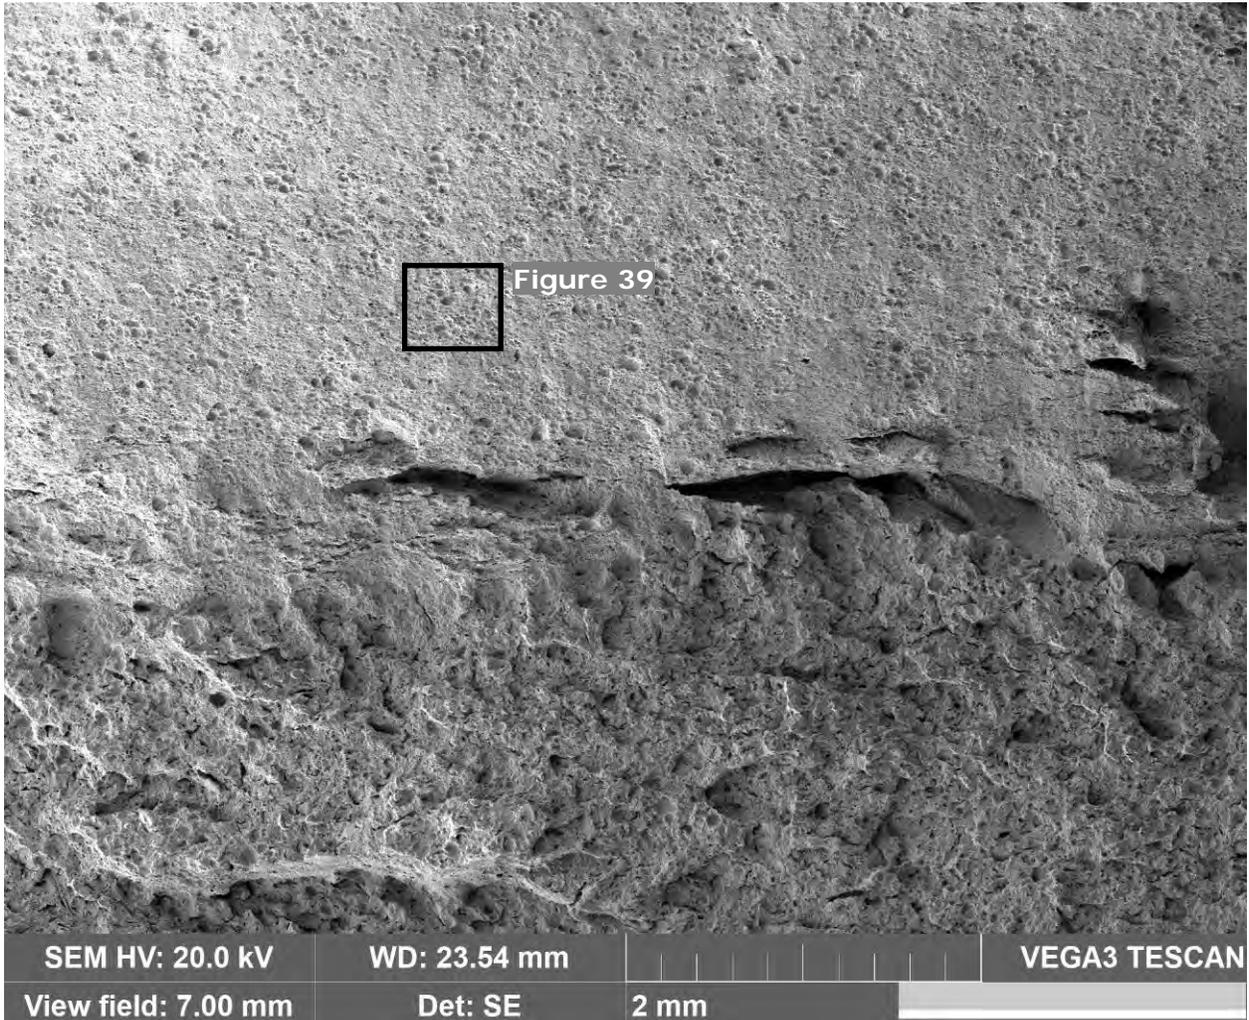
Figure 38. SEM image of Sample S2 midwall, showing macroscopically rough and smooth regions; area indicated in Figure 32.

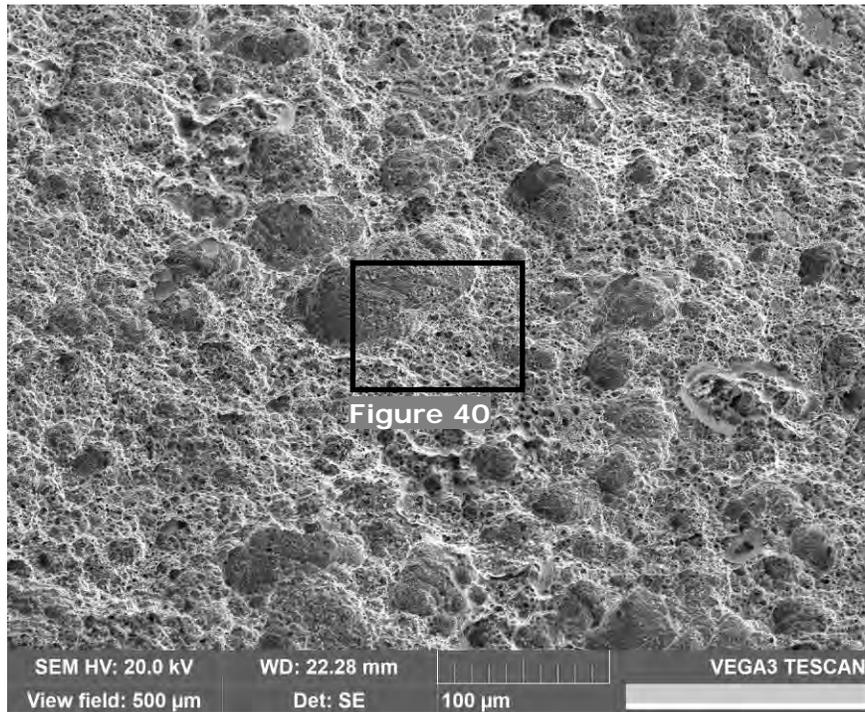
Figure 39. SEM image of Sample S2 in a macroscopically smooth region, near the OD surface; area indicated in Figure 38.

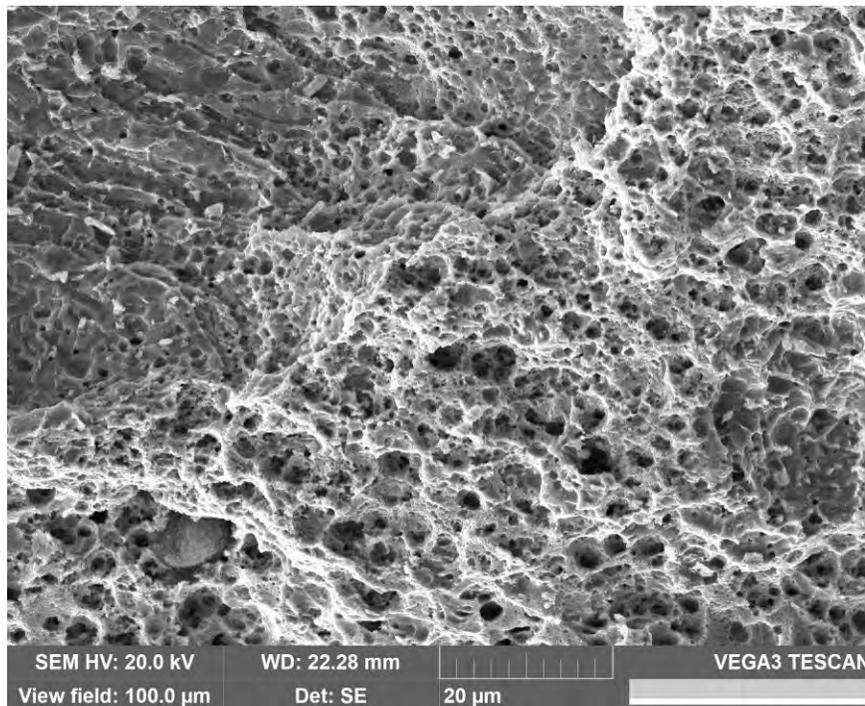
Figure 40. High magnification SEM image of Sample S2 in a macroscopically smooth region, near the OD surface; area indicated in Figure 39.

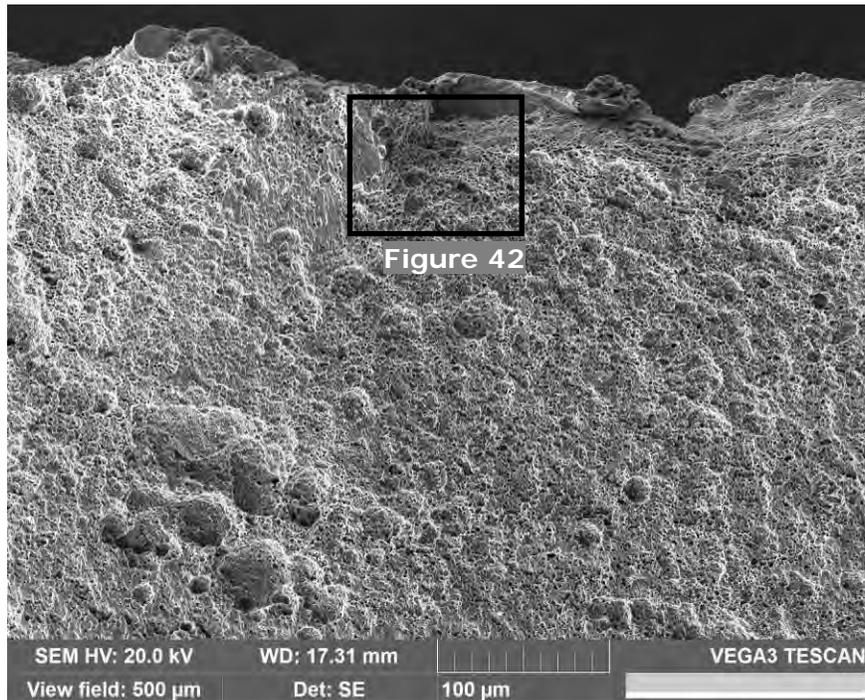
Figure 41. SEM image of Sample S2 adjacent to the OD surface; area indicated in Figure 32.

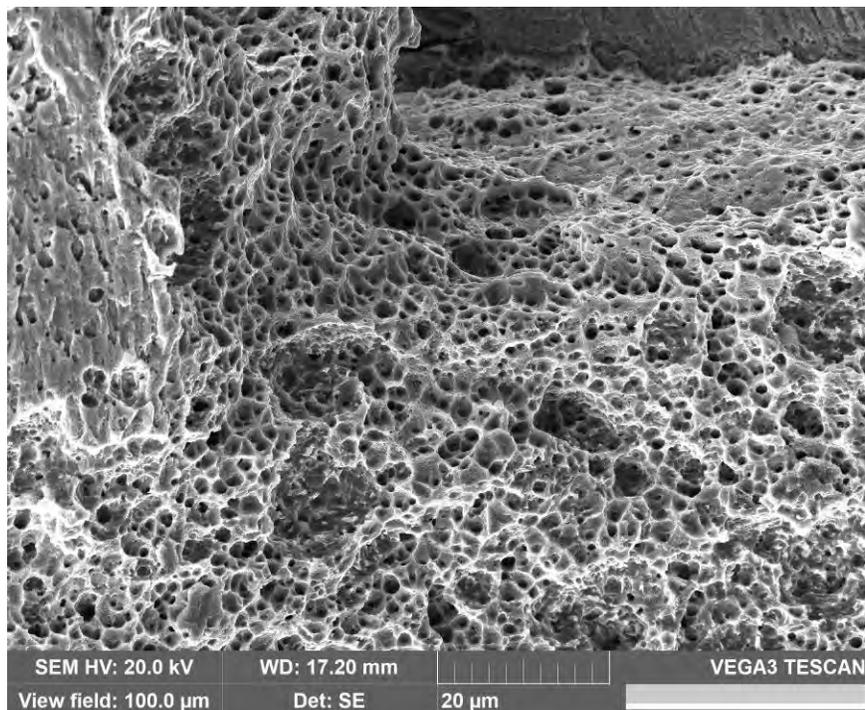
Figure 42. High magnification SEM image of Sample S2 adjacent to the OD surface; area indicated in Figure 41.

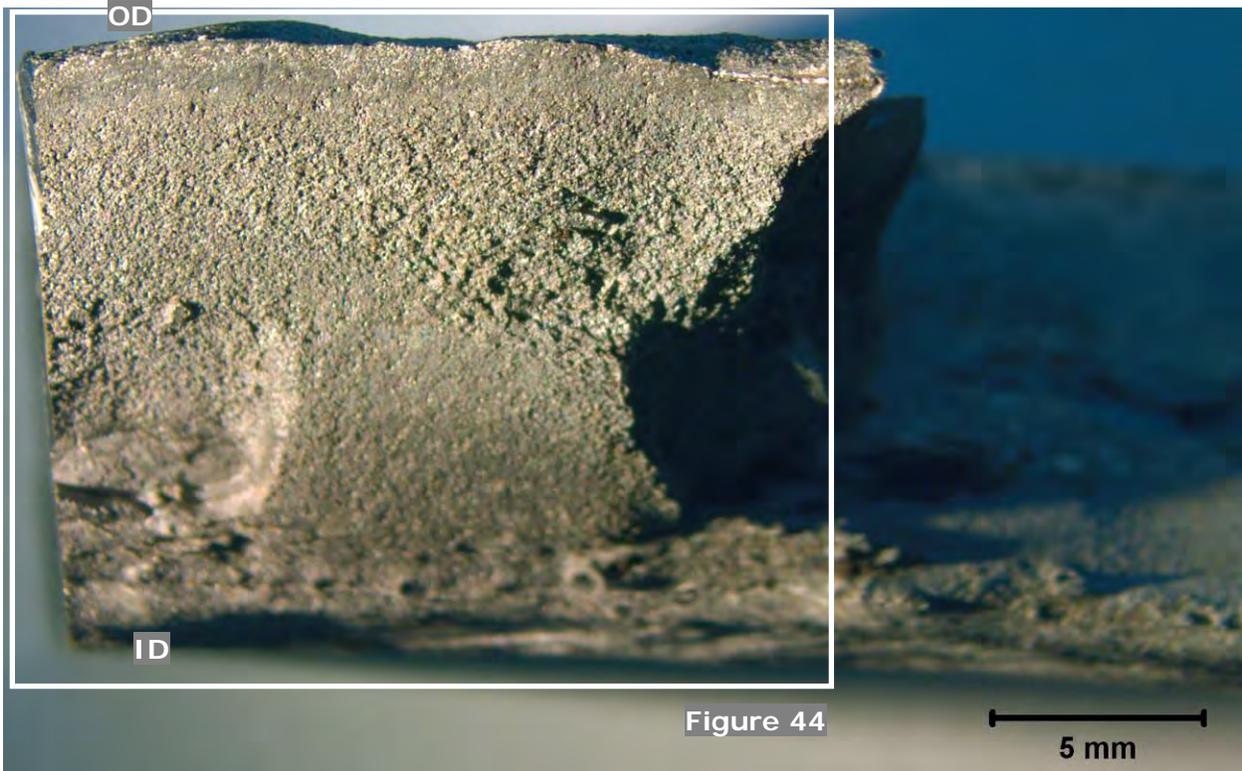
Figure 43. Light photomicrograph of the fracture surface of Sample S3, following cleaning in ENPREP® 214. The sample was removed near the 8:00 orientation; area indicated in Figure 28.

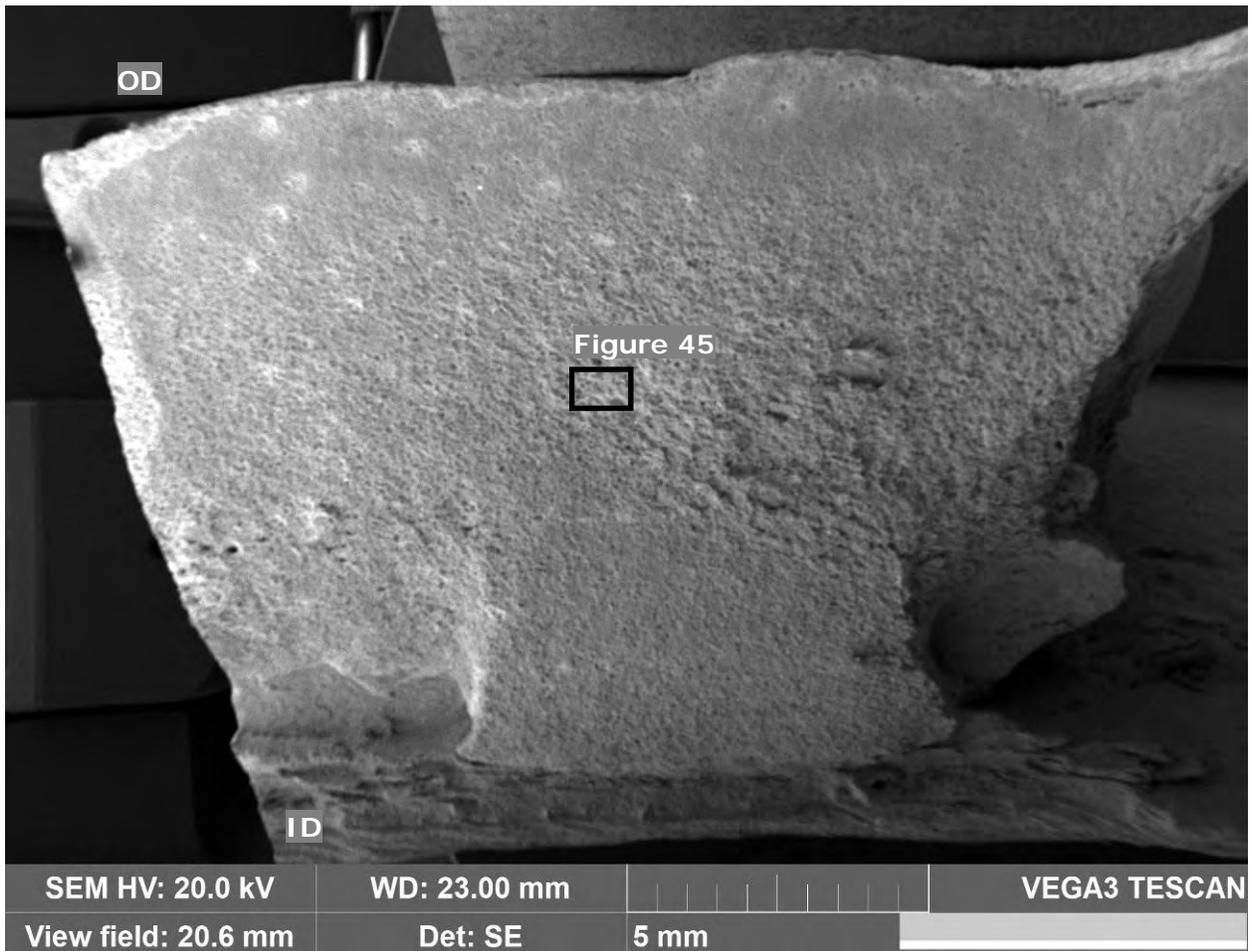
Figure 44. SEM image of Sample S3; area indicated in Figure 43.

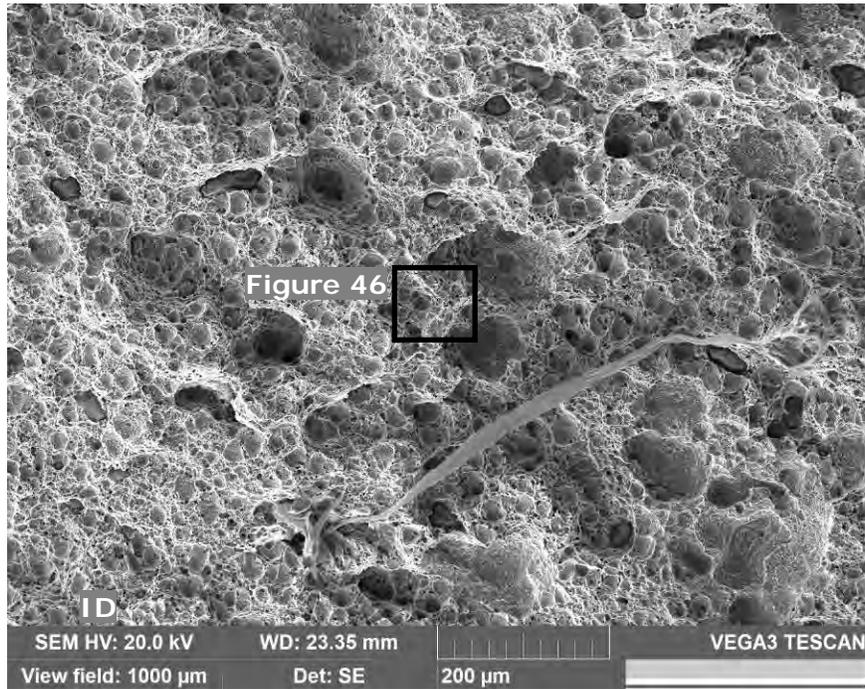
Figure 45. SEM image of Sample S3 midwall; area indicated in Figure 44.

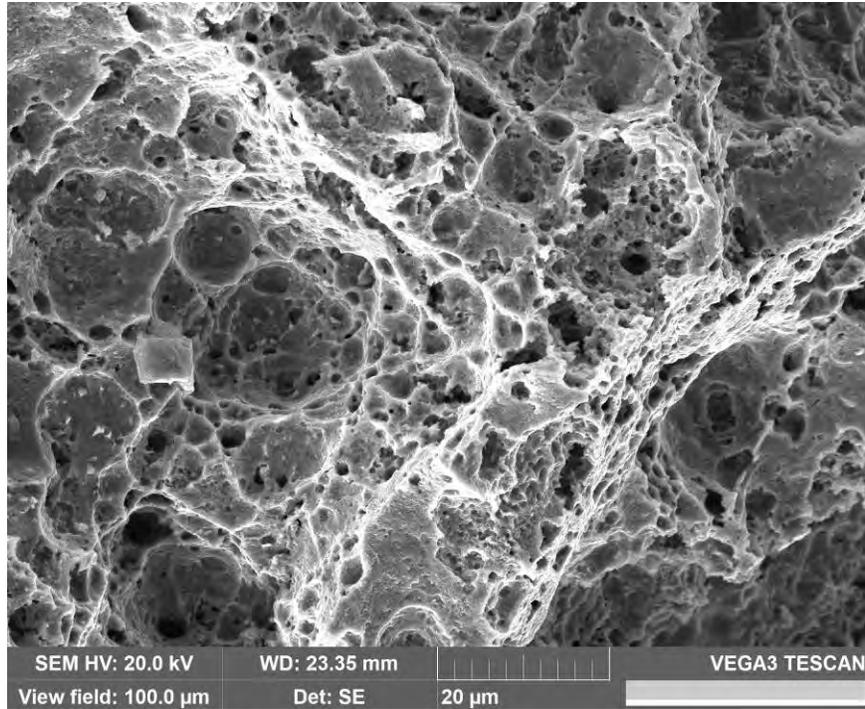
Figure 46. High magnification SEM image of Sample S3 midwall; area indicated in Figure 45.
