DOT US Department of Transportation
PHMSA Pipeline and Hazardous Materials Safety Administration
OPS Office of Pipeline Safety – Accident Investigation Division

Principal Investigator Wesley Mathews
Acting Accident Investigation Director Chris Ruhl
Date of Report May 26, 2022
Subject Failure Investigation Report - Denbury Gulf Coast Pipelines, LLC – Pipeline Rupture/ Natural Force Damage

Failure Investigation Report – Denbury Gulf Coast Pipelines LLC
Pipeline Rupture/Natural Force Damage
February 22, 2020

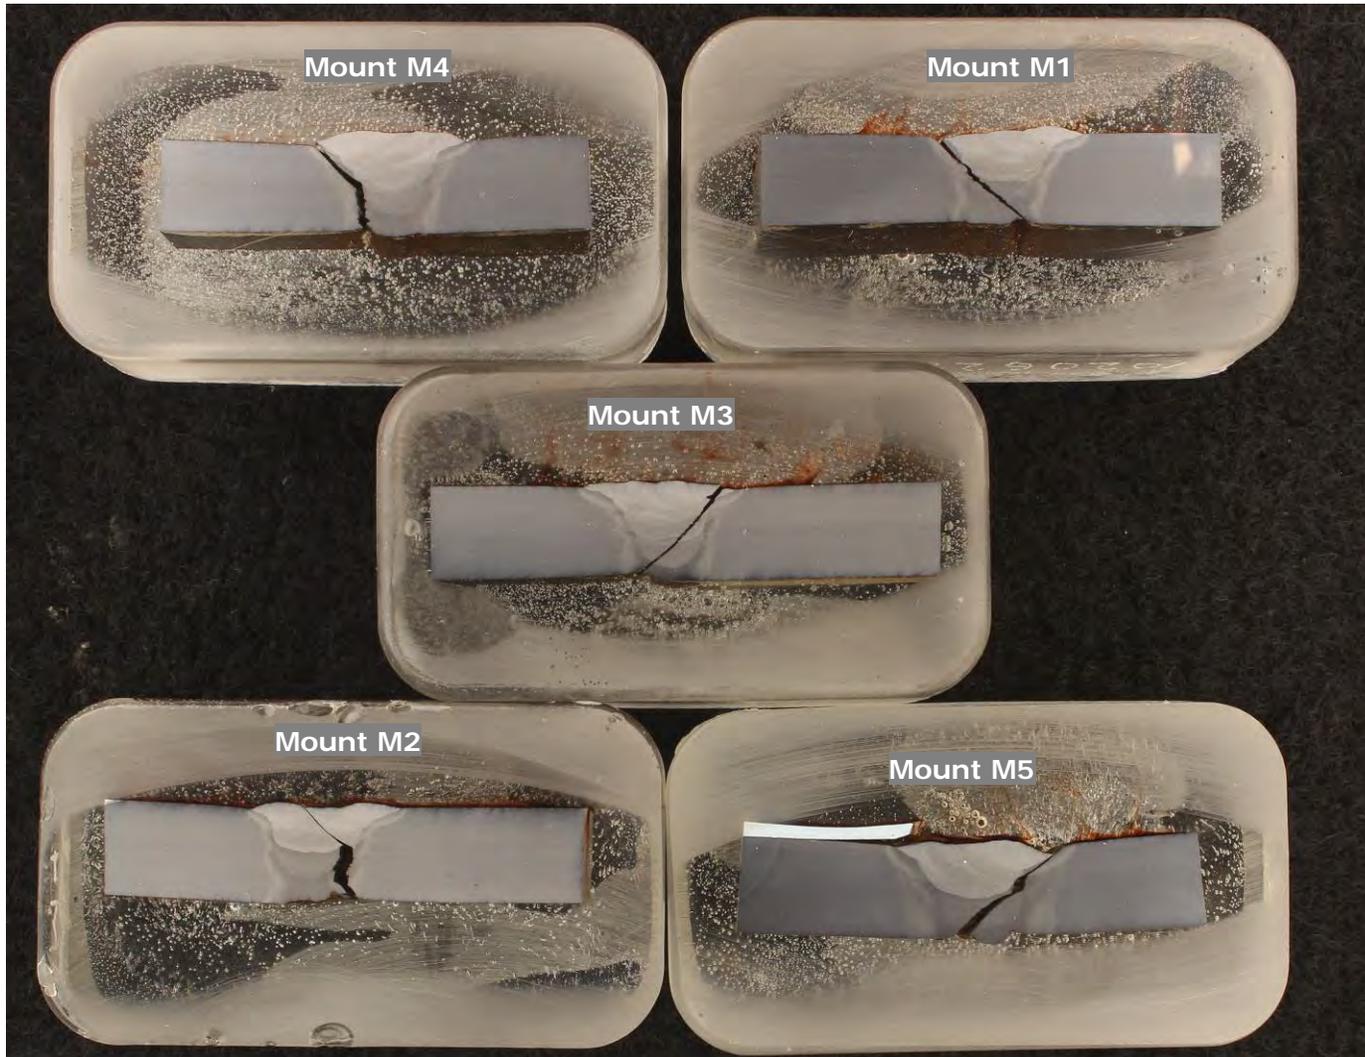
Figure 47. Photograph of the mounts (M1, M2, M3, M4, and M5) that were removed across the failure opening (2% Nital Etchant).

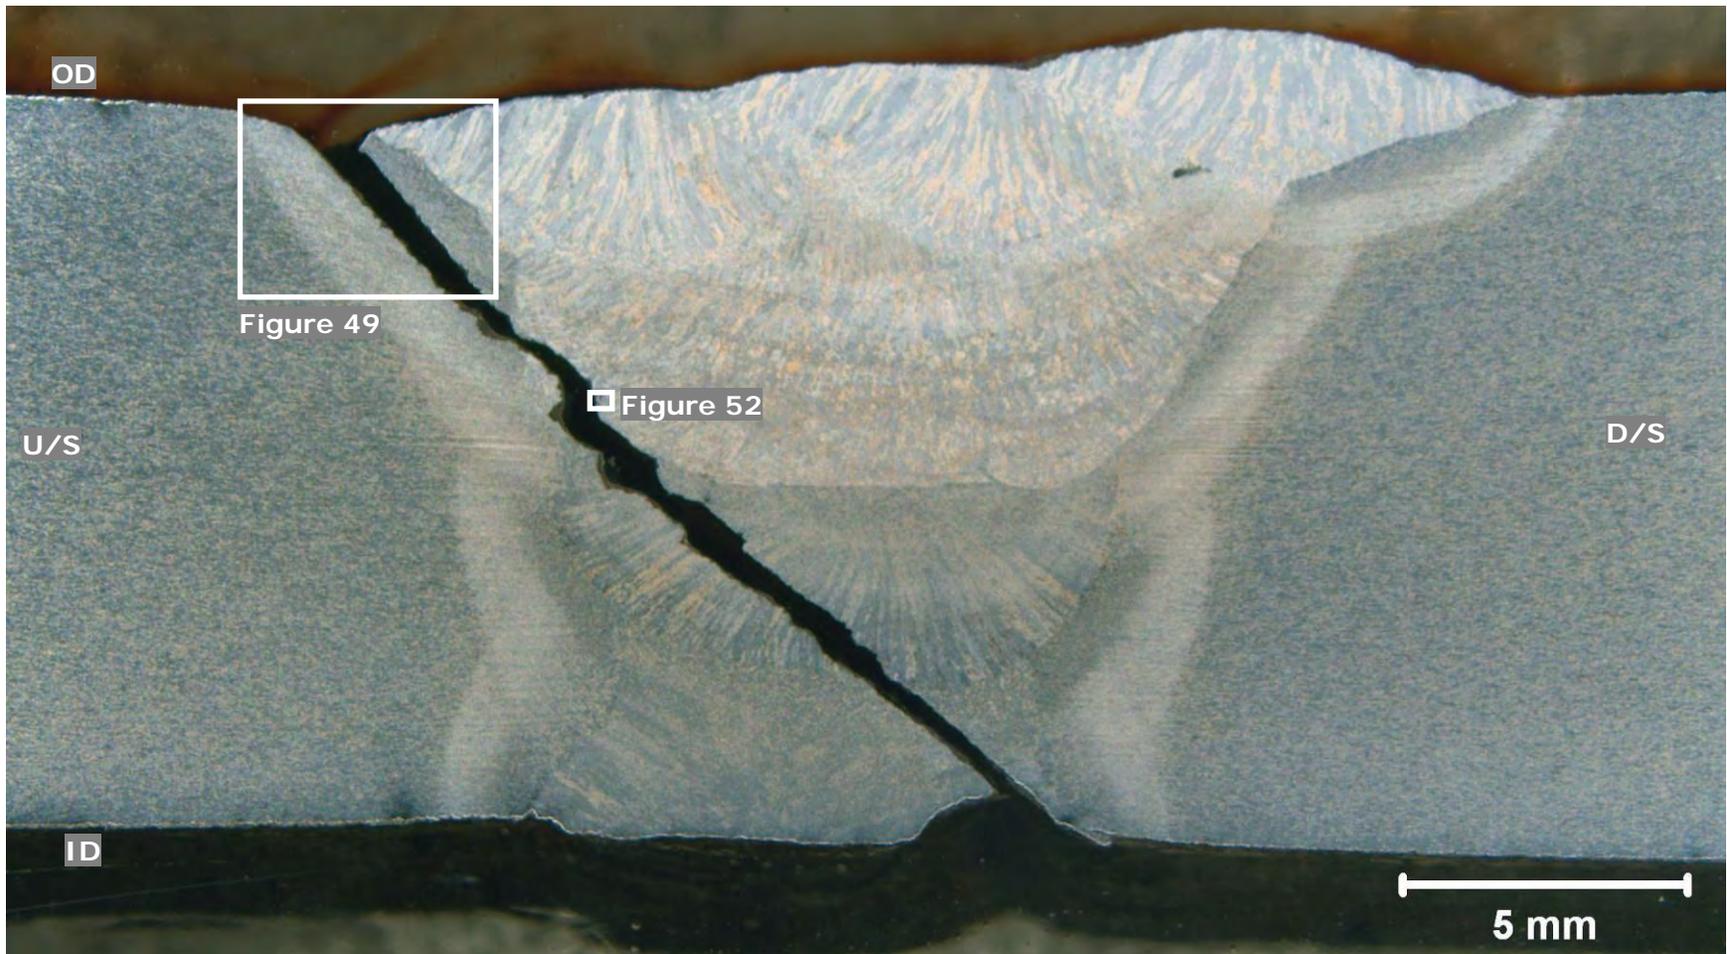
Figure 48. Light photomicrograph of Mount M1 (axial cross-section), which was removed from the failed GW at the 1:35 orientation; refer to Figure 1, Figure 11, and Figure 21 for location (2% Nital Etchant).

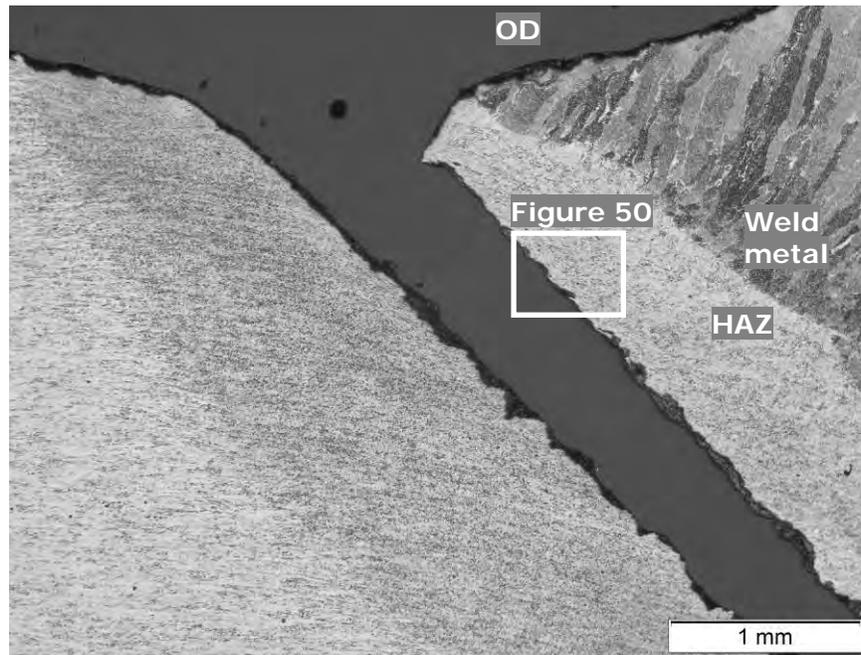
Figure 49. Light photomicrograph of Mount M1 adjacent to the OD surface (2% Nital Etchant); area indicated in Figure 48.

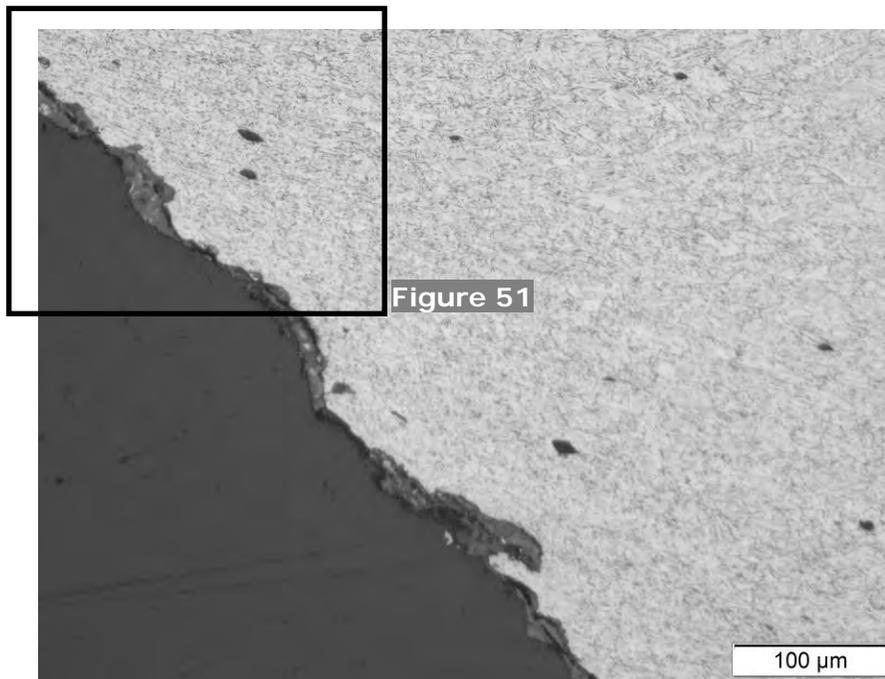
Figure 50. Light photomicrograph of Mount M1 showing inclusions in HAZ adjacent to the fracture surface; area indicated in Figure 49.

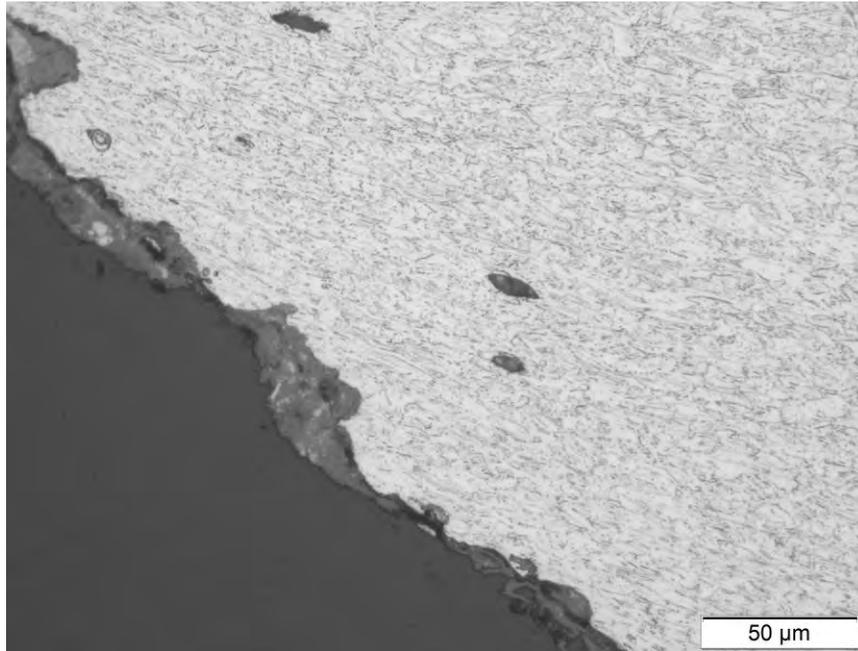
Figure 51. High magnification light photomicrograph of Mount M1 showing grain elongation adjacent to the fracture surface; area indicated in Figure 50.

- d) Grain elongations due to the cold work that took place during the rupture process which is consistent with ductile overloading (see fig. 21 of the Mears report),

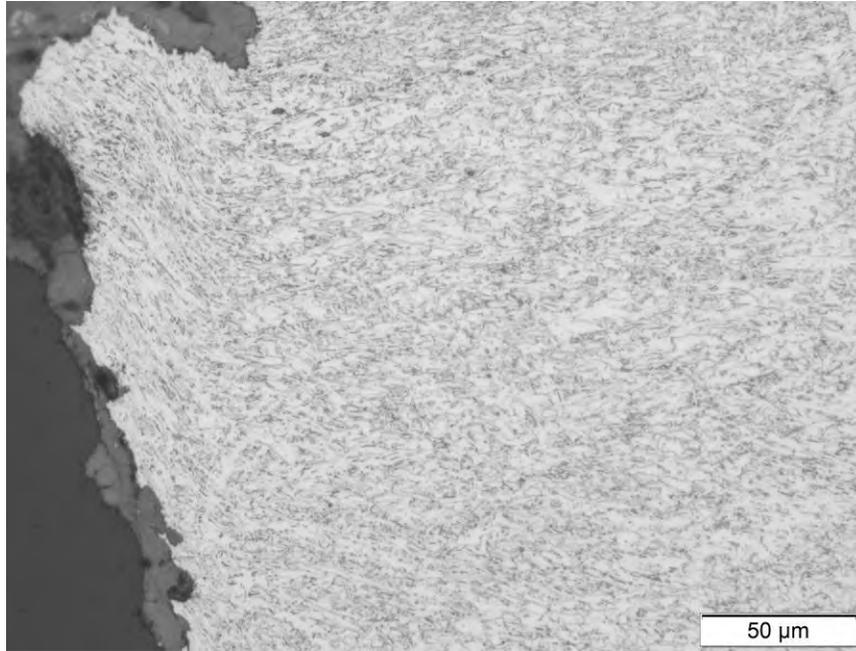
Figure 52. High magnification light photomicrograph of Mount M1 midwall adjacent to the fracture surface (2% Nital Etchant); area indicated in Figure 48.

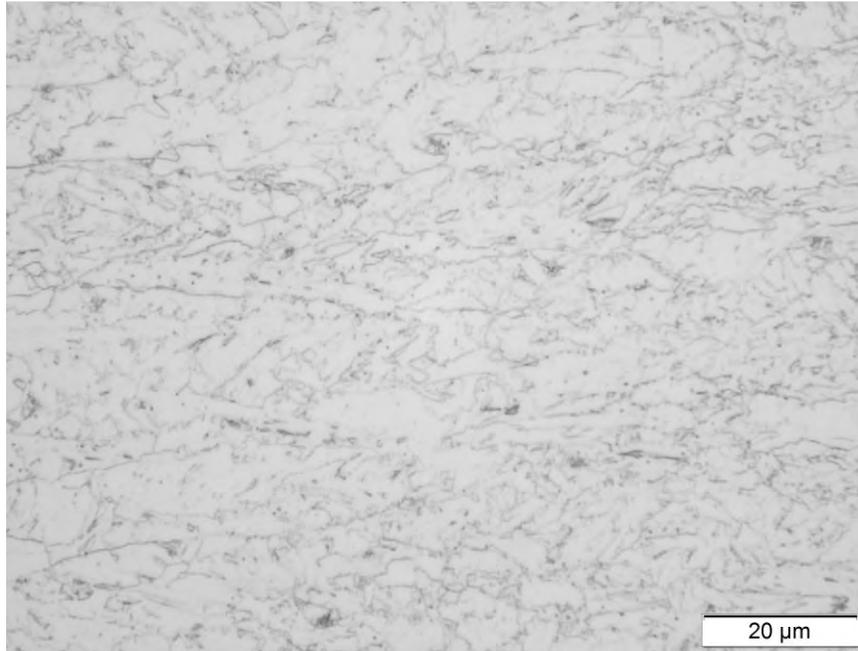
Figure 53. High magnification light photomicrograph of Mount M1 showing the typical base metal microstructure of the U/S Joint (PS B, 2% Nital Etchant).

Figures 53 and 54 of the DNV Metallurgical Analysis Report (Section 3.4) characterize the microstructure of the upstream and downstream pipe. Analysis of these photomicrographs indicate a significantly larger amount of ferrite than pearlite, which is consistent with the expected microstructure for pipe with the specified minimum yield strength and vintage of the Delhi 24-inch pipeline. Compared with photomicrographs of metal samples provided through industry literature, the microstructure of the 24-inch pipeline has a low carbon content, consistent with other X-80 pipelines. The microstructure of the failed girth shows similar characteristics (see Figure 62 of the DNV Metallurgical Analysis Report).

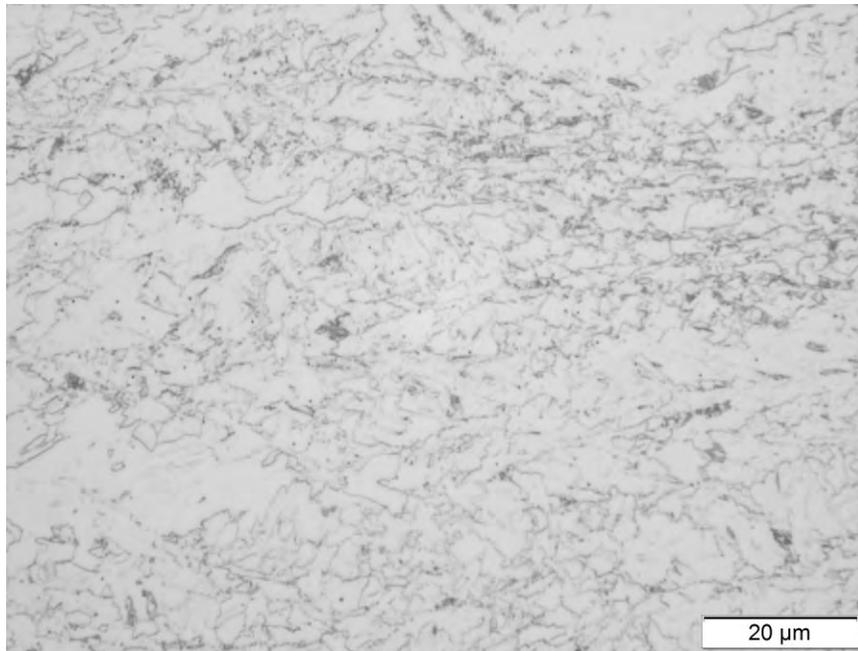
Figure 54. High magnification light photomicrograph of Mount M1 showing the typical base metal microstructure of the D/S Joint (PS A, 2% Nital Etchant).

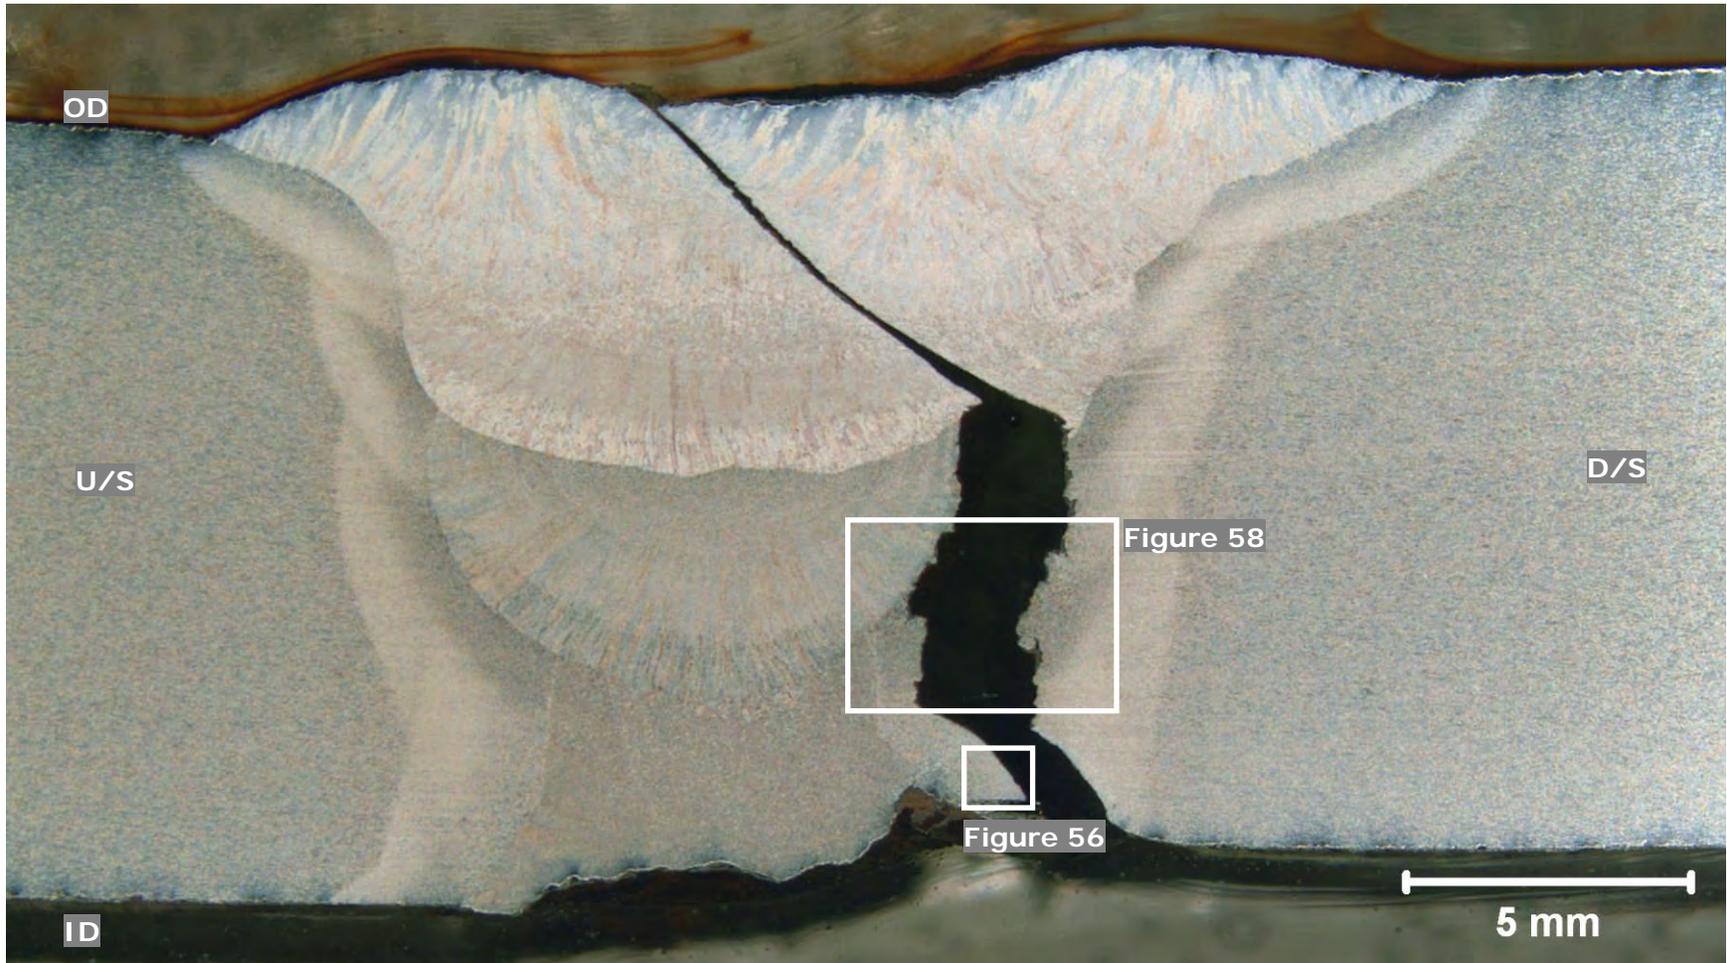
Figure 55. Light photomicrograph of Mount M2 (axial cross-section), which was removed from the GW at the 3:55 orientation; refer to Figure 1, Figure 12, and Figure 23 for location (2% Nital Etchant).

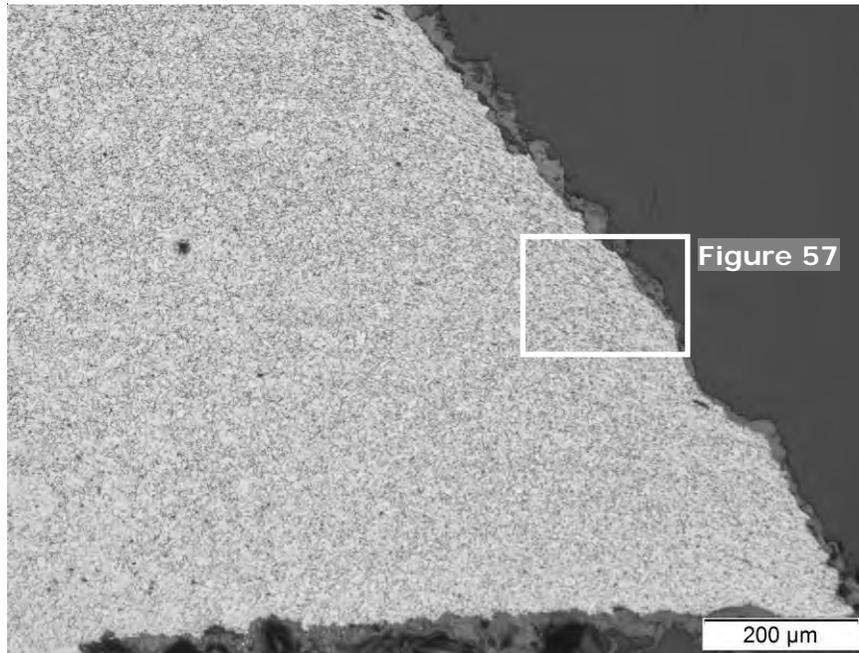
Figure 56. Light photomicrograph of Mount M2 adjacent to the ID surface (2% Nital Etchant); area indicated in Figure 55.

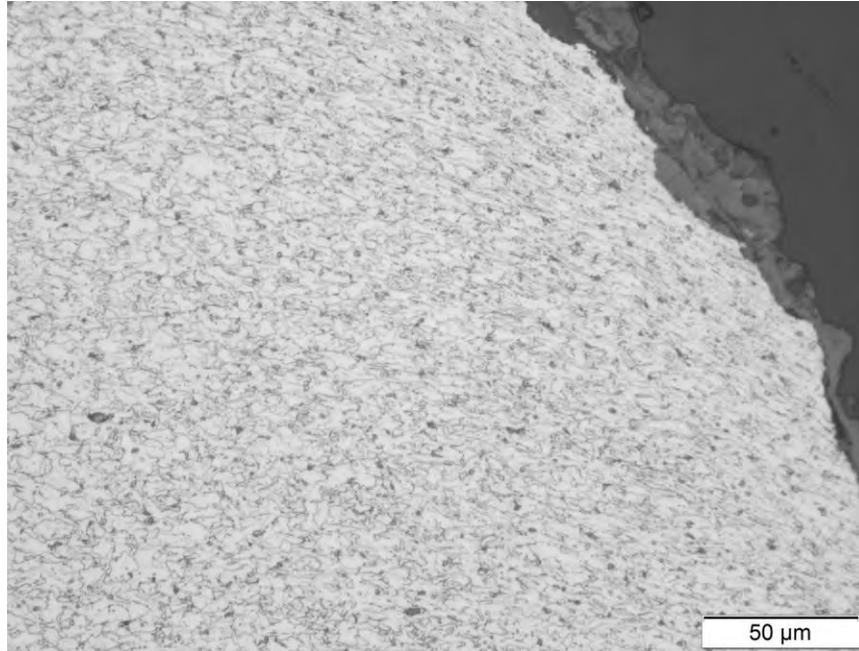
Figure 57. High magnification light photomicrograph of Mount M2 near the ID surface, adjacent to the fracture surface (2% Nital Etchant); area indicated in Figure 56.

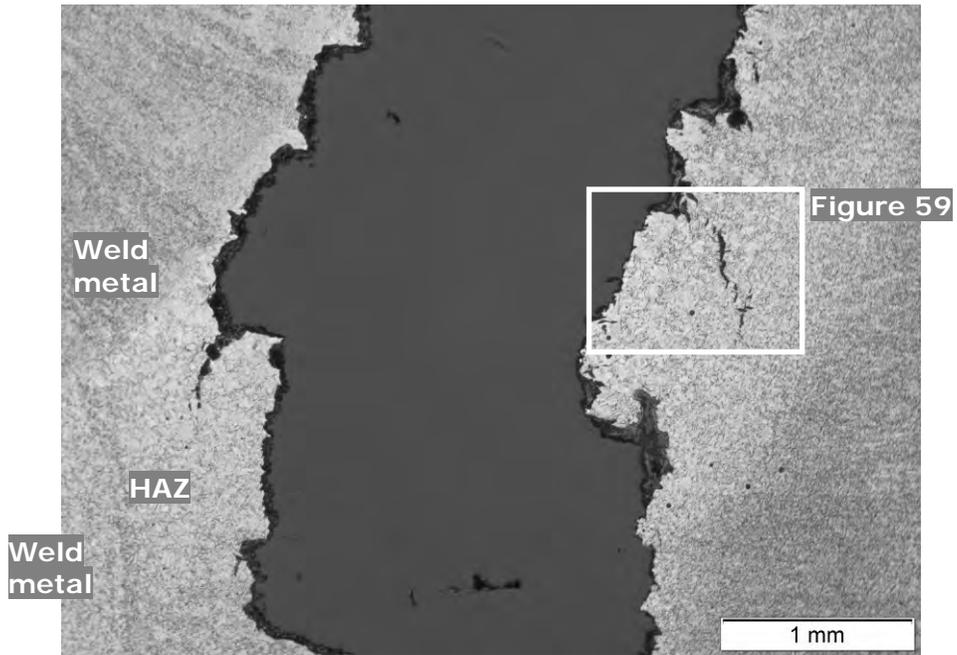
Figure 58. Light photomicrograph of Mount M2 midwall (2% Nital Etchant); area indicated in Figure 55.

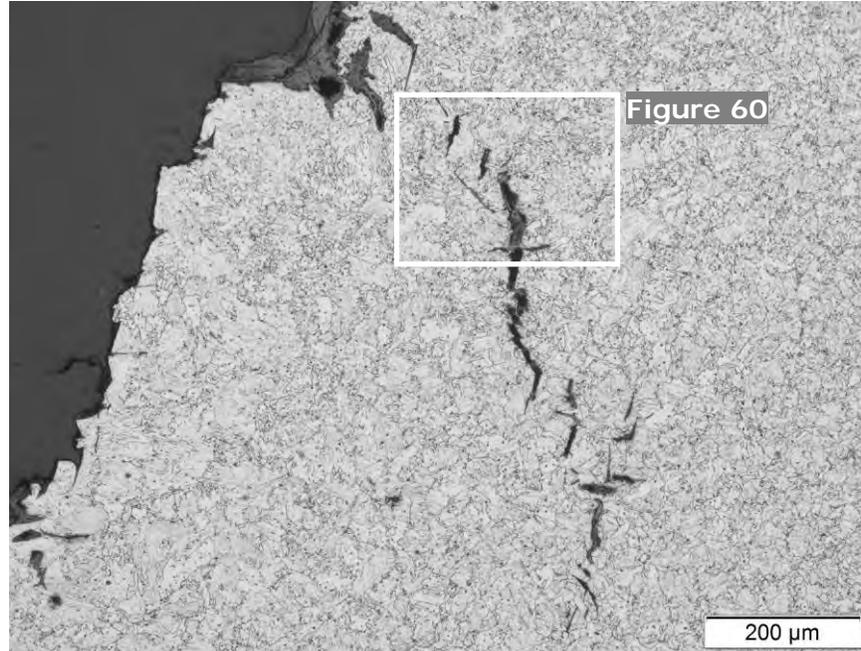
Figure 59. Light photomicrograph of Mount M2 adjacent to the fracture surface showing fissures (2% Nital Etchant); area indicated in Figure 58.

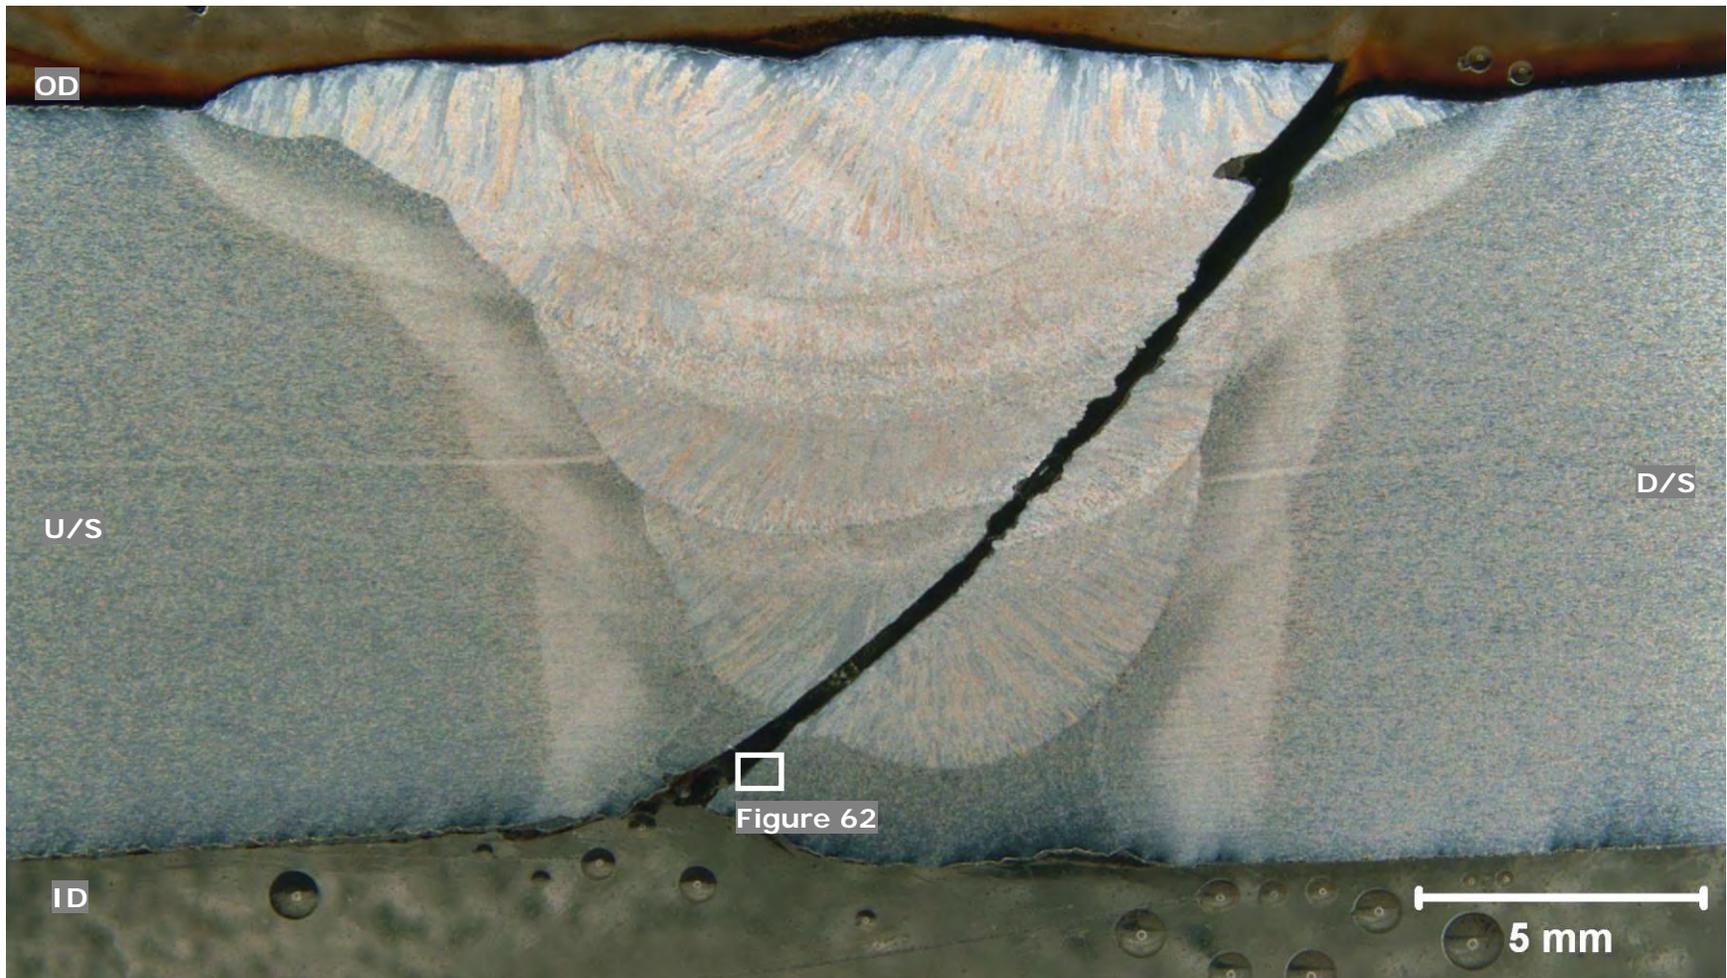
Figure 61. Light photomicrograph of Mount M3 (axial cross-section), which was removed from the GW at the 8:35 orientation; refer to Figure 1, Figure 13, and Figure 28 for location (2% Nital Etchant).

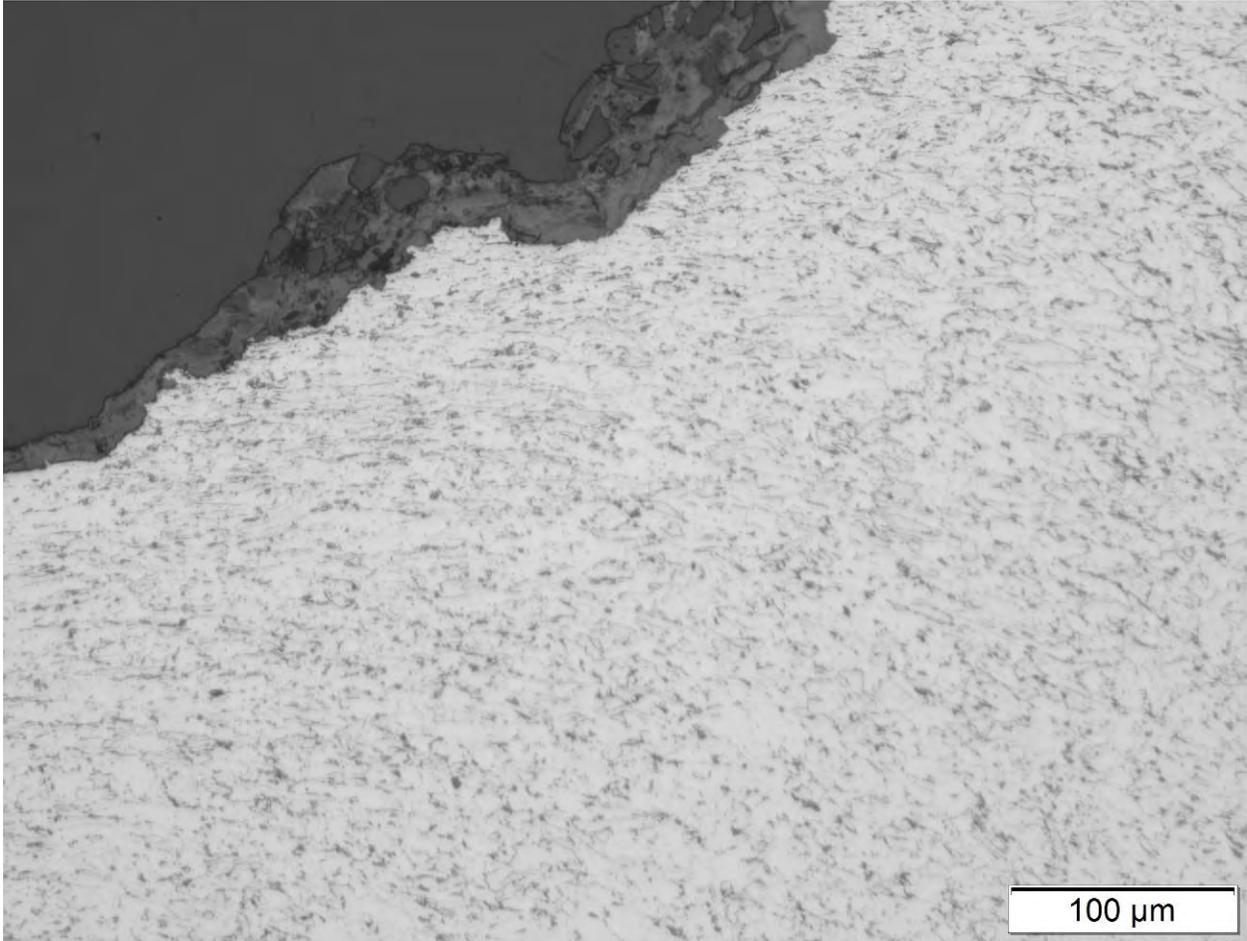
Figure 62. Light photomicrograph of Mount M3 adjacent to the fracture surface, near the ID surface (2% Nital Etchant); area indicated in Figure 61.

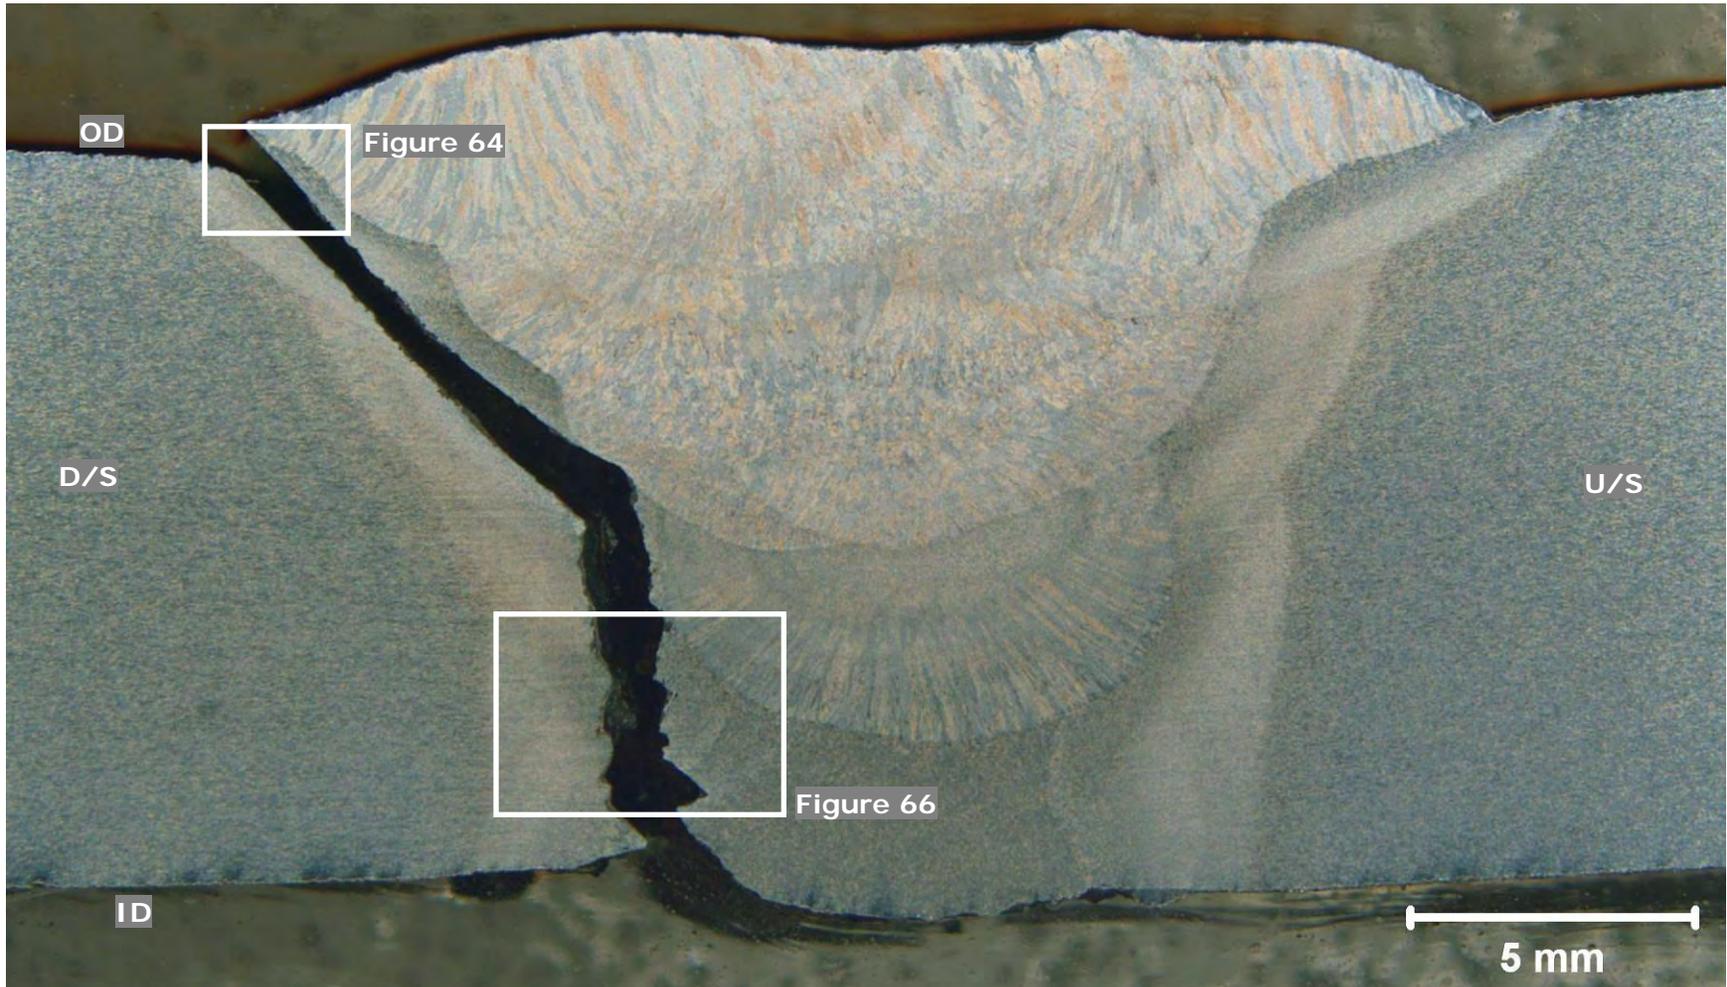
Figure 63. Light photomicrograph of Mount M4 (axial cross-section), which was removed from the GW at the 10:24 orientation; refer to Figure 1, Figure 14, and Figure 30 for location (2% Nital Etchant).

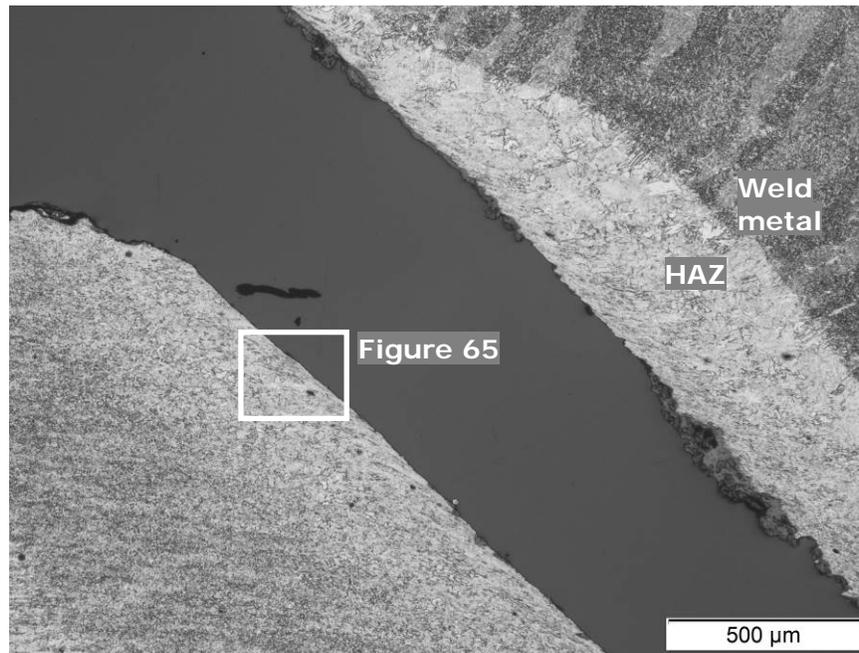
Figure 64. Light photomicrograph of Mount M4 near the OD surface (2% Nital Etchant); area indicated in Figure 63.

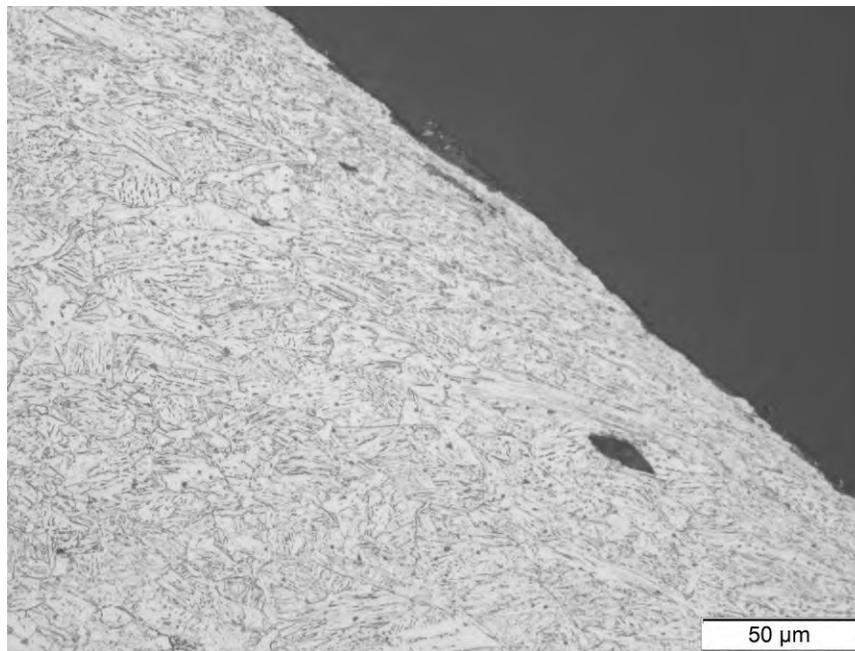
Figure 65. High magnification light photomicrograph of Mount M4 showing grain elongation adjacent to the fracture surface (2% Nital Etchant); area indicated in Figure 64.

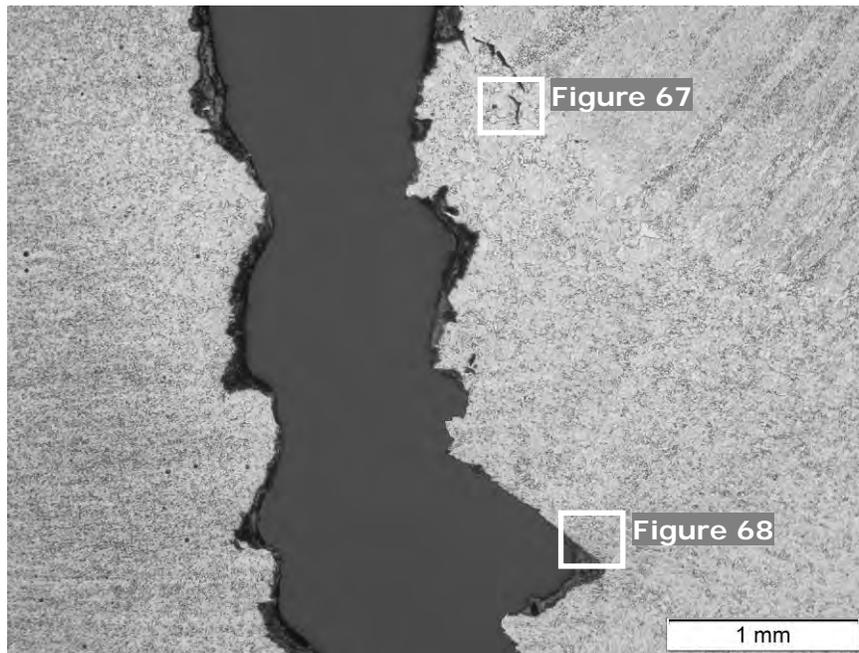
Figure 66. Light photomicrograph of Mount M4 near the ID surface (2% Nital Etchant); area indicated in Figure 63.

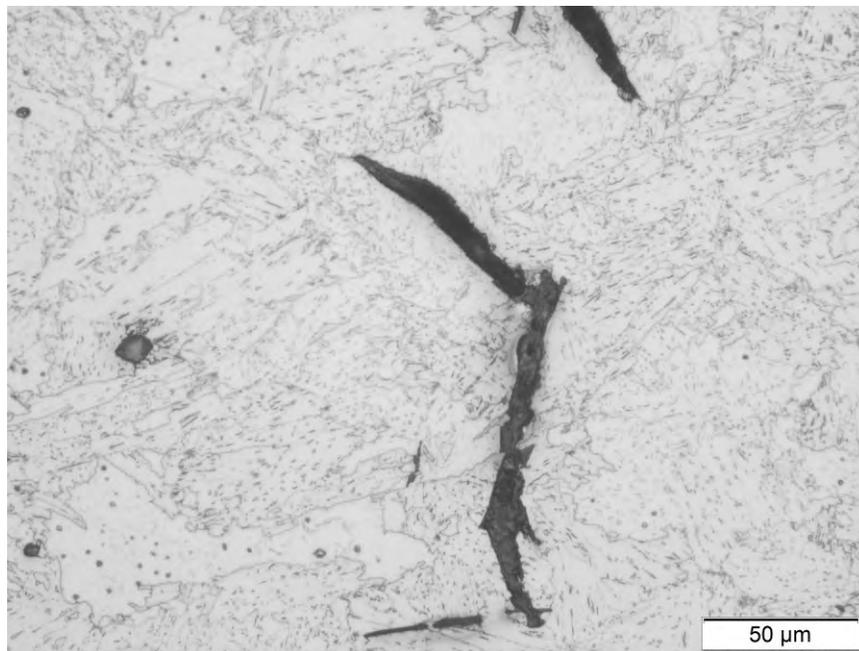
Figure 67. High magnification light photomicrograph of Mount M4 showing fissures (2% Nital Etchant); area indicated in Figure 66.

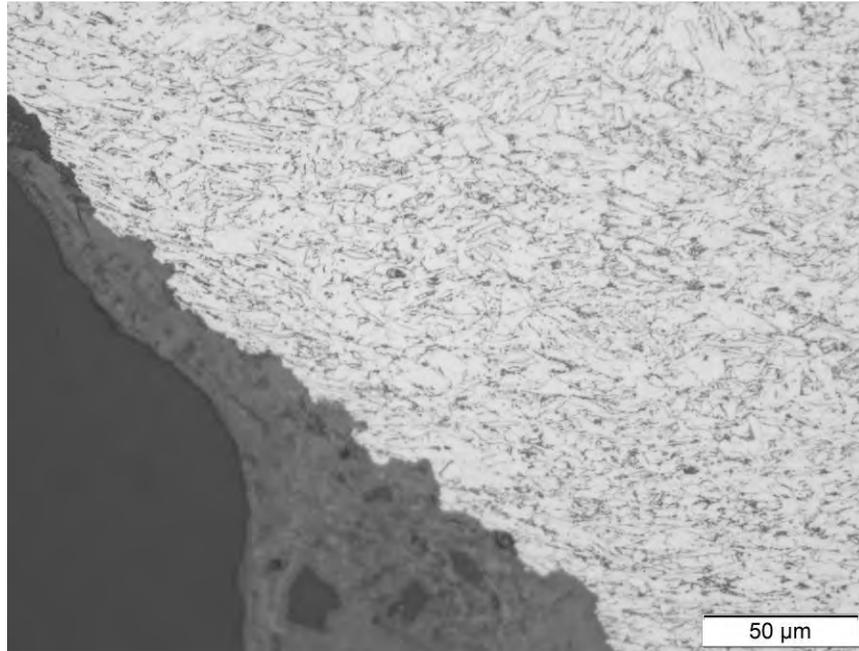
Figure 68. High magnification light photomicrograph of Mount M4 showing grain elongation adjacent to the fracture surface, near the ID surface (2% Nital Etchant); area indicated in Figure 66.

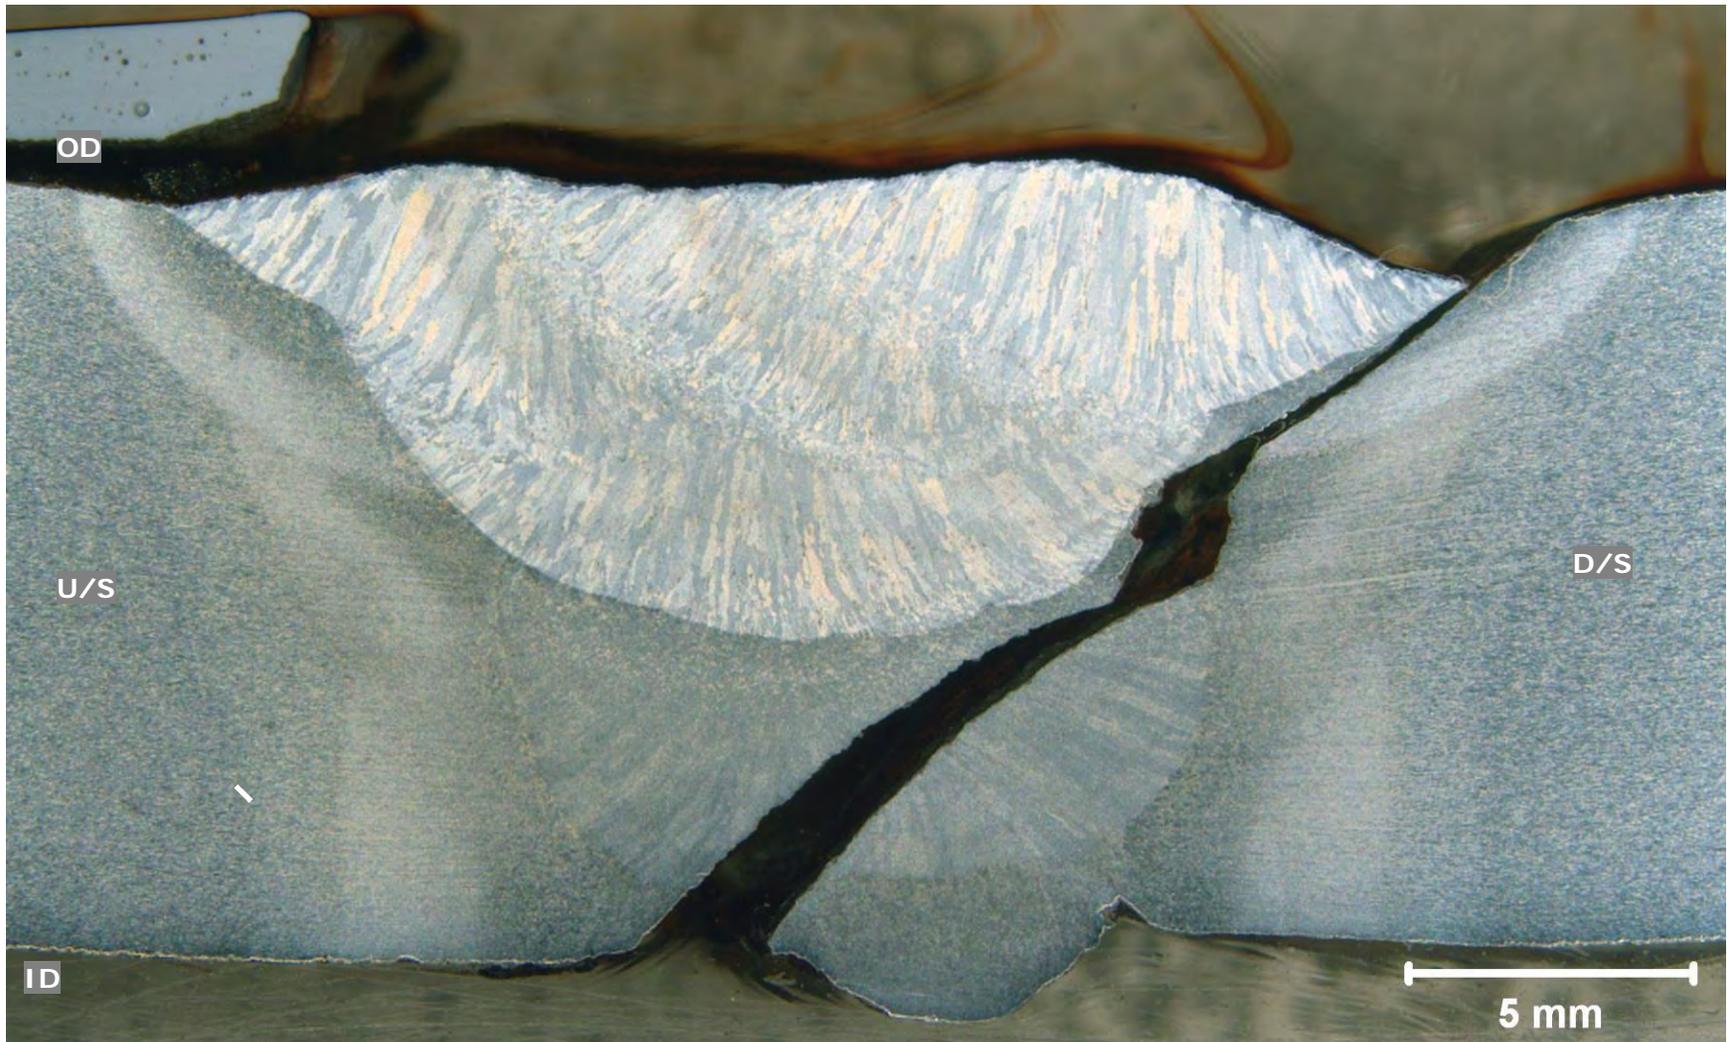
Figure 69. Light photomicrograph of Mount M5 (axial cross-section), which was removed from the GW at the 11:37 orientation; refer to Figure 1, Figure 14, and Figure 31 for location (2% Nital Etchant).

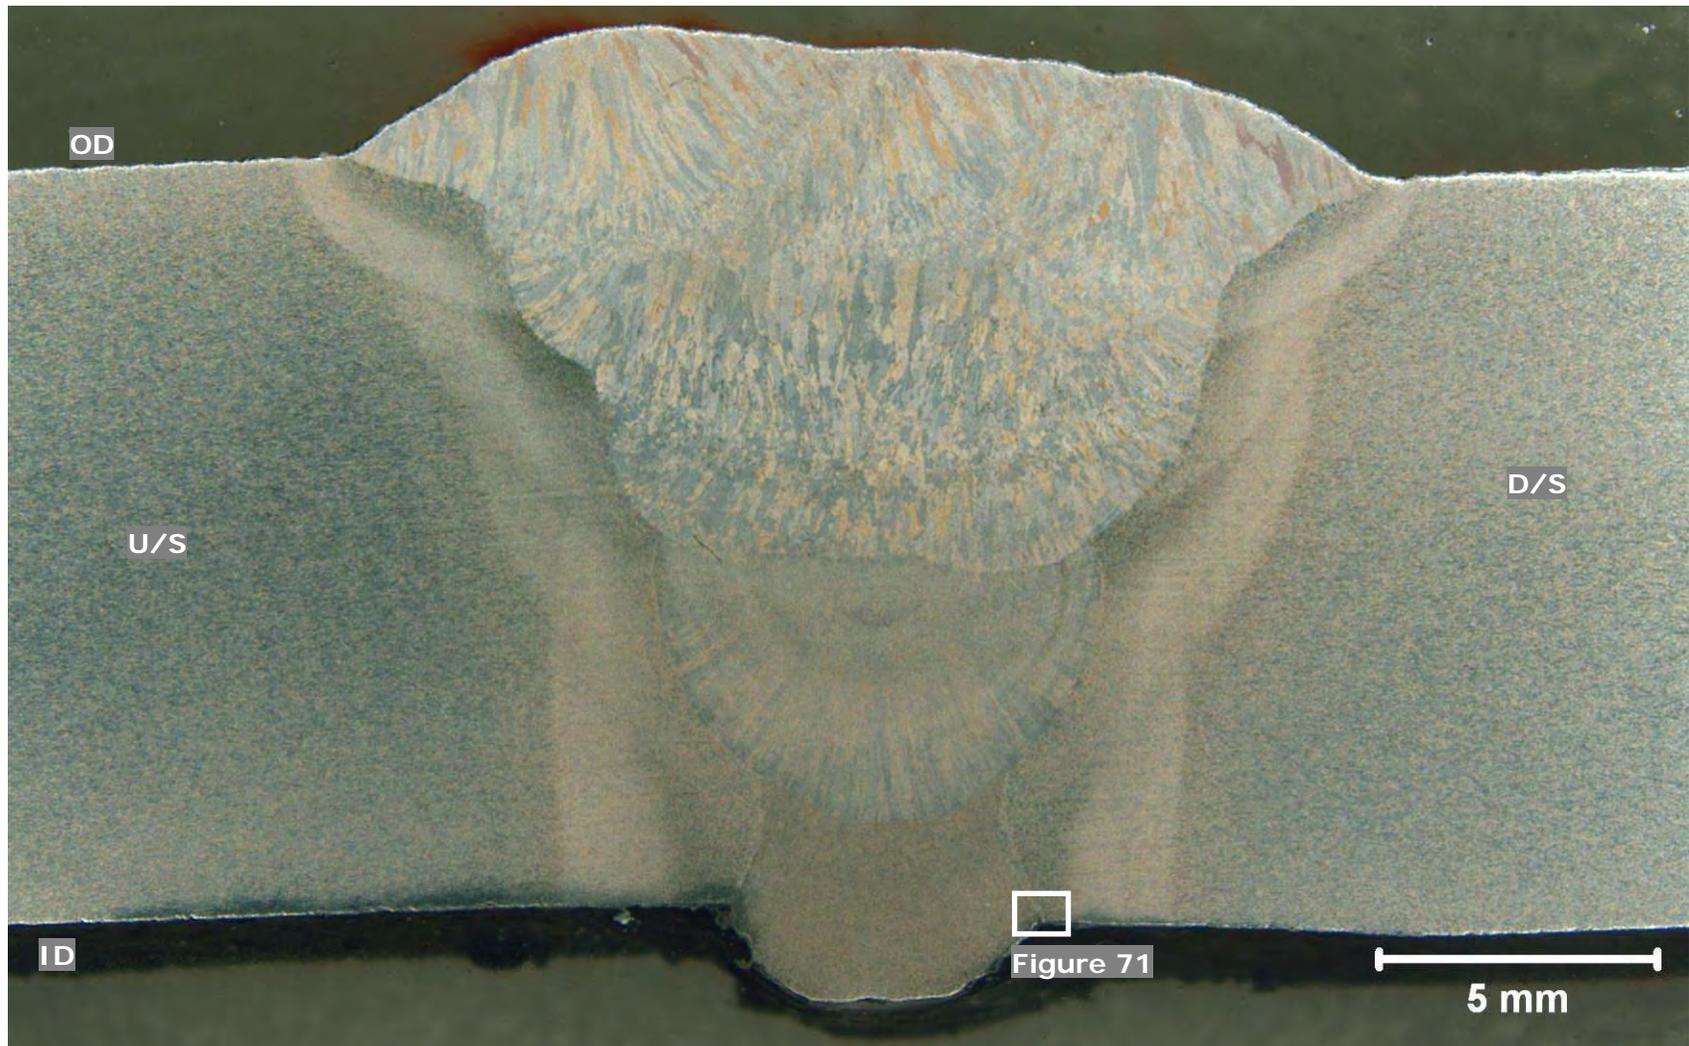
Figure 70. Light photomicrograph of Mount MU1 (axial cross-section), which was removed from the intact GW at the 12:27 orientation; refer to Figure 1 and Figure 17 for location (2% Nital Etchant).
