DOT US Department of Transportation
PHMSA Pipeline and Hazardous Materials Safety Administration
OPS Office of Pipeline Safety – Accident Investigation Division

Principal Investigator Wesley Mathews
Acting Accident Investigation Director Chris Ruhl
Date of Report May 26, 2022
Subject Failure Investigation Report - Denbury Gulf Coast Pipelines, LLC – Pipeline Rupture/ Natural Force Damage

Failure Investigation Report – Denbury Gulf Coast Pipelines LLC
Pipeline Rupture/Natural Force Damage
February 22, 2020

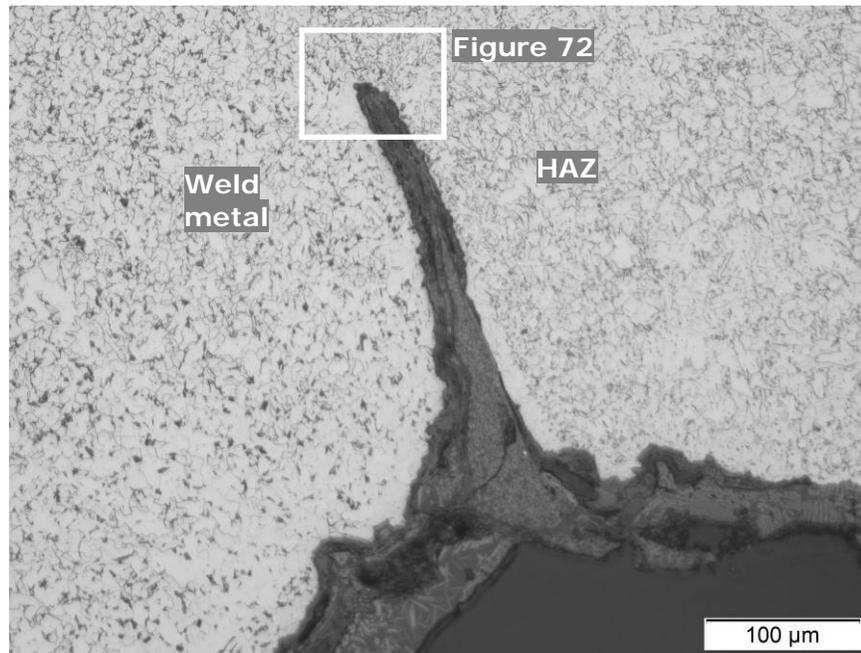
Figure 71. Light photomicrograph of Mount MU1 adjacent to the ID surface (2% Nital Etchant); area indicated in Figure 70.

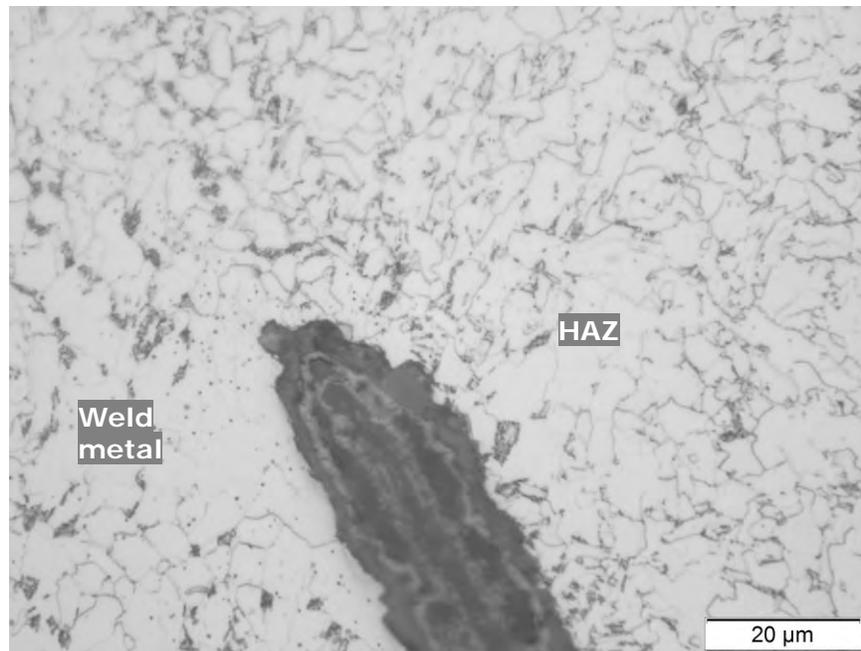
Figure 72. High magnification light photomicrograph of Mount MU1 at the tip of a shallow incomplete fusion (IF) flaw (2% Nital Etchant); area indicated in Figure 71.

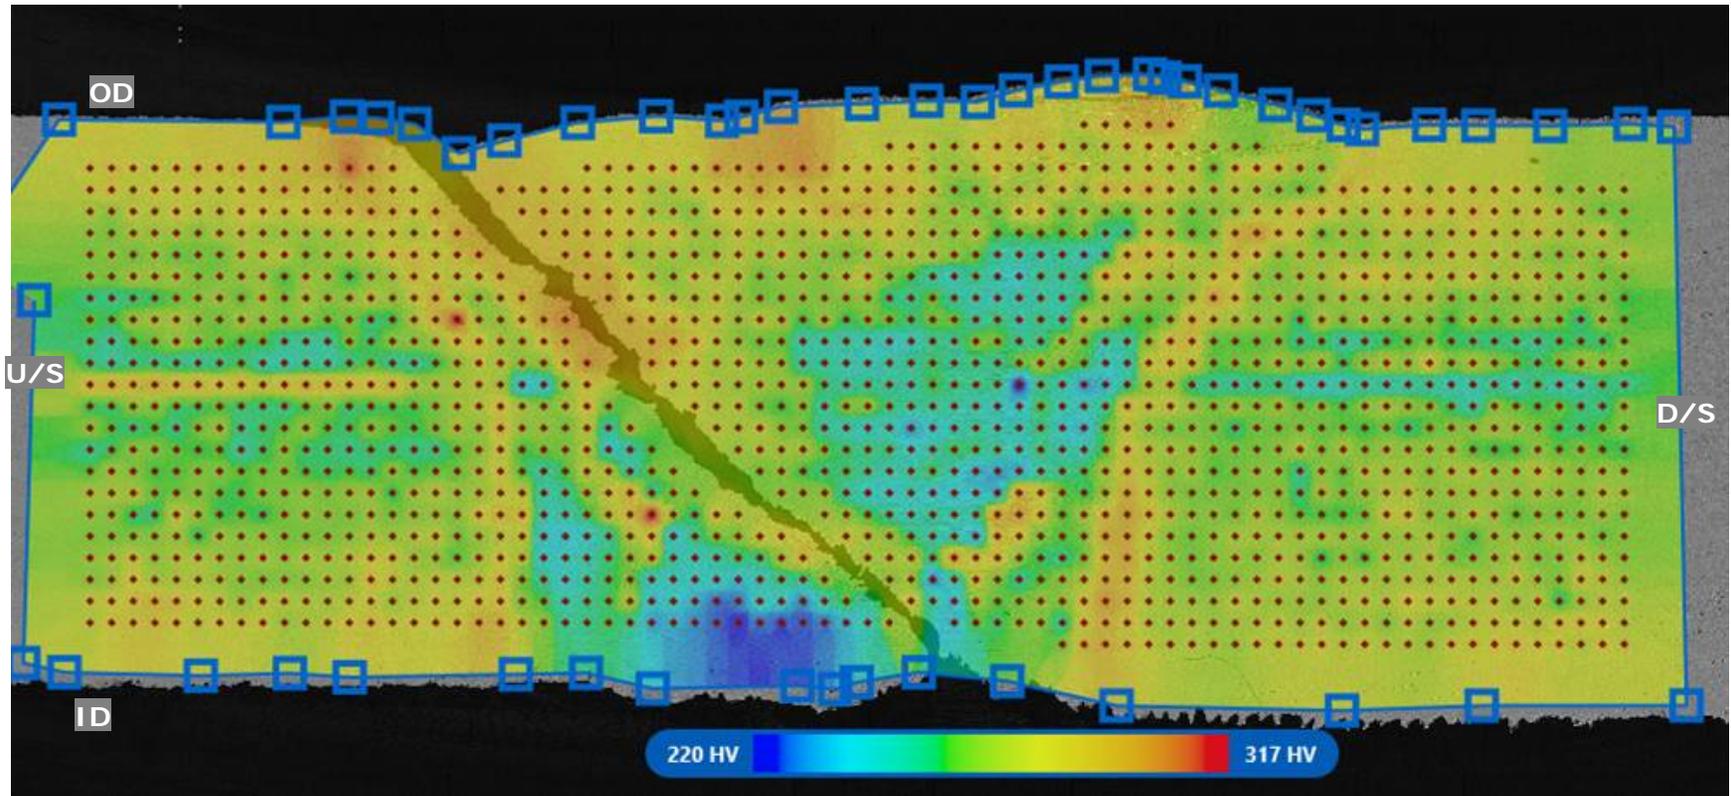
Figure 73. Hardness map overlay following hardness testing (Vickers 1 kg load) performed on Mount M1.

- f) Hardness measurements were conducted on all metallographic cross sections. The values ranged between 205 and 304 HV. All the values were found to be in accordance with the applicable standards. Hardness testing of the failed weld presented variability that is likely associated with cold work sustained during the failure. The intact weld was the best representation of the base hardness of the pipe metal. The results indicate lower hardness of the weld metal compared to the pipe metal, which indicates that the weld metal is softer than the parent metal, however tests results were consistent with specifications for pipe of this vintage and yield strength in both the base metal and weld metal. Typically, the parent metal is harder than the weld metal. The axial tensile tests on the intact GW show similar failure to the actual failed pipe sample, further indicating that the lower hardness typical of the weld was the preferred location for the overload failure under applied axial stress. (See fig. 39 of the Mears report).

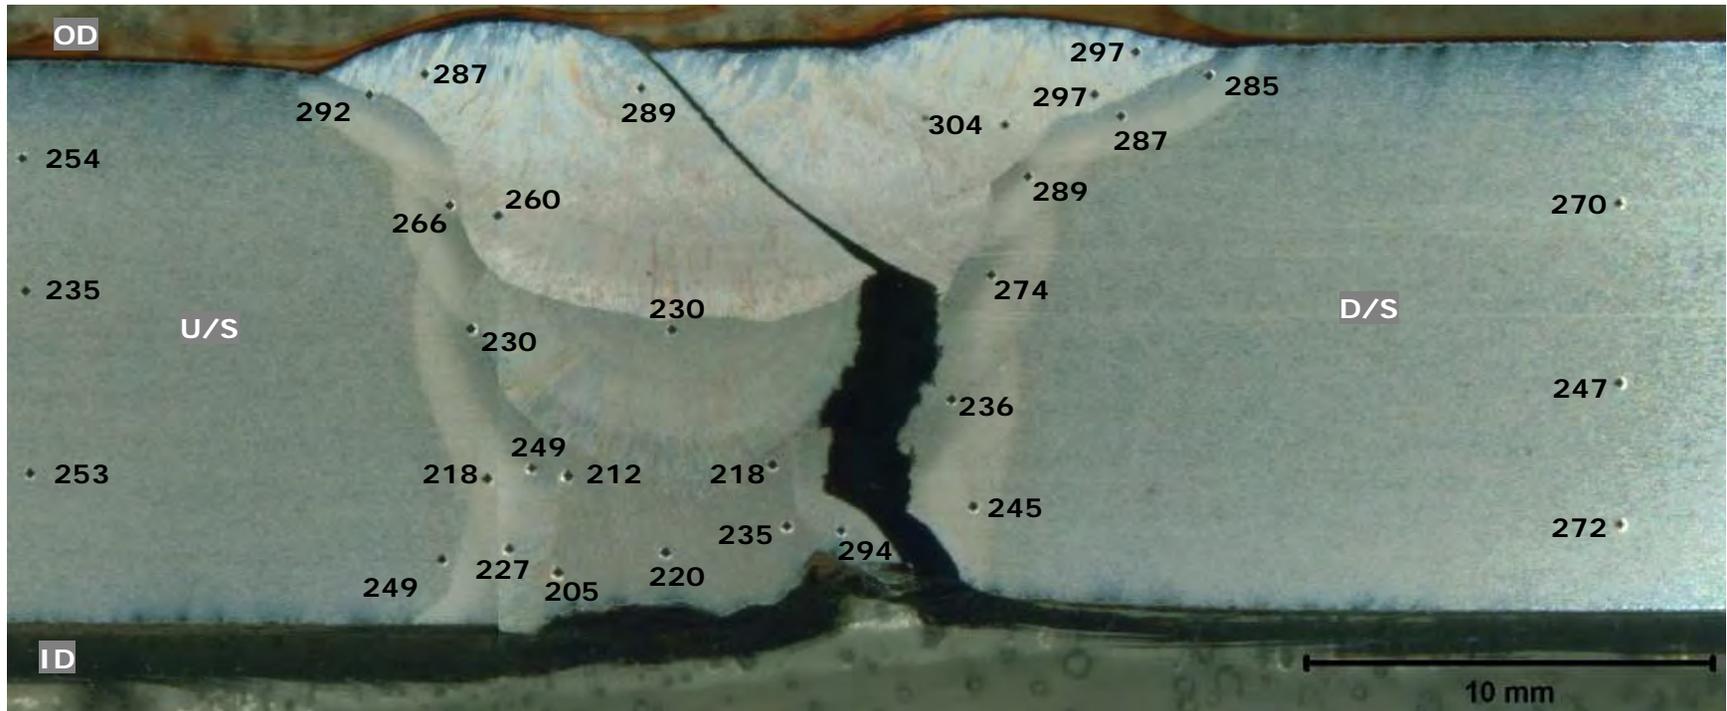
Figure 74. Light photomicrograph montage of Mount M2 (axial cross-section), showing the hardness indentations and the hardness values in HV (2% Nital Etchant).

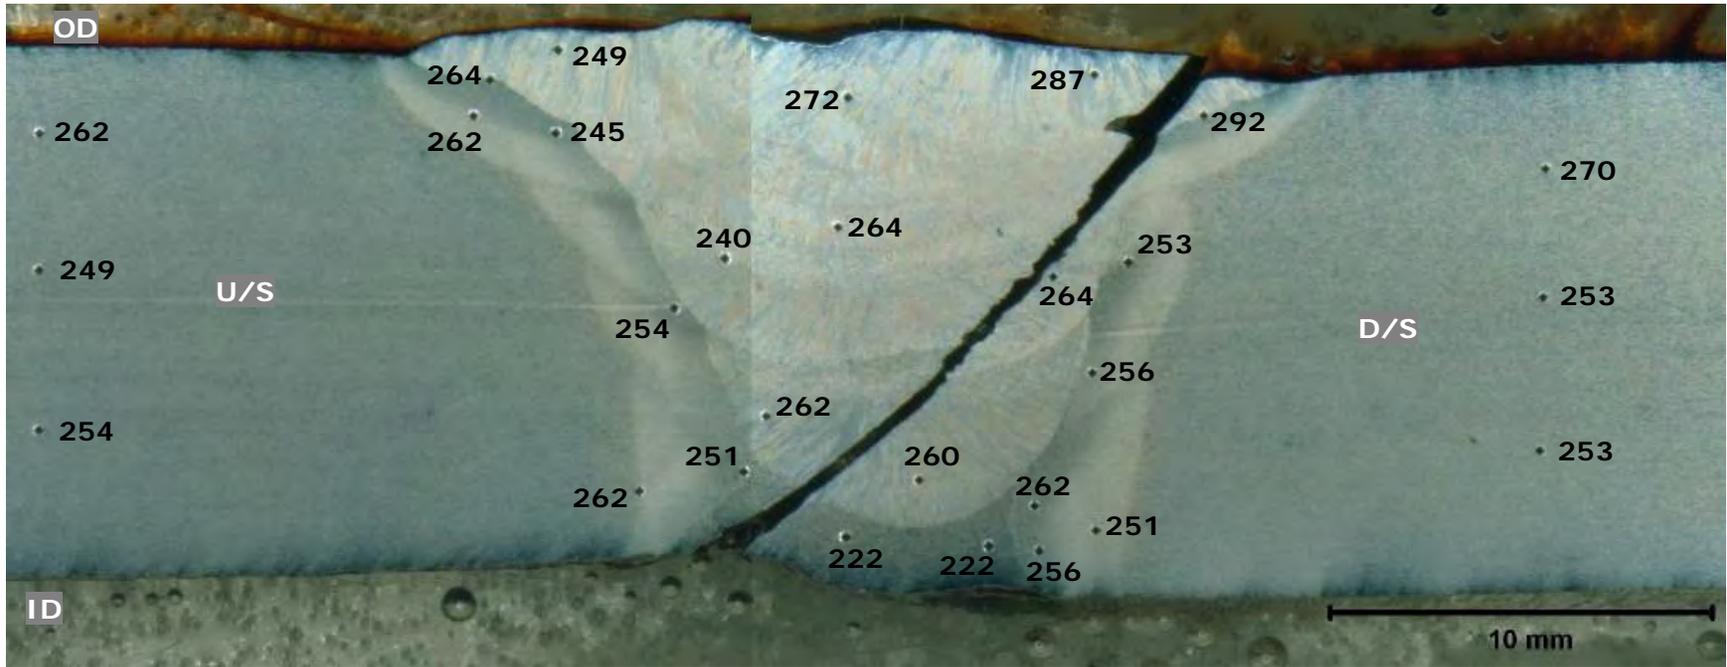
Figure 75. Light photomicrograph montage of Mount M3 (axial cross-section), showing the hardness indentations and the hardness values in HV (2% Nital Etchant).

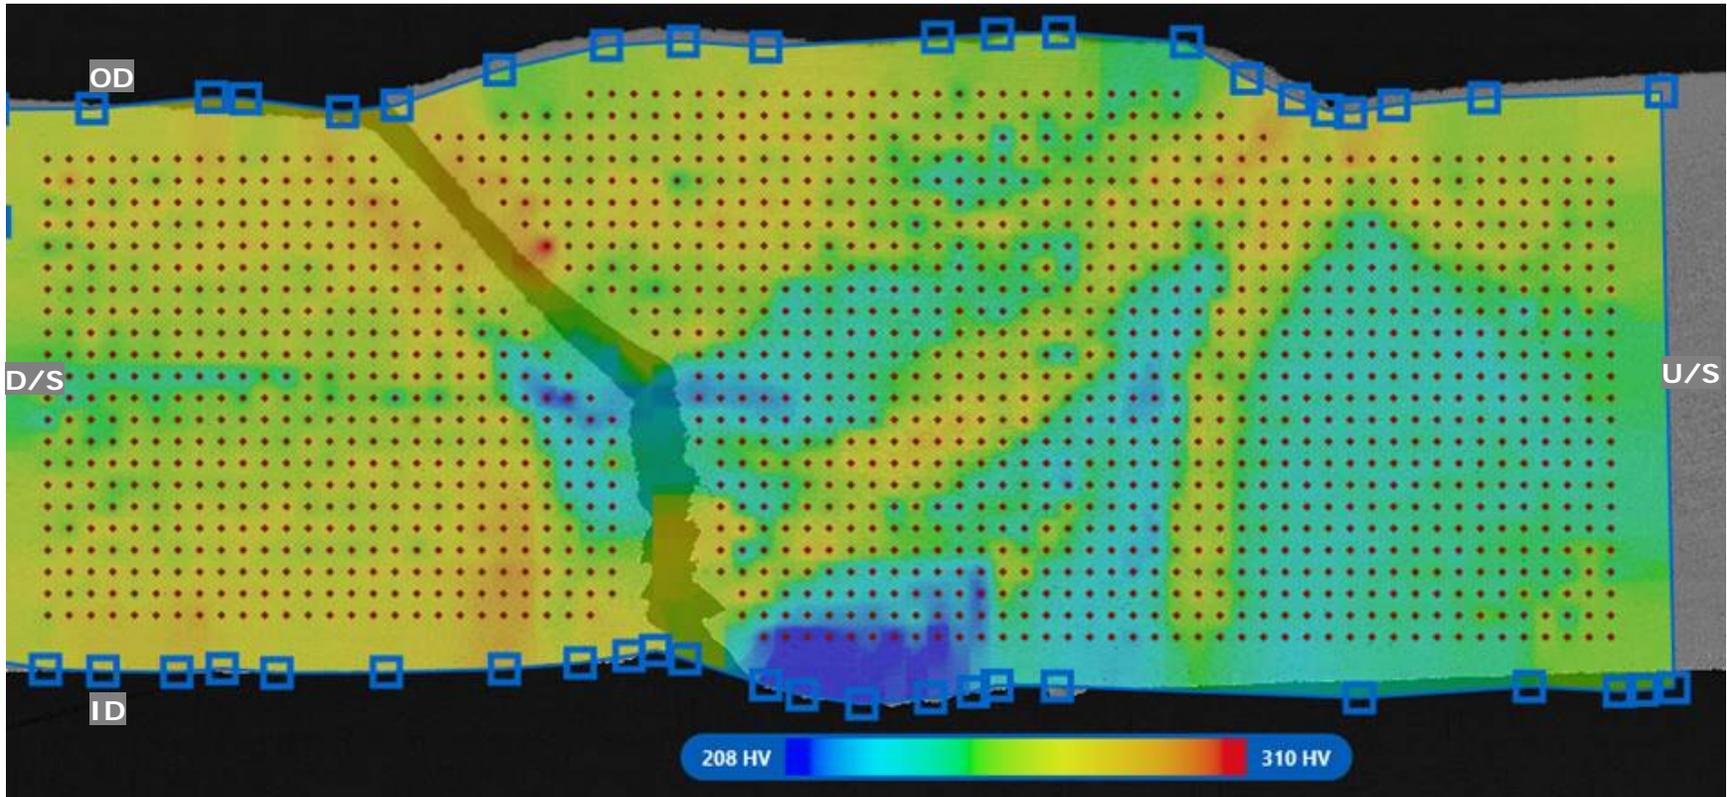
Figure 76. Hardness map overlay following hardness testing (Vickers 1 kg load) performed on Mount M4.

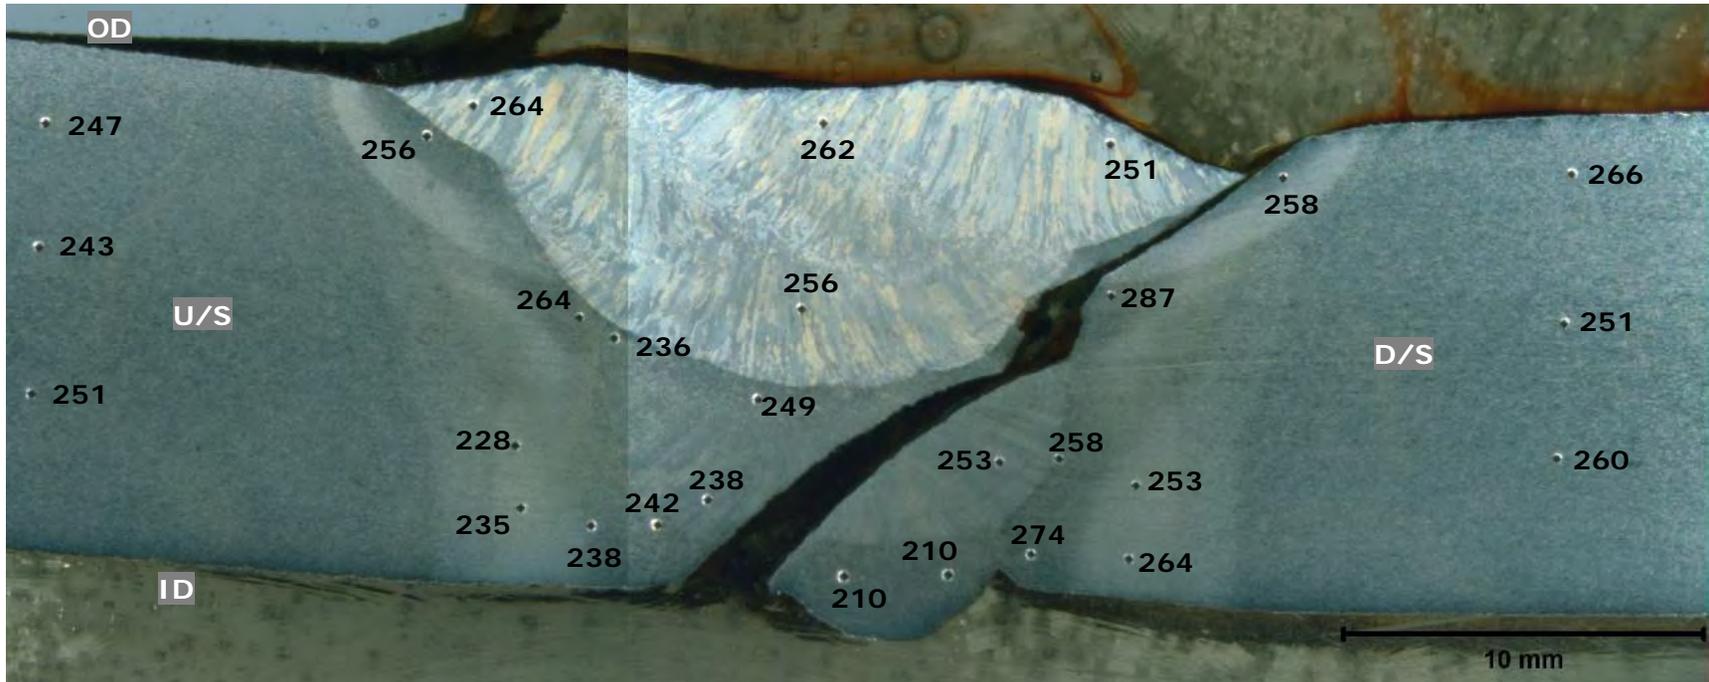
Figure 77. Light photomicrograph montage of Mount M5 (axial cross-section), showing the hardness indentations and the hardness values in HV (2% Nital Etchant).

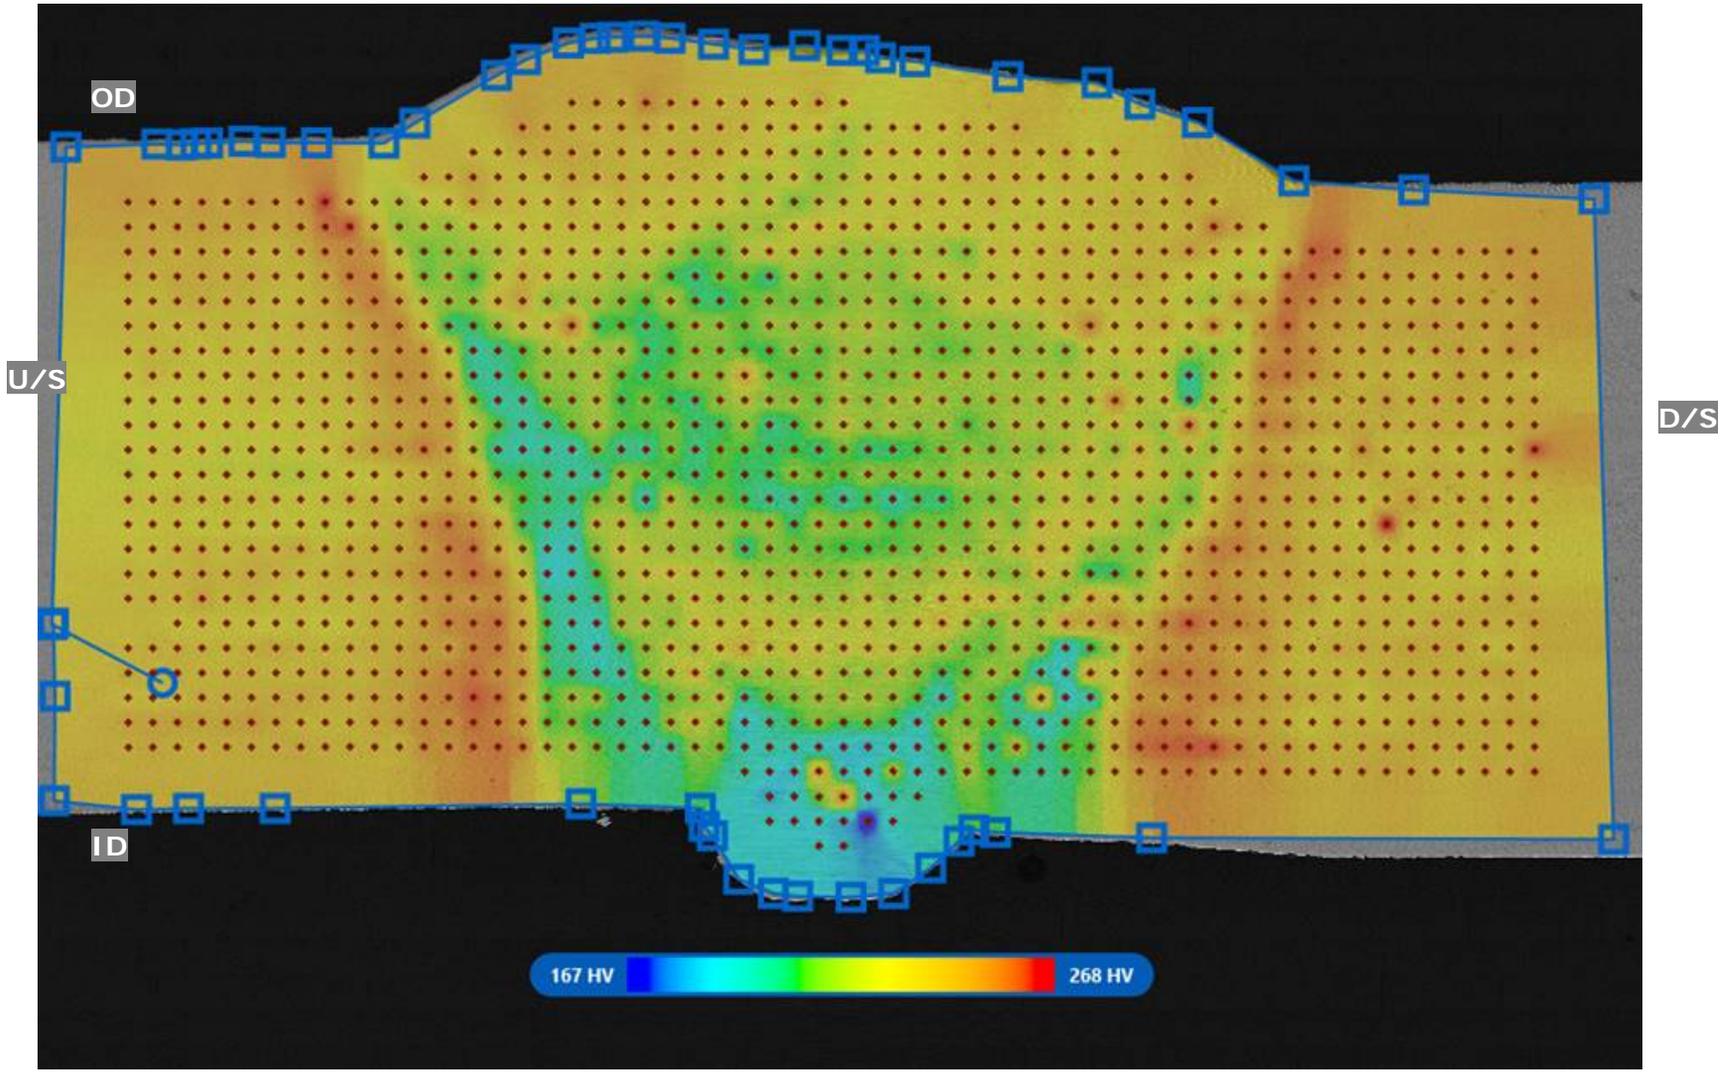
Figure 78. Hardness map overlay following hardness testing (Vickers 1 kg load) performed on Mount MU1.

The hardness montage for mount MU1 is provided in Figure 78 of the DNV Metallurgical Analysis Report (Appendix C).

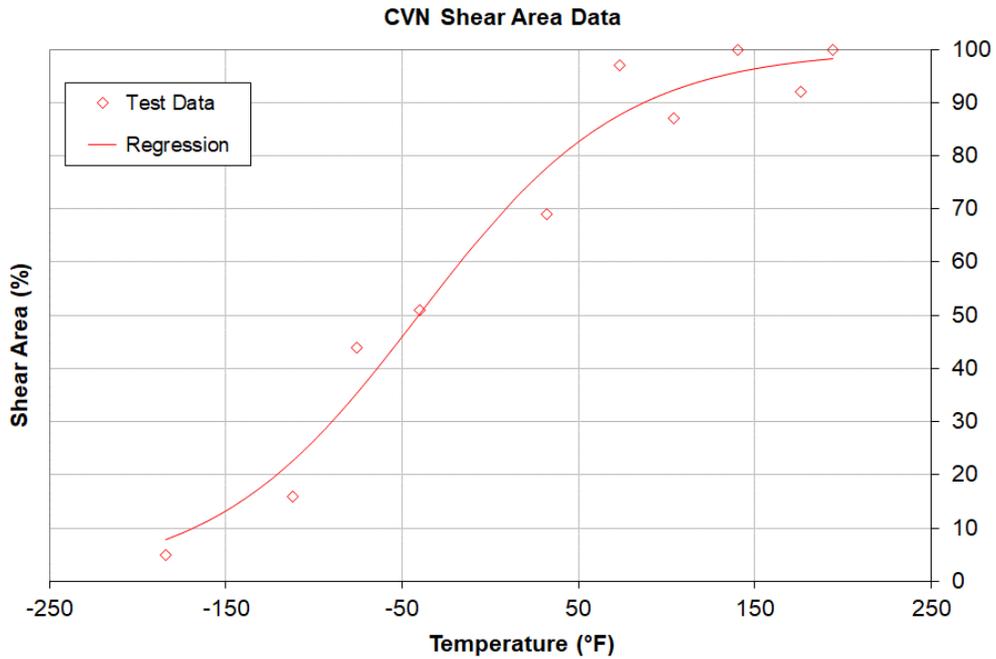
Figure 79. Percent shear from Charpy V-notch tests as a function of temperature for axial/cross-girth weld (HAZ notch) specimens removed from Pipe Section C.

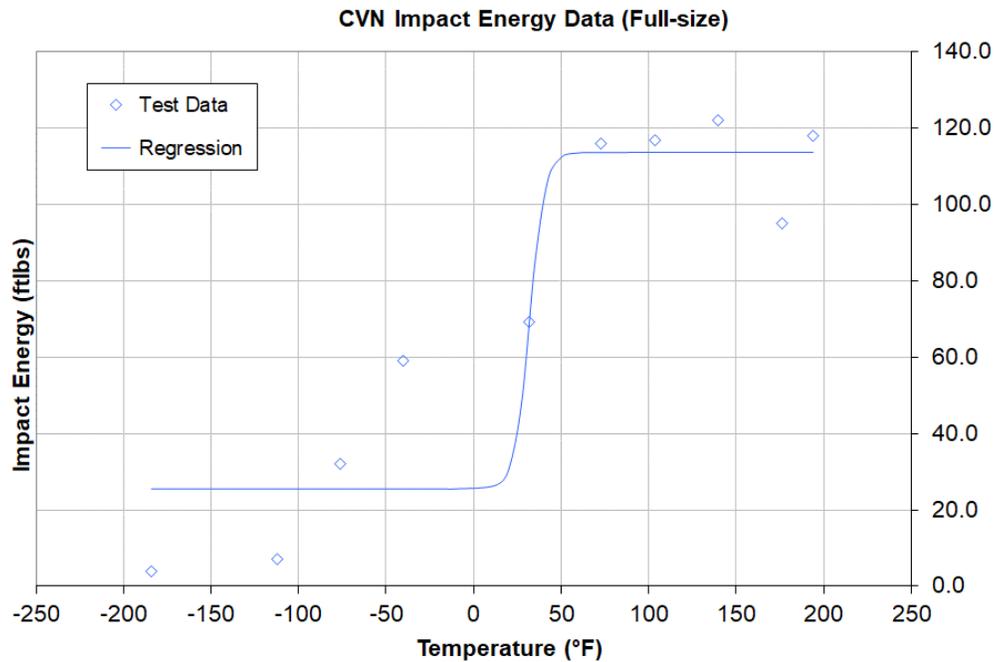
Figure 80. Charpy V-notch impact energy as a function of temperature for axial/cross-girth weld (HAZ notch) specimens removed from Pipe Section C.

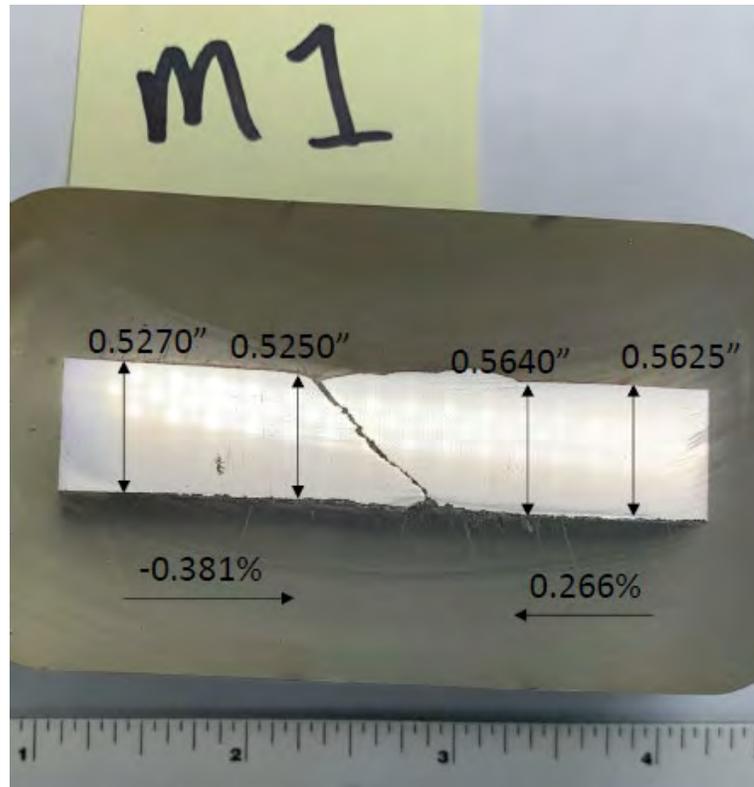
Figure 1: Cross-Sectional Measurements, Mount M1

Evaluation of the metallurgical samples indicated slight reduction in wall thickness in each sample, ranging from 1.44% to 6.46%. Photos and measurements are provided in in figures 1 through 5 below:

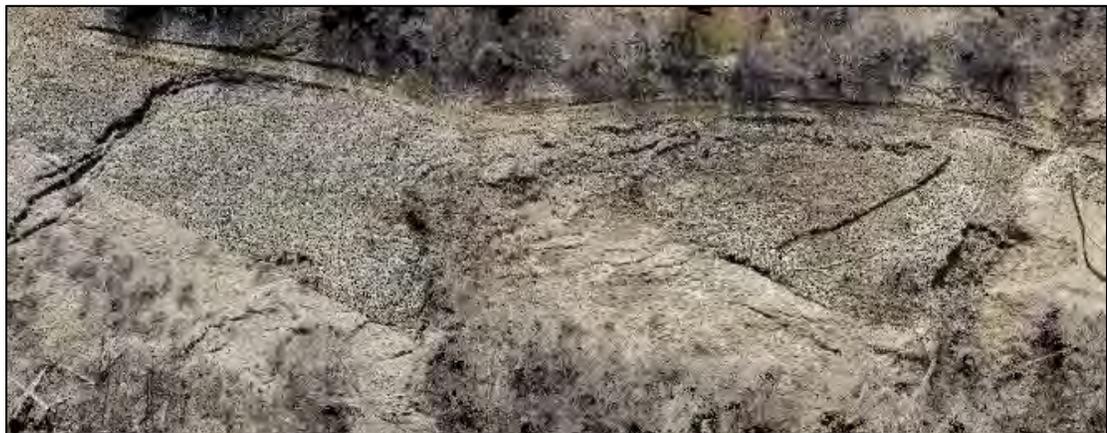
FIGURE 1: SOIL MOVEMENT PLAN VIEW

During the initial site visit, Mott MacDonald noticed evidence of soil movement along the ROW. The soil failure planes in the ROW extended approximately 900 ft at varying angles from 45° to 90°. Figure 1 and Figure 2 below show 3D photogrammetry scans taken of the ROW and displays the long linear failures.

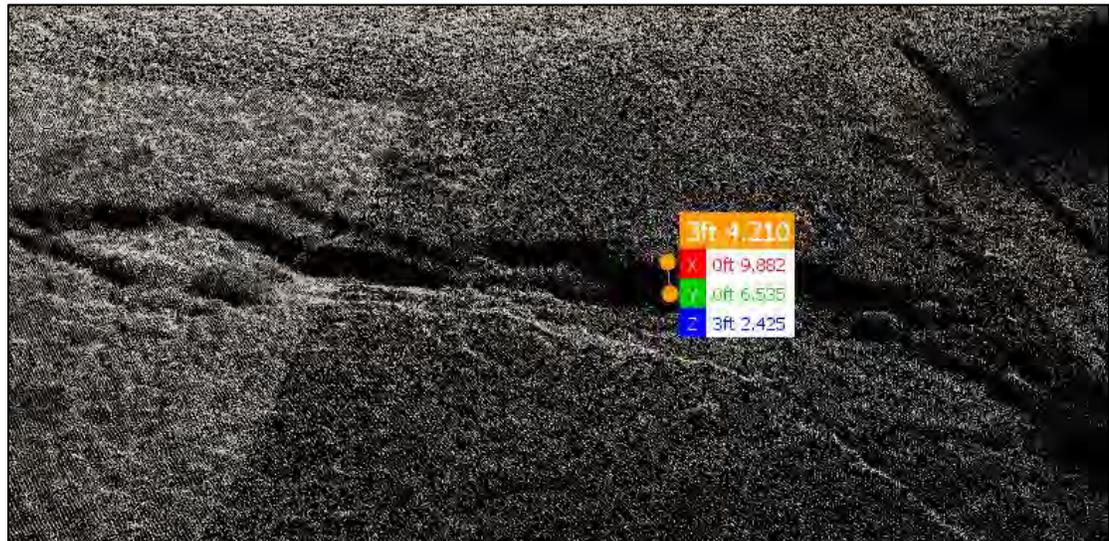
FIGURE 3: SOIL FAILURE DEPTH

The depth of the soil failures varied throughout the ROW, but as shown in Figure 3, the high level of detail captured with the 3D photogrammetry allowed for accurate measurements.

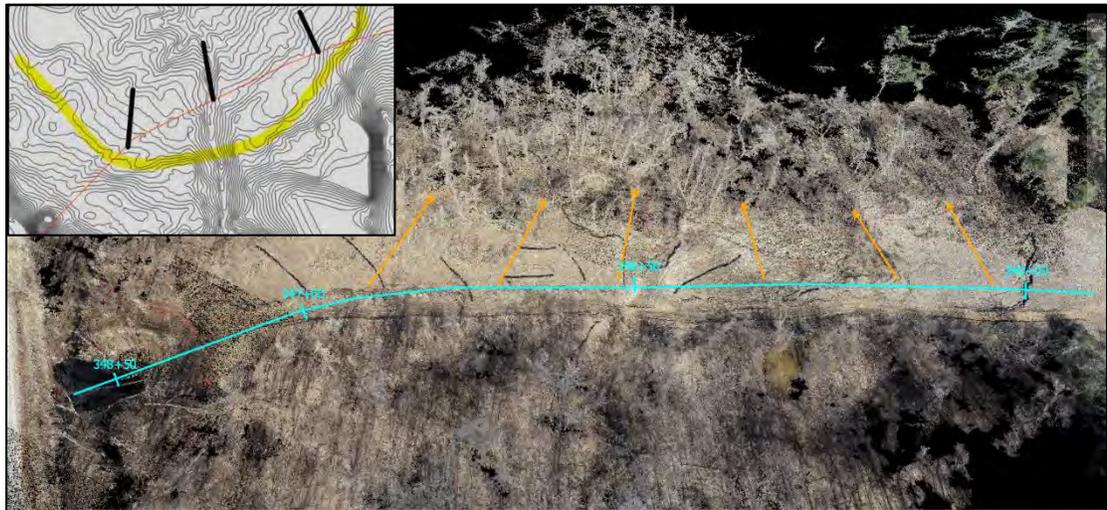
FIGURE 4: SOIL MOVEMENT DIRECTION

The distributed loads were applied in the model based on understanding of the topography in the area as shown in the Figure 4 below.

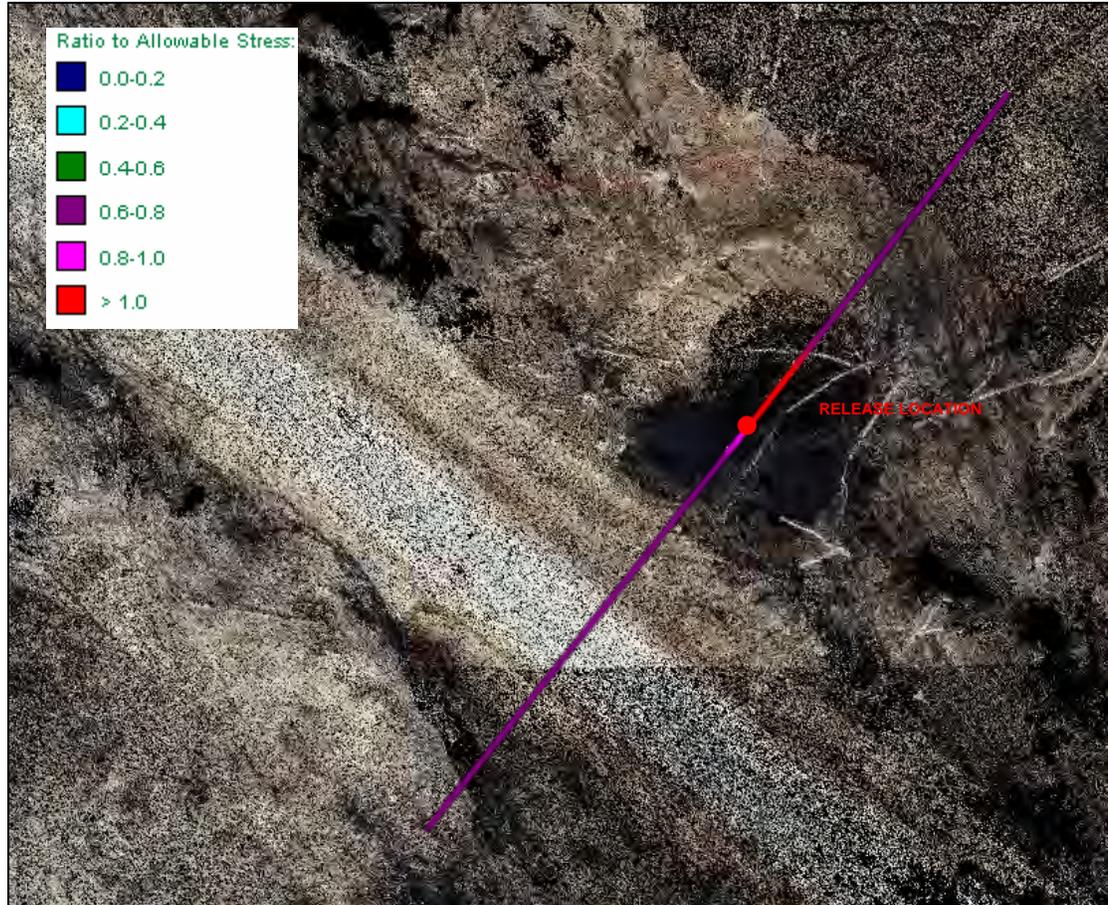
FIGURE 10: FAILURE LOCATION

The most significant stress values came from the external loading from soil movement. To establish a baseline, the stress team determined the maximum horizontal distributed load the pipe could withstand without rupture. Once the geotechnical team determined the estimated distributed loads, these numbers were compared. The comparison showed that the geotechnically determined loads exceeded the allowable horizontal distributed loads by more than 300 lbs/ft (2,800 lbs/ft vs. 2,475 lbs/ft).

As shown in Figure 10 below, the pipeline release location experienced excessive stress. The focal point of the stress at this location shows a maximum stress ratio of 1.43.

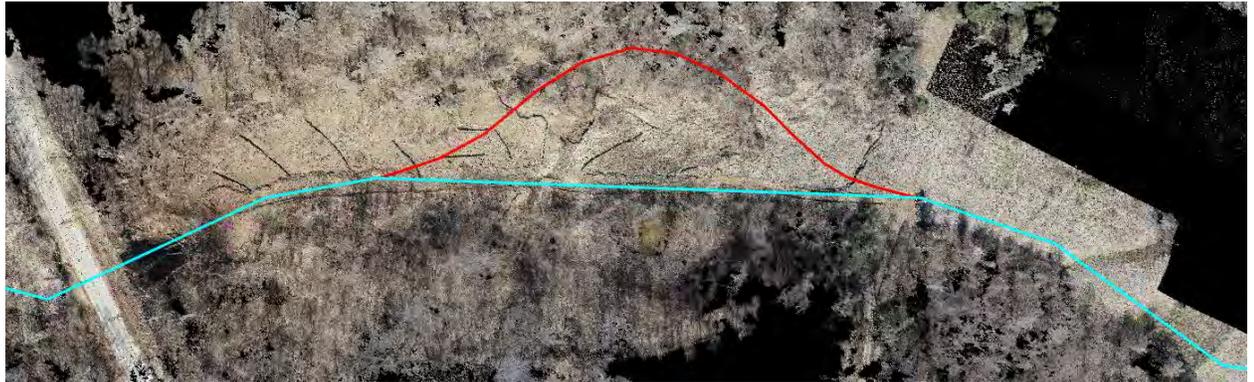
FIGURE 11: DEFLECTION CURVE

Figure 11 below shows an exaggerated deflection curve of the pipeline.

Mott MacDonald examined results as full design group to analyze the failure types and deflection curves. It was established that forces applied to the pipeline from the soil movement were significant enough to exceed the allowable stress limit of the Delhi Pipeline and likely was a contributing factor to the rupture.

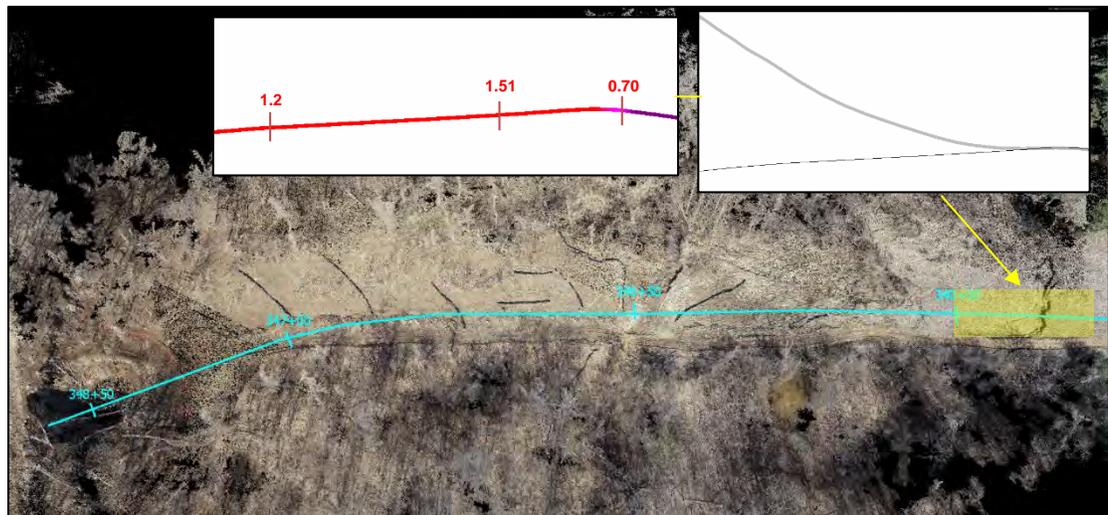
FIGURE 12: RECOMMENDED

The stress on the downstream side of 339+00 was caused by the restrained/unrestrained boundary condition created by the soil movement. This bending stress is the target of the relief exercise. The area shown in Figure 12 below, show a sharp rise in stress from a ratio of 0.70 to 1.51 in less than 50 ft. This boundary condition at the soil failure plane did not relieve after the pipeline failure and will have to be repaired.

Exposing at least 135 ft and removing and replacing as least a 10 ft section of pipe as recommended in the repair alleviates the overstressed boundary condition left by the soil movement and allows for safe transition between the two soil conditions. This recommendation is with the understanding that the remainder of the area of concern will be hydrotested as per ASME B31.4 to ensure the integrity of the pipe that experienced high tensile loads.
