Veritas Property Inspection

Inspection Report

**1234 Safe Harbor Dr
Pleasantville, California 95555**

Inspection Date January 27, 2018
Client John Doe
Inspector Nicholas Peres, CPI
P.O. Box 1004
Lake Elsinore, CA 92530
(951) 230-5831
veritasproinspect@gmail.com
interNACHI, Infrared, IAC2 Mold Certified

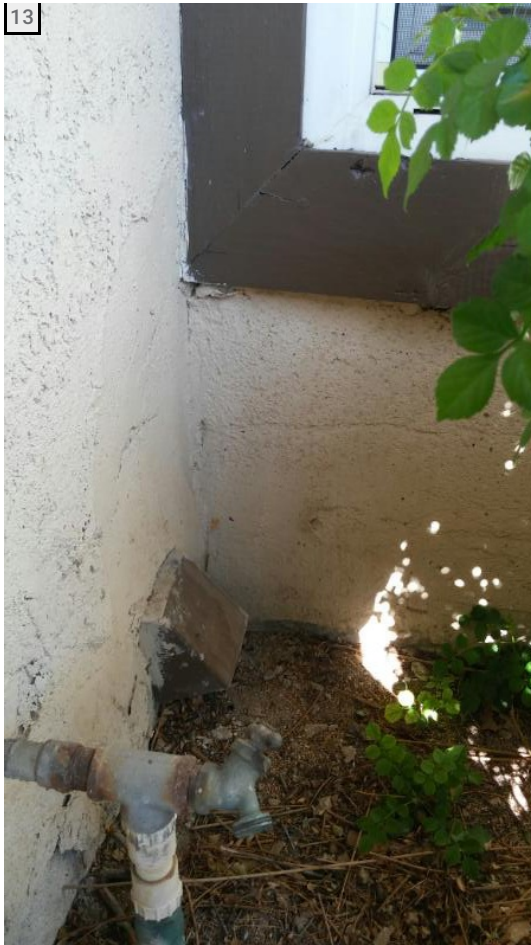
Located within 3 feet of a window, door or other vent

Location	Exterior: Ground View
Impact	When a vent is too close to a window, exhaust gas could re-enter the home
Suggested Action	Relocate the exhaust vent to be further than 3 feet from any window, door or other vent

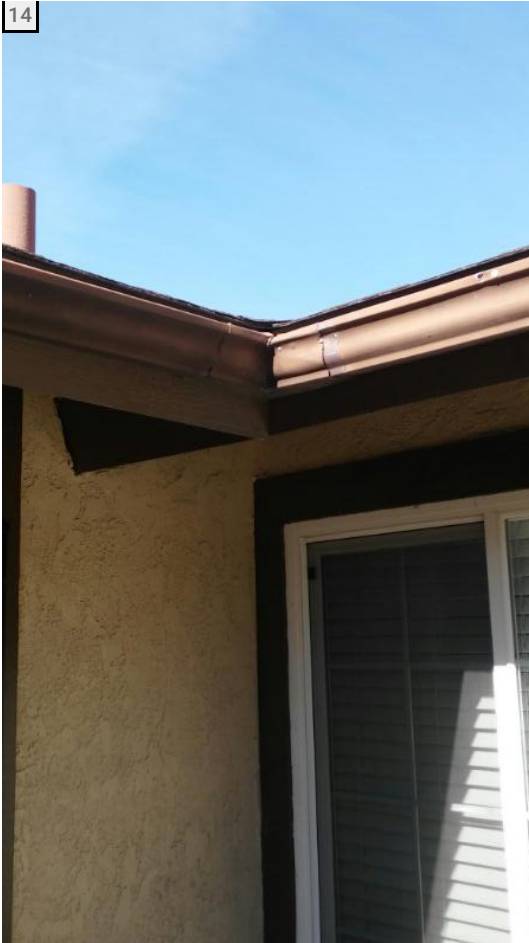
Impact If the leak is not addressed, it may cause gutter expansion further exacerbating the leak

Suggested Action Repair the gutters

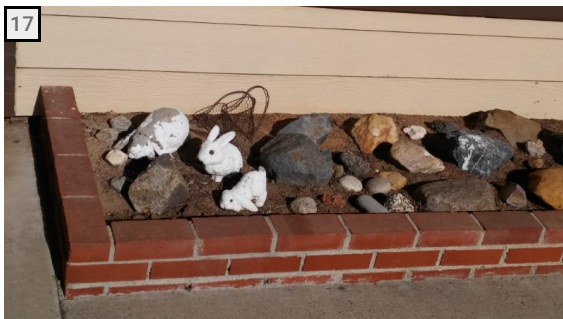
Weep screed at the bottom (the metal lip) is not above grade at least 4" to soil, or 2" to concrete/pavement

Location	Exterior: Ground View
Impact	Without a weep screed, the siding is at risk of moisture and insect intrusion
Suggested Action	Have a certified stucco/siding contractor repair the affected areas
Other Information	Observed several affected areas

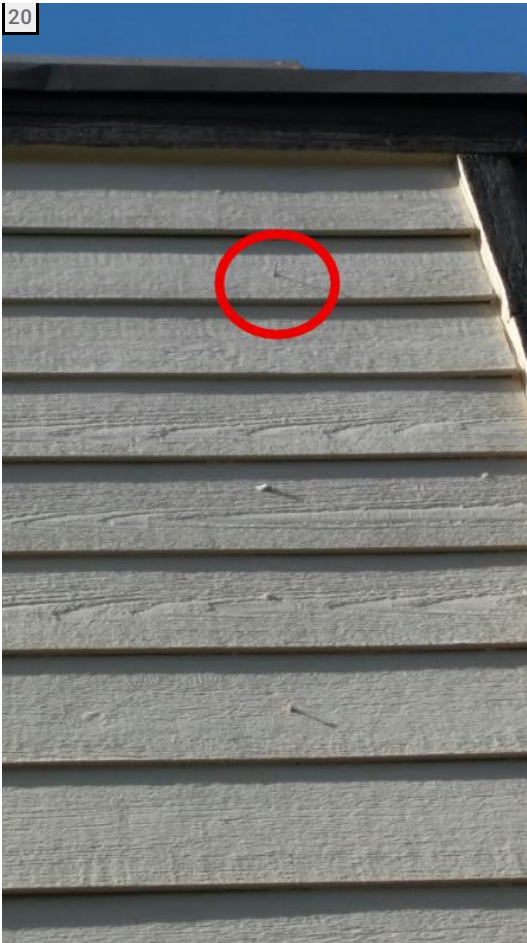
Nail pop

Location	Exterior: Ground View (Chimney chase)
Impact	May cause siding to detach from the building
Suggested Action	Have a professional siding contractor repair the siding

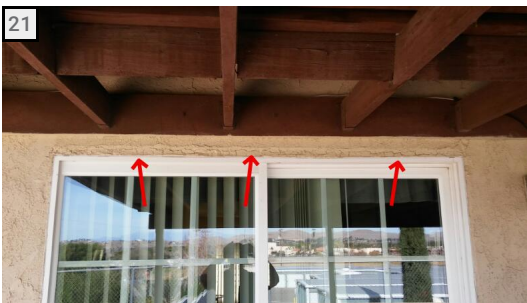
Minor Concern

Observed appearance of sub-standard repair

Location	Exterior: Ground View (Top kitchen door)
Impact	If the repair was not up to standard, the damage could allow for moisture and insect intrusion
Suggested Action	Have evaluated by a licensed stucco contractor

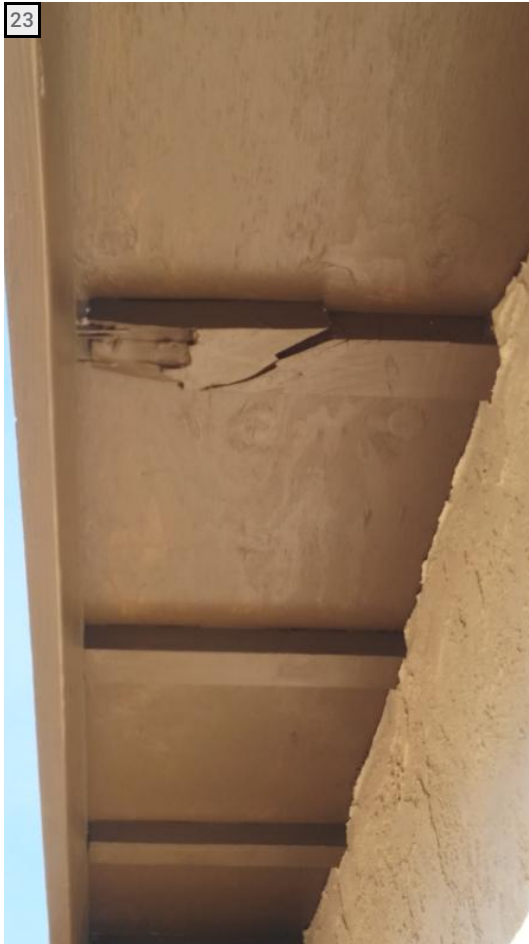
16. Rafter Tail(Exterior: Ground View): Damaged or rotted
17. Truss(Attic): Cracked

Major Concern**Damaged or rotted**

Location	Exterior: Ground View (Garage)
Impact	When damaged, neither soffit nor fascia can be attached to protect the wood
Suggested Action	Have repaired by a roofing contractor
Other Information	The rafter tail represents the portion of the rafter that extends over the wall and supports the fascia and soffit

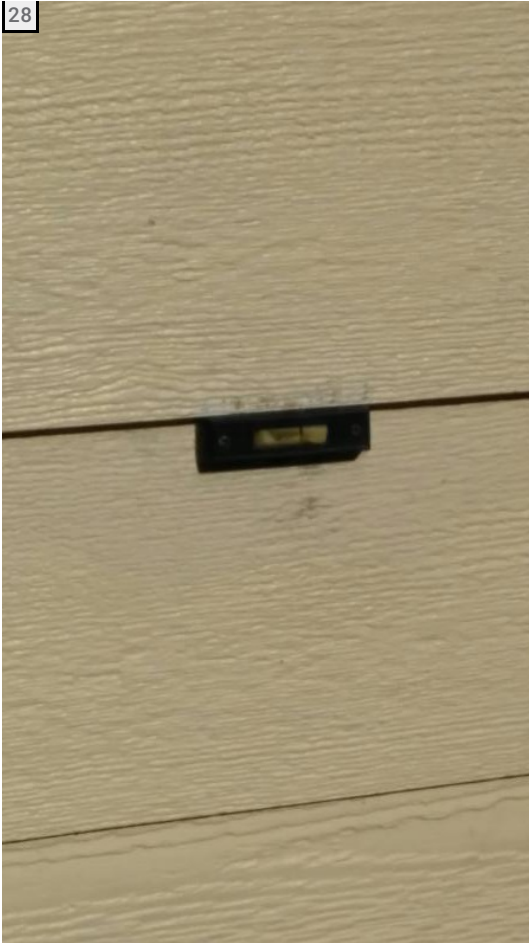
Minor Concern

Button is damaged or loose

Location	Exterior: Ground View
Suggested Action	Replace the door bell

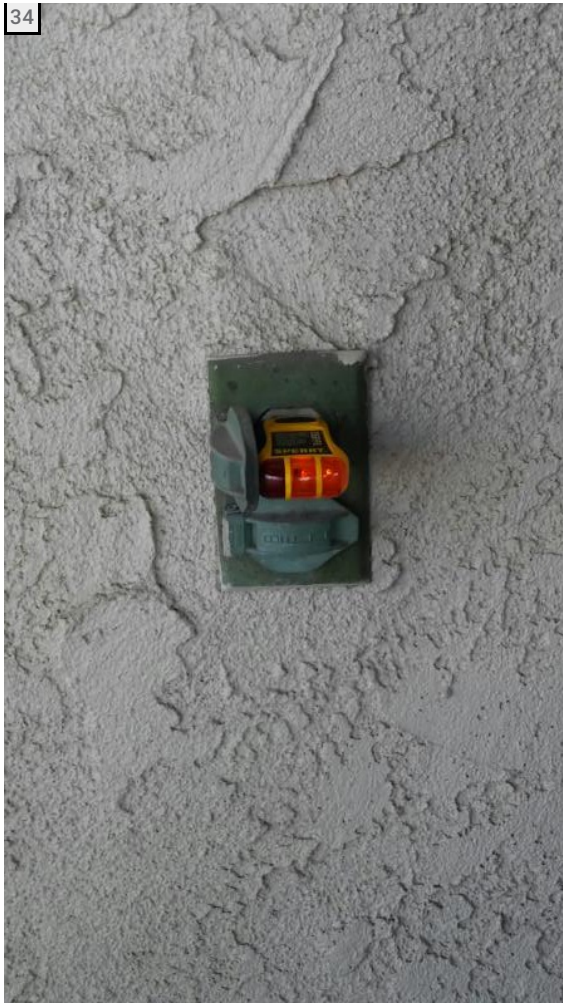
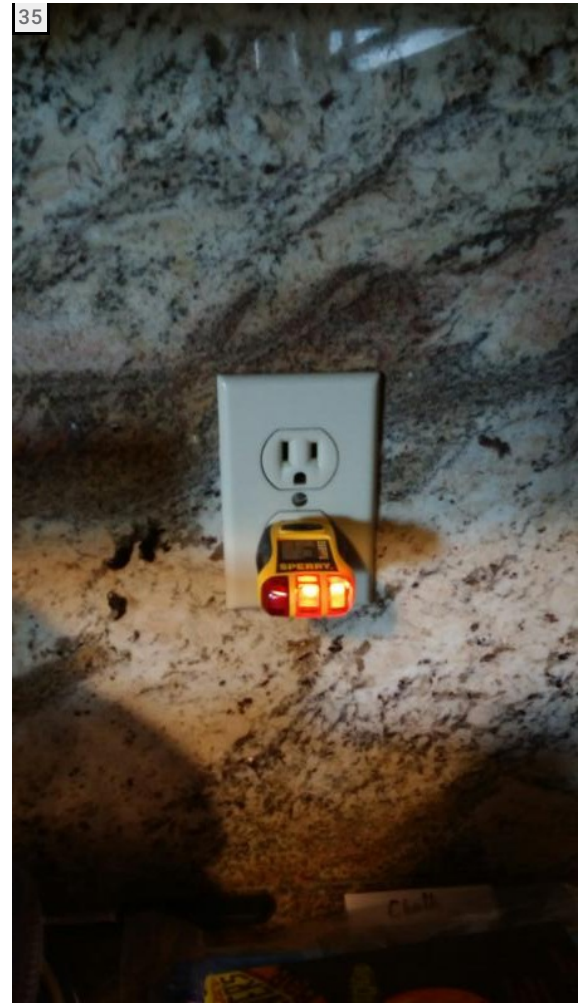
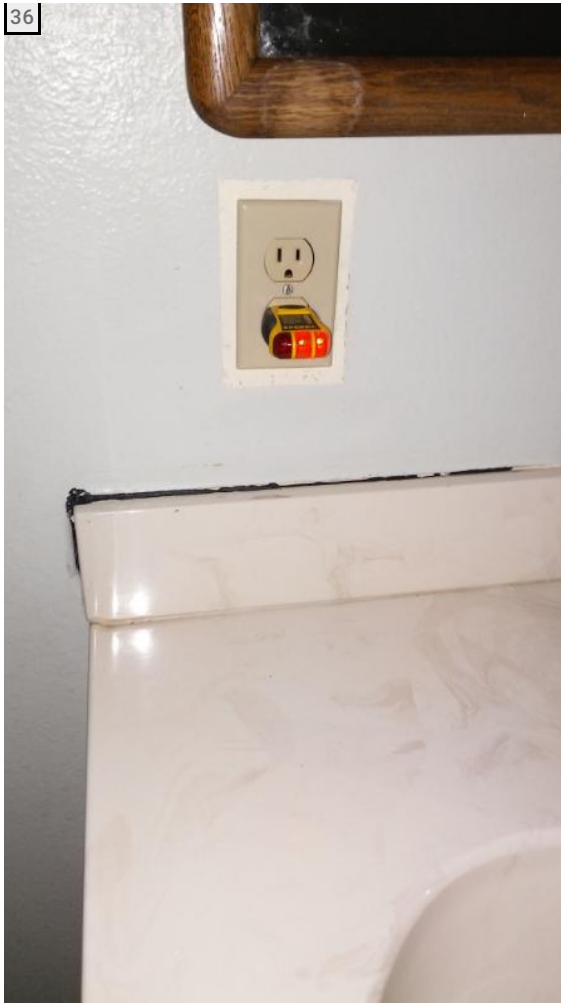
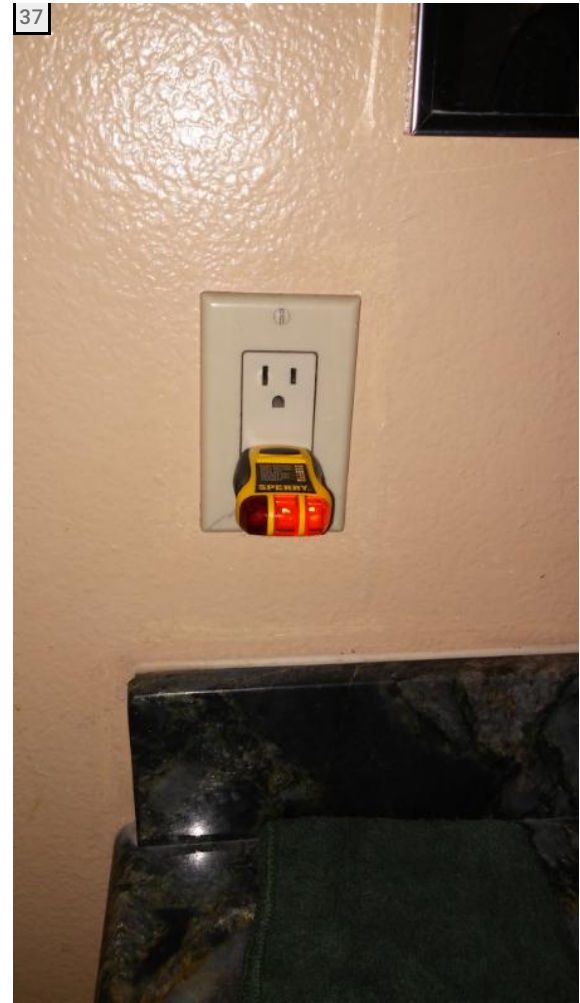
**! GFCI****Safety Concern****Not present**

Location	Master Bathroom, Attached Garage, Exterior: Ground View, Kitchen, 2nd Bathroom
Impact	Without a GFCI, there is no mechanism to prevent an electrical short
Suggested Action	Upgrade all receptacle to GFCI protection within 6 feet of all potential wet locations

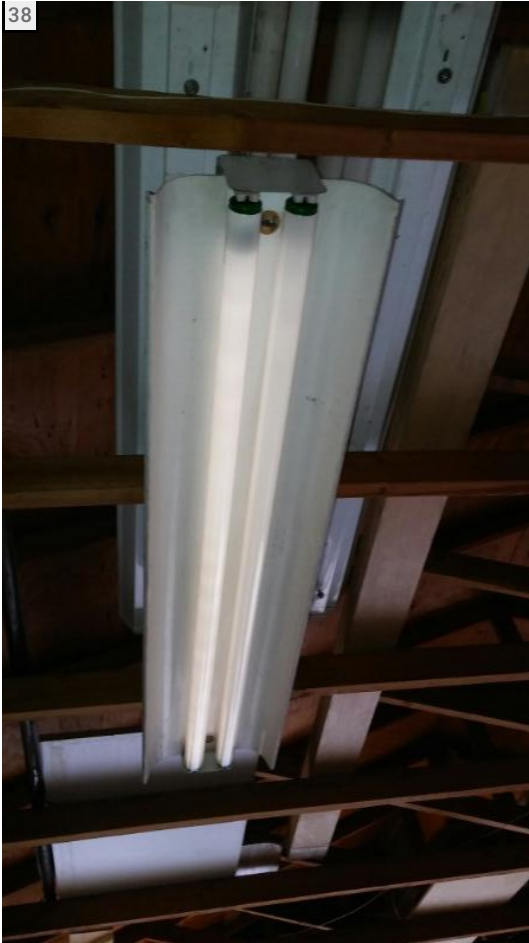
Other Information A flickering bulb may indicate potential loose wiring

Suggested Action Ensure the wires are securely connected with a proper connector. If the bulb is still flickering, have repaired by a qualified electrician.

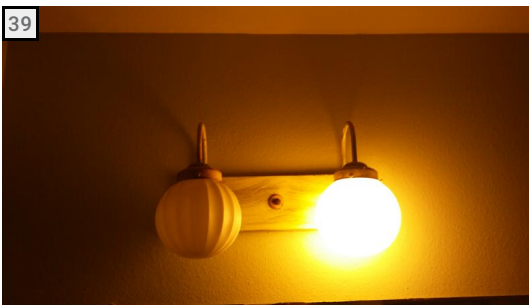
Minor Concern

Bulb is burned out

Location	Master Bathroom
Suggested Action	Replace the bulb

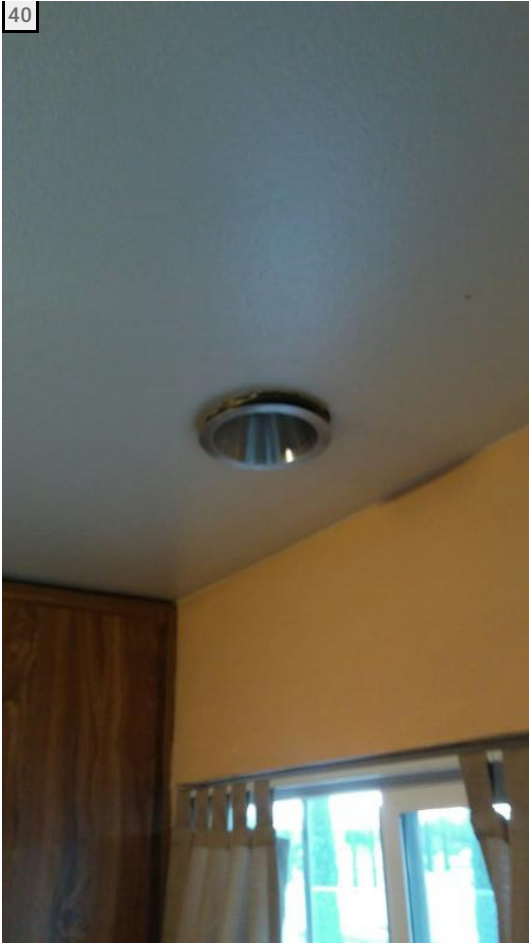
Minor Concern

Loose and/or not affixed to the ceiling or wall

Location	Kitchen
Impact	A loose light fixture may dislodge from the ceiling
Suggested Action	Secure to the wall or ceiling

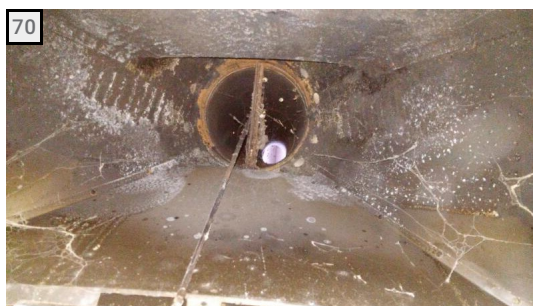
Flue has creosote buildup

Location	Living Room
Impact	With too much creosote, the chimney could ignite
Suggested Action	Have cleaned by a chimney sweep

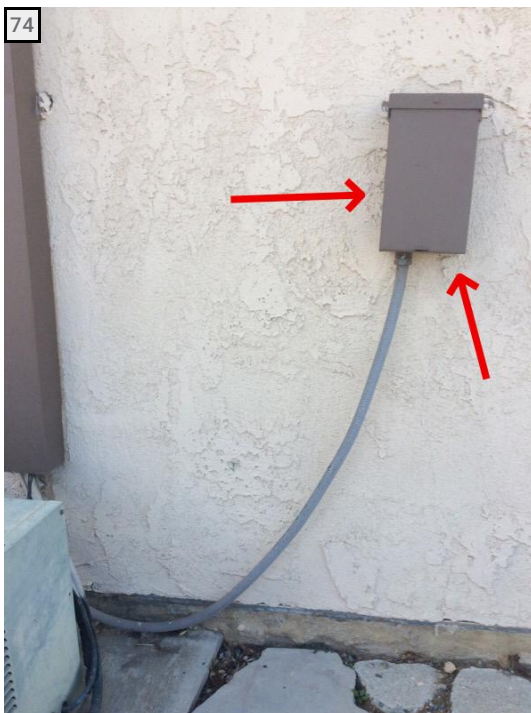
AC Compressor outside disconnect location

Location Exterior: Ground View

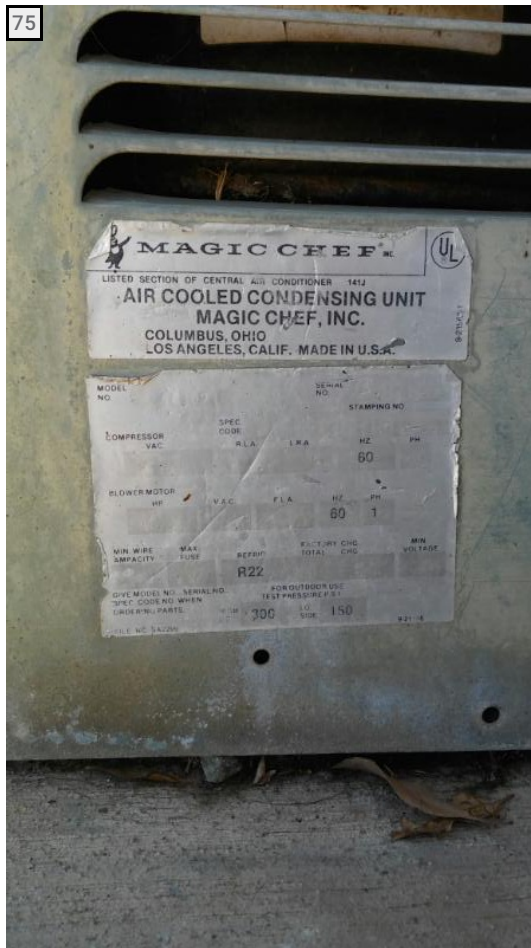
Manufacturer data plate

Location Exterior: Ground View

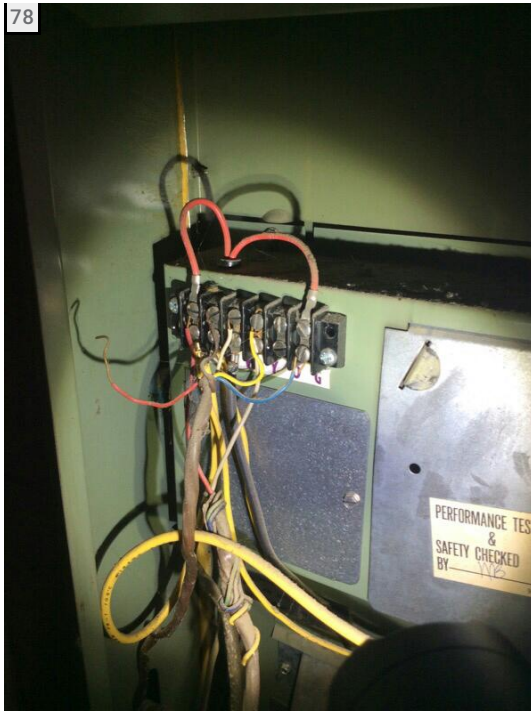
Exposed wires

Location	Hallway and Stairs
Suggested Action	Have repaired by an HVAC service professional

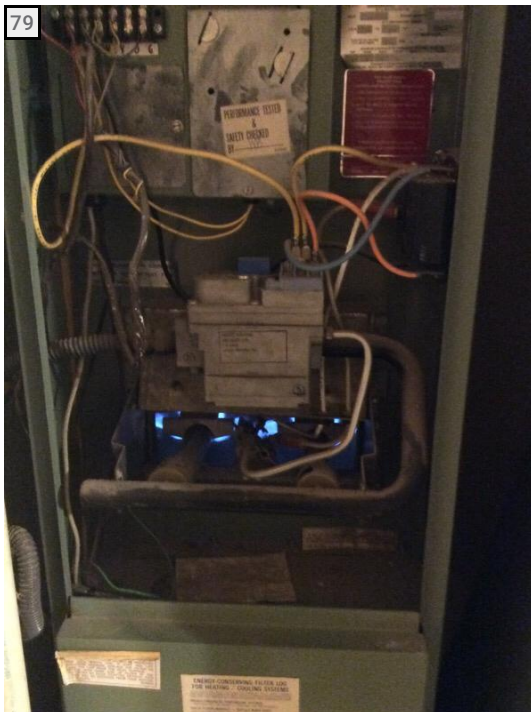
Cycles incorrectly

Impact The inconsistent cycling will cause the furnace to run too often or continuously, increasing operational costs. May also cause premature wear

Suggested Action Have serviced by an HVAC service professional

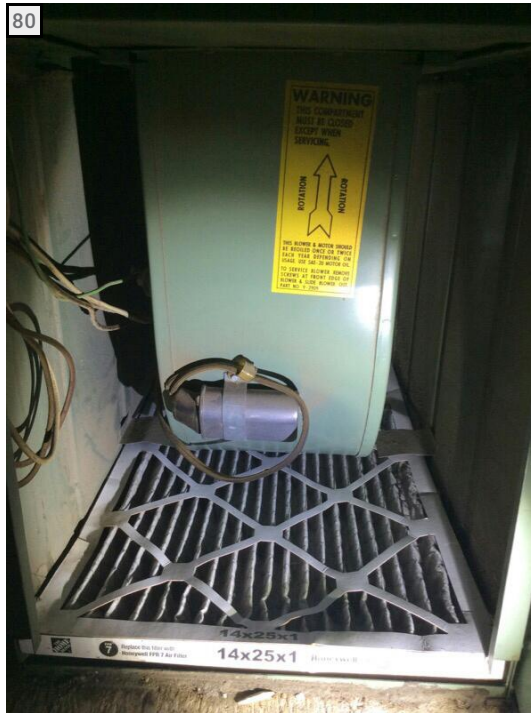
Filter is dirty

Location	Hallway and Stairs
Impact	A dirty filter causes the furnace to be less efficient
Suggested Action	Change the filter

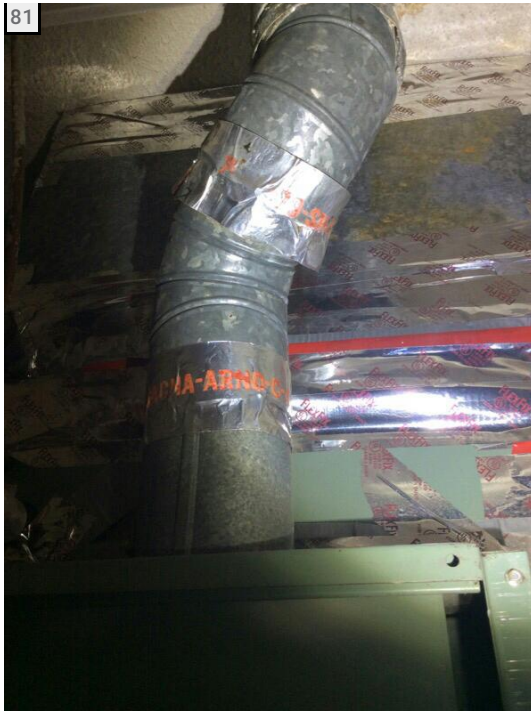
Flue is sealed with duct tape

Location	Hallway and Stairs
Impact	Duct tape, despite its name, is not designed for long term use as it allows too much air to escape or it will just fall off after a few weeks or months
Suggested Action	Replace with a higher rated tape or seal the ducts with mastics, which are gooey sealants that are painted on and allowed to harden

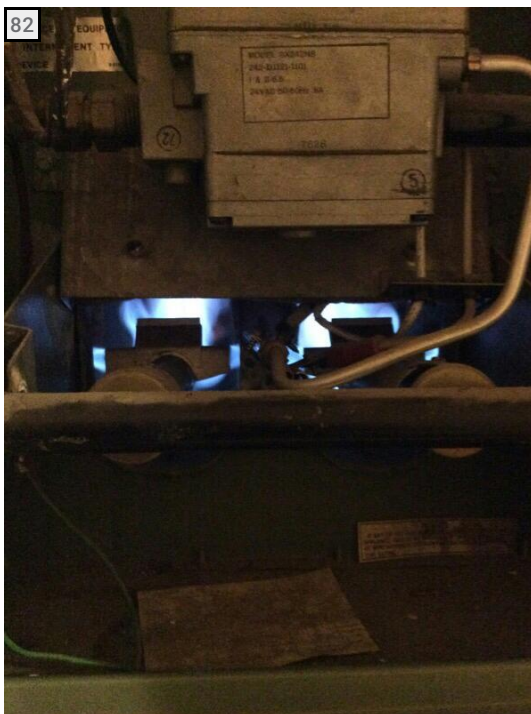
Flame is consistently blue reflecting normal operation

Location Hallway and Stairs

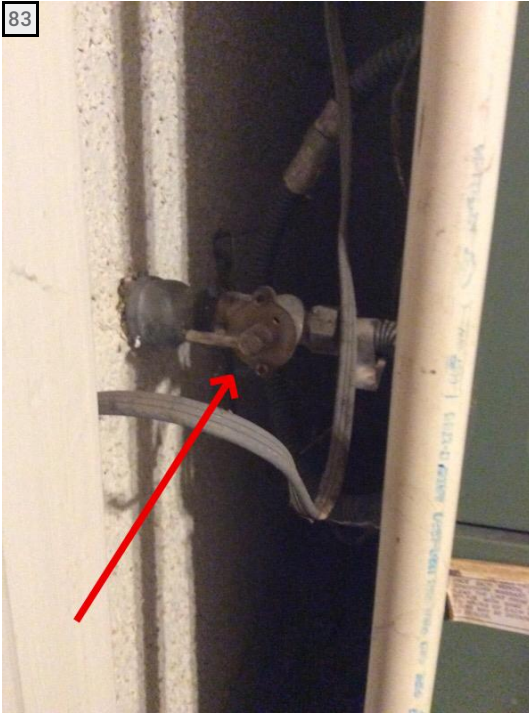
Furnace gas shutoff valve location

Location Hallway and Stairs

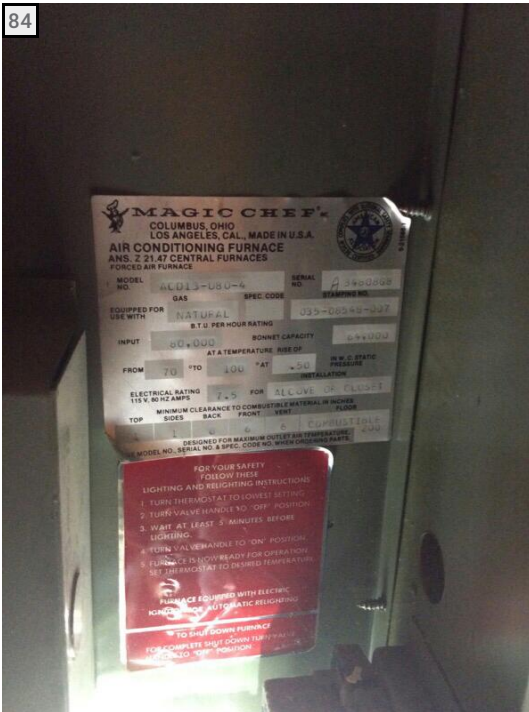
Manufacturer data plate

Location Hallway and Stairs

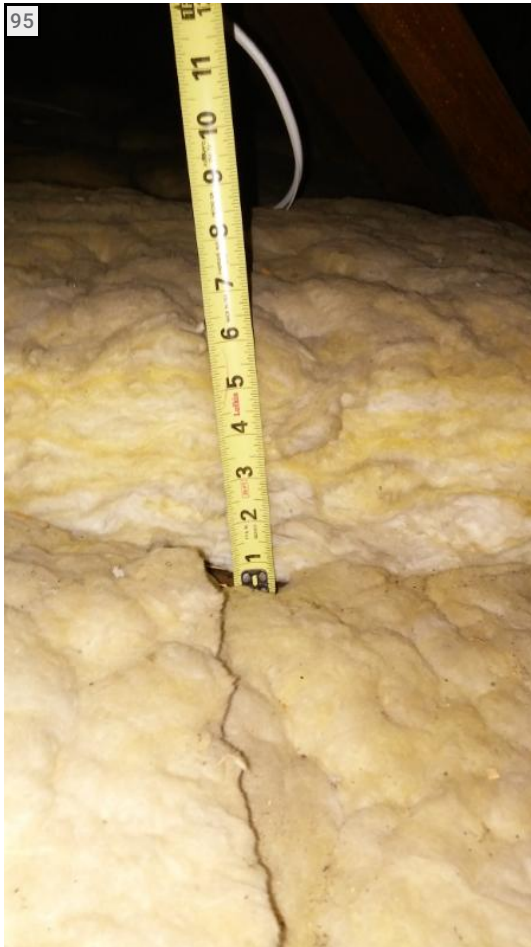
Impact The heat loss and cost of energy is reduced by 1/2 every time the insulation thickness (R-value) is doubled

Suggested Action Evaluate the cost of increasing the R-value levels in comparison to the energy savings

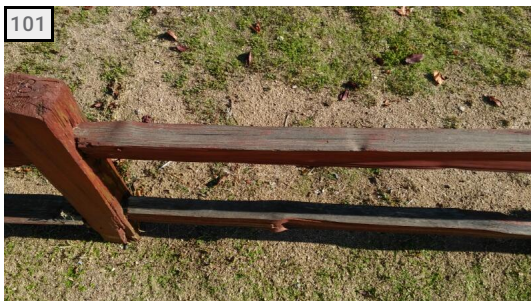
In need of normal staining

Location	Exterior: Ground View
Impact	Wood fences need to be sealed regularly to prevent premature wear

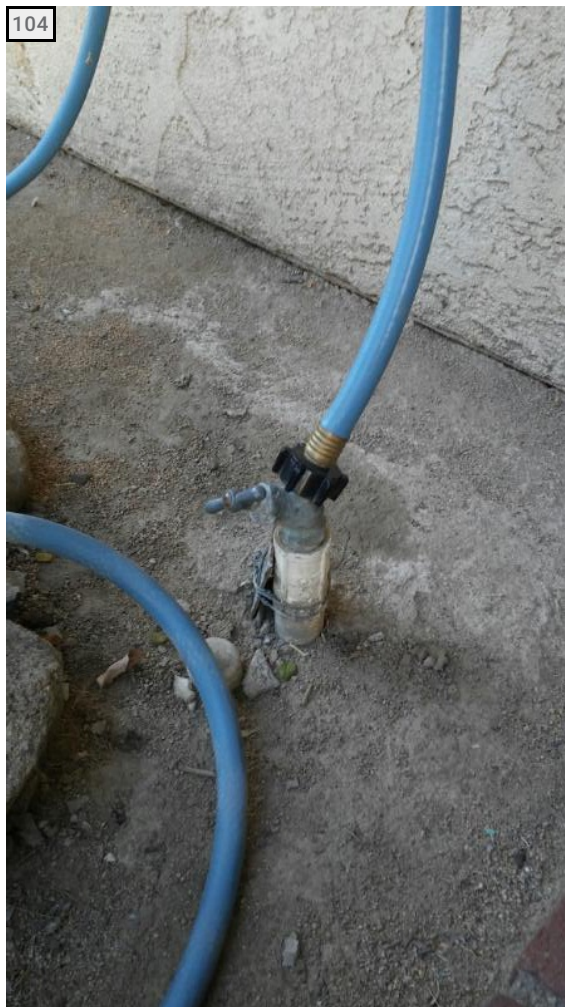
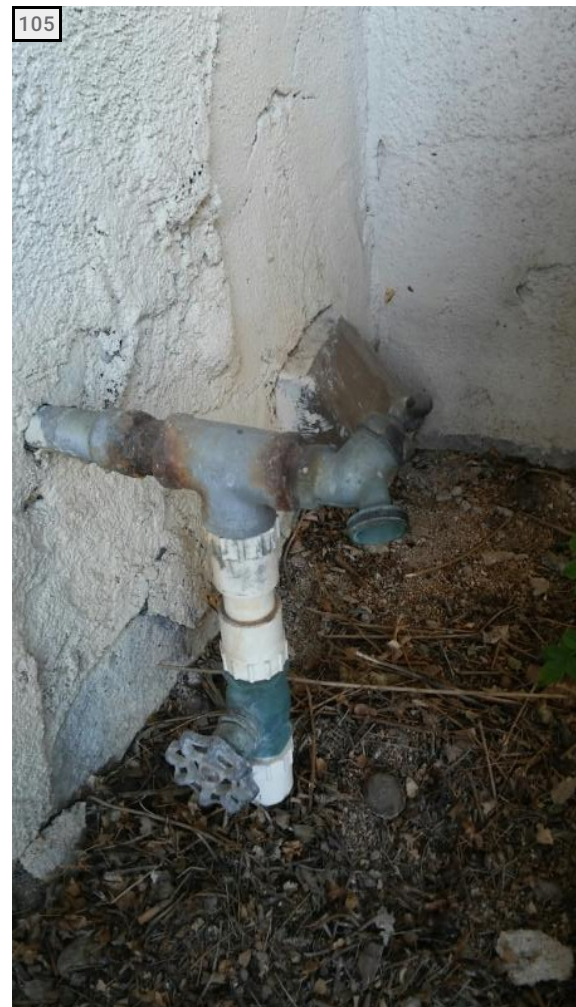
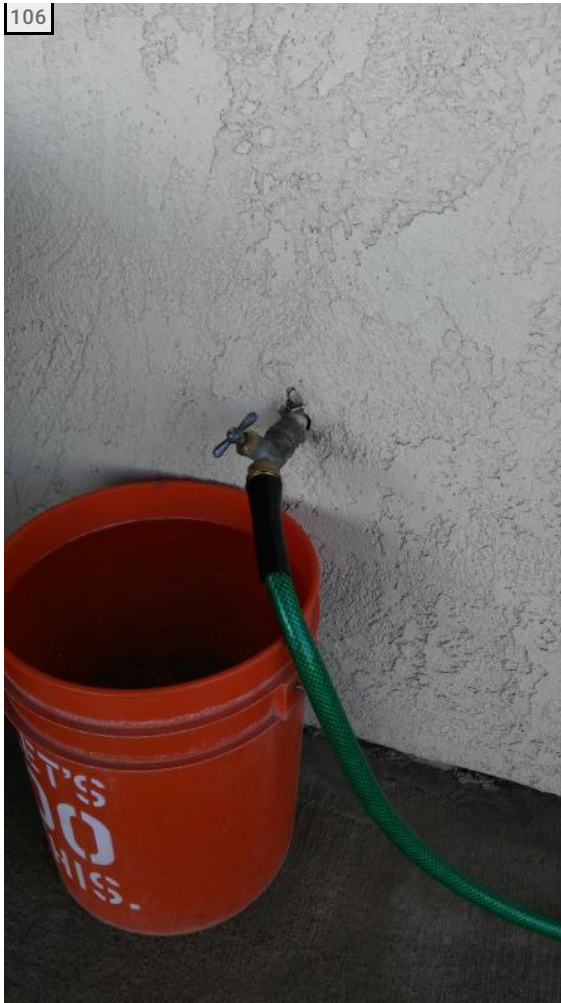
No anti siphon devices were observed.

Location Exterior: Ground View

Impact These backflow prevention devices are vacuum breakers that prevent contaminated water from entering the potable water system.

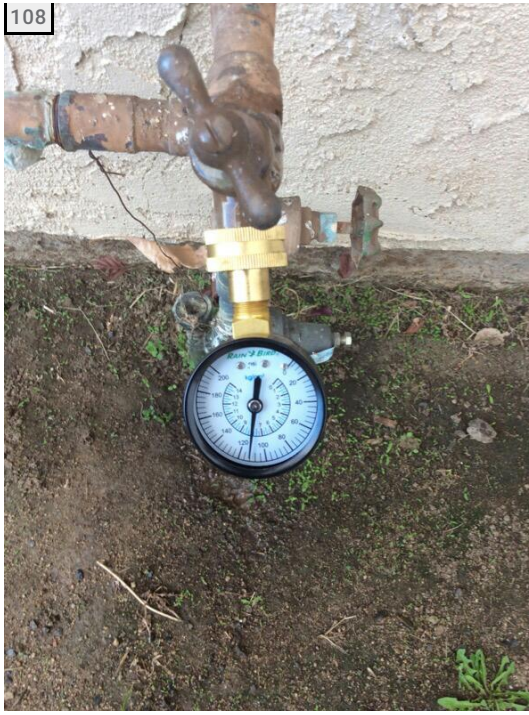
Water Pressure too high.

Location	Exterior: Ground View
Impact	Water pressure higher than 80 psi May contribute to failure of pipes and seals in plumbing system
Suggested Action	Have evaluated by a licensed plumber

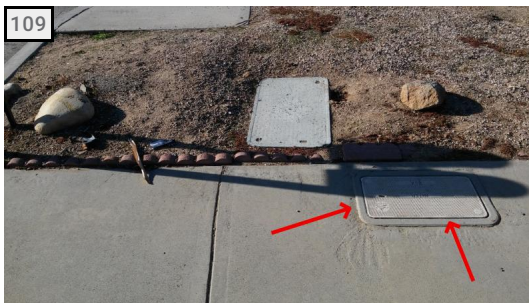
Water meter location

Location Exterior: Ground View

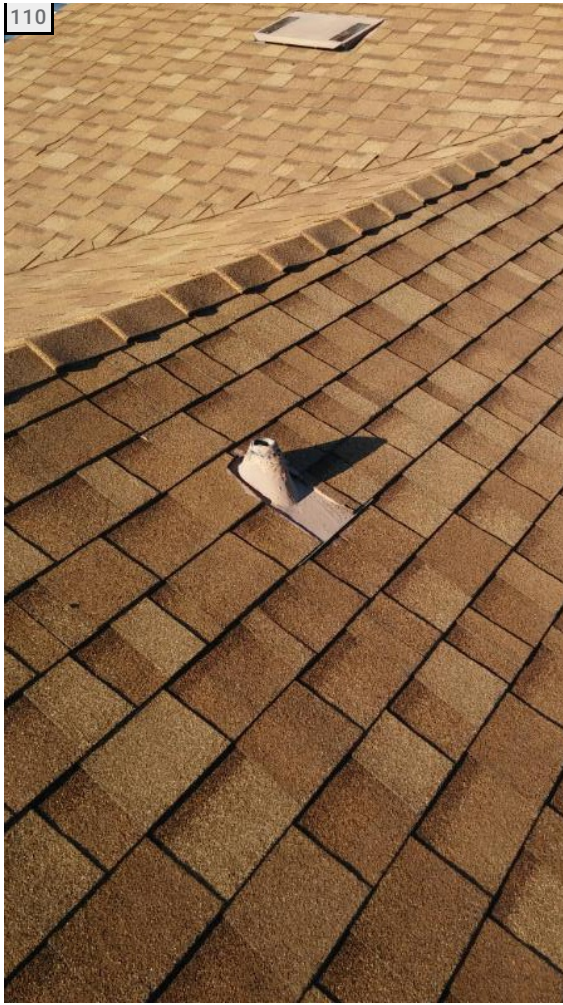
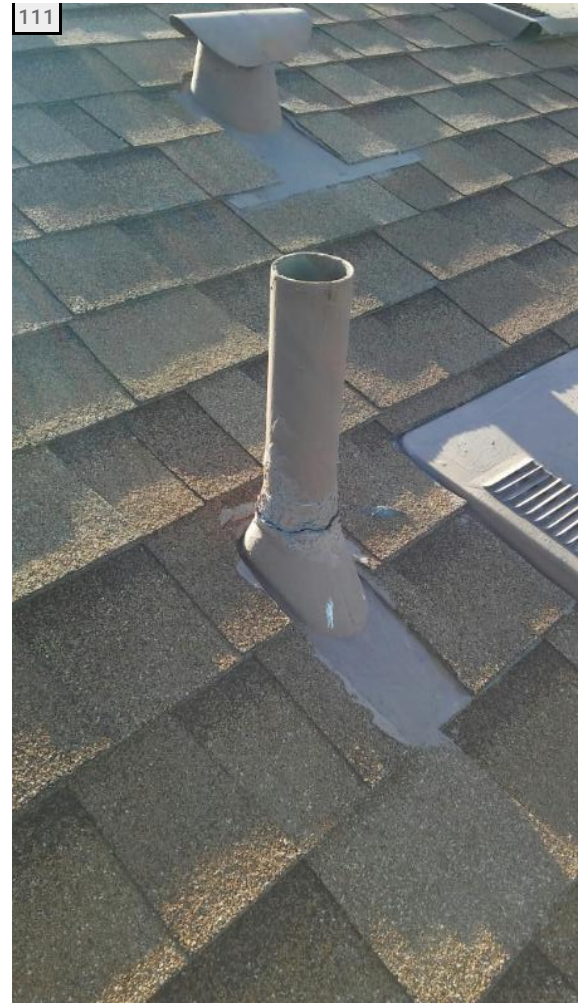
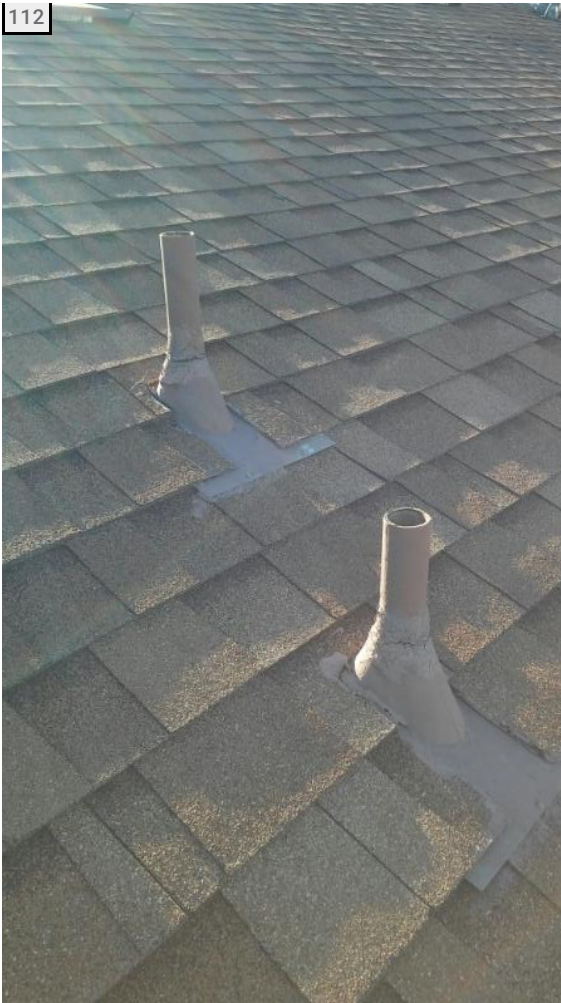
Rubber boot flashing is damaged or deteriorated

Impact The damage may cause the vent to allow for moisture and insect intrusion

Suggested Action Have repaired by a licensed roofing contractor

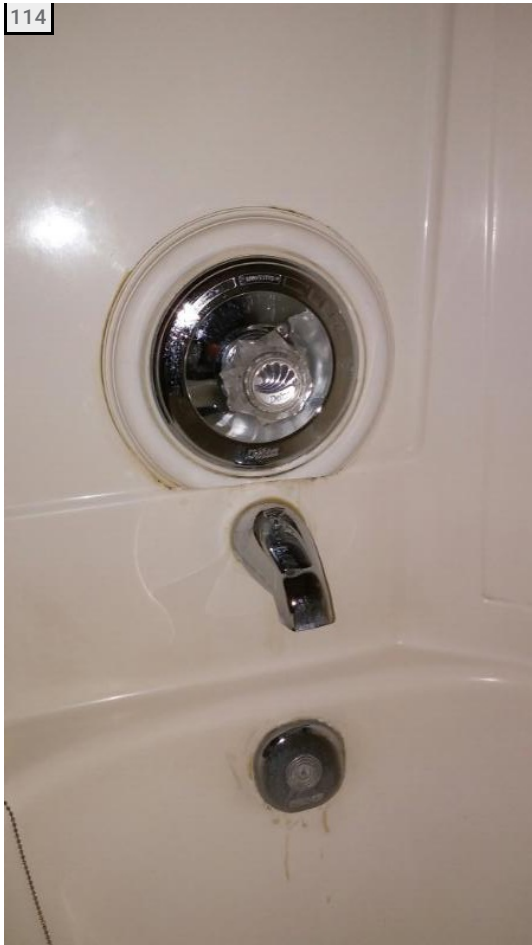
Impact Having the connections reversed creates an environment for injury due to burning

Suggested Action Have a plumber reverse the connections

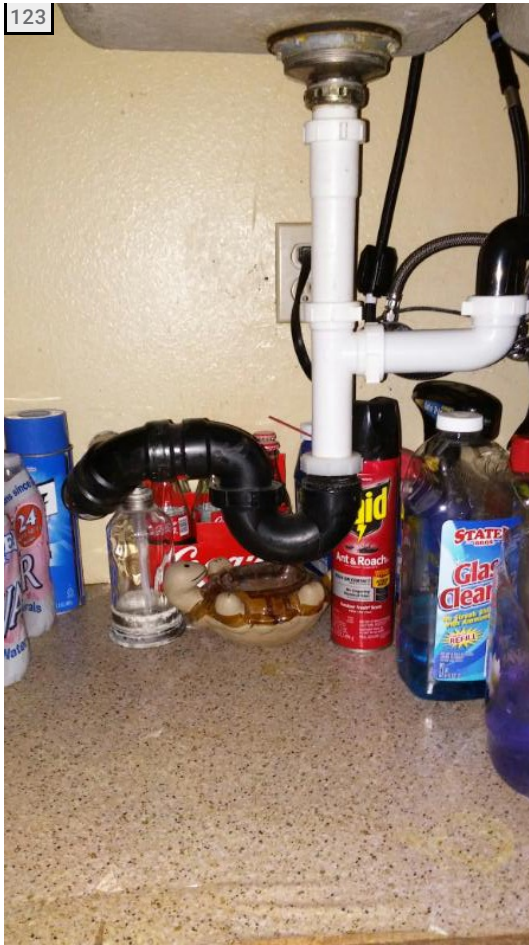
Shows signs of corrosion

Location	2nd Bathroom
Impact	The corrosion may worsen and leak
Suggested Action	Have repaired by a plumber

Impact "S" traps have the potential to suck, or 'siphon' water out of the trap as the water flows down the drain thus allowing sewer gasses to enter the home

Suggested Action Have evaluated by a licensed plumber

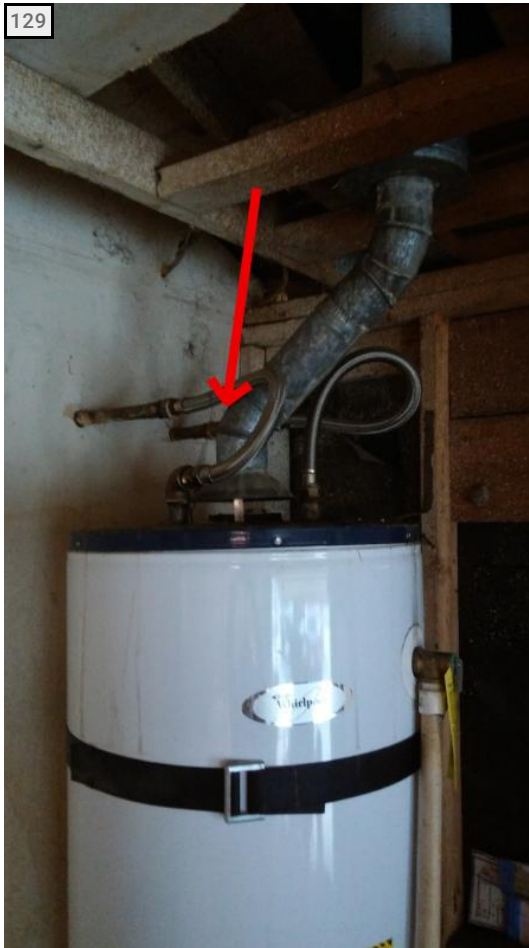
Has corrosion on one or more pipes or fittings

Location	Kitchen
Impact	Corrosion can indicate prior leaks and may indicate the possibility of future leaks
Suggested Action	Have evaluated by a licensed plumber

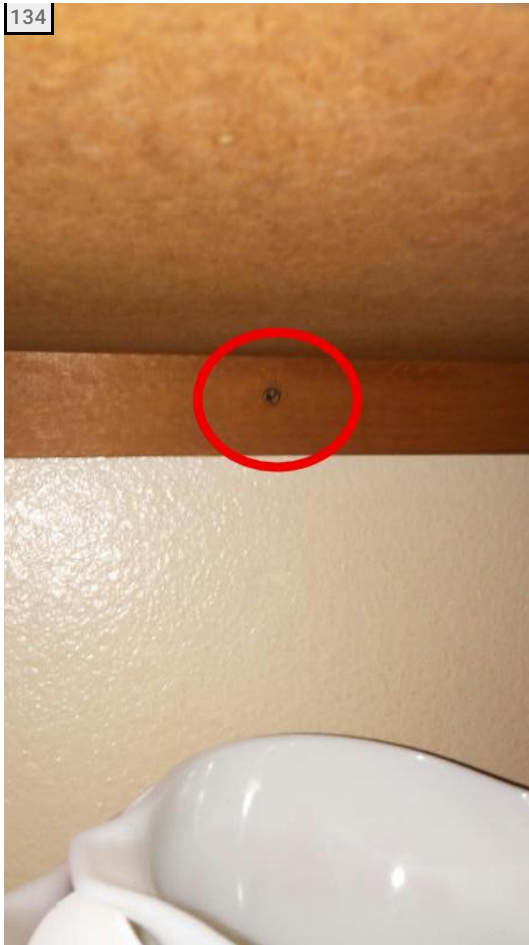
**Observation to Monitor****Improper fasteners used to mount cabinet.**

Location	Kitchen
Impact	Fasteners such as nails or drywall screws may not securely mount cabinets
Suggested Action	Recommend evaluation by licensed Carpenter.

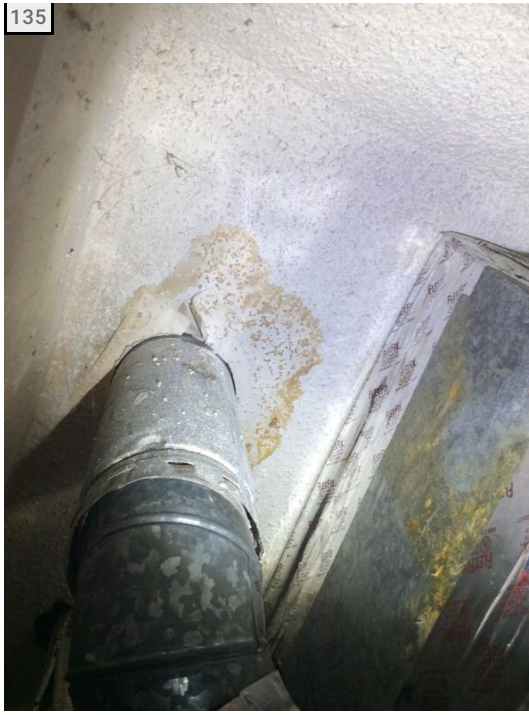
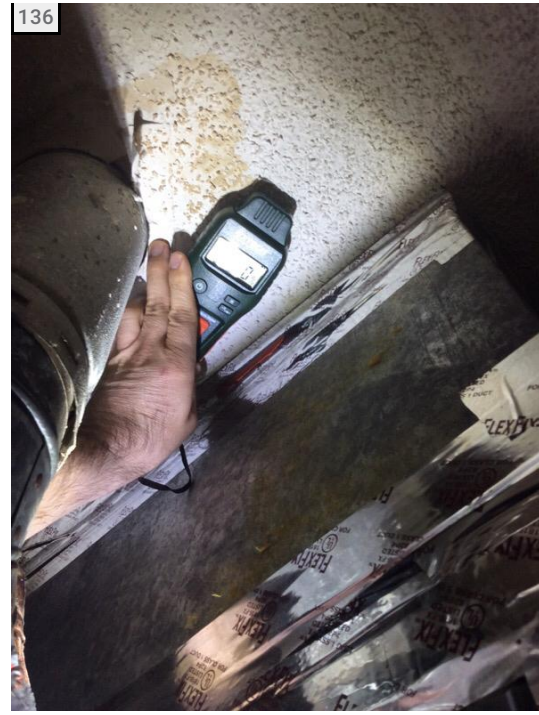
Ceiling has water damage

Location	Hallway and Stairs (HVAC Closet)
Impact	Cosmetic only, assuming the leak is fixed
Suggested Action	After repairing the leak, repair or replace the damaged area
Other Information	This is likely a result of moisture intrusion from and old roof leak. The areas seemed to be dry.

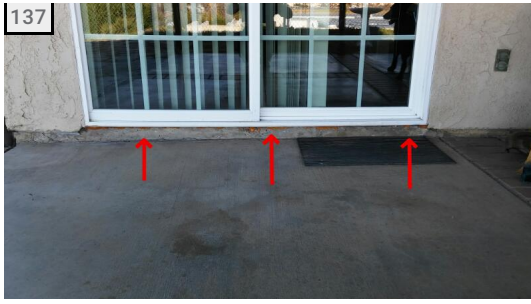
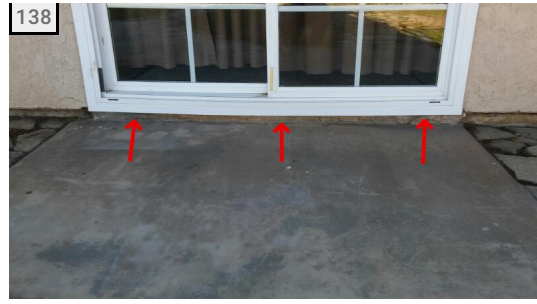
Concrete base below the threshold is cracking

Impact The crack is allowing moisture intrusion. In freezing temperatures, it will expand and exacerbate the cracking

Suggested Action Seal the crack(s) with weather-resistant pliable concrete caulk

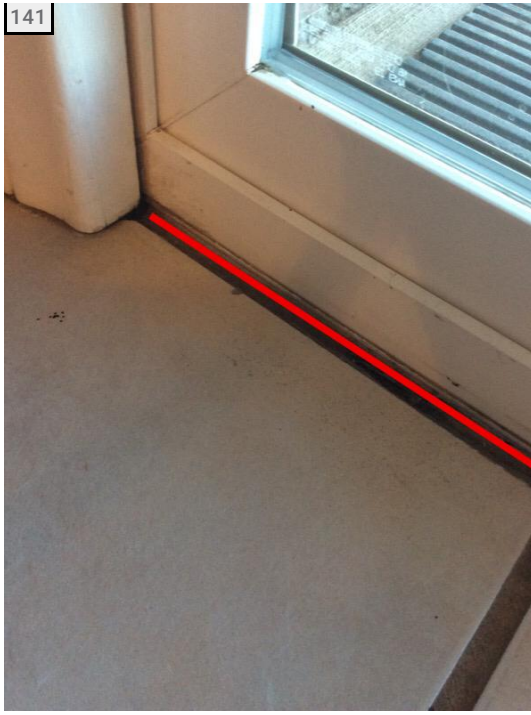
Grout is loose or missing

Location	Kitchen
Impact	Missing grout could allow moisture intrusion, possibly loosening floor tiles
Suggested Action	Remove and regrout the affected areas
Other Information	Observed several affected areas

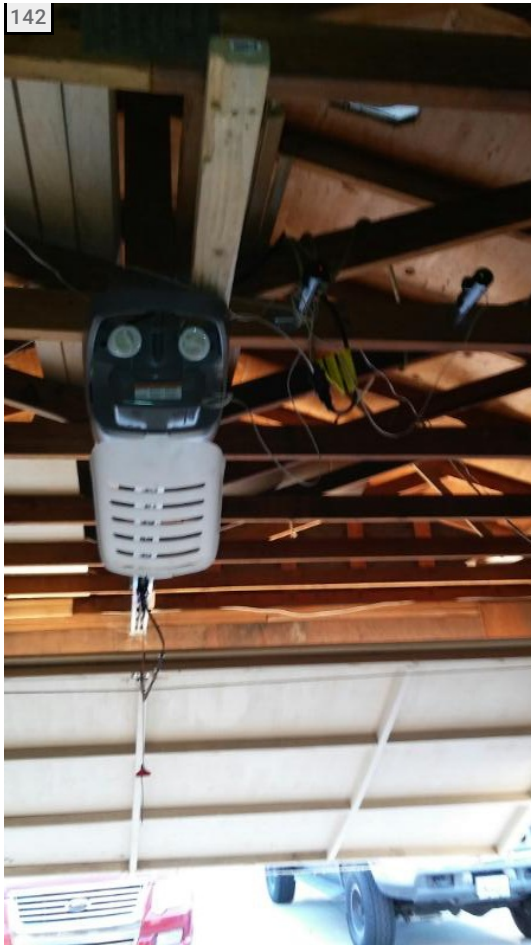
Location Attached Garage

Suggested Action Replace the garage door wall switch

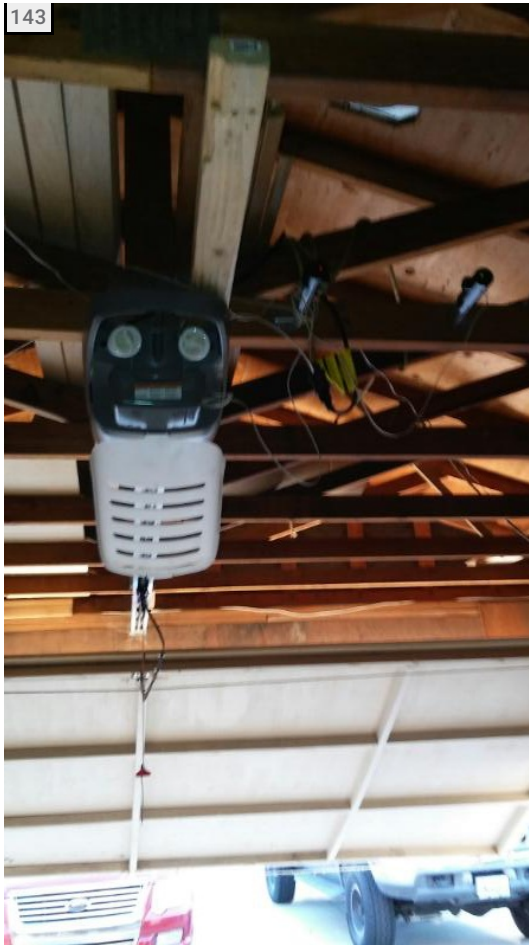
Not working

Location	Attached Garage
Suggested Action	Replace the garage door opener

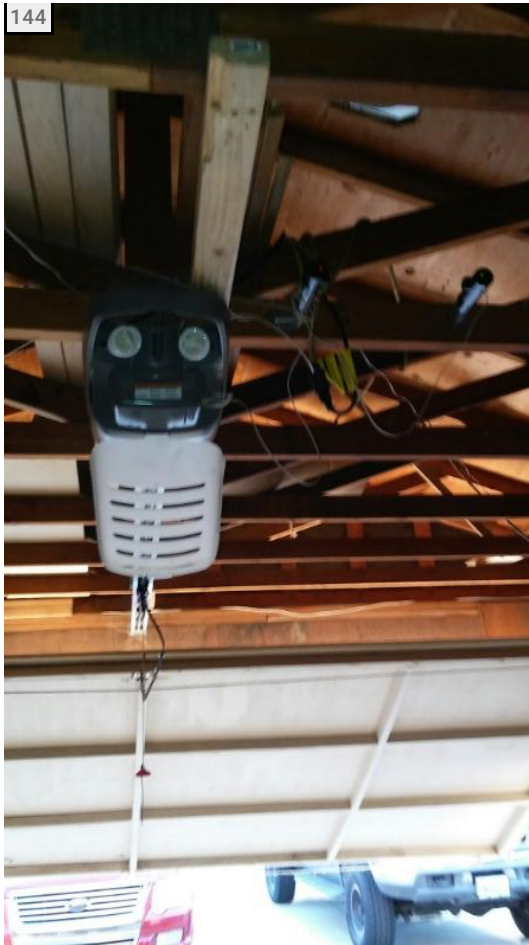
Safety reversing sensor is not mounted in its correct location

Location	Attached Garage
Impact	Safety reversing sensors installed anywhere but 6-8 inches above the floor on either side of the overhead door offer no safety protection whatsoever
Suggested Action	Reposition to its correct location to improve safety effectiveness

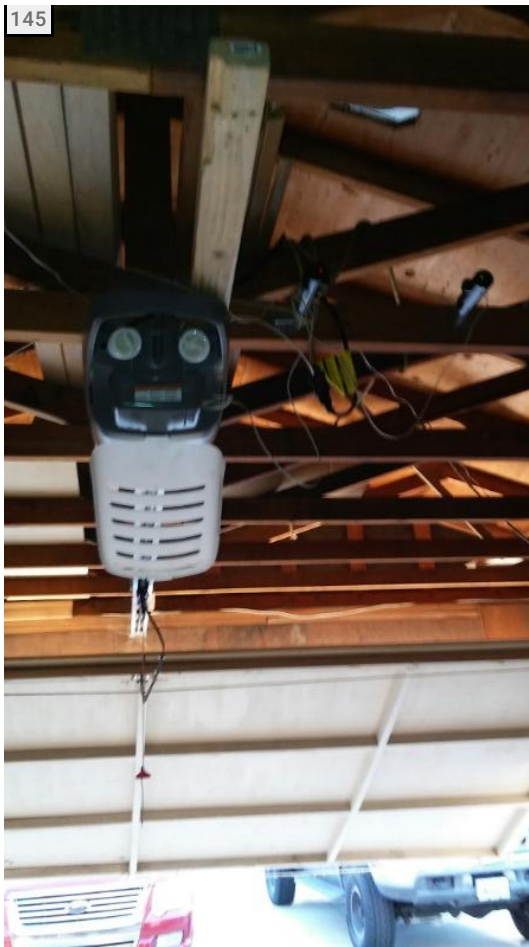
Safety reversing sensors do not align

Location	Attached Garage
Impact	Unaligned safety reversing sensors make it difficult to close the garage door
Suggested Action	Realign the sensors

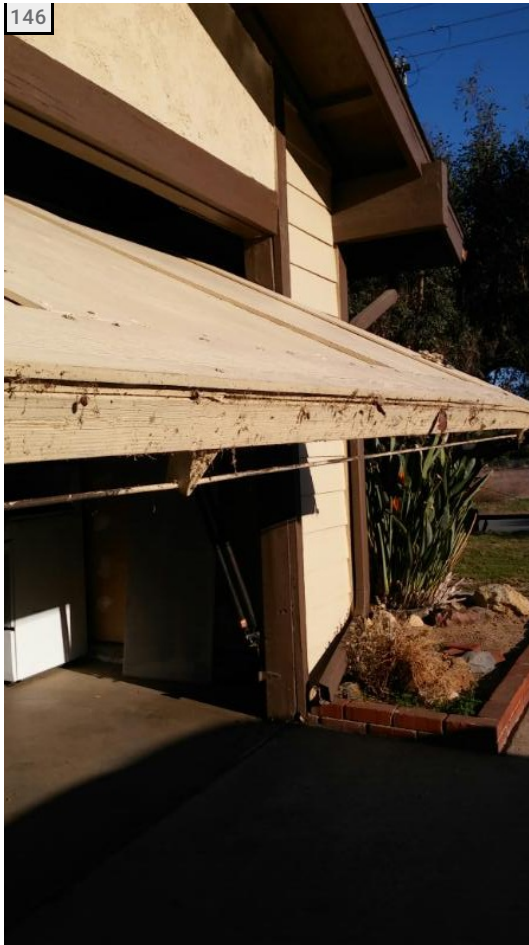
Bottom weather seal is damaged or missing

Impact Without a weather seal, exterior air and elements could enter the garage

Suggested Action Replace or install new weather seal
