Veritas Property Inspection

Inspection Report

**1234 Safe Harbor Dr
Pleasantville, California 95555**

Inspection Date January 27, 2018
Client John Doe
Inspector Nicholas Peres, CPI
P.O. Box 1004
Lake Elsinore, CA 92530
(951) 230-5831
veritasproinspect@gmail.com
interNACHI, Infrared, IAC2 Mold Certified

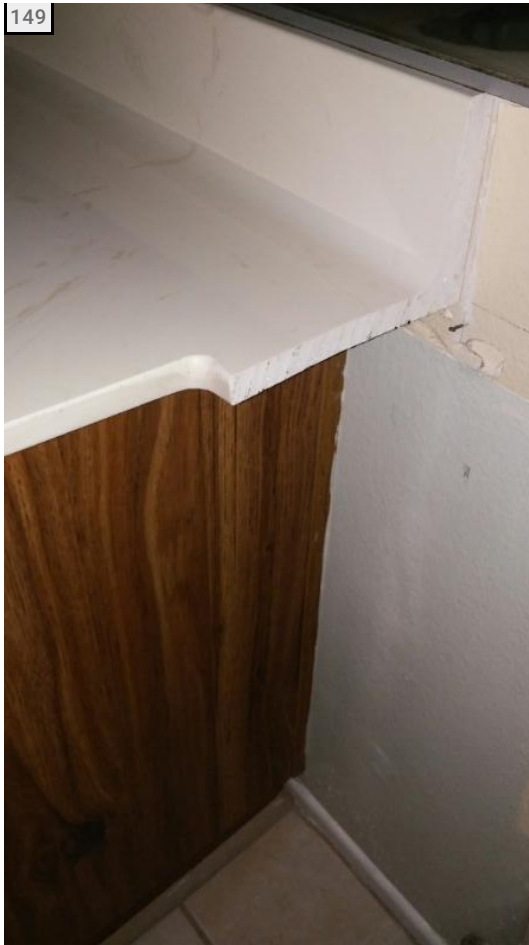
Damaged

Location	Master Bathroom
Suggested Action	Repair the damage as desired

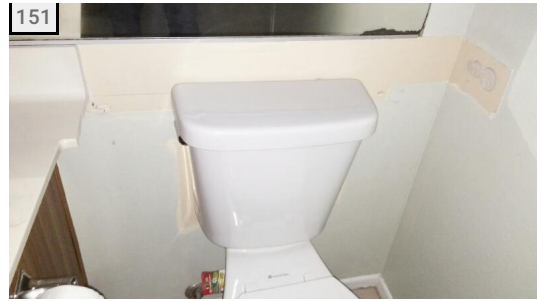
Drywall has damage

Location	Master Bathroom
Impact	Beyond being an aesthetic issue, the lack of the gaps in the wall affect the thermal boundary of the home
Suggested Action	Replace the damaged areas of the wall
Other Information	The finished aspect of the wall is a component in creating a thermal boundary of a home which controls the transfer of energy (heat) between the interior and the exterior
