# INSPECTION REPORT

For the Property at:  
**282 ##### AVE**  
TORONTO, ON #####

Prepared for: Client  
Inspection Date: Thursday, August 5, 2021  
Prepared by: DAN LIU

Report No. 1021

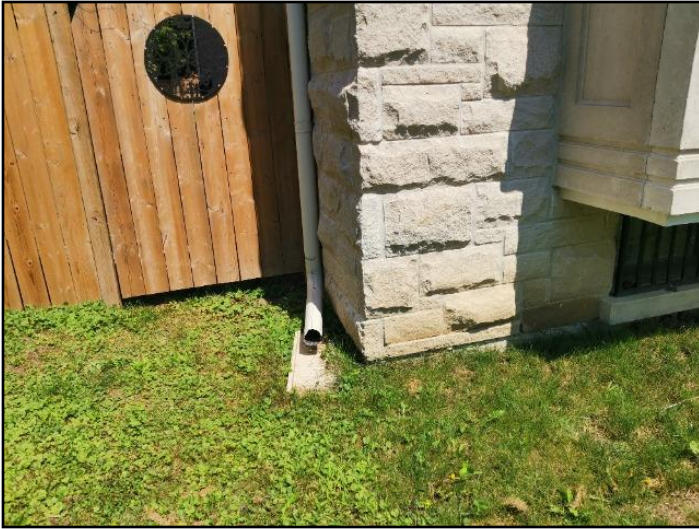
3. Condition: • [Should discharge 6 feet from building](#)

Implication(s): Chance of water damage to structure, finishes and contents

9. Should discharge 6 feet from building

Task: Improve

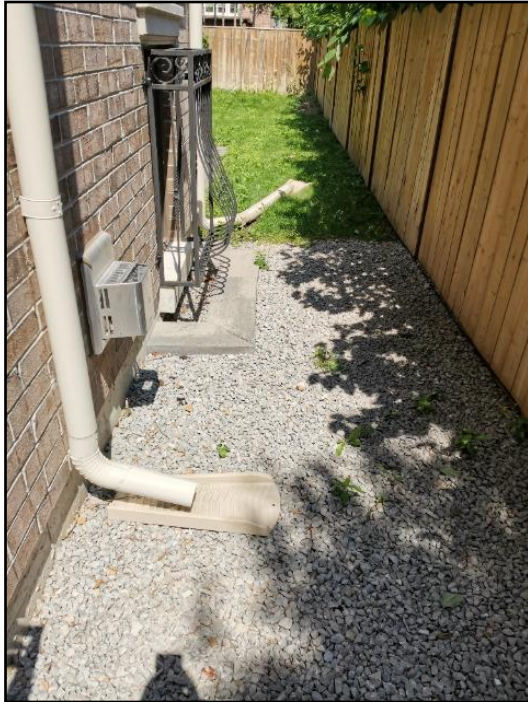
13. Should discharge 6 feet from building

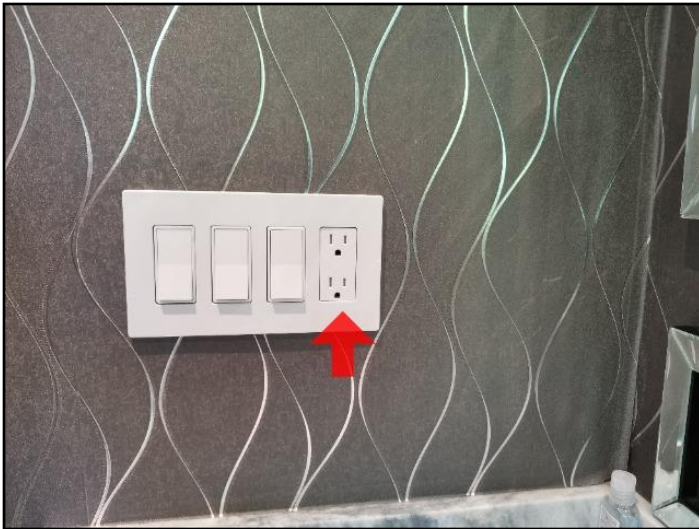
16. Condition: • [GFCI/GFI needed \(Ground Fault Circuit Interrupter\)](#)

33. GFCI/GFI needed (Ground Fault Circuit...

Task: Replace

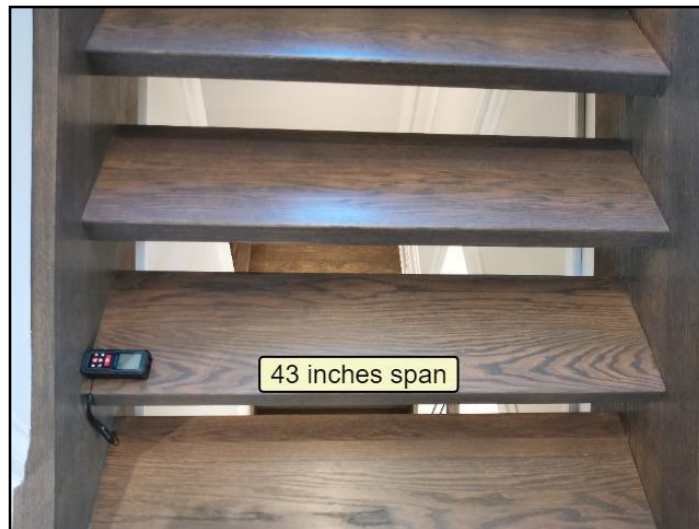
**66.** *Excessive span between stringers*

**Task:** Improve
