INSPECTION REPORT

SAMPLE REPORT

VAUGHAN, ON L0D 6J9

RE: Report No. 1041, v.3
Sample Report
Vaughan, ON
L0D 6J9

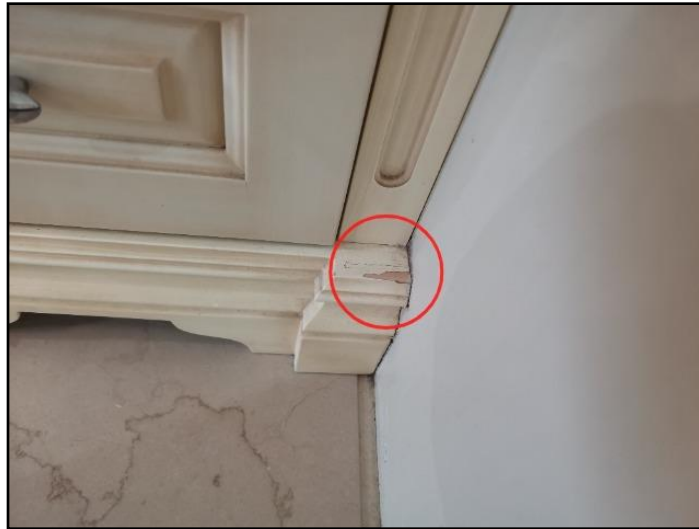
161. Water damage

60. Condition: • Water damage

Implication(s): Material deterioration

Task: Repair
