Outline Condition Survey of Melin Daron, Aberdaron

Date of Inspection: 12 August 2020
Weather Conditions: Sunny, clear, dry 20°C

Issue date: September 2020

Prepared by: Gethin Roberts & Matt Osmont

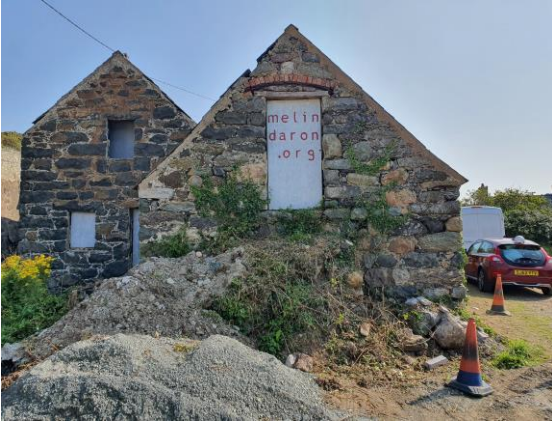
Front elevation with the gable walls of the Grain Dryer (right) and Dresser Range (left).

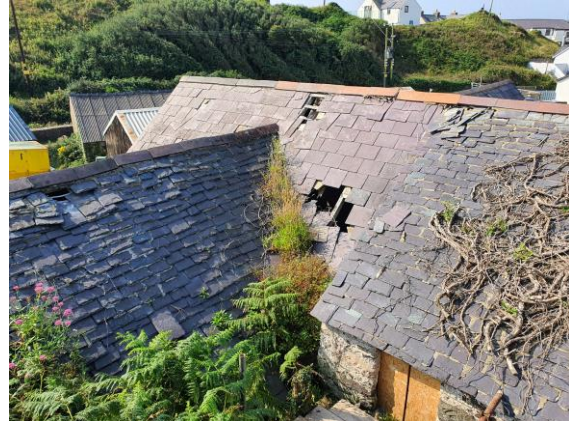
Intersection of the roofs of the Mill Range (right) and the Stable (left).

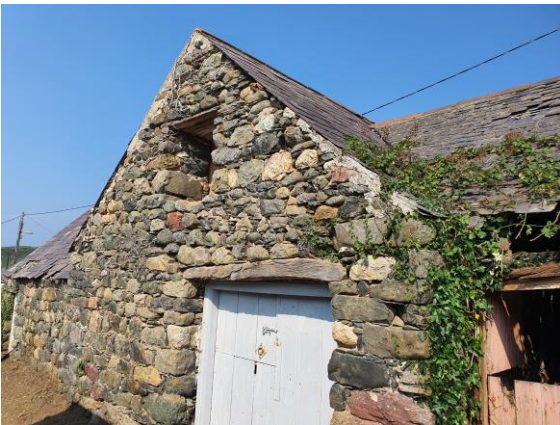
Gable wall of the south eastern end of the Mill Range with the Grain Dryer (left) and Stable (right).

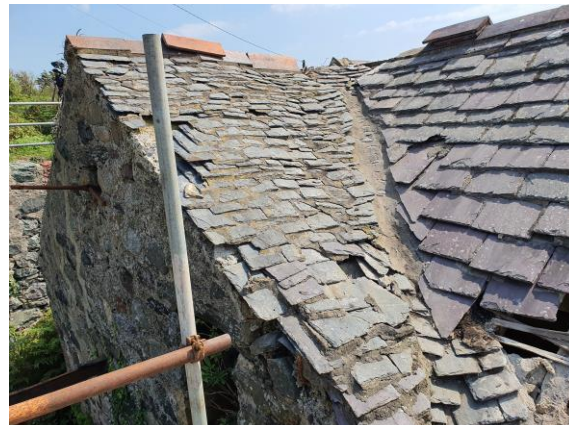
Welsh valley with random diminishing slate roofs of the Dresser Range and north gable of the Mill Range.

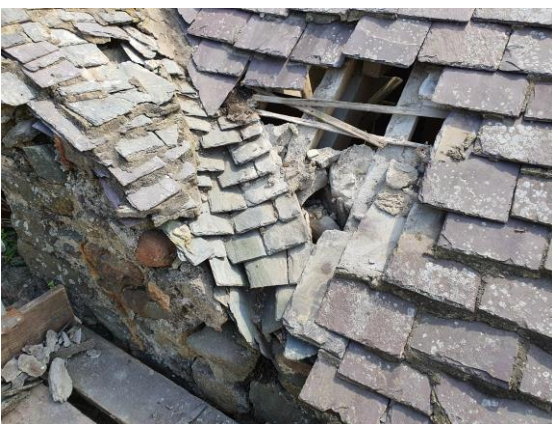
Close up of a classic traditional Welsh valley between the Main Range and Dresser Range.

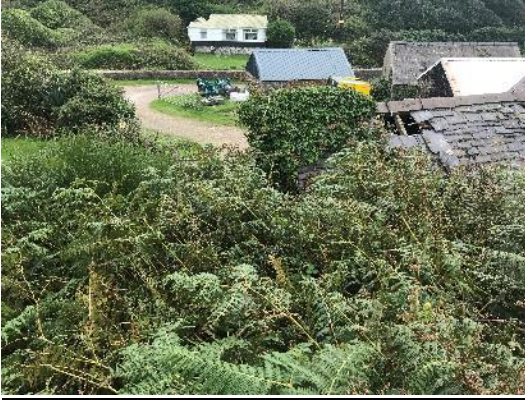
Unable to adequately assess condition of walls as they were obscured by vegetation.

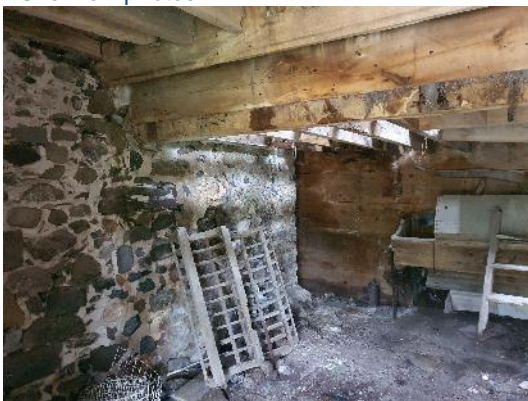
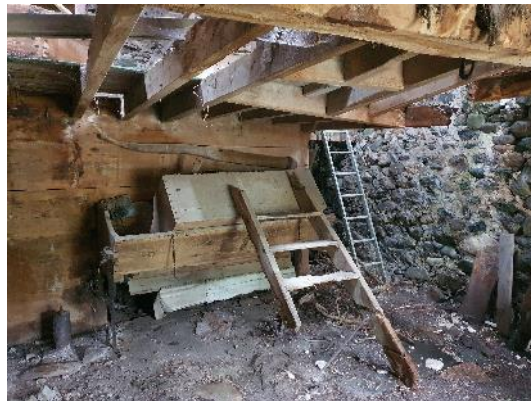
9.1.4 G04 – The Mill Range

Buttered pointing generally satisfactory. Debris covering majority of floor surface, therefore, unable to fully assess condition of flags. Localised bowing and dishing to west wall. Chute currently unstable. Ledged and brace doors in fair condition.

- Repair the hopper, horse and shoe. Varnish with an environmentally friendly varnish.

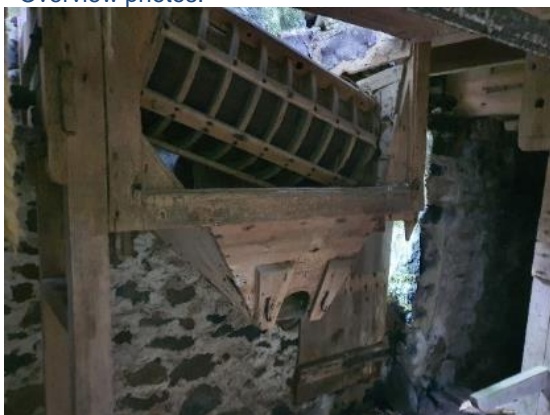
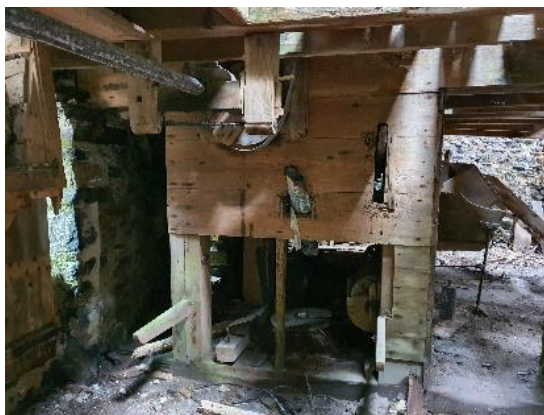
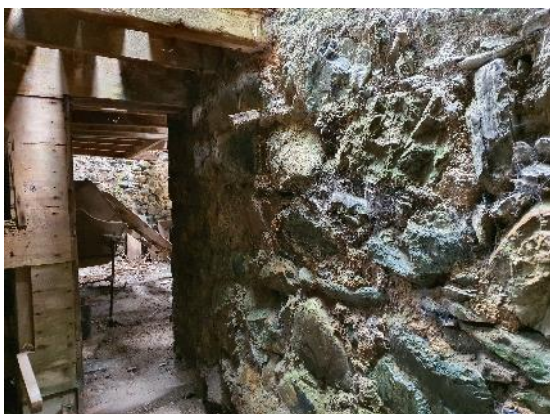
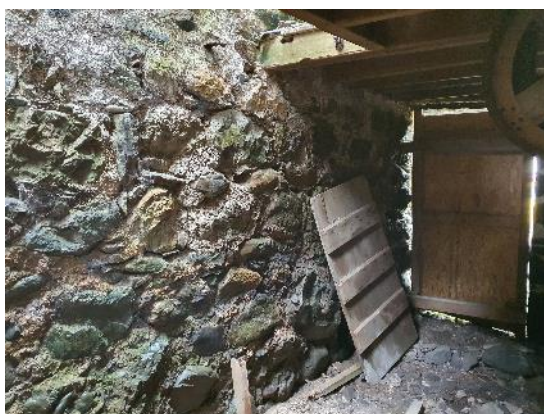
9.1.5 G05 – The Dresser Range

Buttered pointing generally satisfactory. Debris covering majority of floor surface, therefore, unable to fully assess condition of flags. Boardings to openings in very poor condition.

- Design, manufacture and install new take off gear to ground floor lay shaft.
- Repair sack hoist drive.
- Overhaul sack hoist, provide new chain, pin and get operational.
- Carry out minor works to west corner dresser to stabilise and conserve.
- Repair, so visually correct, other dressing machine to enable it to rotate but not be functional.
- Renew flour chutes.
- Overhaul ground floor flour bin. Overhaul tentering mechanism to make it operational.
- Conserve and stabilise hurst frame line shaft driving possible fan (not to make operational).

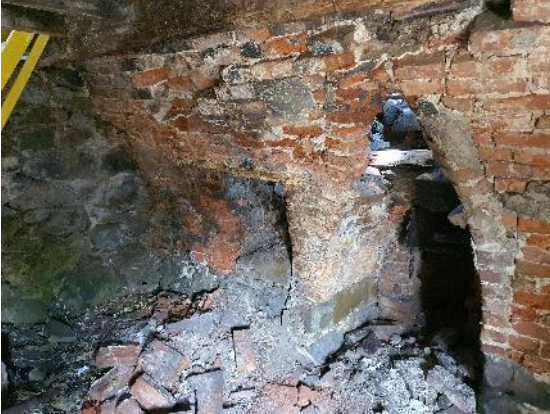
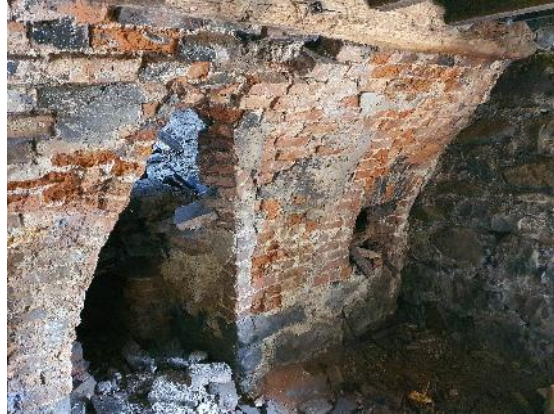
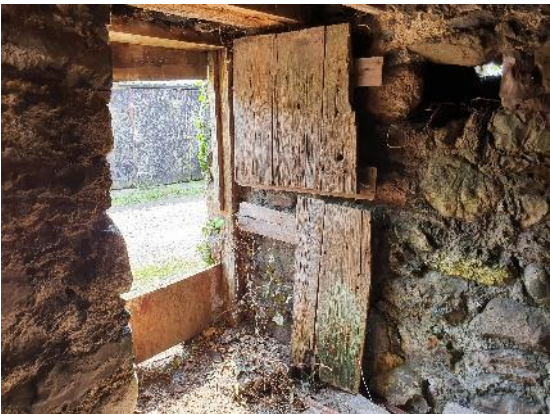
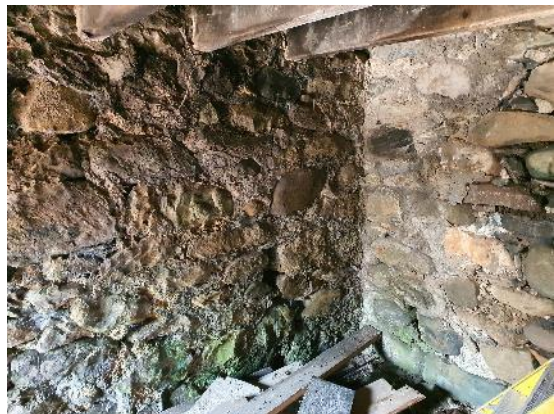
9.1.6 G06a – The Grain Dryer (Heated Chamber)

Metal rods have bowed and are largely rusted. Heat distributing brick tube generally in satisfactory condition.

- Allow to replace both in-situ ferrous metal rods with new non-ferrous rods and provide 4no new steel bearers to match to support sub-frame for the perforated clay tile drying floor.
- Allow to provide new non-ferrous sub-frame.
- Allow to renew and consolidate heat distributing brick tube.

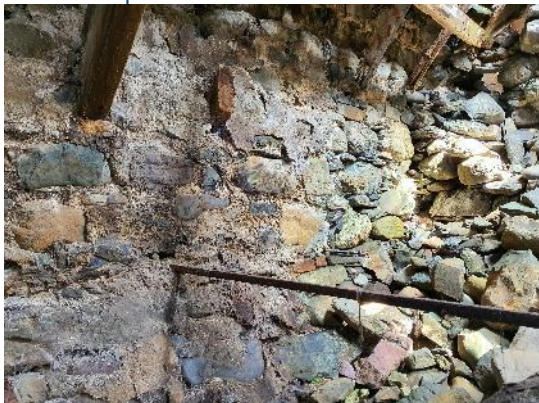
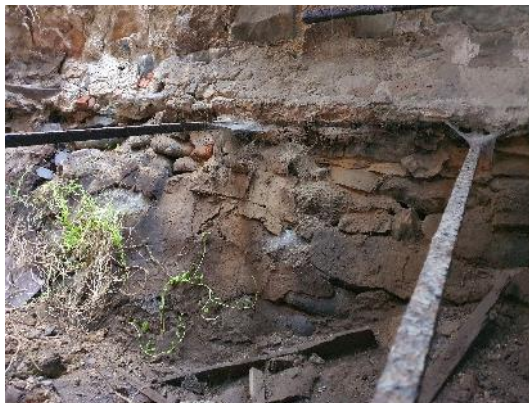
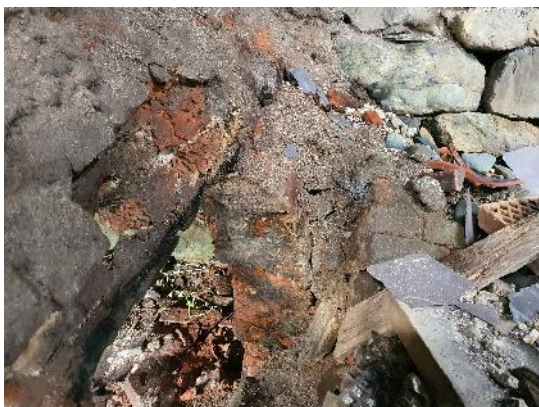
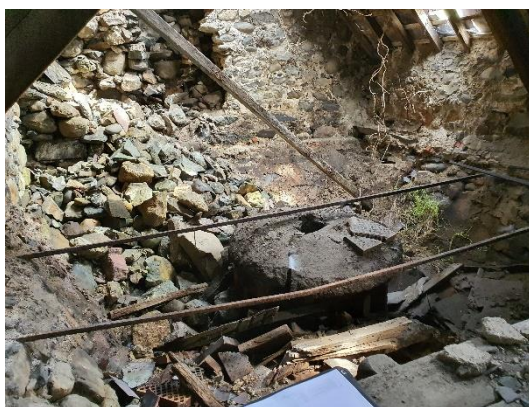
9.1.7 G06b – The Grain Dryer (Stoke House)

Buttered pointing generally satisfactory. Arched brick wall to corn drying oven in poor condition. Lintel to north wall in very poor condition. Ledge and brace timber door in very poor condition.

- Allow to clear all debris from floor and expose assumed brick cobbled floor.
- Allow to brush down pointing and consolidate with new to 25% of 2no. walls and repoint 1no. entirely.
- Allow to replace 25% brick cobbles and repoint entire floor.

- Allow for full archaeological recording of arched wall to corn drying oven and rebuild in its entirety using any recovered bricks. Allow for 75% replacement salvaged bricks. 'Specials' required for pointed arch and significant rebuilding to northern half of wall.
- Allow for new lintel to north opening.

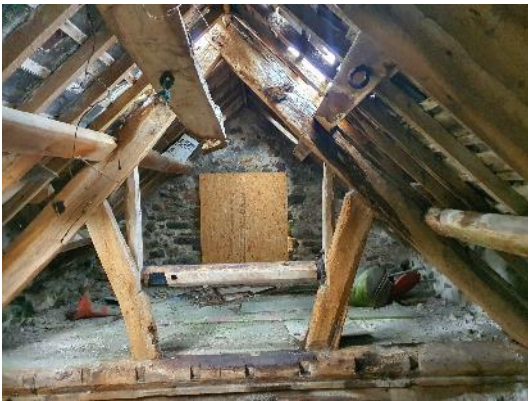
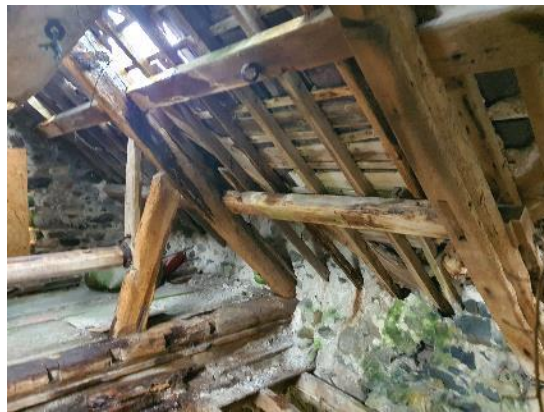
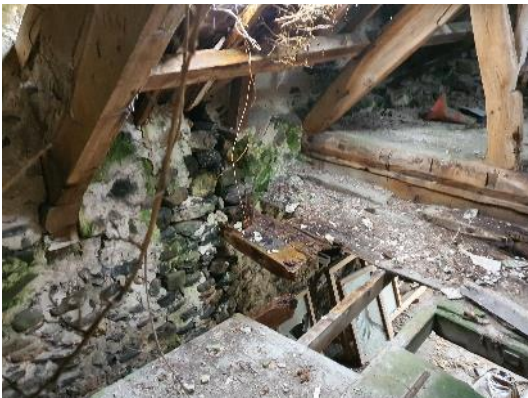
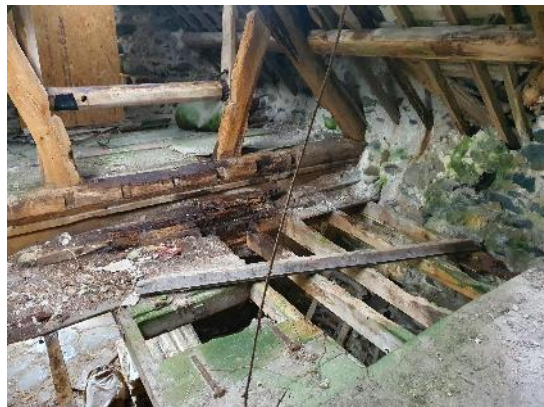
9.2.1 F01a – The Mill Range

Buttered pointing generally satisfactory. Timber floor (both boards and structure) perished to approx. half the floor. Some of rafters have signs of rot. Majority of torching has failed.

- Allow to brush down pointing and consolidate with new to 25%.
- Allow for 5no. splice repairs to rafters to 50% of length.

- Allow to replace boards and joists in their entirety to this area on a like-for-like basis (joists 65 x 125mm and floorboards 170 x 25mm).
- Allow to locally rebuild outer skin of stonework immediately below valley to east wall.
- Allow to shim under rafters to reinstate connection to 4no. purlins.

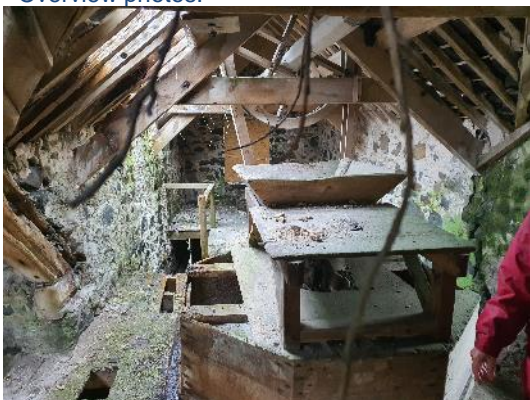
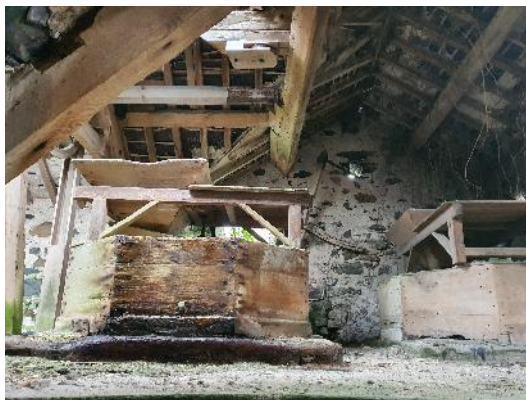
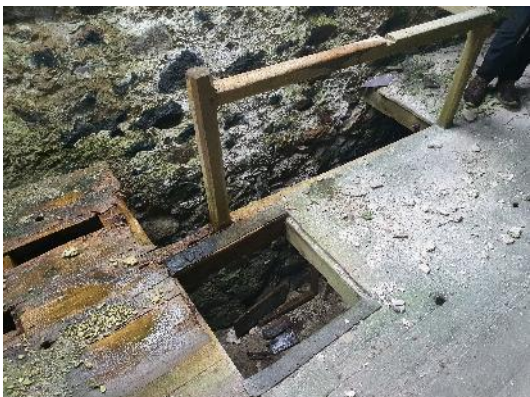
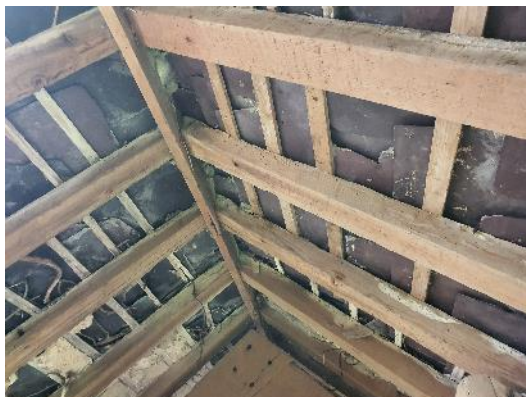
9.2.2 F01b – The Mill Range

Buttered pointing generally satisfactory. Timber floor (both boards and structure) perished to approx. half the floor. Some of rafters have signs of rot. Majority of torching has failed.

- Allow to brush down pointing and consolidate with new to 25%.
- Allow to replace valley board to west wall.
- Allow for 5no. splice repairs to rafters to 50% of length.

- Renew the octagonal Tuns complete.
- Install operating ropes.

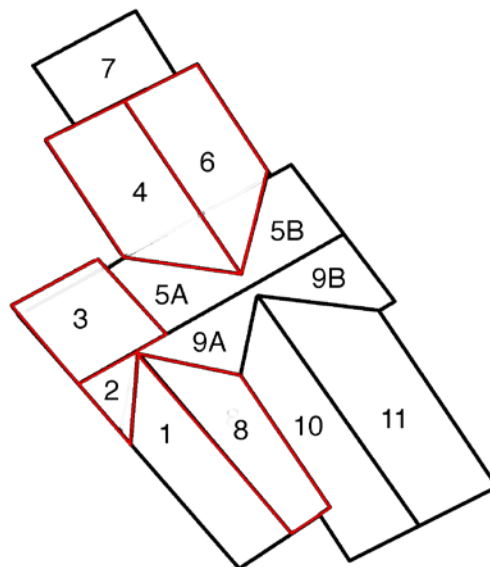
The roof was inspected on the 12th August 2020 from the ground and at roof level on slopes 1- 5A, 8, 9A and 10 shown in Figure 1. Other areas were not accessible closely and area 7 was not inspected. The valleys at areas 4-5A and 8-10 were heavily covered in plants and deep compost. The former was cleared and inspected but it was not possible to clear the latter.

Figure 1. The roof was inspected at roof level at slopes 1- 5A, 8, 9A and 10. The areas in red are covered with random sized slates. The remainder are single sized.

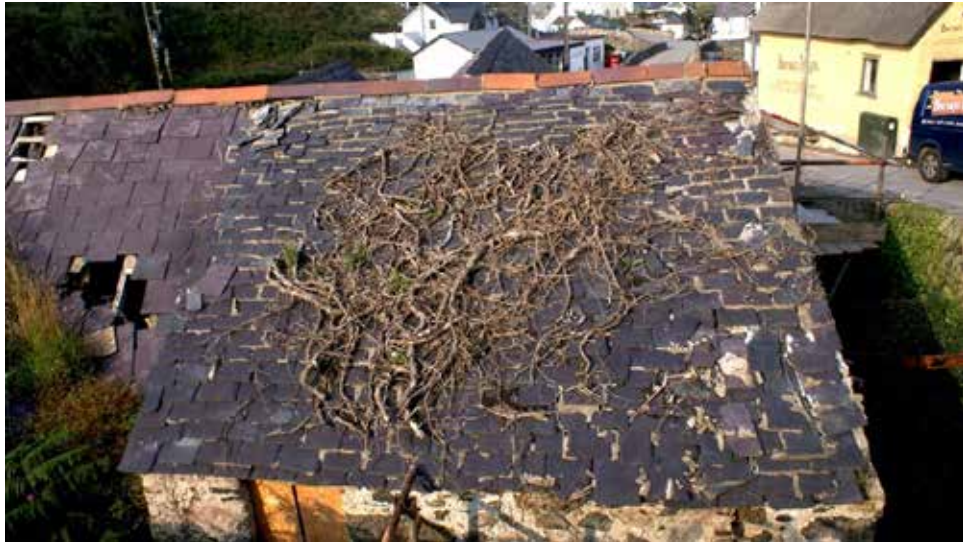
Figure 3. Area 3. Larger random slates from the Cambrian age, Bethesda to Nantlle slate belt.

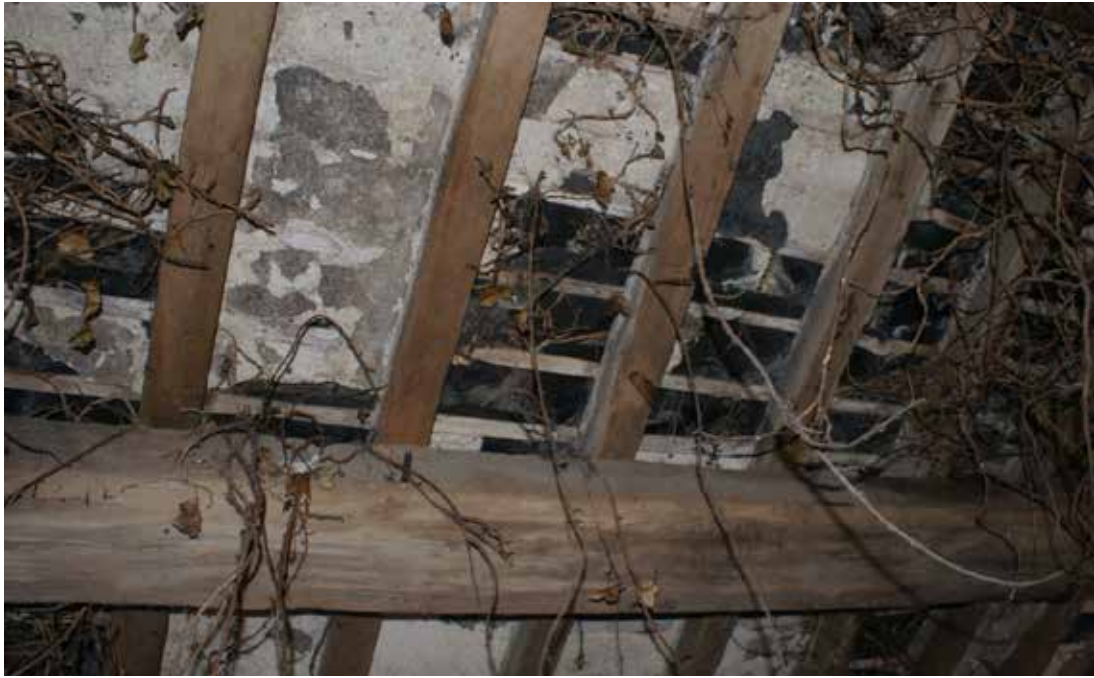
The majority of the slates are peg hung on riven (areas 1, 2, 4 and 8 see figure 5) or sawn laths (areas 3, 5 and 9 s 3 and-11 see figure 6) but on areas 5 and 9 they are centre nailed to sawn laths. All the mill areas are torched although much of it has fallen off. Torching, besides draft-proofing the roofs would be important for a mill to prevent drips from condensation on the underside of the slates which could hamper the milling and cake the flour. Besides moisture generated by the corn drying, sea mists could also be a source of moisture and condensation.

Figure 5. Area 3 Top hung slating on riven laths and torching.

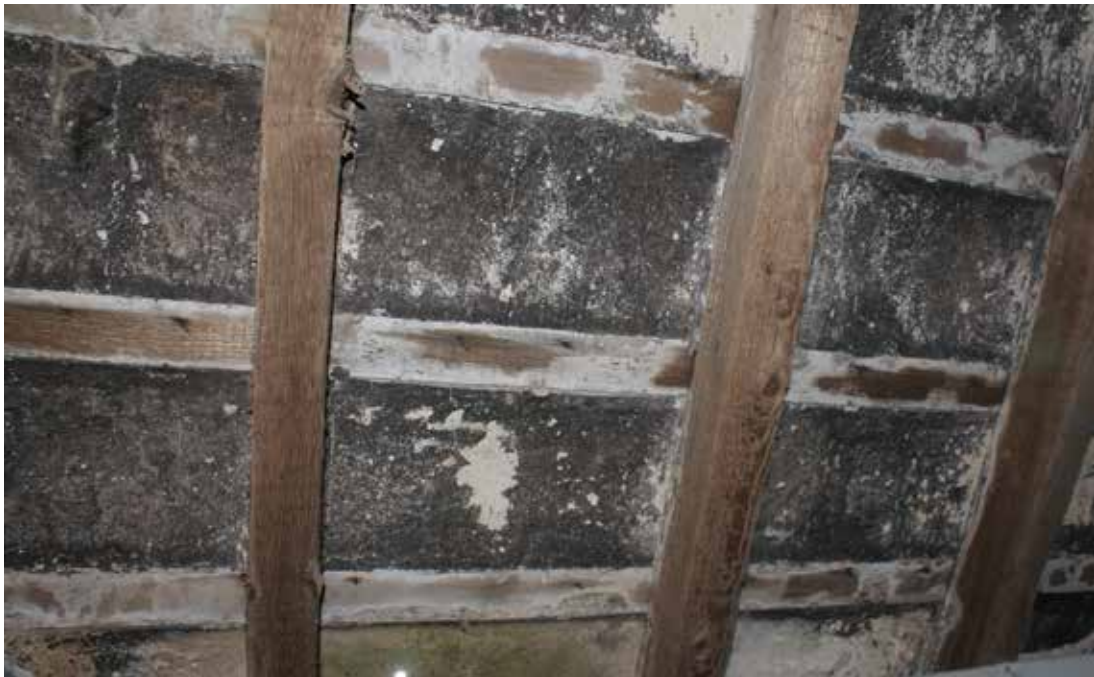
Figure 6. Area 5 Centre-nailed slating on sawn laths and torching. The slate nails are visible in the laths

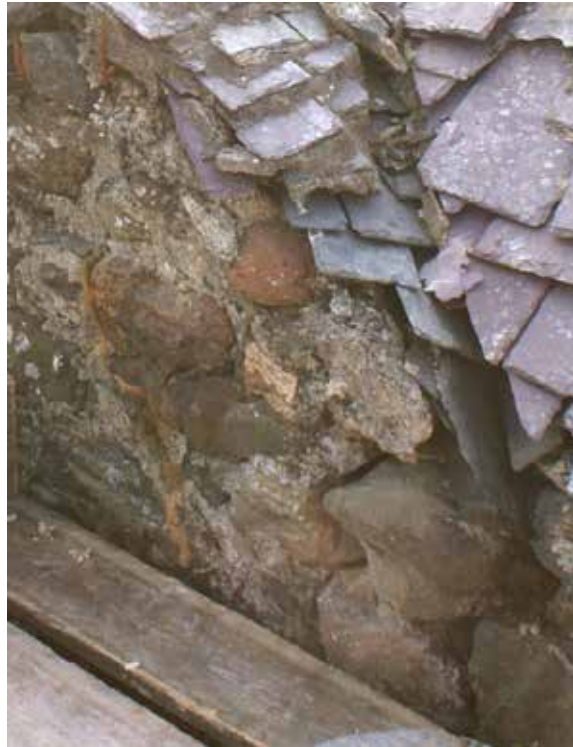
The eaves slates are bedded onto the wall head and the first course bedded on to the under-eave slates (Fig 4). There is generally an eaves overhang of 2 to 3 inches. At the eave of the Welsh valley there appears to have been little overhang and consequently the masonry mortar below has been washed out (Fig 10). All the ridges are closed with plain clay tiles coloured either blue-brindle or red (Figs 3 and 11). The half bond to the slating at the verges is closed with alternate narrow and wide slates. The tally slate verges are closed with various width rather than exactly half slates or slate-and-a-half width slates (Fig 12).

Figure 10, The eave of the Welsh valley appears to have had little overhang. Consequently, the masonry mortar below has been washed out.

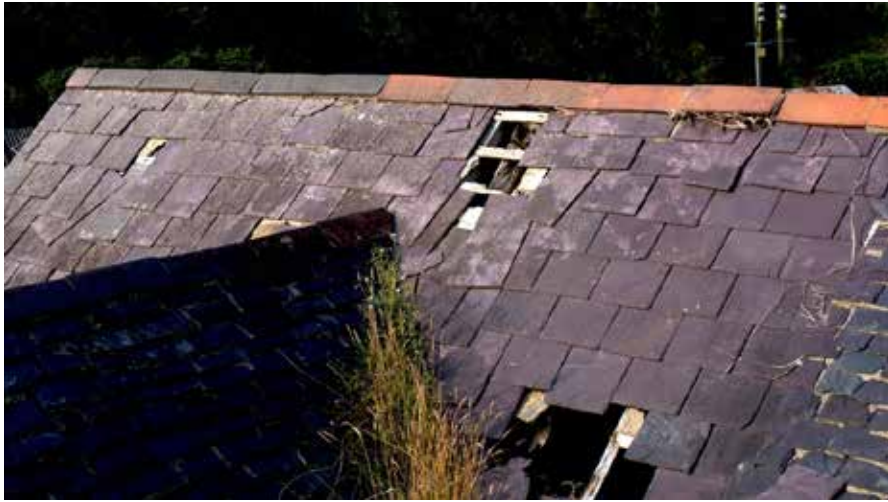
Figure 11. Area 5. Blue brindle and red plain ridge tiles.

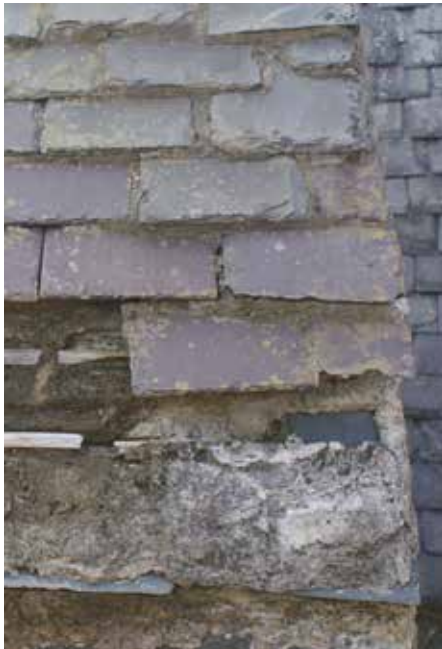
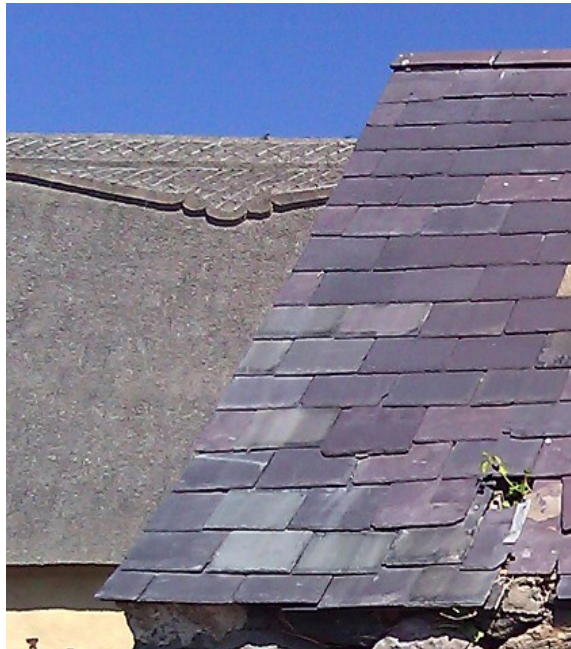
Figure 12. The half bond at the tally slate verges has been closed with various width rather than exactly half slates or slate-and-a-half width slates
