TRI-COM BOARD OF DIRECTORS SPECIAL MEETING
Special Meeting Agenda
Friday, September 20, 2019

Project Name: STARCOM21 Conversion Project

Customer Name:	Tri-Com Central Dispatch						
Equipment Location	3823 Karl Madsen Drive, St. Charles, IL 60175						
Requestor:	Debra Brown			Project #:		TBD	
Inspector's Name:	Michael Barton			Audit Date:		August 5th, 2019	
Site Name:	Central Dispatch						
Motorola Pass/Fail	Pass	33	Fail	12	N/A	95

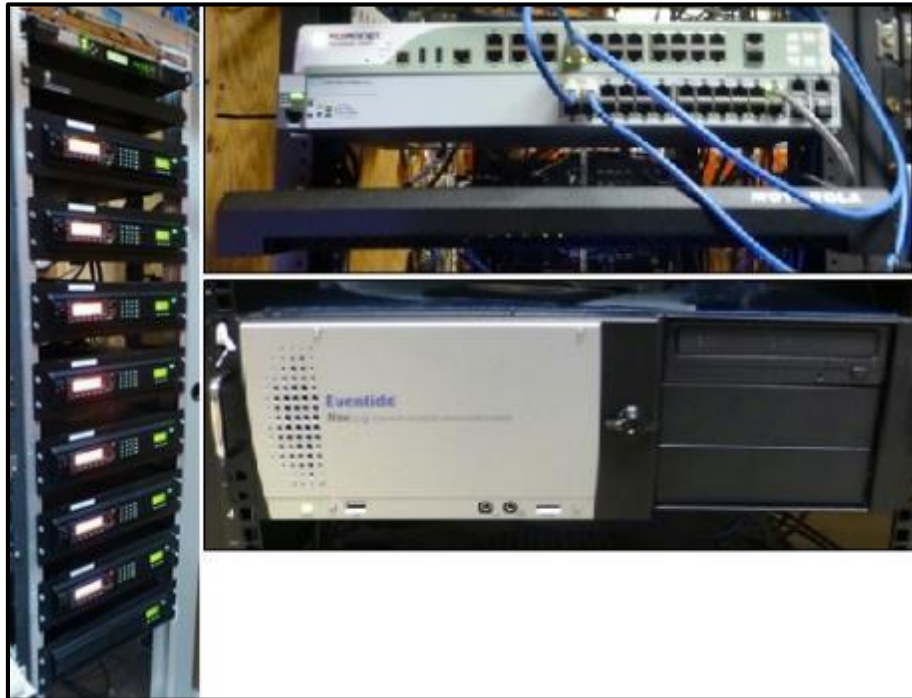
Central Dispatch Equipment.

The Tri-Com Central Dispatch new equipment consists of 7 new APX Consolettes, RFI Combiner, FortiGate, LAN switch, KVM, GGM 8000, SDM, IP Logger and other associated peripherals. Two new Omni antennas were mounted on a steel structure on the roof. Some existing equipment was reviewed and listed on this report for information. Not all deficiencies listed are related to the new equipment. This R56 audit consists of defining all deficiencies that are related to the installation of equipment that was installed under the above noted project number only. Any existing conditions of this site were not part of this audit and no deficiencies have been identified on this document that pertains to those existing conditions.
