Inspection report for the property at  
99 Big Tree Lane, Jackson, TN 38301

This report is prepared exclusively for **John Smith**  
Inspected On: **04-16-2026**

Inside Out Home Inspections  
(731) 410-7111

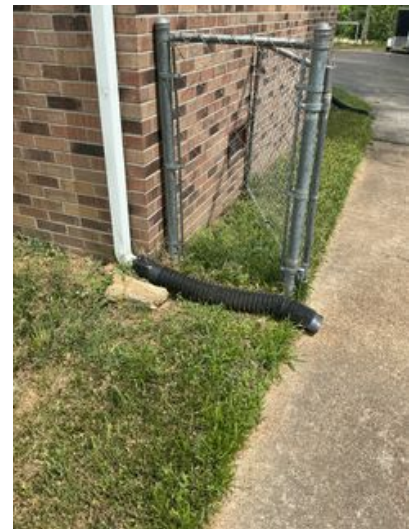
All downspouts had extension, discharging water away from the foundation

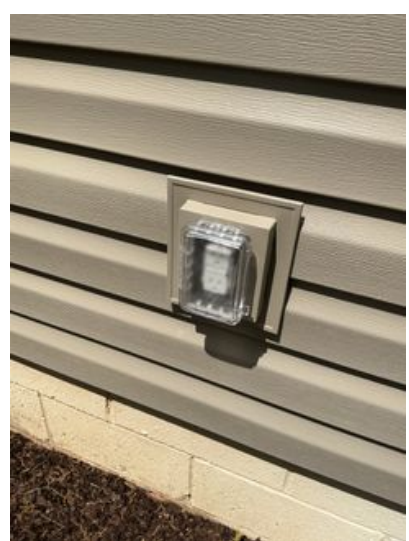
Appropriate GFCI and weather proof cover on receptacle on south side of house

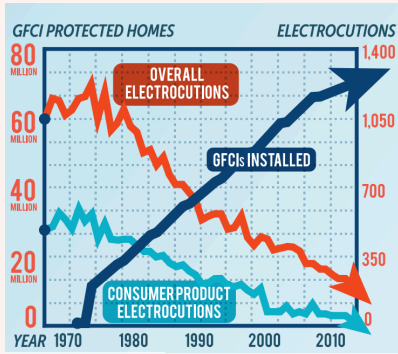
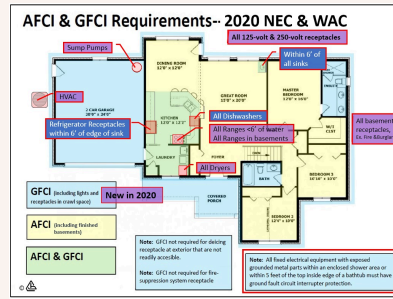
***During inspection today, I noted that GFCI protection is inconsistent with modern minimum standards for safety in the following locations: carport***

***During inspection today, I noted that GFCI protection is inconsistent with modern minimum standards for safety in the following locations:***

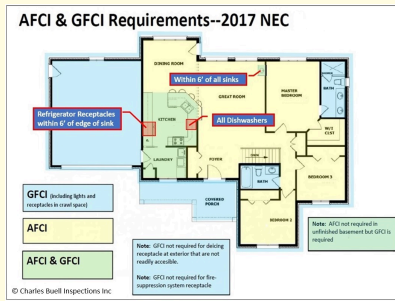
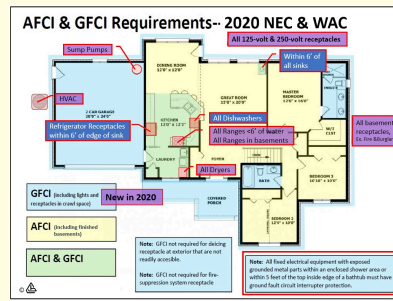
### **(ES-3) Improve or Upgrade: MODERN AFCI PROTECTION IS A SAFETY IMPROVEMENT**

AFCI (arc fault protection) is now required on all branch circuits supplying outlets or devices installed in residential dwelling unit kitchens, family rooms, dining rooms, living rooms, parlors, libraries, dens, bedrooms, sunrooms, recreation rooms, closets, hallways, laundry areas, and similar rooms and areas. The goal of this protection is to reduce risks of electrical fires. Consult with a licensed electrician about improving circuit protection as desired. I would consider this improvement in the context of other electrical repairs or upgrades. ***Please note that if you add or replace receptacle outlets to the existing system, they should comply with modern AFCI standards.***

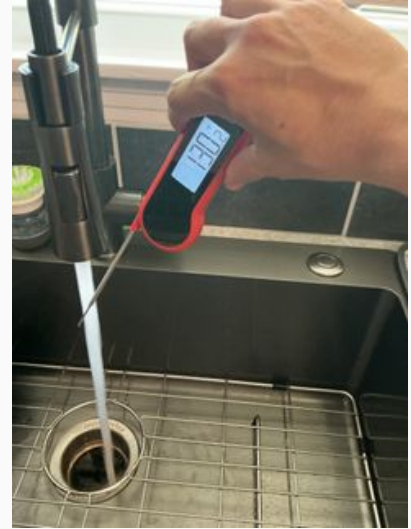
**Water Temperature Measured During Inspection:** 130 Degrees F

*This shows the approximate water temperature at the kitchen sink time of inspection.*

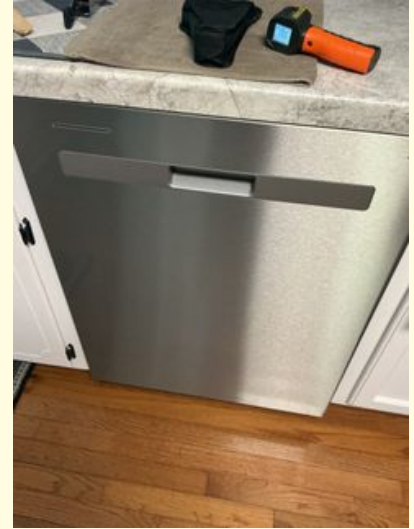
**NO WATER HAMMER ARRESTOR WAS FOUND - DISHWASHER**

Water hammer arrestors are now [required](#) where quick closing valves are utilized - this is most dishwashers and washing machines. Installation of a hammer arrestor device is recommended for improved reliability of the piping system.

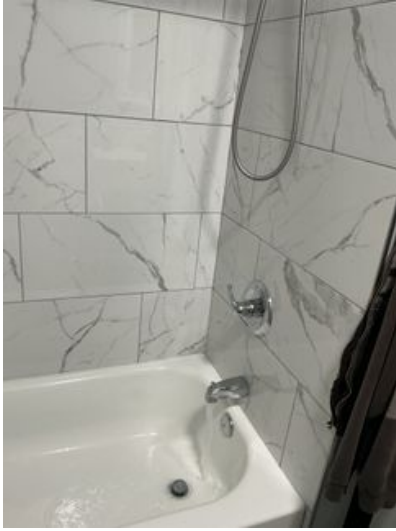
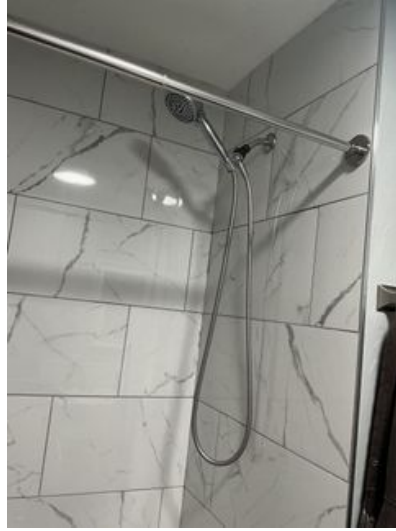
### ***TILE SHOWER NOTED***

*Please note that the longevity and reliability of the tile depend on what it is mounted on and what it is mounted with. This critical tile preparation is not visible to inspection. We make our best guesses about tile reliability using visual inspection and sounding for loose tiles. Moisture meters can also be used in some wall applications, but the moisture meter presents a false positive on most tile floors or pans. Regular tile cleaning and sealing can help prolong the life of a tile shower installation.*

**Tub Type:** Pressed steel

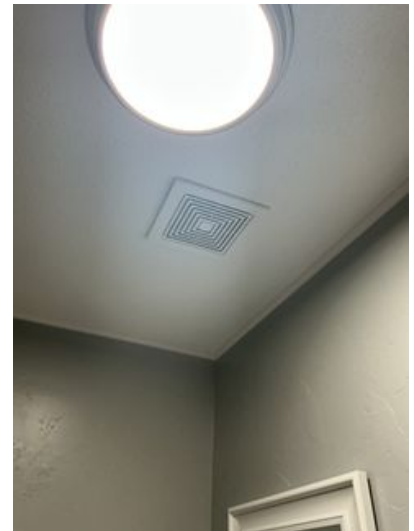
**Type:** Bath fan

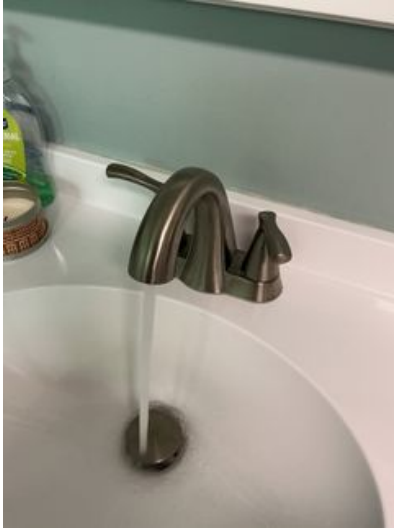
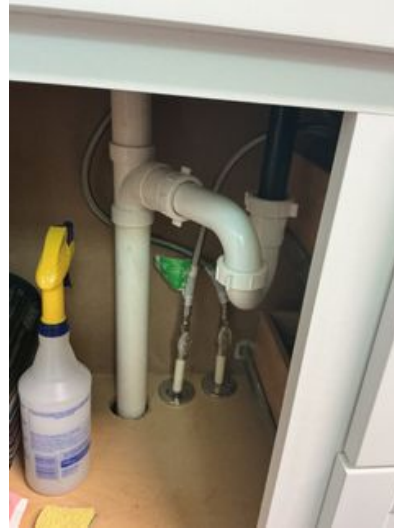
Functional Flow at Sink  Functional Drainage at Sink

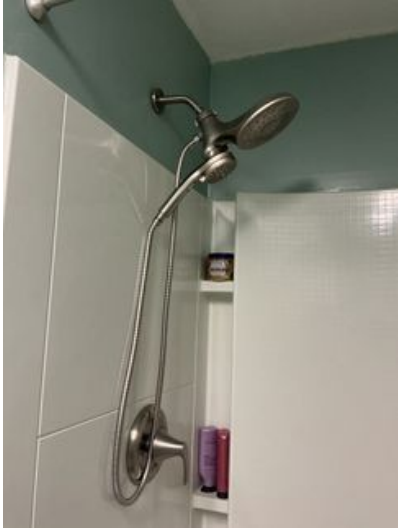
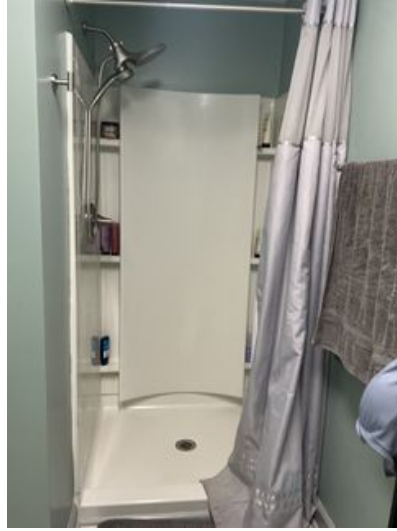
**Acrylic Shower/Tub:** It appears well-mounted, minimal flexing noted underfoot

*Stepping inside the acrylic shower/tub I did not find any significant flexing underfoot.*

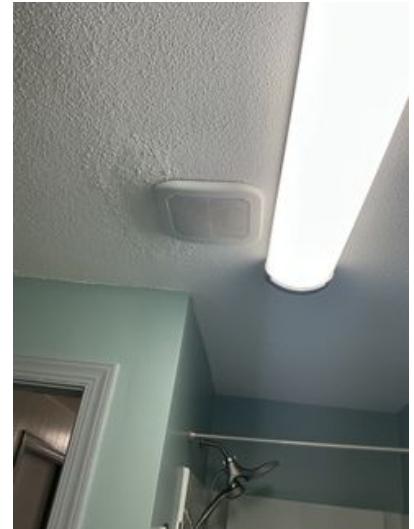
**Type:** Bath fan, Operable window

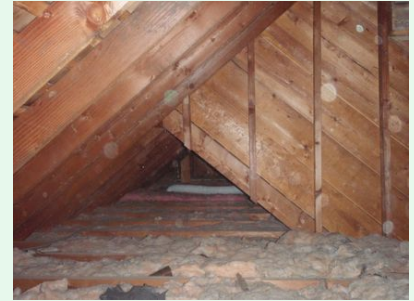
#### **NO ACCESS DECKING IN ATTIC**

There is no decking or safe way to access the attic space. Crawling through insulation and on top of framing risks damaging thermal barriers and ceiling finishes and is not a safe way to access an attic. This limited inspection of this space.

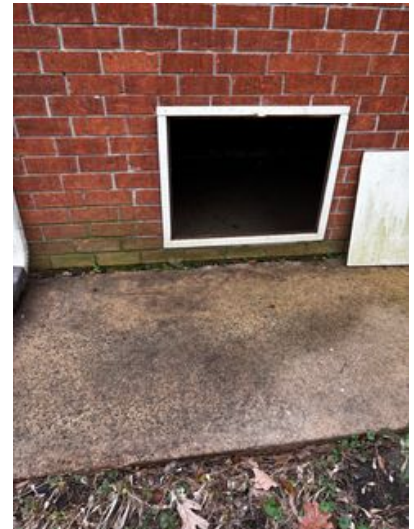
**Crawl Space Access Locations:** Exterior access (East Side)

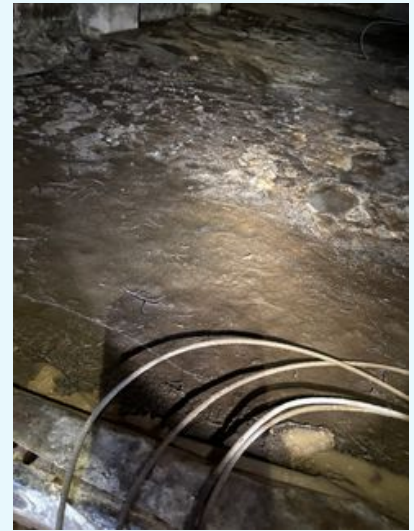
**(CS-3) Recommended Disclosure Items:**

**SIGNS OF PAST DRAINAGE PROBLEMS NOTED**

The crawl space was dry at the time of inspection, but I noted indications of prior water in the crawl space. This is difficult to understand during a one-time inspection as conditions can change seasonally.
