How To: Automatic Transmission Indicator Pin Replacement

PRNDL

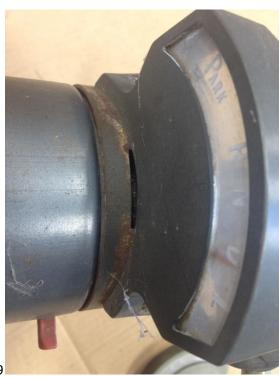
Pic 39

The housing for the PRNDL indicator is held on with two screws. (Leave them on for now) If the housing has already been removed then you will see this (pic 40) if the pin is in place.

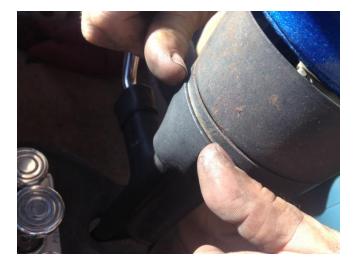
Remove this carefully by gently squeezing the topsides with both of your thumbnails under the plastic. Gently squeeze toward the middle. Use both thumbs under the top part of the plastic cover. It's a tight fit and the plastic can break easily. If it is cold outside, you may wish to apply some gentle heat with a heat gun or hair dryer. If it feels real hot to the touch then back off with the heat as it could melt or distort.

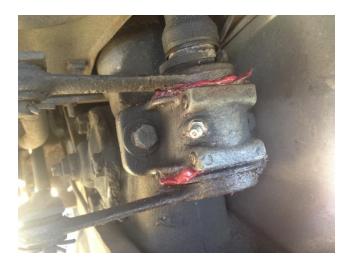
Locate the lower shift rod connection. This is located on the top of the steering box. .

It can be seen through the front of the grille on the driver's side.

Crack loose the two bolts holding the lower shift housing onto the steering gear. Remove them enough to apply penetrating oil on the now exposed threads of the two bolts. Use a long spout on the oil can to put the lube right on the threads. Then work the bolts back in. If the bolts do not come loose, do not

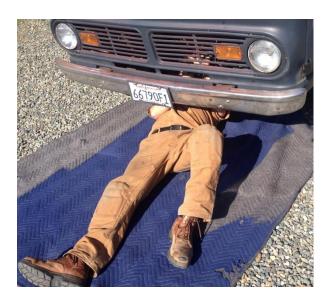
Start with a pointed punch if desired. If there is no movement then use a ½" pin punch. The goal is to avoid striking the housing. Drive the pin only partially out of the housing. This pic shows the position that worked well for me. In this pic, the punch is not centered on the pin correctly. Be sure the punch is centered before striking hammer blows. Be sure the pin punch is not flattened at the top or it will be too big for the housing and possible damage it. Do not drive the punch into the housing too far. Shorter pin punches will allow the tapered of the punch to be driven into the housing and cause damage. Do not try to drive the pin all the way. Stop driving the pin just as the pin touches the sheet metal. The pin should remain in the lower shift housing.

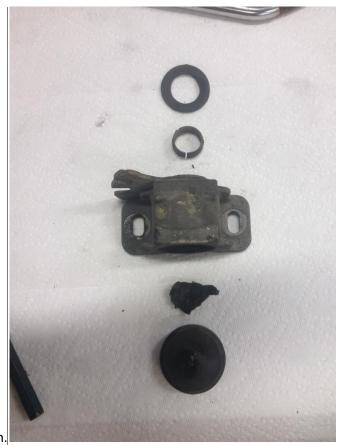
Lay everything out and inspect after cleaning. By the way, the piece above the round plastic plug on the bottom is a 50 year old chunk of dried up grease.

Disassemble the lower shift housing and clean.

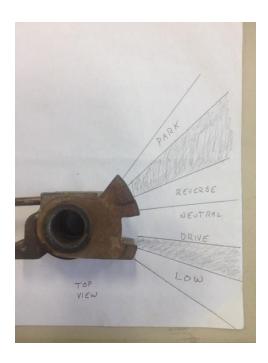
This pic shows the underside of the auto column lower shift housing. The pressed in ring is part of the rooster tail.

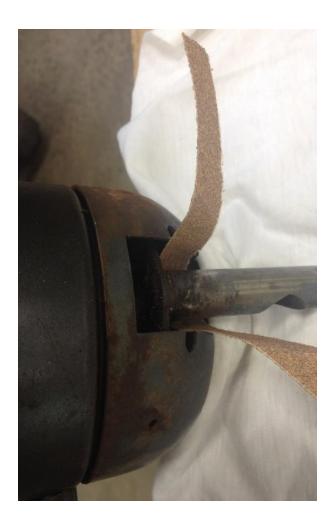
The top can be cleaned with a small file. Be careful not to remove too much. If you use a file, apply only gentle pressure while rotating around the shaft. Avoid "flatspotting" the shaft.

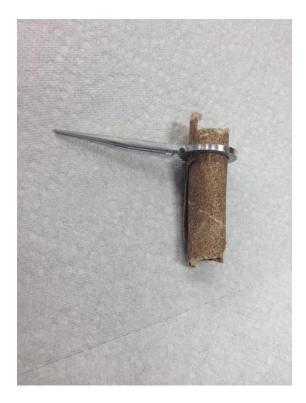
The pin will likely need some additional sanding to allow it to fit well over the shaft. These pins are shipped undersized slightly so that you can make the final fit. The pic below shows the inside diameter of the shaft being enlarged. Here I'm using 100 grit sandpaper rolled up for minor size adjustments. Just rotate the pin on the sandpaper to remove small amounts of material. (This pic shows a pin without the spring clip retainer.)

For faster material removal, wrap a socket with the 100 grit. For me, a 3/8" Snap-On 3/8" drive deep socket worked well. Reposition the sandpaper often. Recheck the fit frequently. You want a nice tight fit with little play. Don't take off too much too fast. Use finer grit sandpaper as required. When you are finished, the pin should go on the shaft smoothly.

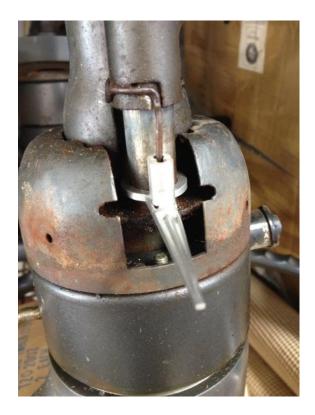
Above pic shows a test fit without snap ring in place. Be sure the lower shift rod does not drop or go off the top of the steering column or the shaft will not align properly and can cause damage.

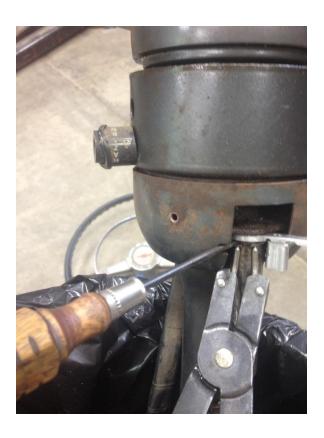
Below pic shows small screwdriver helping remove the snap ring during a trial fit. Too many times removing the snap ring and it's worn out.

The snap ring pliers must fit the ring well or it becomes more difficult to install. This is the most tedious part of the job. It's much worse if the column is in the vehicle. You will likely need to be at a contorted angle. Take your time.

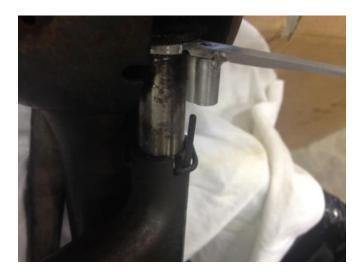
Carefully raise the shifter column and test fit the spring. The spring must gently fit into one of the two holes.

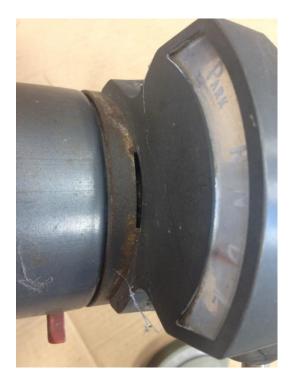
Test fit the PRNDL housing and check for proper fit. The indicator should not touch the PRNDL housing.

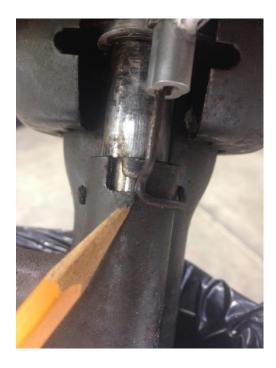
With the lower shift housing loose, avoid excess travel while checking movement. The spring may slide off of the shifter groove as shown below. Just move it back into place.

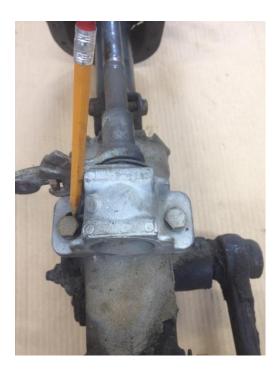
Reinstall the bolts for the lower shift housing. Make sure the slots are evenly aligned and check for depth of column movement.

Adjust accordingly. Tighten bolts.
