ROYAL VALLEY SUBDIVISION DRAINAGE REVIEW

Royal Valley Homeowners Association, Inc.

September, 2021

Revised & Final: September, 2023

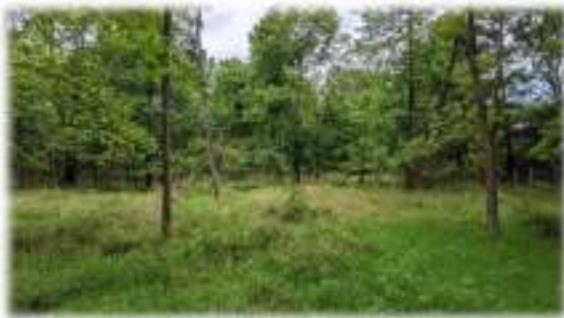
Open space between Corkwood and Scottsdale.

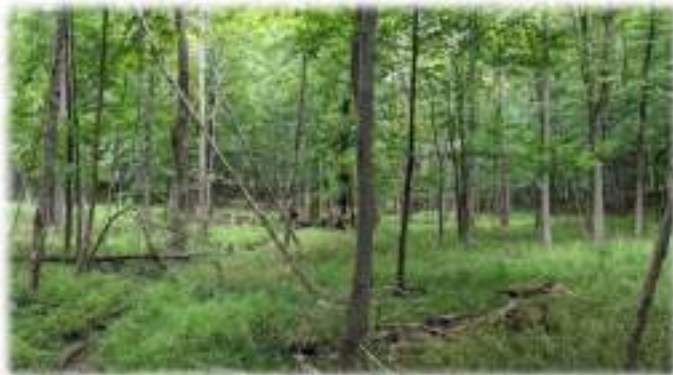
Riparian valley of Common Area PPN#489-17-024

It is likely that the headwater floodplain within this common area is providing significant water retention in the form of a sinuous, braided channel and completely vegetated floodplain.

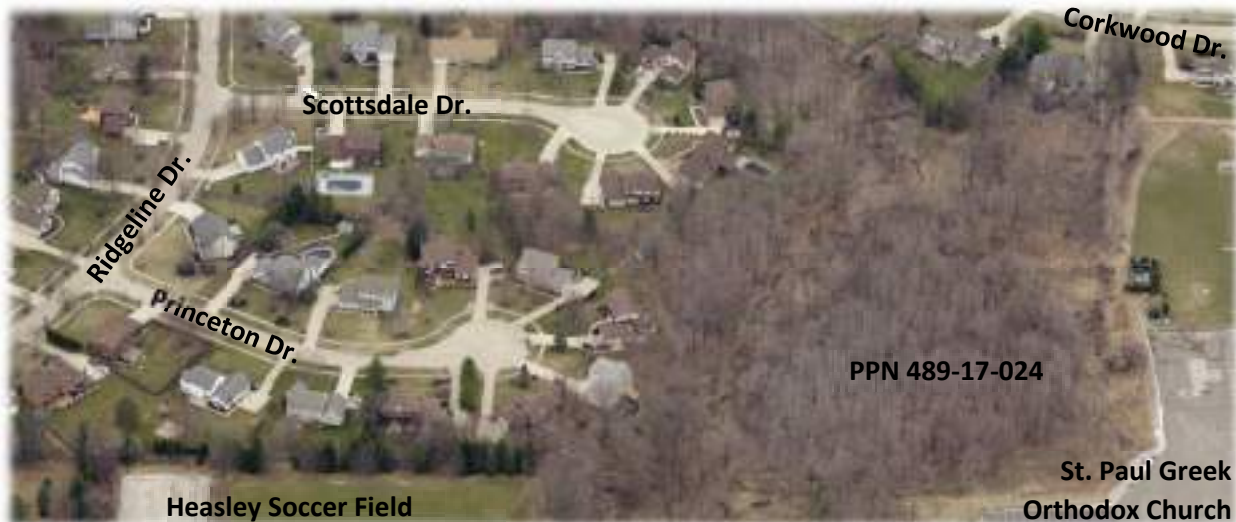
The area receives several point source stormwater inputs from Heasley Soccer Field and residential units to the south. St. Paul Greek Orthodox Church to the southeast also drains a large portion of its area to this parcel. This Common Area collects several upstream stormwater inputs. The stormwater basins along Princeton Drive, Scottsdale Drive, and Vale

Drive all have a point source outlet into the Common Area. Eventually the entire hydrological regime flows to a point at Royal Valley Drive where it is culverted. As the floodplain narrows, plateau areas give way to steeply sloped upland valleys.

Eagleview (CEGIS) of Common Area PPN#489-17-024 headwaters. April 4, 2019

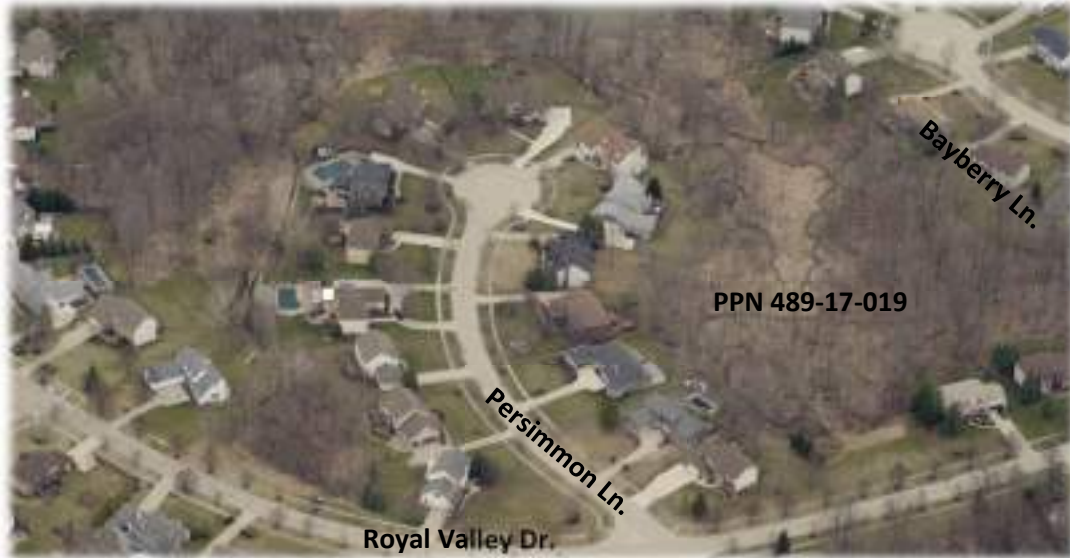
As the Common Area expands, so does the floodplain, eventually becoming a wide, vegetated area which terminates at Basin #53. During investigations it was found that this area contained depositions of silt and detritus from yard waste and upstream erosion or transportation of sediment.

East of Persimmon Lane the common area contains a wide floodplain which receives hydrology from the road culvert at Royal Valley Drive and receives overland flow from the southeast where a gently sloping upland woods was noted. In addition, an outlet from Persimmon Ln was observed discharging into the riparian corridor. As was described with the western tributary, the riparian corridor becomes inundated with silt and detritus.

Eagleview (CEGIS) of Common Area PPN#489-17-019 headwaters. April 4, 2019

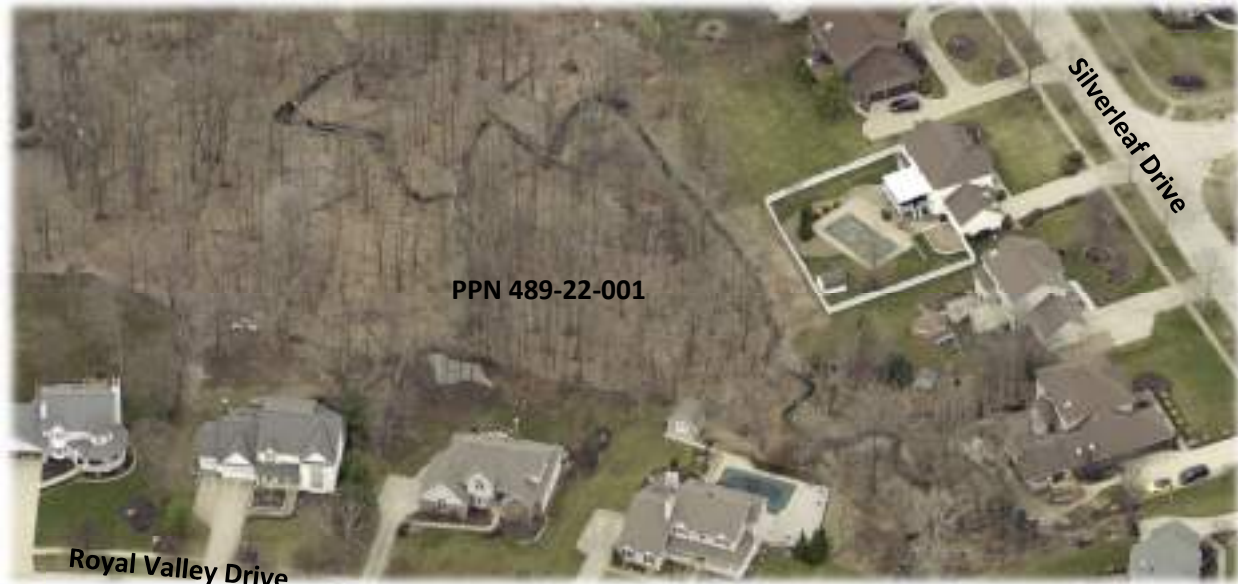
This open area is fairly uniform as it leads into Basin #54. The open space begins at the culvert under Royal Valley Drive just west of Silverleaf Drive. A narrow and eroded right bank was noted within the open space at the rear of 9804 Silverleaf Drive. A floodplain surrounds a stream channel which is flanked by upland sloped wooded area.

Aerialview (CEGIS) of Common Area PPN#489-21-001. April 4, 2019

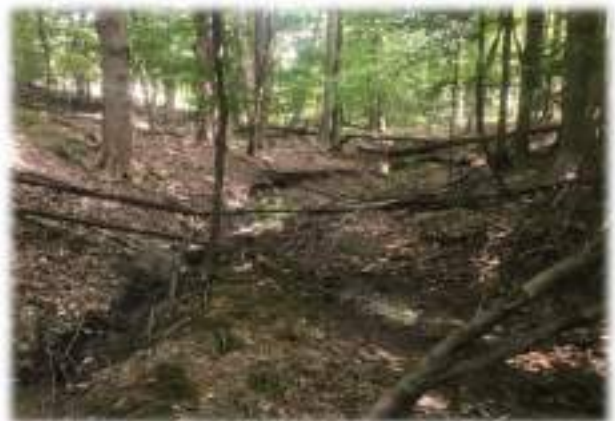
Riparian corridor between Buttonbush and Dublin Drive

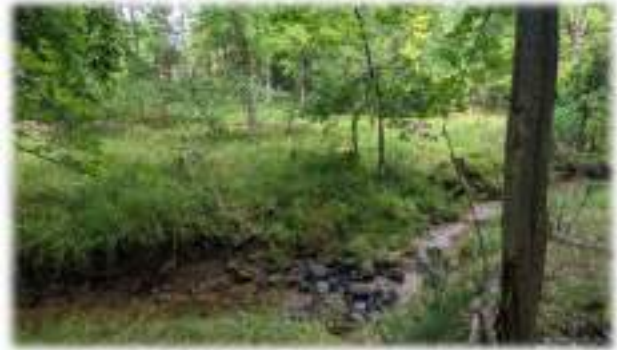
Stream 53 West Between Scottsdale Dr. and Corkwood Dr.

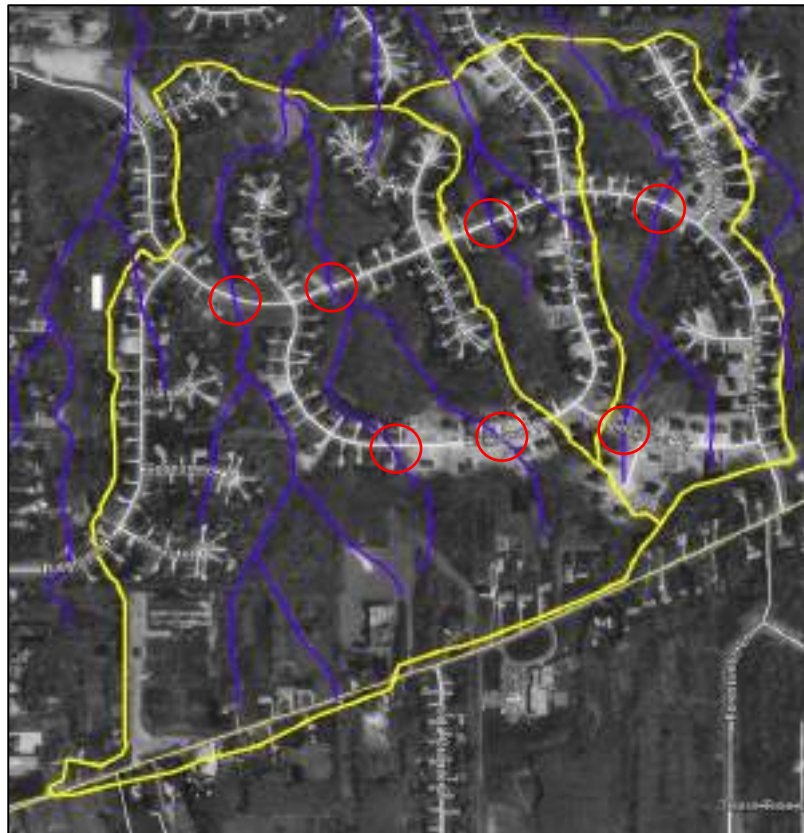
By 1994, the infrastructure and majority of homes within the subdivision were in place. This includes culverting of stream channels, construction of stormwater basins, and all other stormwater features. The photo below shows an aerial (Google Earth Pro) from 1994, the boundary of the drainage areas to each stormwater basin, and the approximate original stream channel footprint prior to construction of the subdevelopment. Red circles indicate current culvert location. At 5030 Corkwood Drive, the stream is captured in several stormwater basin inlets, and then culverted north.

1994 Aerial overlay with Cuyahoga County Stream GIS Layer.

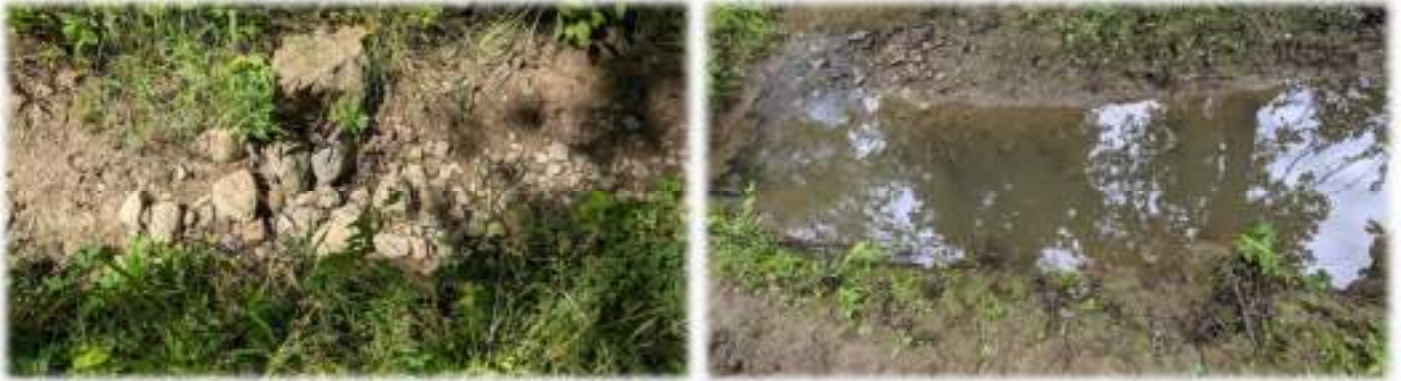
Today, the four stream channels exhibit similar morphology due to their urbanization. Their upstream components are relatively high quality including a wide flood plain, sinuous channel, and substrate free from embeddedness or washed-out hardpan. This contrasts to the downstream portions, with heavily incised channels, higher levels of turbidity and silt, and hardened substrate as the channels are culverted and receive additional stormwater inputs.

Comparison of upstream higher quality channel substrate (left) vs downstream lower quality (right)

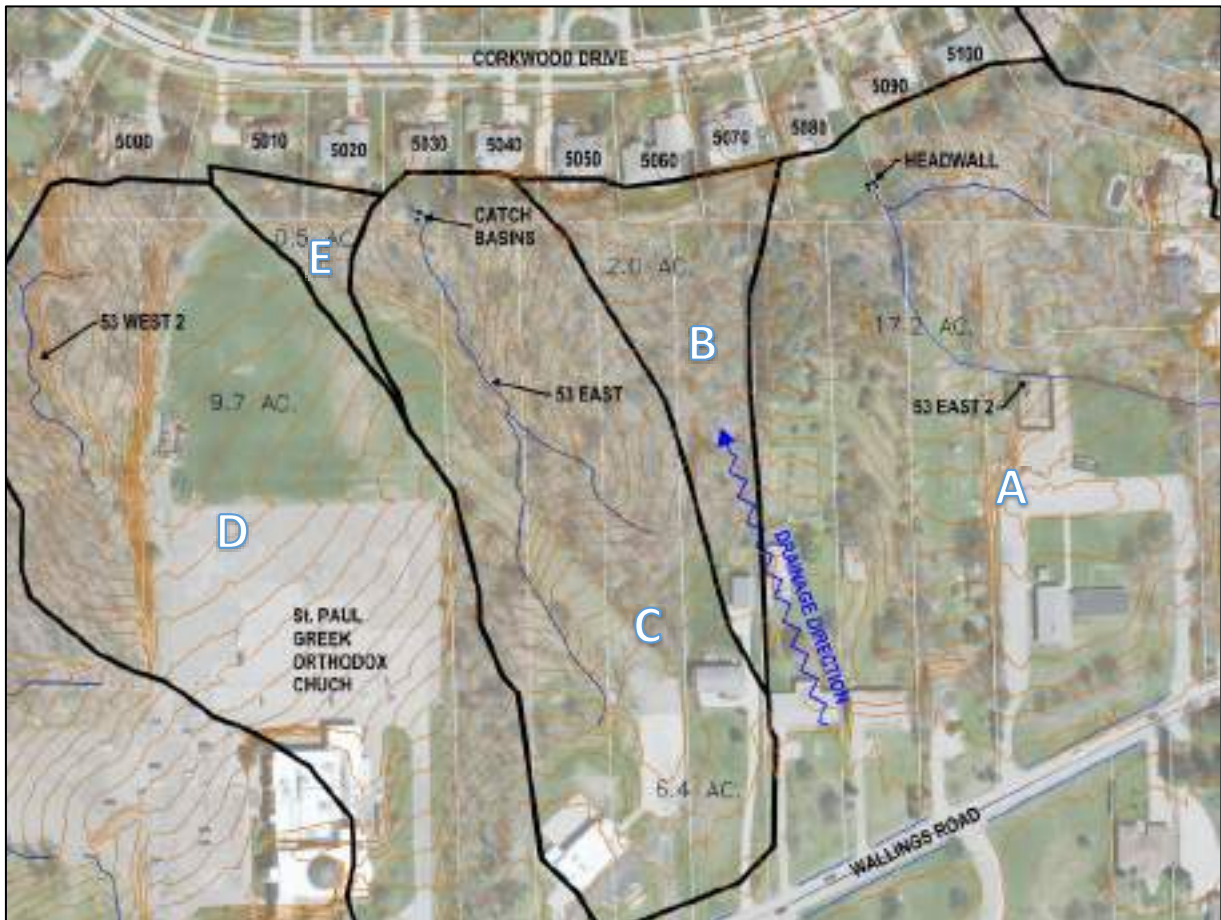
There are four drainage divides for this sub-watershed, which include a headwall to storm sewer at 5080/5090 (A), rear yard catch basin to storm sewer at 5060 (B), rear yard catch basin to storm sewer at 5030 (C), and an open channel running behind 4990/5000 that continues northwest towards River Valley Drive (D). A minor sub-catchment (0.5-acre) of overland flow is uncaptured by the 5030 basins or the riparian valley south and west of 5000 Corkwood (E). This area drains to 5010 and 5020 Corkwood. The headwall at 5080/5090 as well as the open channel behind 4990/5000 (A/D) were identified as areas of least concern with only minor impairments. The inlets for the other two channels (B/C) do exhibit deficiencies that indicate flow is not efficiently entering the storm sewer system and is contributing to drainage concerns.

Existing Corkwood sub-watershed and minor sub-catchment drainage areas between Wallings Road and Corkwood Drive.

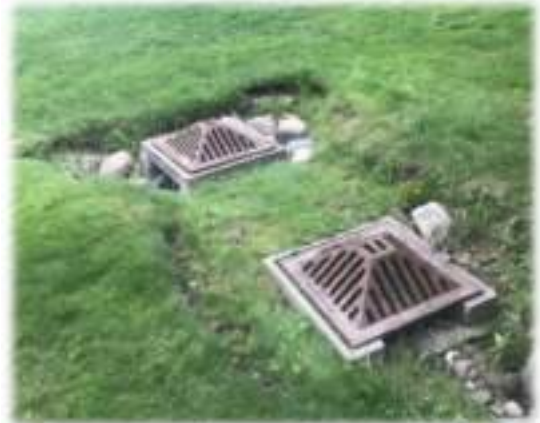
The most significant issue identified for this AOI is the drainage divide to 5030 Corkwood Drive. This yard is at the end of an approximately 6.3-acre drainage area. There are two (2) yard basins with trapezoidal raised grates that have insufficient inlet capacity (see Figures 1 and 2, right). A localized depression has developed at the basins. This appears to be a function of the type of structure and casting at the location. There are windows on one side of each structure, so water is ponding on the other three sides before reaching the level of the inlet grate. The capacity of one of these windows is also further restricted by a drainage pipe tied directly into the window. The trapezoidal grate requires water to pond before the full capacity of the grate can be utilized. The depth of the localized depression at the basins is about equal to the top of the grate, indicating that ponding levels do periodically reach the top of the basin, and that the full capacity of the inlet grate is needed at this location.

Figure 1. Rear yard basins at 5030 Corkwood

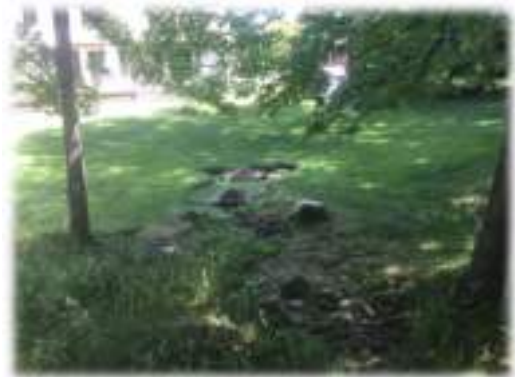
Figure 2. Drainage channel to basins at 5030 Corkwood

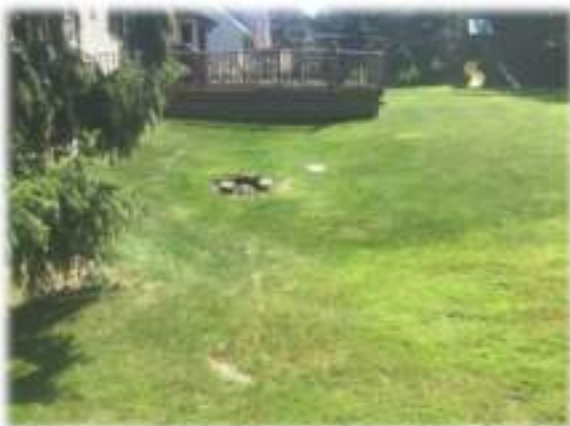
These dual basins drain to a third catch basin located nearer the home (see Figures 3 and 4 below, next page). This basin has a beehive grate and is surrounded by landscape pavers on three sides, which appears to have been installed as a measure against the erosion occurring at the basin. This basin does not appear to have as significant issues as the dual upstream basins.

Figure 3. Downstream beehive basin at 5030 Corkwood Drive

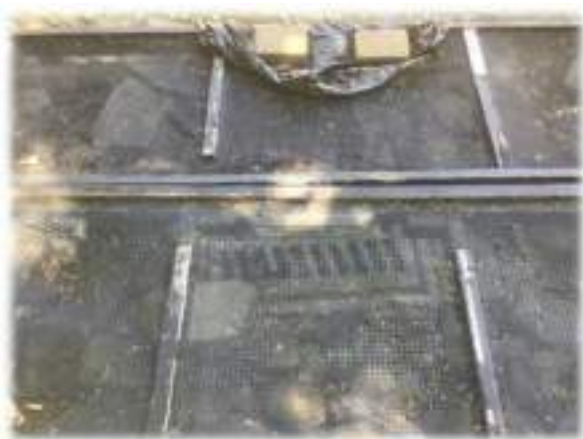
The drainage channel at 5060 includes a rock-lined channel to a rear yard catch basin that is covered with screening in order to capture debris (see Figures 5 and 6, below). This catch basin catches approximately 2.0 acres of drainage, which is mostly wooded land and can be defined as good condition, based on the presence of adequate litter and brush covering the soil. The drainage area is naturalized and no specific cause for the excessive debris to this catch basin was noted. Flooding specific to this residence was not evident in field investigation. However, the installed debris screening indicates there is excessive debris within the runoff carried to this inlet. The current homeowner is maintaining the system and it appears in good condition; however there is concern that such a high burden of maintenance rests with a homeowner on a private property.

Figure 6. Inlet basin at 5060 Corkwood Drive

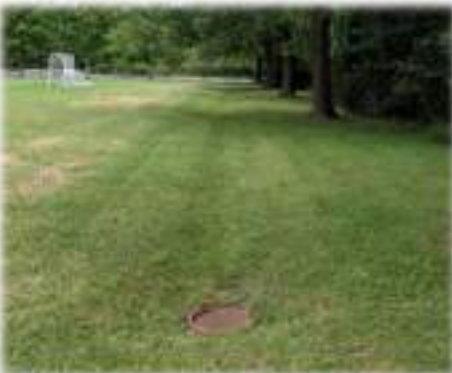
Circular Basin 1 (CB1) looking west within the drainage swale of Heasley Soccer Fields

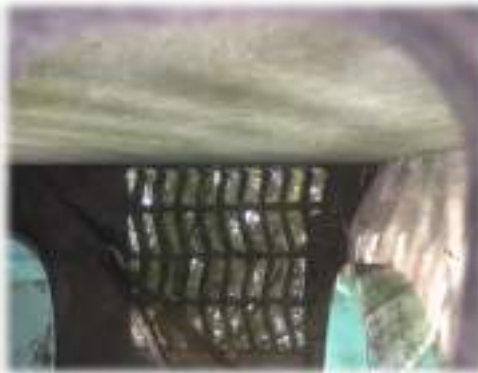
Inside of Inlet Basin 2 (IB2) from north showing an east and west pipe orientation.

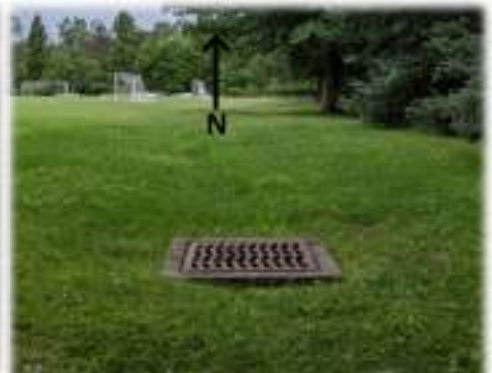
Inlet Basin 3 (IB3) looking west within drainage swale of Heasley Soccer Fields

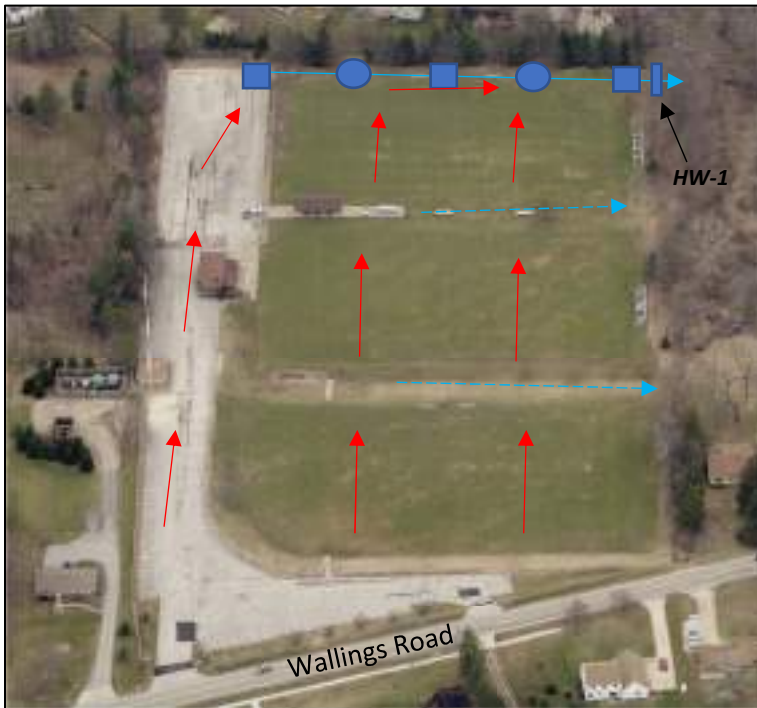
Eagleview (CEGIS) of Heasley Soccer Fields PPN#489-19-010, with approximate catch basin locations and general flow direction. April 4, 2019

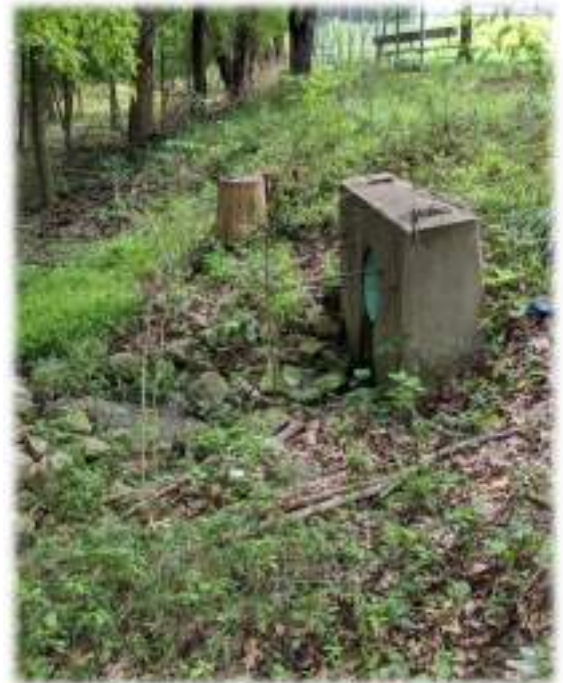
View looking south at HW-1 (see aerial view (left) for location) which discharges the storm drains along the northern field border.

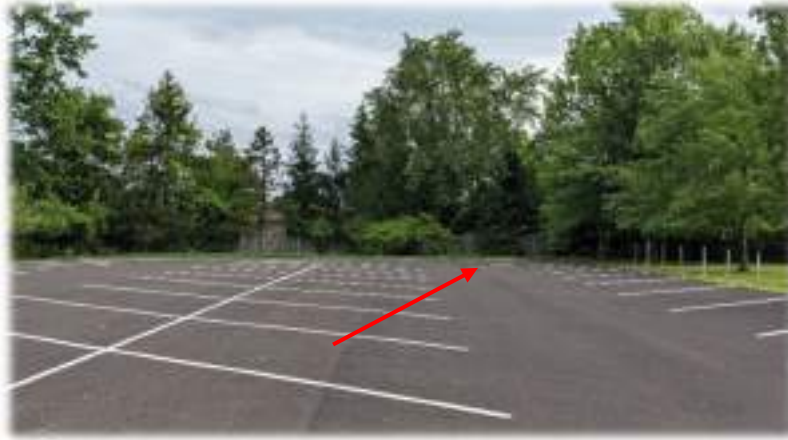
Northern limit of parking lot, with arrow pointing to single inlet basin (IB1).

The soccer fields are bordered to the west by an asphalt drive and parking lot. This area amounts to approximately 2.0 acres of impervious surface, all of which drains to the north. The slope within the parking lot is as much as 6% in the southern sections of the lot. These characteristics mean that stormwater travels at a rapid velocity down the parking lot, unimpeded and uncaptured. There is a single inlet basin located at the

northeast corner of the parking lot. The northern-most portion of the parking lot appears to have been recently paved, and visually appears to drain towards the basin. However, this single inlet is likely insufficient for all of the runoff from the 2.0 acres of pavement. There is evidence of channelizing and erosion within the grass north of the parking lot, suggesting that during heavy rain events the stormwater continues to flow north towards Princeton Drive. Unlike the system of grass drainage swale and series of inlet basins, the drainage within the pavement is sheet flow to a single basin. There is no redundancy or overflow protection for drainage that bypasses the single inlet.

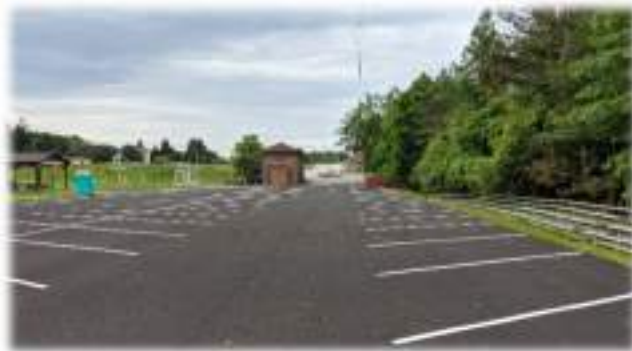
Looking south, view of parking lot draining north towards single inlet basin.

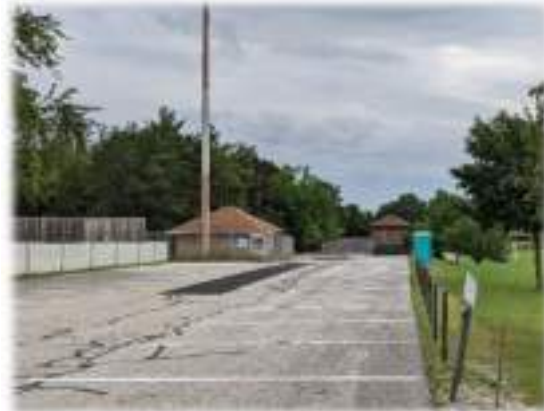
Southern portion of parking lot. No inlet basins.

The main recommendation for the Heasley parcel is to introduce additional inlets throughout the parking areas, the most likely contributor to deleterious stormwater flow. This installation would require additional storm sewer. There is a break in the parking lot, delineating the newer portion of the pavement from the old. A topographic survey would be required, but visually it appears it may be possible to introduce a local depression at or near this break point. Additional catch basins located here and tied into the existing storm sewer system north would reduce the flow concentrating down the parking lot and into backyards along Princeton. It may also be possible to repave portions of the lot to direct drainage of the parking lot into a grass or rock-lined channel outside of the pavement area. Such a diversion could slow the flow of water, and inlet basins could be installed along with perforated pipe within the swale to maximize capture of rainwater.

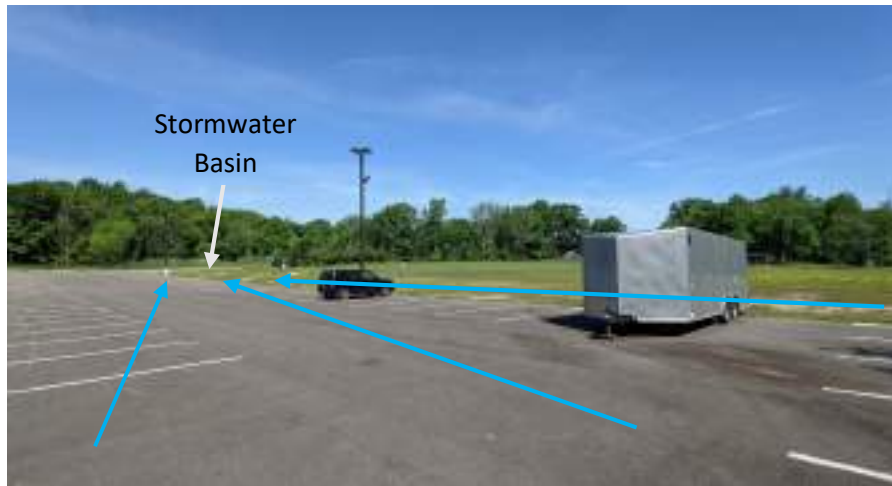
View of Church Parking Lot from the east which drains to PPN 489-17-024.

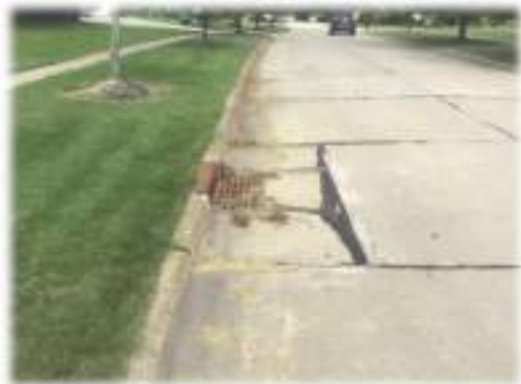
Roadway debris within gutter along Pickneya Drive

One of the suggestions is to clean out catch basins within the drainage area. Restricting the outflow to a small orifice, which appears to be the case in certain locations throughout the drainage area, means the catch basins are highly susceptible to clogging. Developing a routine schedule for inspecting and maintaining the catch basins, on an annual basis or periodically by street or section, would be a best practice to adapt to encourage efficient flow to the storm sewer system during rain events. The standing debris within streets suggests that water is ponding within gutters during rain events, and generally suggests that the local storm sewer system is not effectively conveying stormwater.

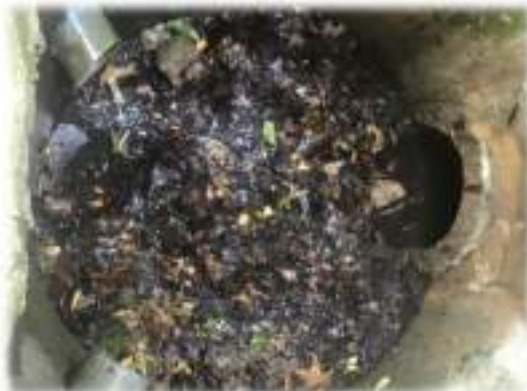
Catch basin debris- Ridge Line Drive

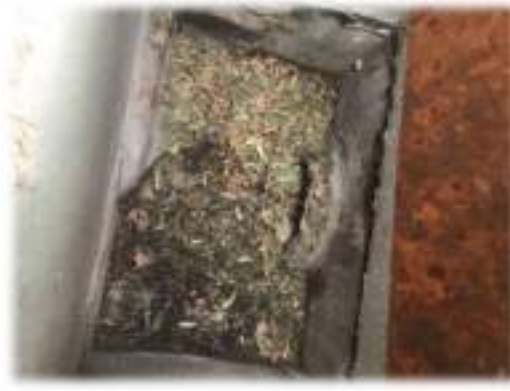
Catch basin debris- Sweetleaf Lane

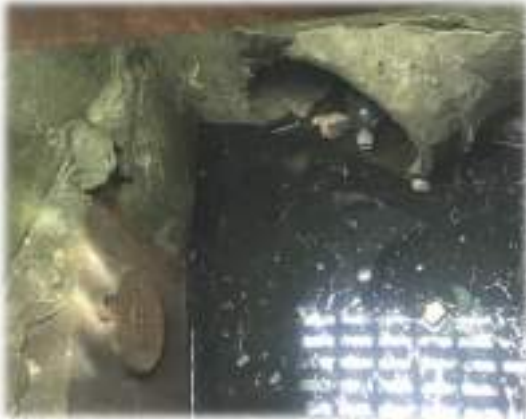
Circular orifice plate restriction- Corkwood Drive

An additional step would be to consider authorizing full analysis of the existing closed conduit system, to determine if outlet restrictions can be removed. It may also be beneficial to determine if storm sewer is appropriately sized for the drainage area and current rainfall intensities. Undersized storm sewers result in higher tailwater for open channels to drain to, and this may contribute to flooding within open channels and the small tributaries or outlet pipes that drain to those channels. A review of the subdivision plans and original design for the storm sewers could be performed, to determine the relevancy of the design to today's standards and methodology (similar to the review described herein for the stormwater management basins). It would be valuable to identify any deficiencies within the closed conduit system, and if the local sewer system is magnifying flooding concerns or otherwise contributing negatively to the stormwater management system.

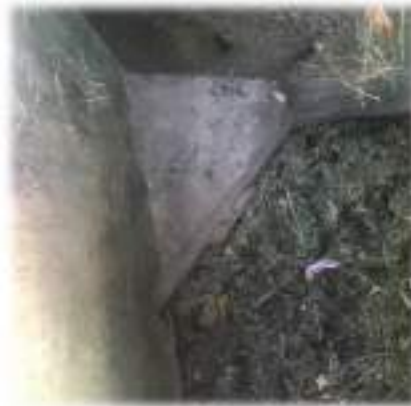
Catch basin debris with orifice restriction- Pickneya Drive

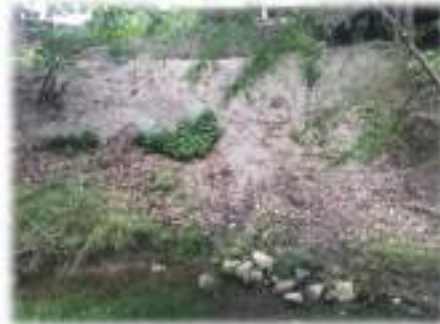
Steep eroded bank at 9836 Silverleaf

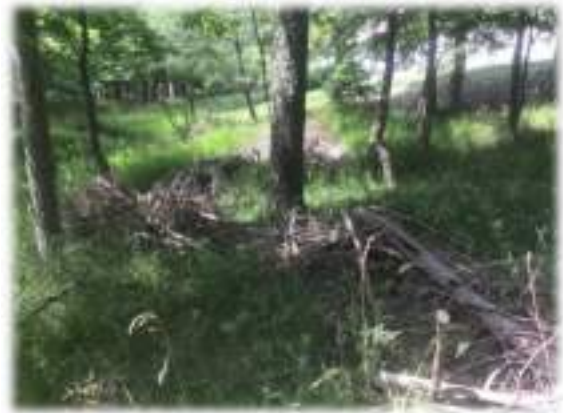
Yard waste/debris- Silverleaf Drive

RVHA regulations specifically restrict this type of dumping and disposal of yard waste. One measure that can be taken to address this behavior is to issue communication to all homeowners within the subdivision. This should be a multi-faceted approach, including potentially a public meeting, mailer, and posted signs indicating specifically the types of behavior that are restricted. The RVHA may want to consider instituting specific policies that allow for formal issuance of warnings, fines, and removal of obstructions at the expense of responsible parties.

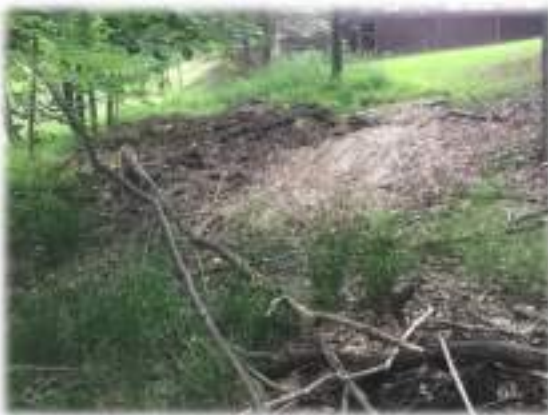
Yard waste/debris- Dublin Drive

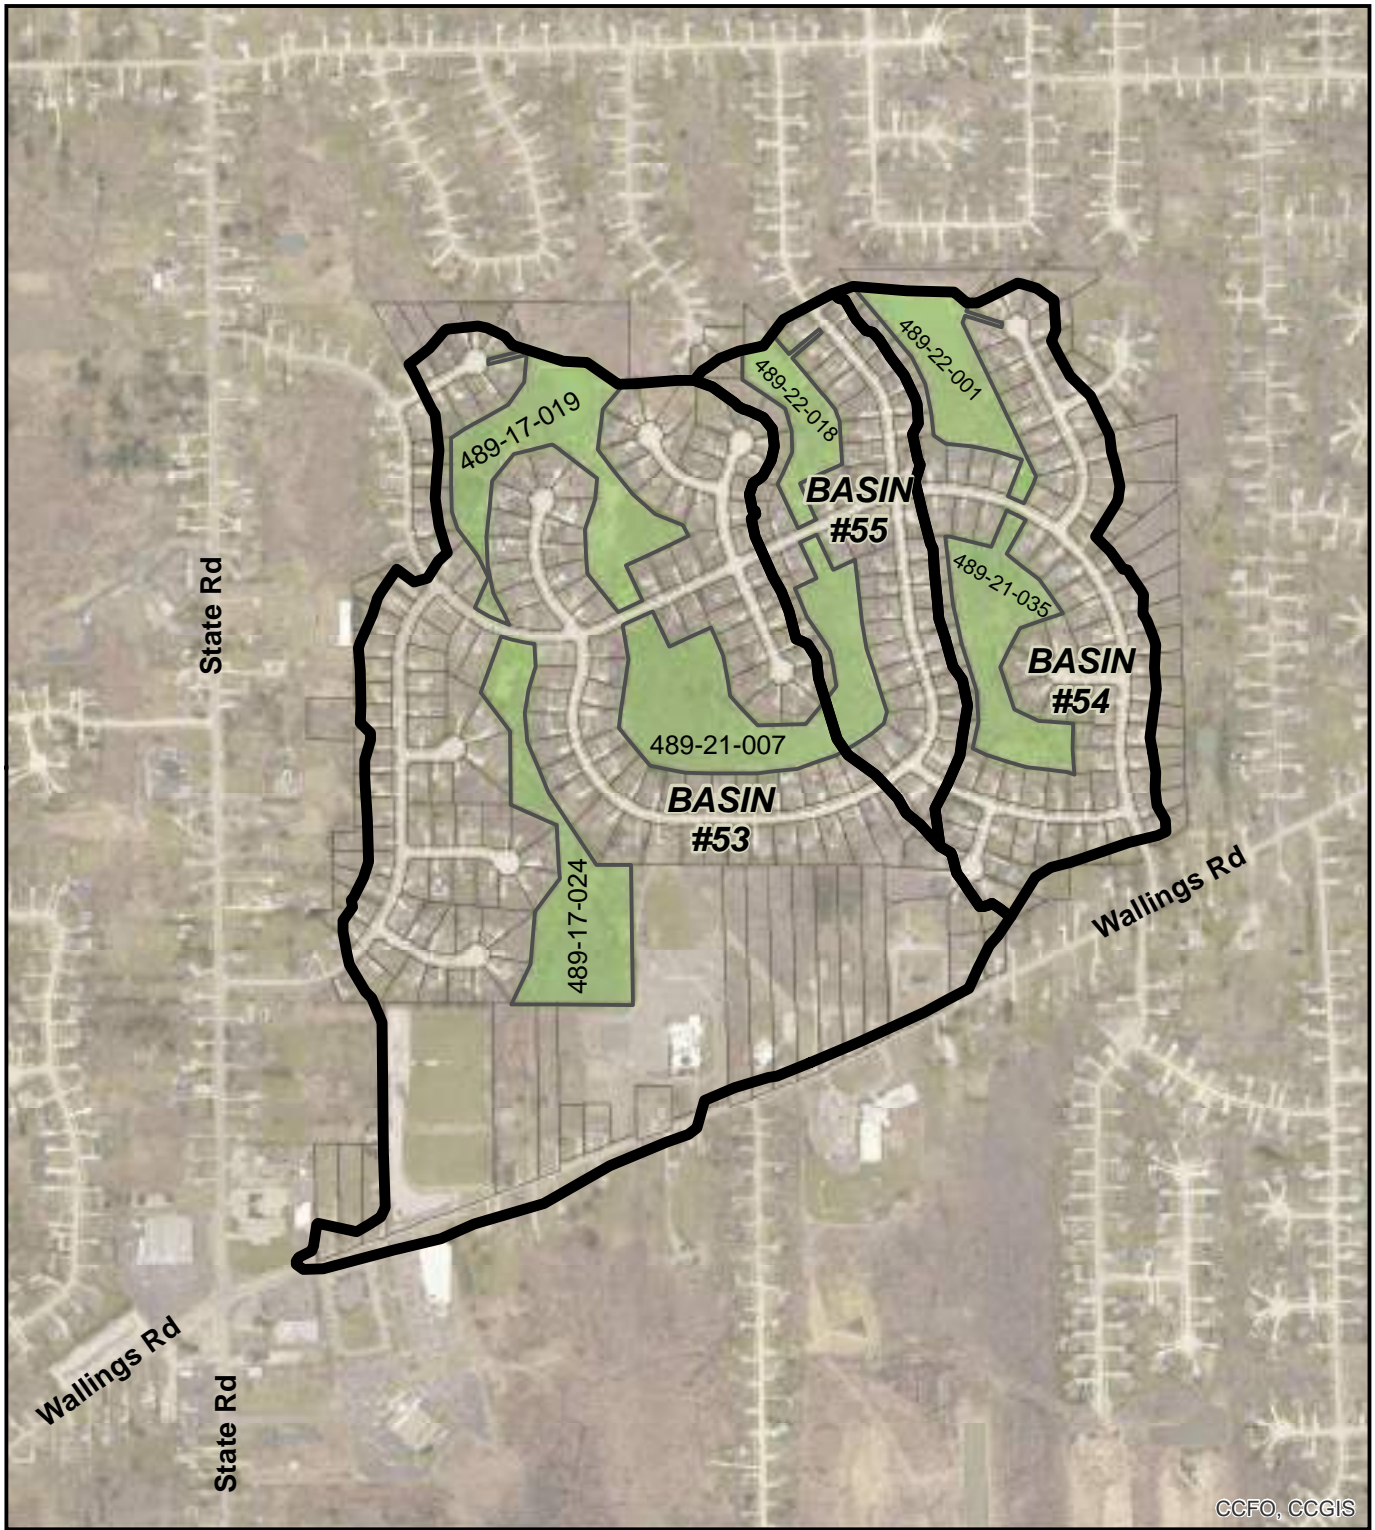
There are six areas of preserved open space within the Royal Valley Subdivision (see Appendix C, Figure 4 for a map of the open areas labeled with Permanent Parcel Number). These areas are designed common areas, and generally serve as drainage paths for open channel portions of stream. Preserved natural open

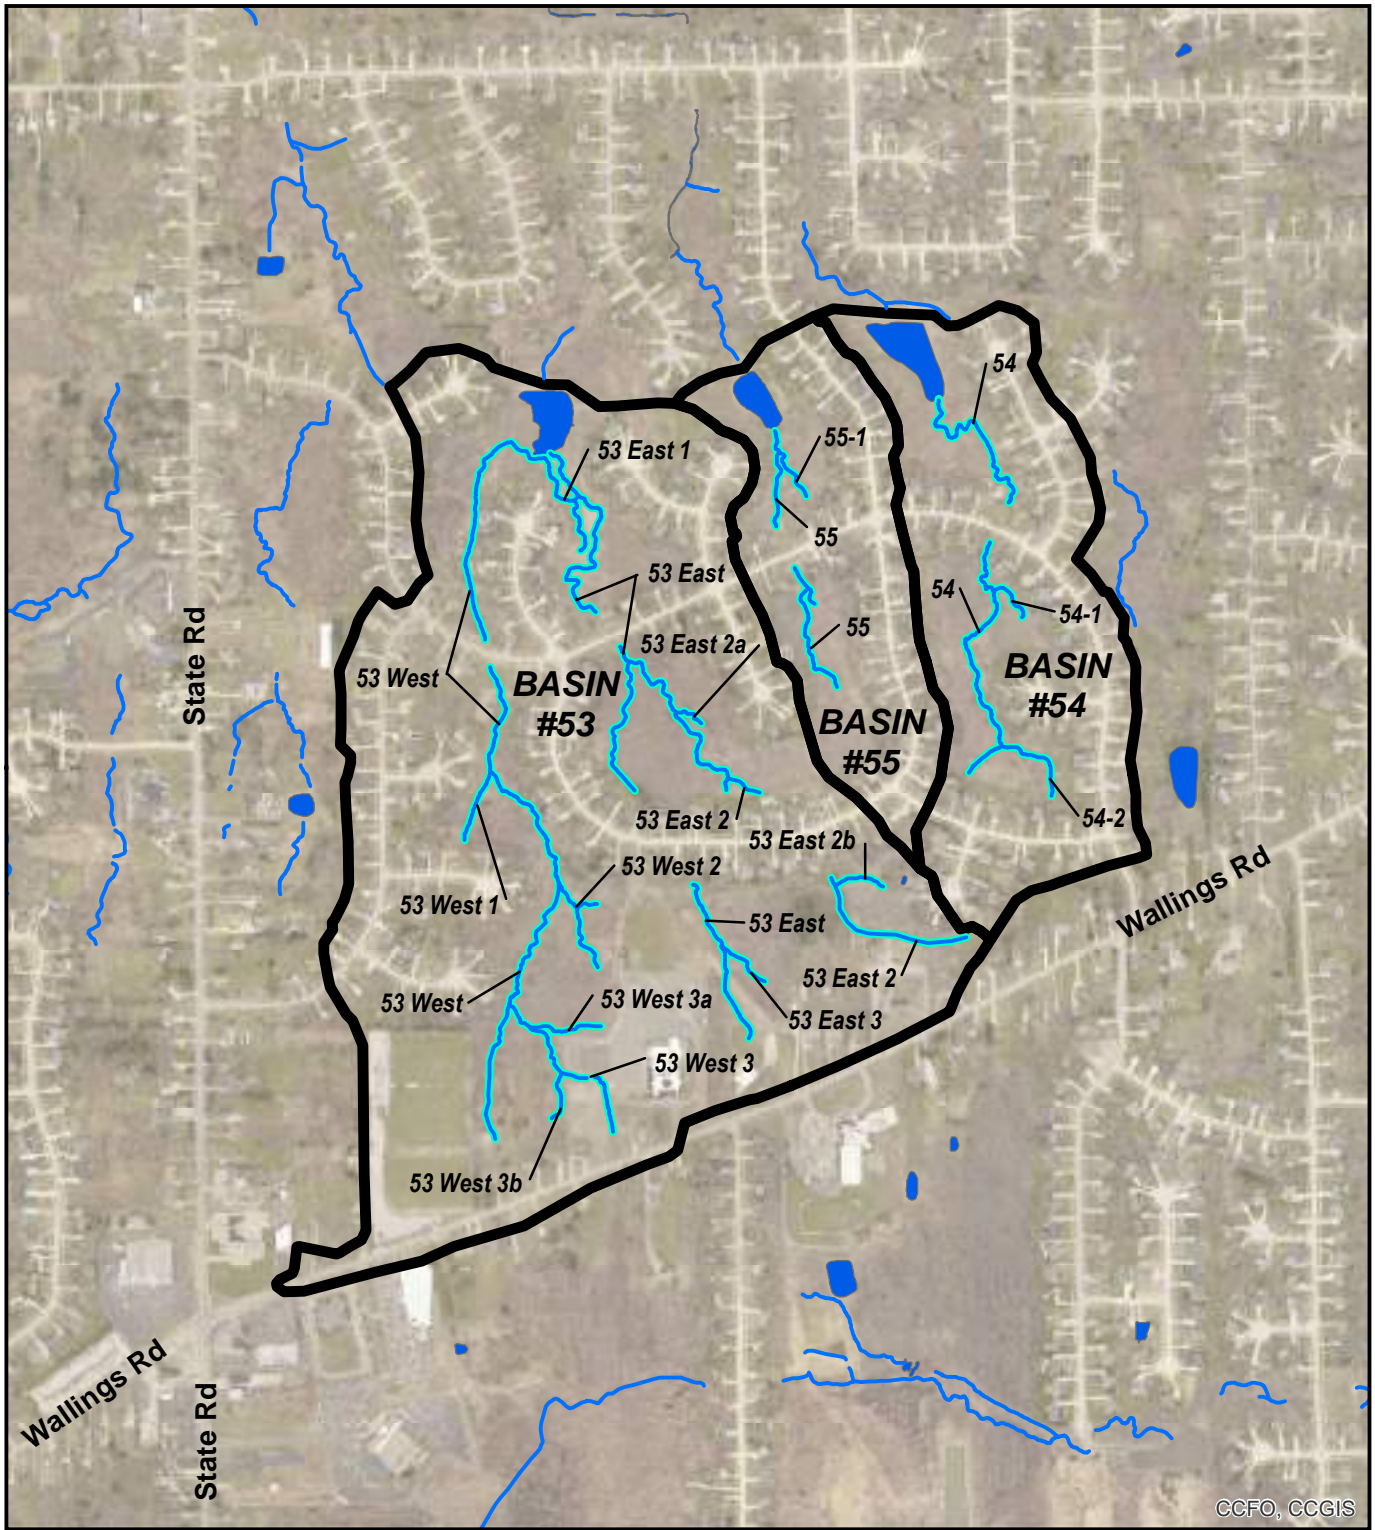
Four main channels currently exist within the development. These are classified as 53-West, 53-East, Stream 55, and Stream 54 in order of their location west to east (See Figure 5 in Appendix C). Initially a historic analysis of the open channel system was performed. The age of stream channels, their morphological traits, and recovery state is crucial in understanding their capacity for improvement or restoration. Many streams within the Cuyahoga River watershed were channelized or converted into agricultural ditches to support agricultural land use. This appears to have been the case for several streams within the subdivision throughout the mid 20th century.

The streams within the project area were scored using specific quantitative metrics as established by the OEPA's Primary Headwater Habitat Evaluation Index (see Appendix C, Figure 5 for Stream Locations and Appendix F for classification results). These classifications are approximations and not a professional designation. Channels were categorized as ephemeral, intermittent, or perennial streams based on flow regime, and Class I, II, or III based on quality (Class I being the lowest quality and Class III the highest). A Class III perennial stream is one supporting a wide diversity of groundwater-fed native fauna year-round. All streams found within the study area fall between Class I (ephemeral) and Class II (intermittent and perennial) channels.

One potential area that would be an appropriate location for stream channel restoration utilizing facets of natural channel design is in portions of Stream 55 (see Appendix C, Figure 5 for location). The specific project location is both north and south of Royal Valley Drive, west of Dublin Drive. This area of stream exhibits incised banks subject to erosion. There are also failed gabion structures in the area that could be removed, and a natural stream channel with floodplain could be installed. The priority would be to perform the project for the portion North of Royal Valley Drive first, and then proceed with the portion south of Royal Drive once the downstream improvements are installed.

Another segment that would benefit from this type of project is within the drainage area to 5030 Corkwood, the area to the east of St. Paul Orthodox Church. This is Stream 53 West 2 (see Appendix C, Figure 5). This area is a desirable candidate not necessarily due to poor conditions within the channel, but due to the downstream concerns at 5030 Corkwood. This report contains recommendations for improving the

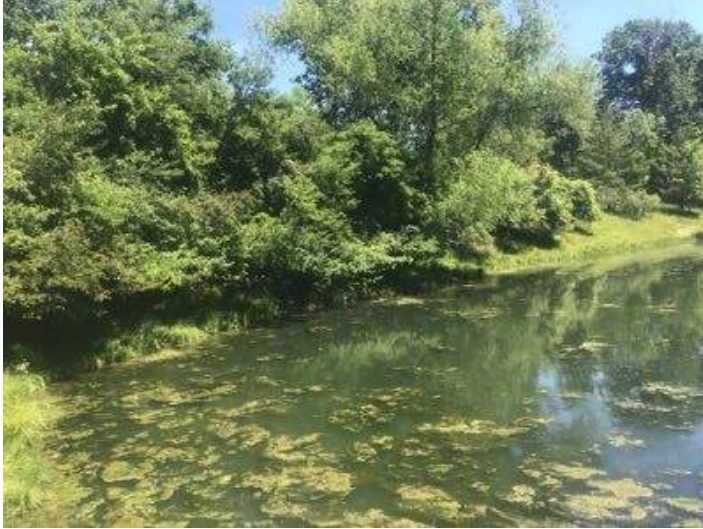
Photo 1 - 07/23/2021

Excessive amounts of algae are present in main pool. Treatment was being ad in is termed during inspection but it doesn't seem to be working efficiently. Consider other methods or more aggressive treatments.

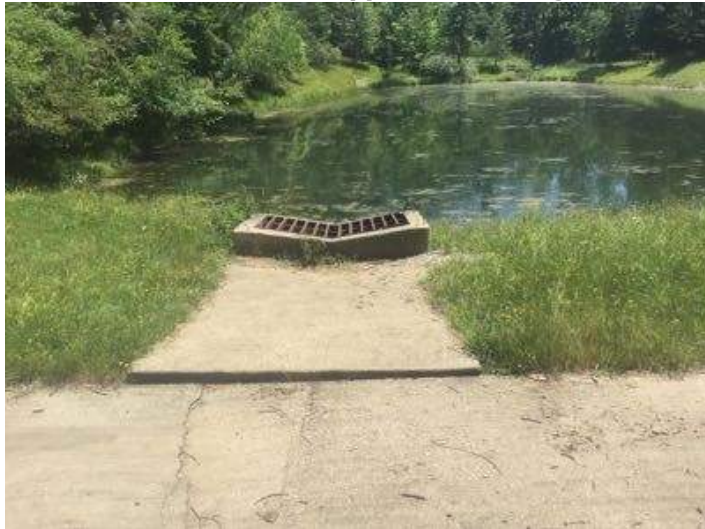
Photo 1 - 07/23/2021

Outlet structure appears to be in good condition and functioning properly.

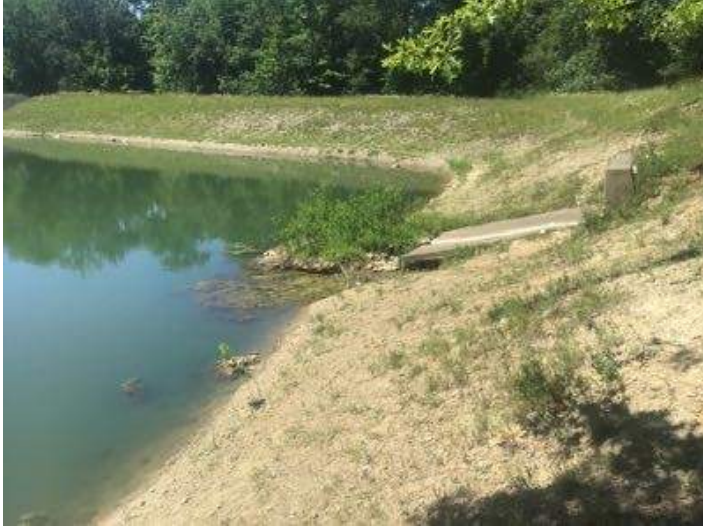
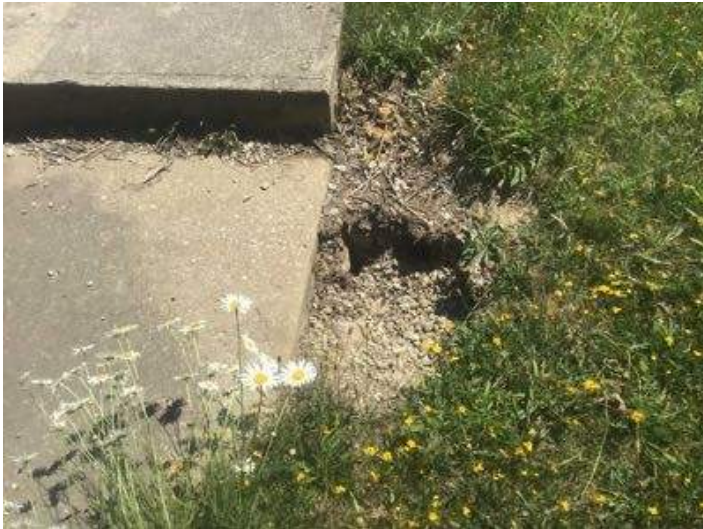
-
- 7) **INLETS: Are inlets free of obstructions that impede flow (sediment, vegetation, trash, debris)?** **Open Work Items Exist**
Maintenance Action Required
Remove vegetation form inlet flow path to insure free flow.

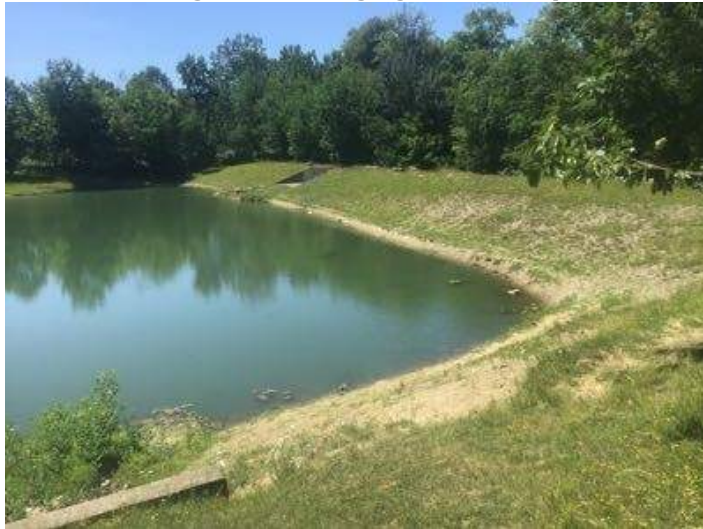
Photo 1 - 07/23/2021

9) **SLOPES & EMBANKMENTS: Are slopes and embankments free of cracks, seeps and evidence of erosion?** **Open Work Items Exist**
Maintenance Action Required
Multiple areas of sparse vegetation and erosion along embankment. Consider using seeded matting to encourage growth and prevent erosion.

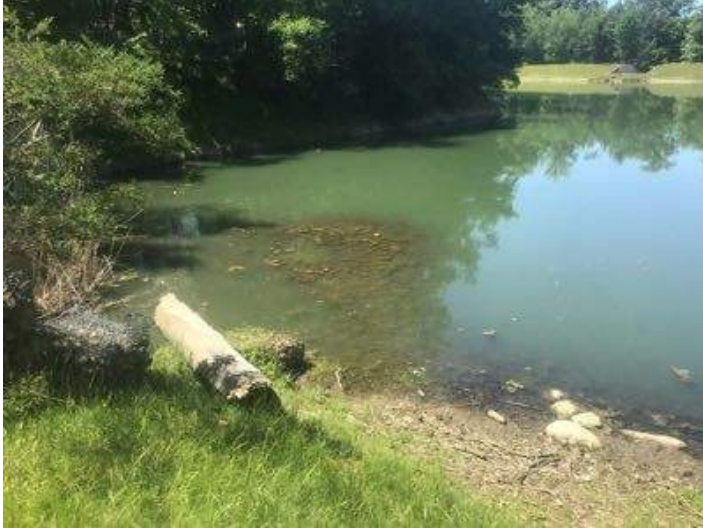
Photo 1 - 07/23/2021

Excessive algal growth is present in main pool. Treatment was being administered at time of inspection but does not seem to be efficient. Consider more aggressive treatment and/or alternative methods.

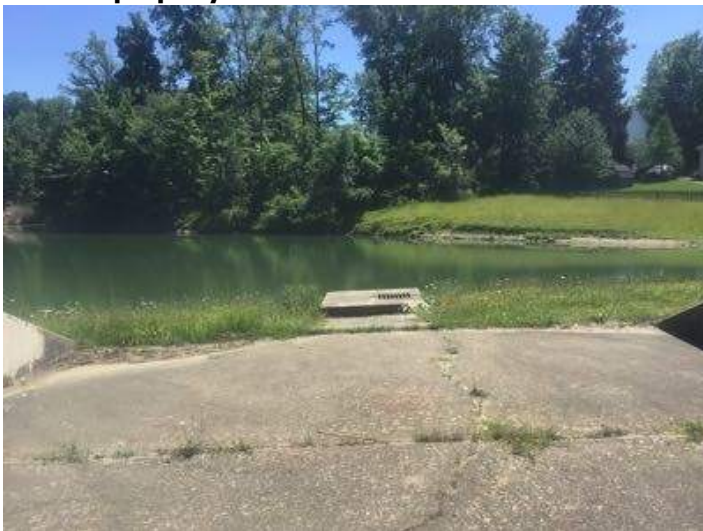
Photo 1 - 07/23/2021

Outlet structure and emergency spill way appear to be in good condition and functioning properly.

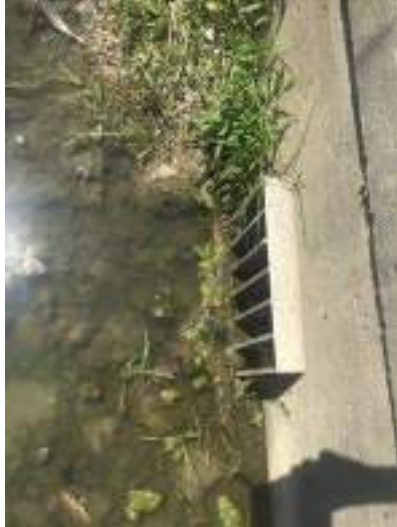
Photo 2 - 07/23/2021

<p>18) OUTLETS & OVERFLOW STRUCTURES: Are outlets and overflow structures free of obstructions (trash, vegetation, debris, sediment)? Maintenance Action Required Routine maintenance is suggested, especially after a rain event, to clear debris rack and make sure outlet is functioning properly.</p>	<p>Open Work Items Exist</p>
<p>19) OUTLETS & OVERFLOW STRUCTURES: Is the area around outlets and overflow structures free of evidence of excessive erosion?</p>	<p>NA</p>
<p>20) OUTLETS & OVERFLOW STRUCTURES: Are joints water tight and free of evidence of leaks?</p>	<p>NA</p>
<p>21) Do items of non-compliance other than those previously noted exist?</p>	<p>Yes</p>
