STATE OF NEW HAMPSHIRE  
INTER-DEPARTMENT COMMUNICATION

DATE: September 16, 2009  
AT(OFFICE): P&DRS

**SUBJECT:** Stage 1 Phase 1 Anchor Trench Repairs/NCES/Bethlehem/  
DES-SW-SP-03-002

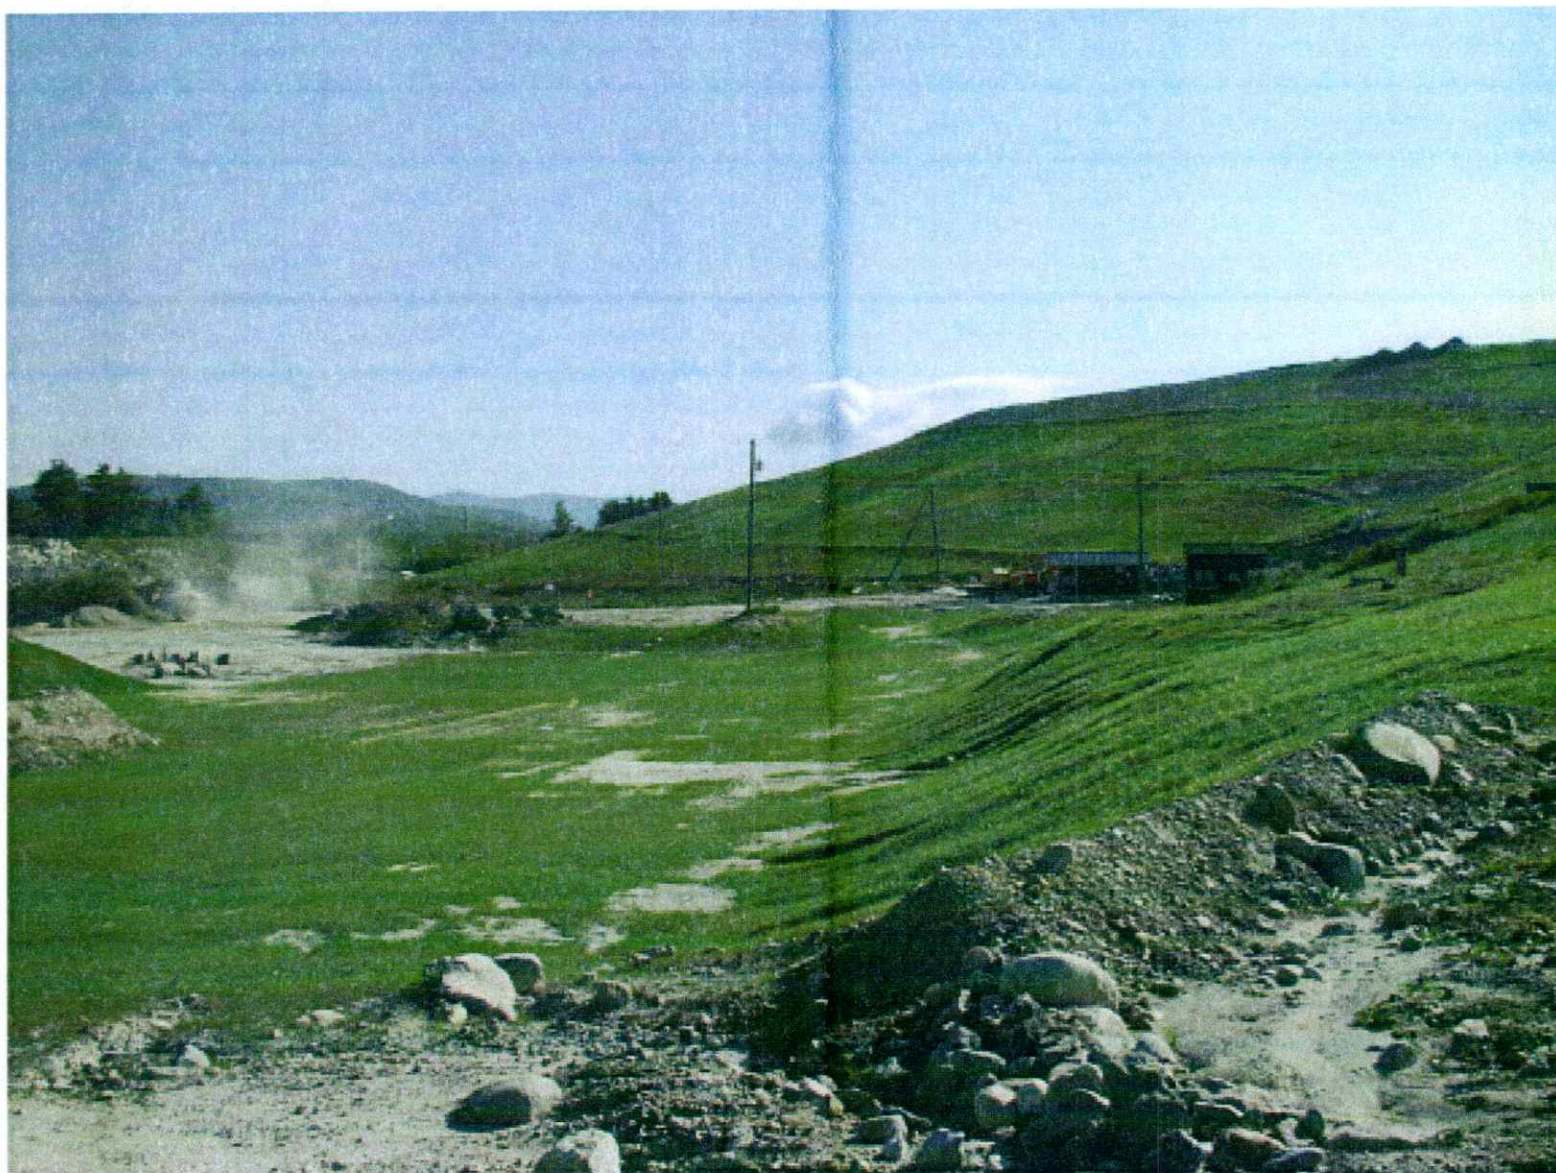
Kevin then proceeded to show us the area near the Stage 1 Phase 1 downchute. While removing the 36-inch culvert, Kevin saw landfill gas coming from the direction of the Stage 1 Phase 1 anchor trench. Upon removing soil from approximately 200 feet of anchor trench and exposing the geomembrane cap, Kevin noted that the cap was badly deteriorated. It had holes in it and the cap was not welded to the liner in this area.

He explained that his intent was to have CMA prepare a plan to replace the existing cap and to weld it to the liner.

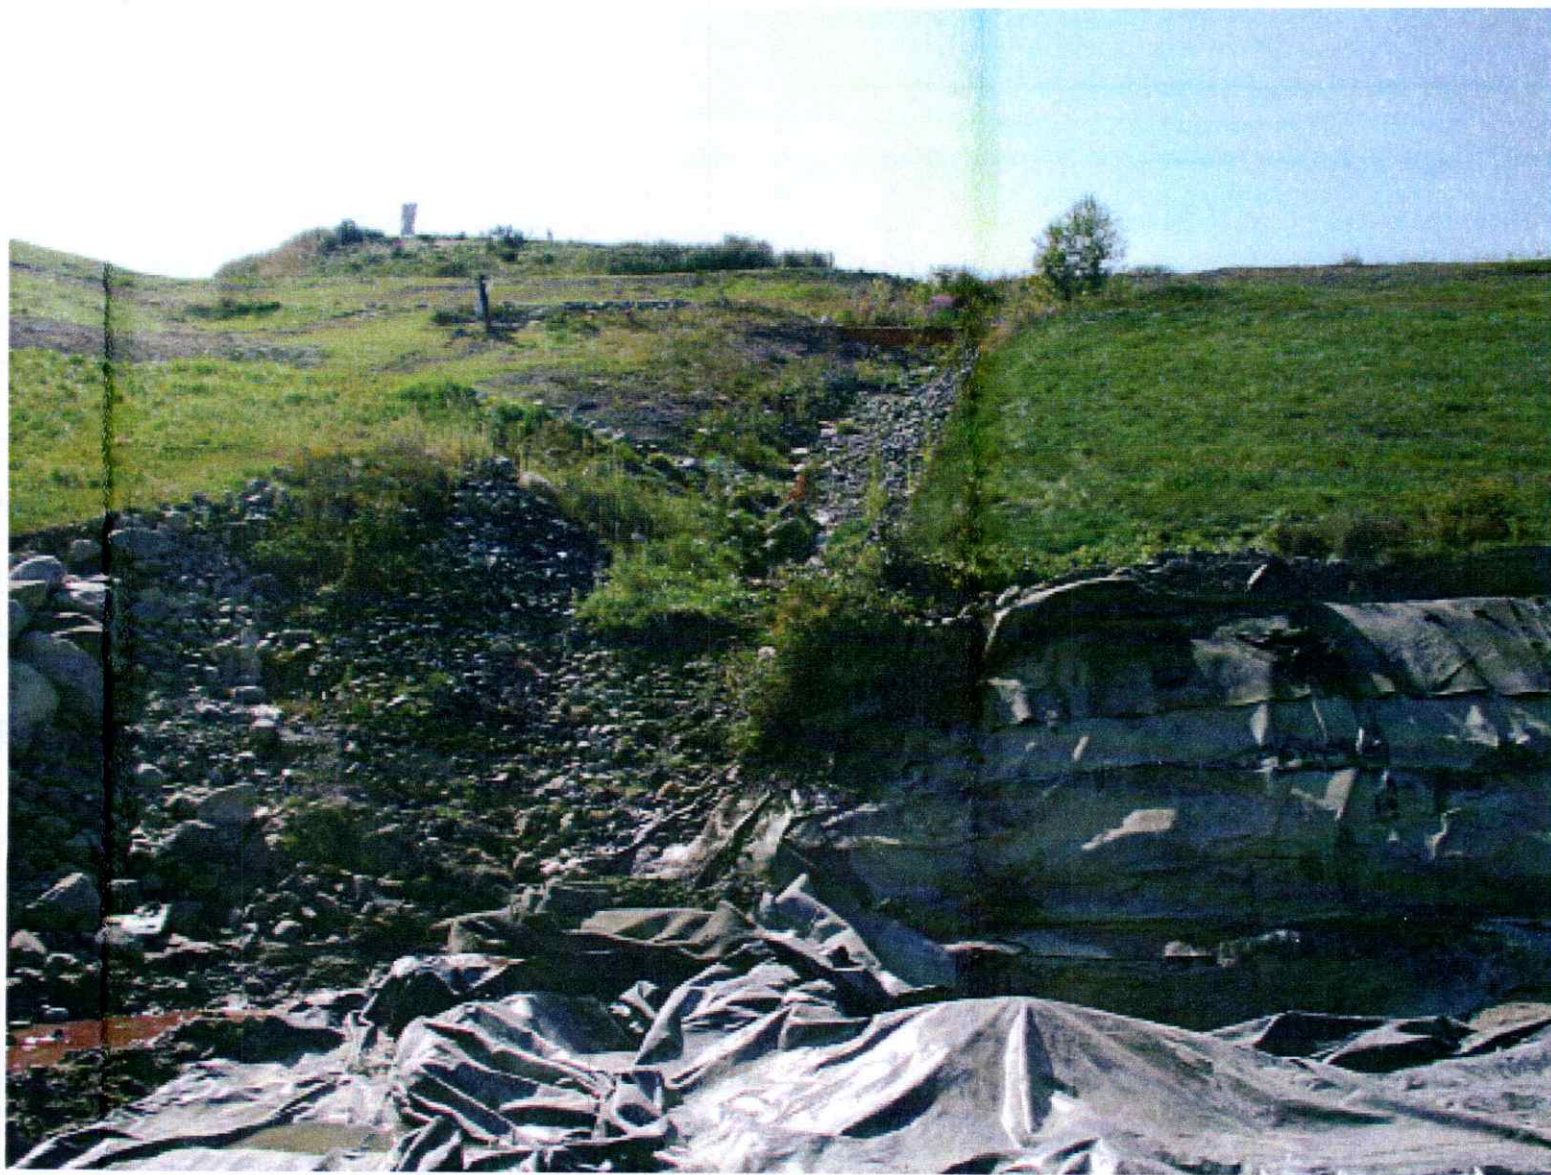
**Picture 3.** This picture is looking north at the Stage 1 Phase 1 anchor trench. Note arrow pointing out hole in geomembrane cap.

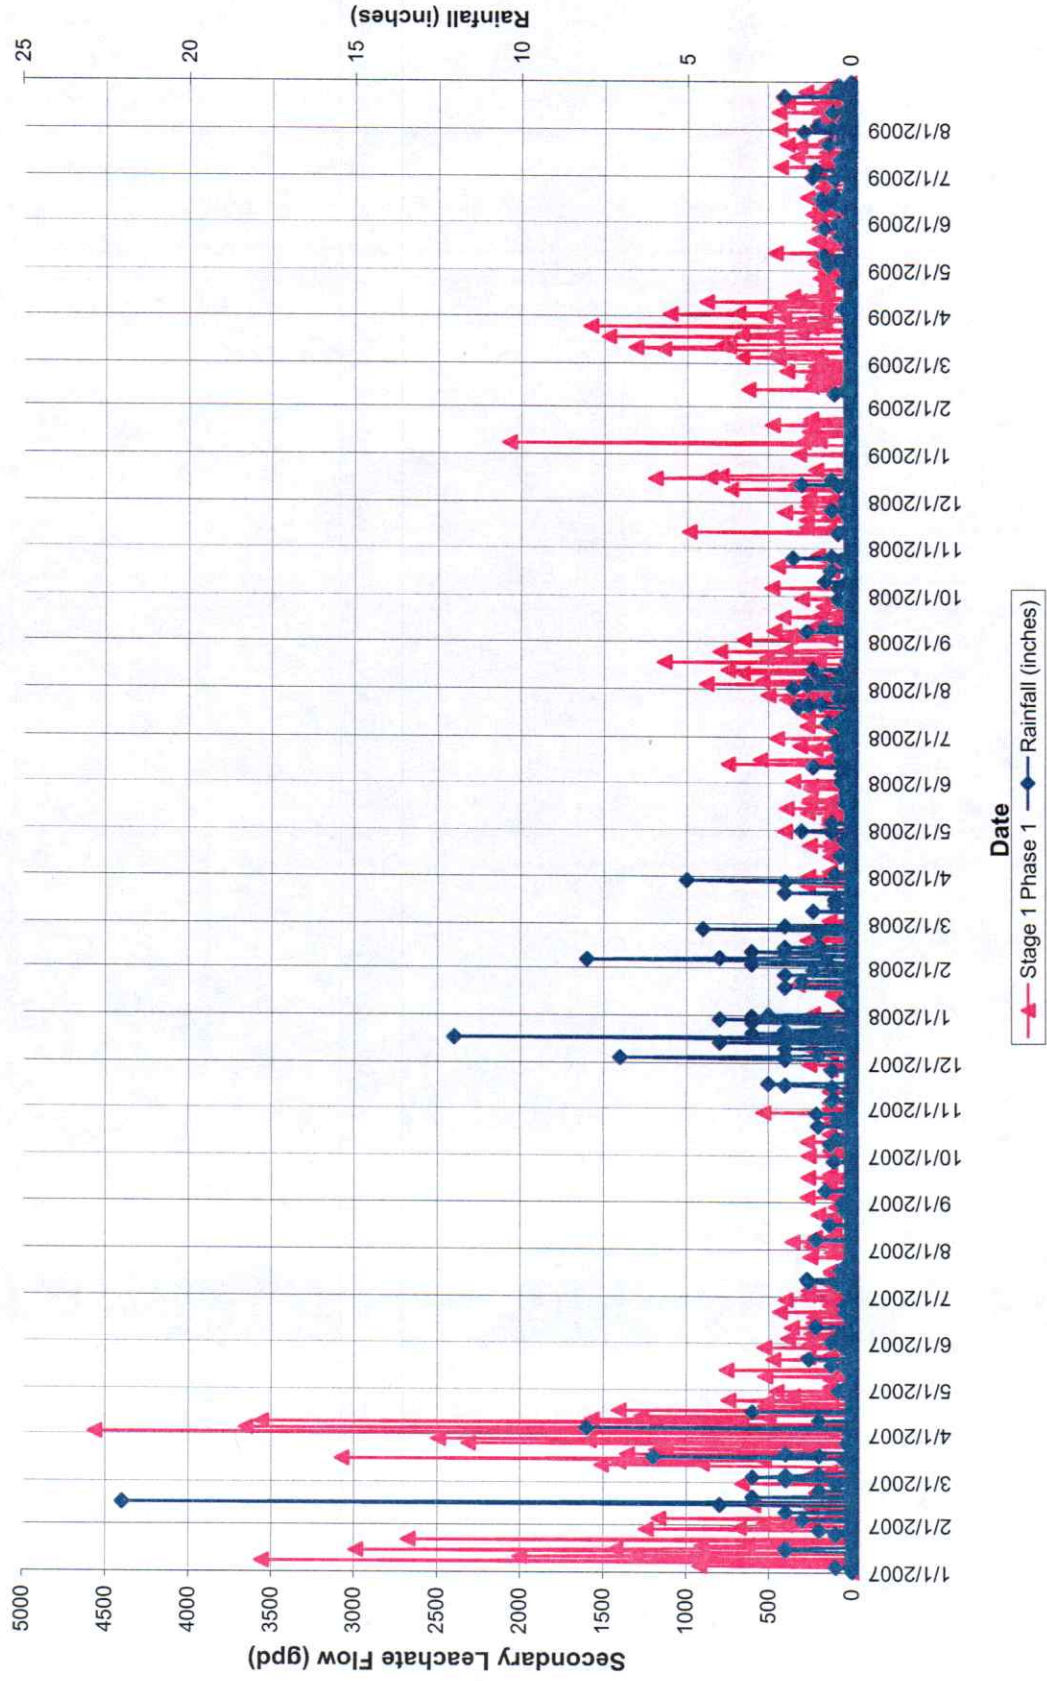
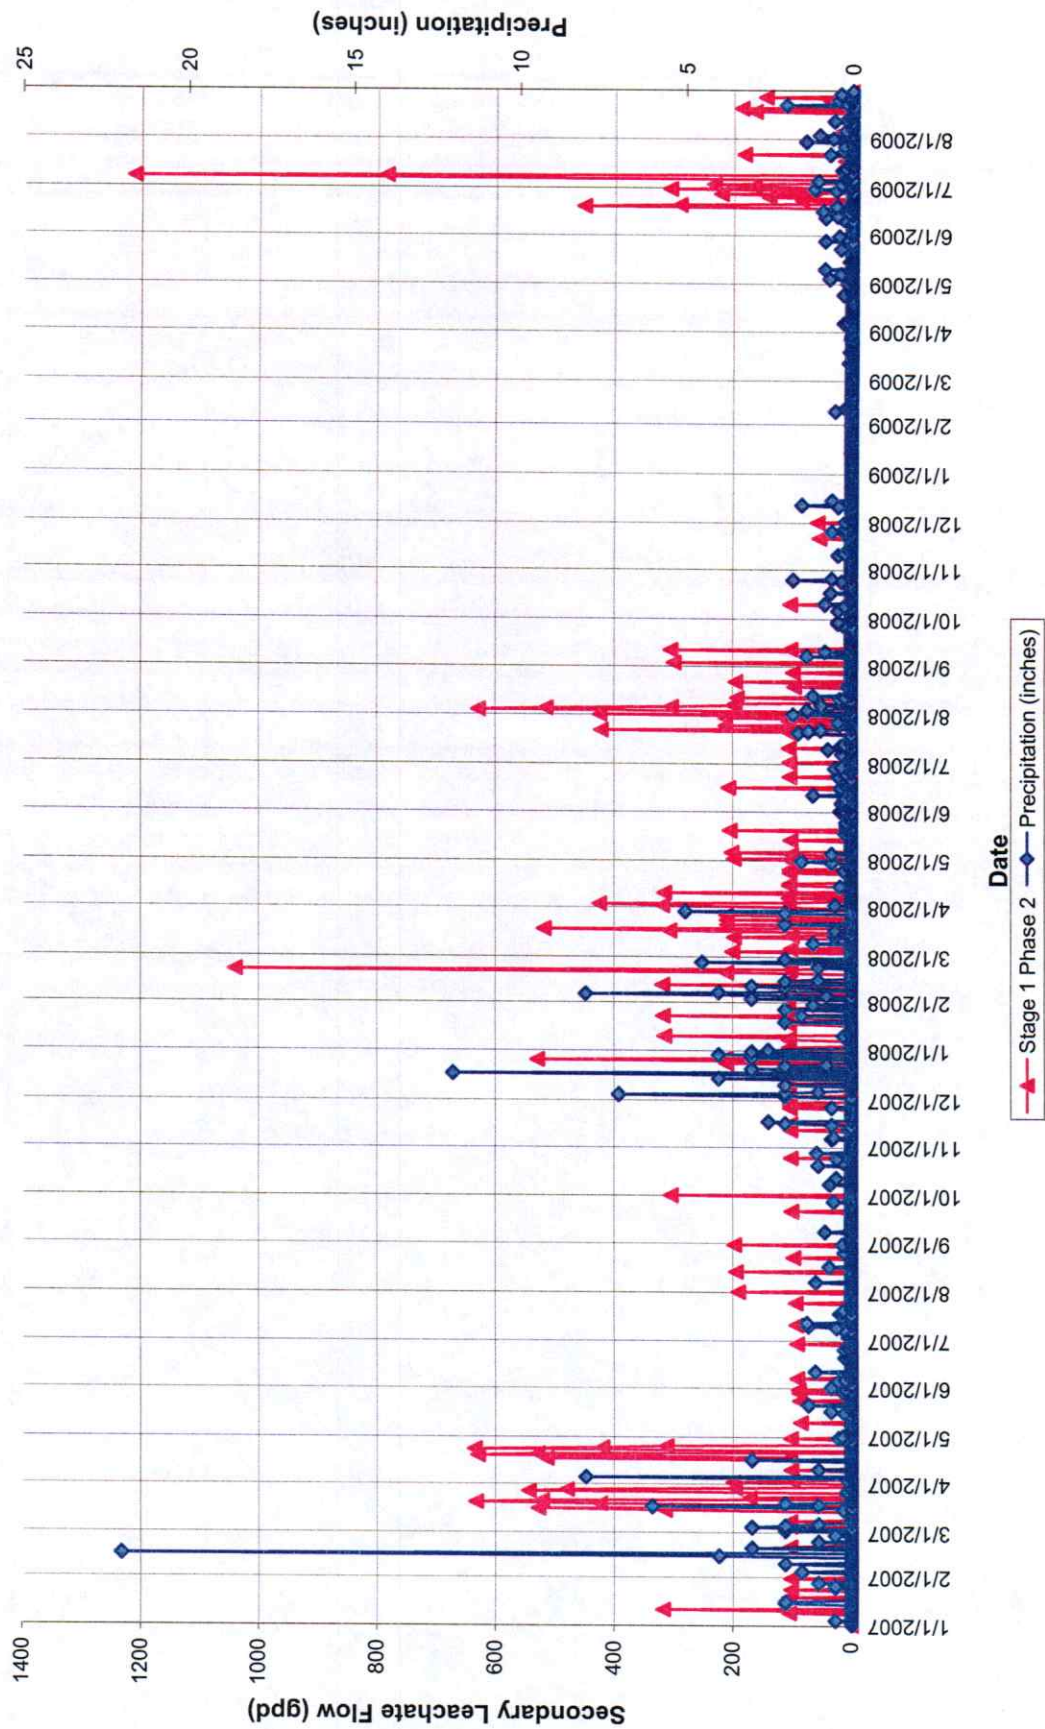
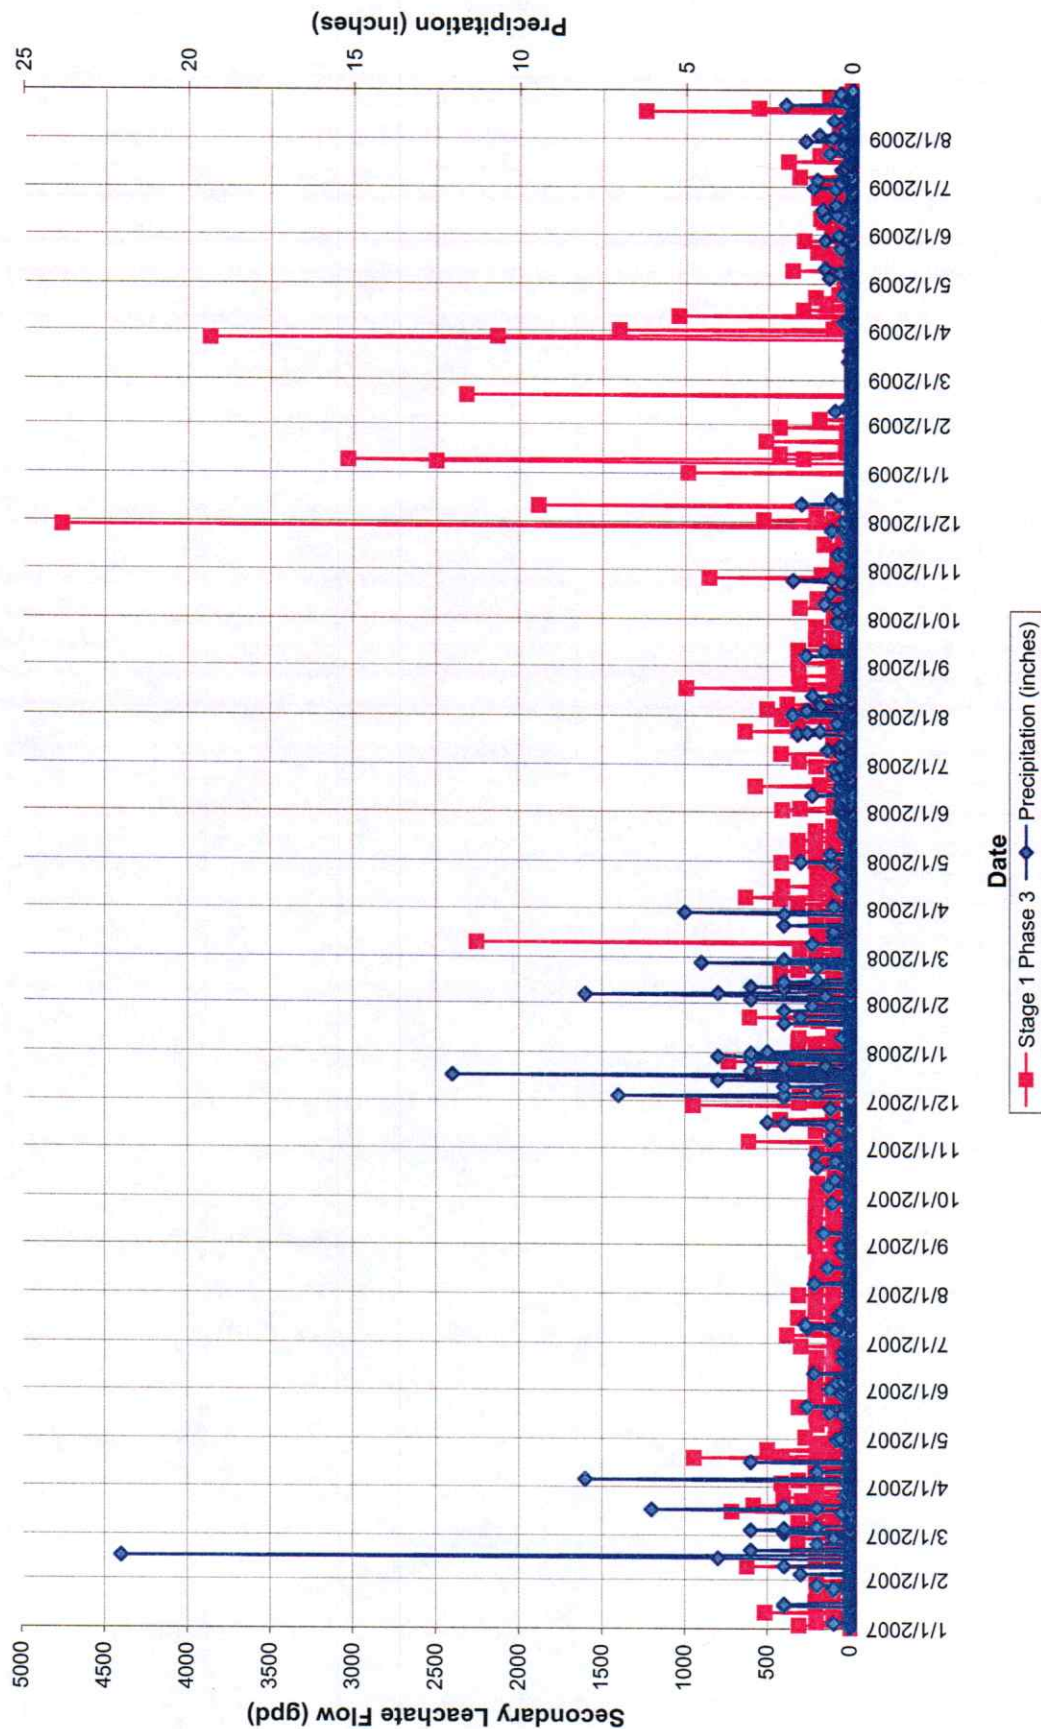
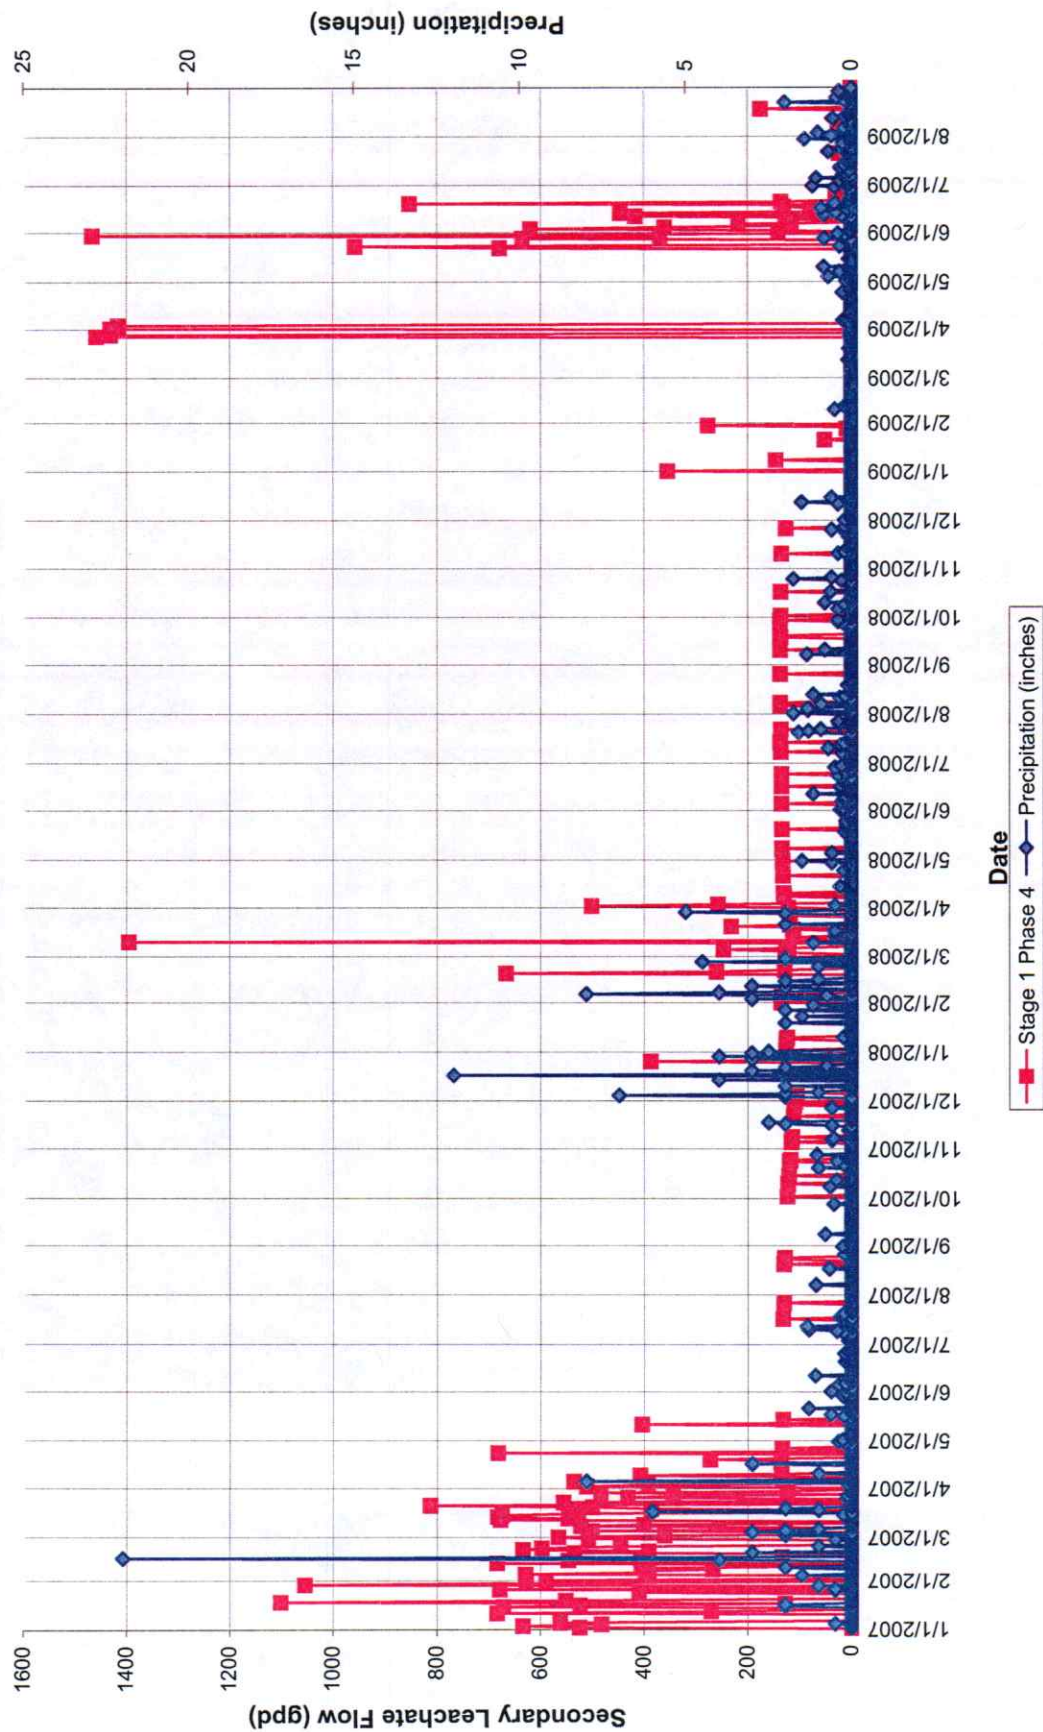
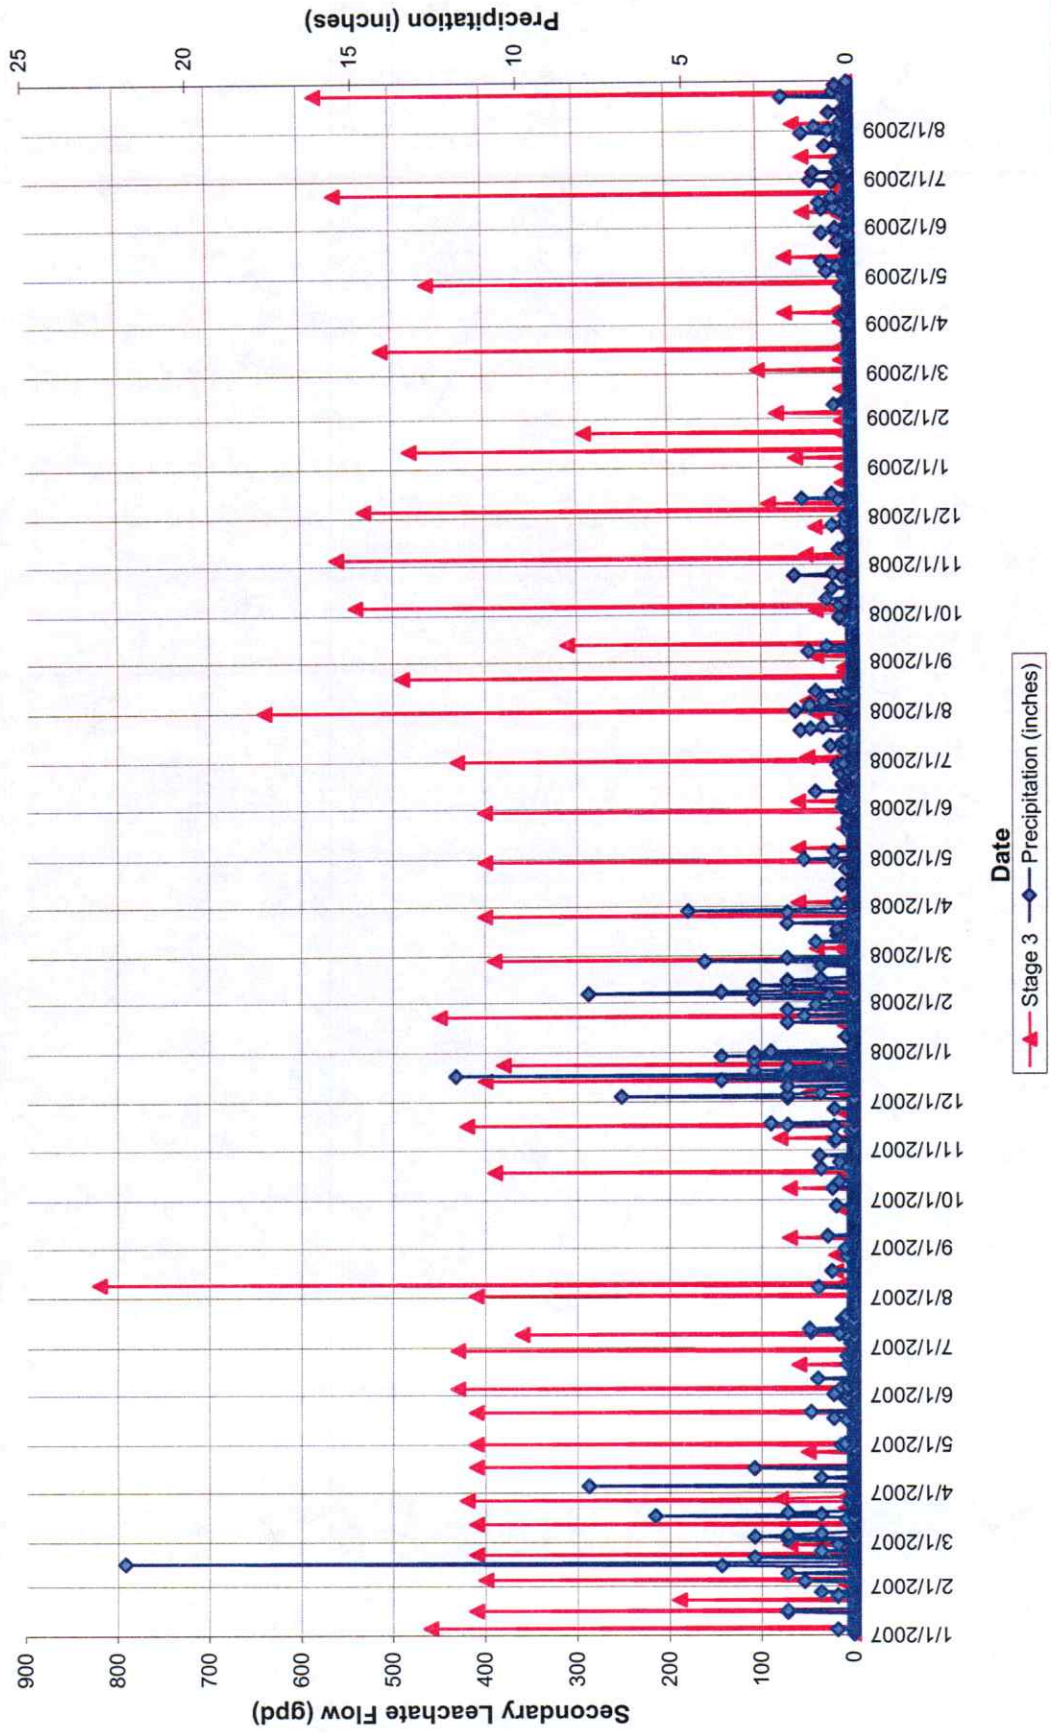
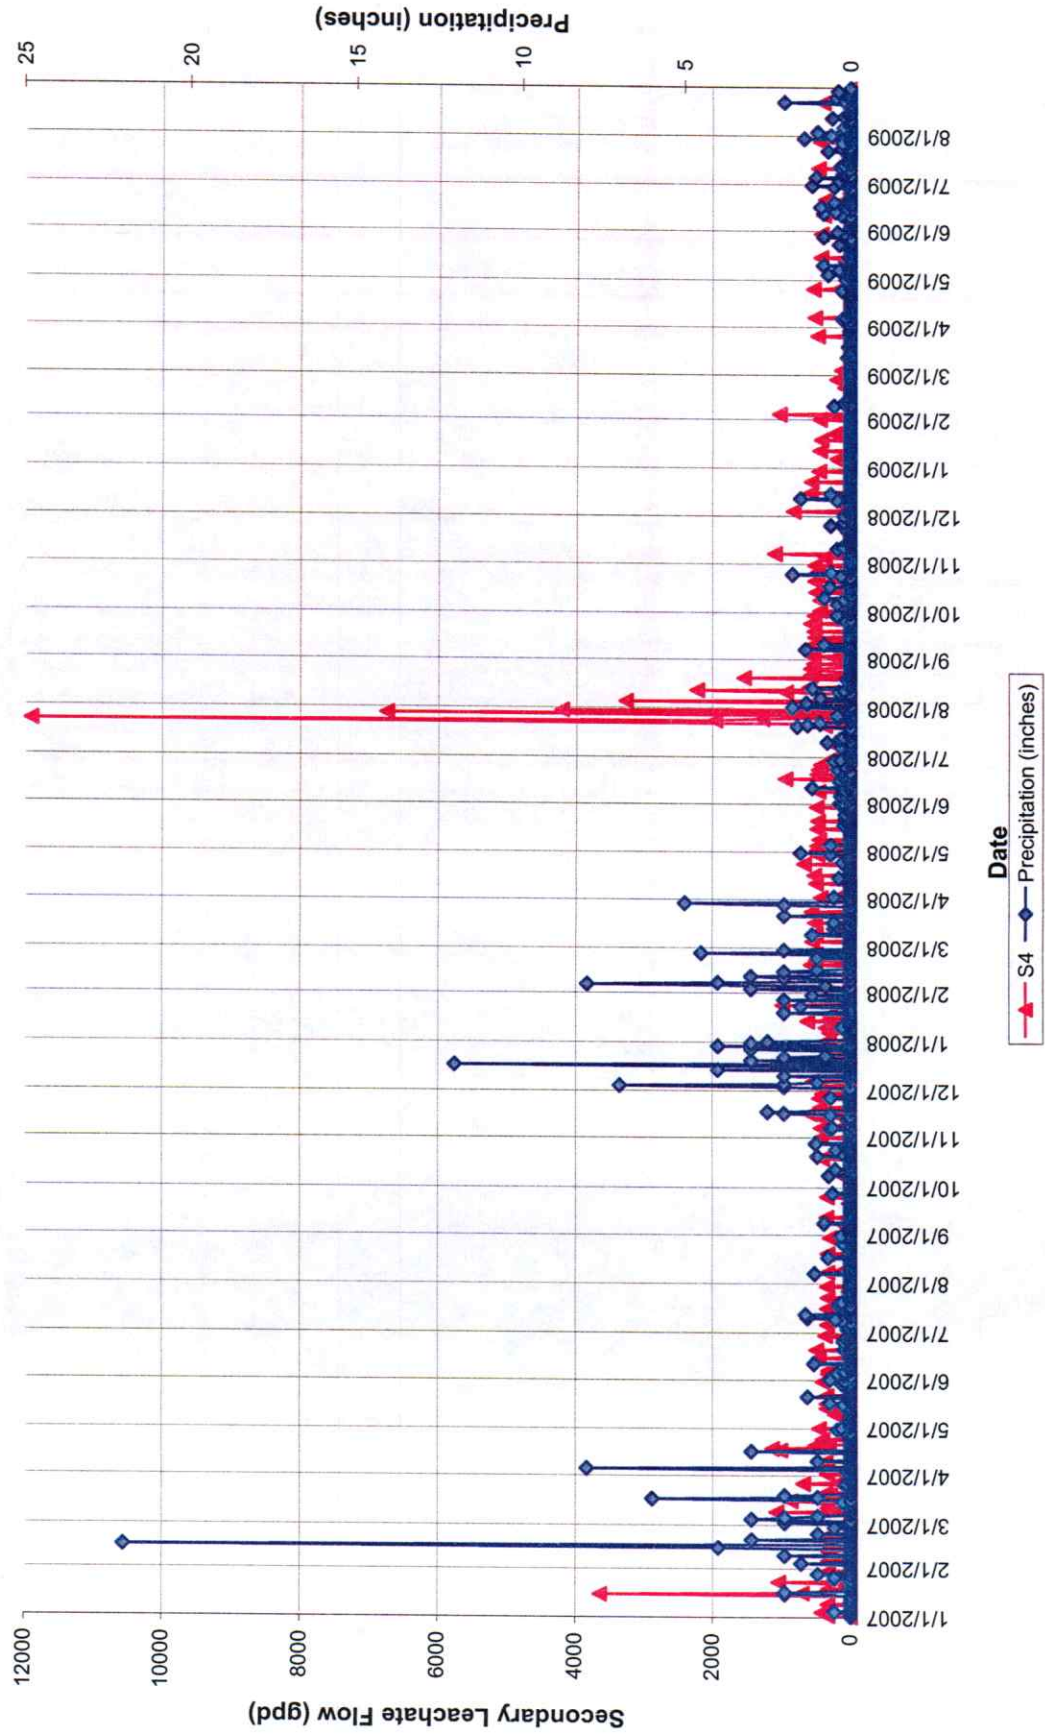
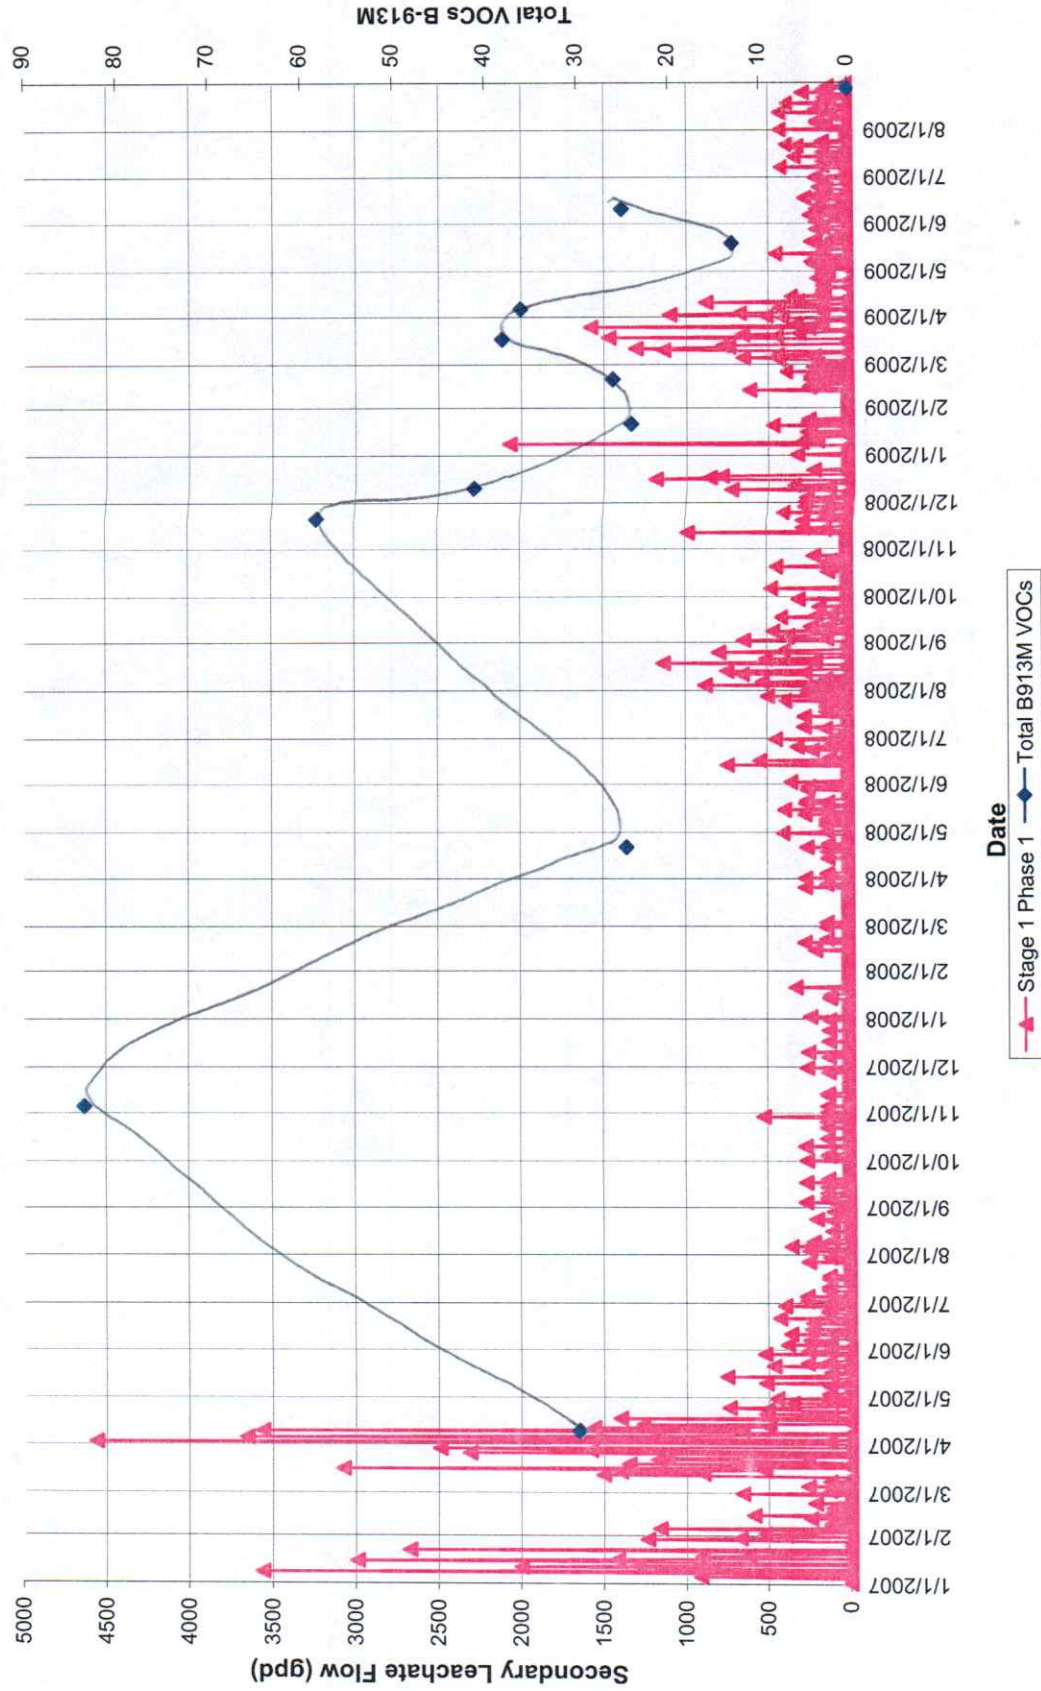
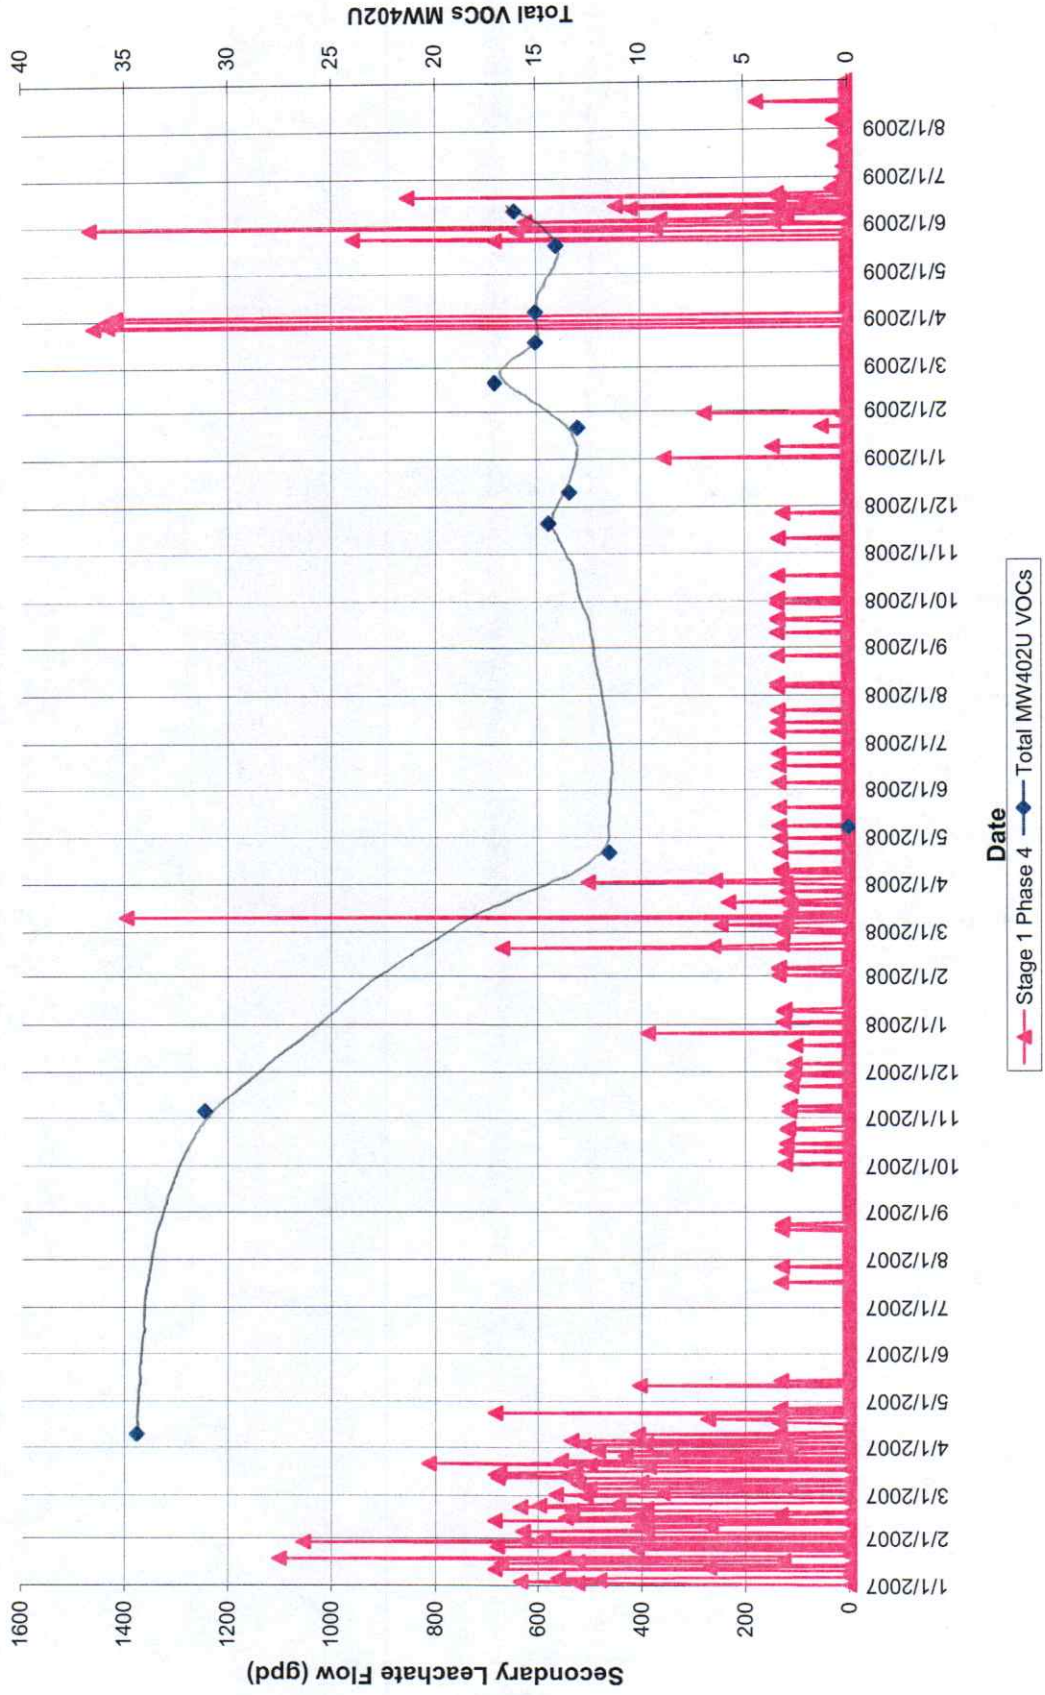
As shown the Stage 1 Leachate Flow charts (esp. Phases 1 and 4), secondary leachate flows appear to have substantially decreased following the repairs.

As shown on the attached charts, Stage 1 secondary flows appear to be influenced by either rainfall events or runoff. In addition and as shown on the attached charts, there appears to be a relationship between total VOCs measured at MW B-913M and secondary leachate flows. I have also plotted Total VOCs for each of the Stage 1 phases.
