STATE OF NEW HAMPSHIRE
INTER-DEPARTMENT COMMUNICATION

DATE: September 16, 2009
AT(OFFICE): P&DRS

SUBJECT: Stage 1 Phase 1 Anchor Trench Repairs/NCES/Bethlehem/
DES-SW-SP-03-002

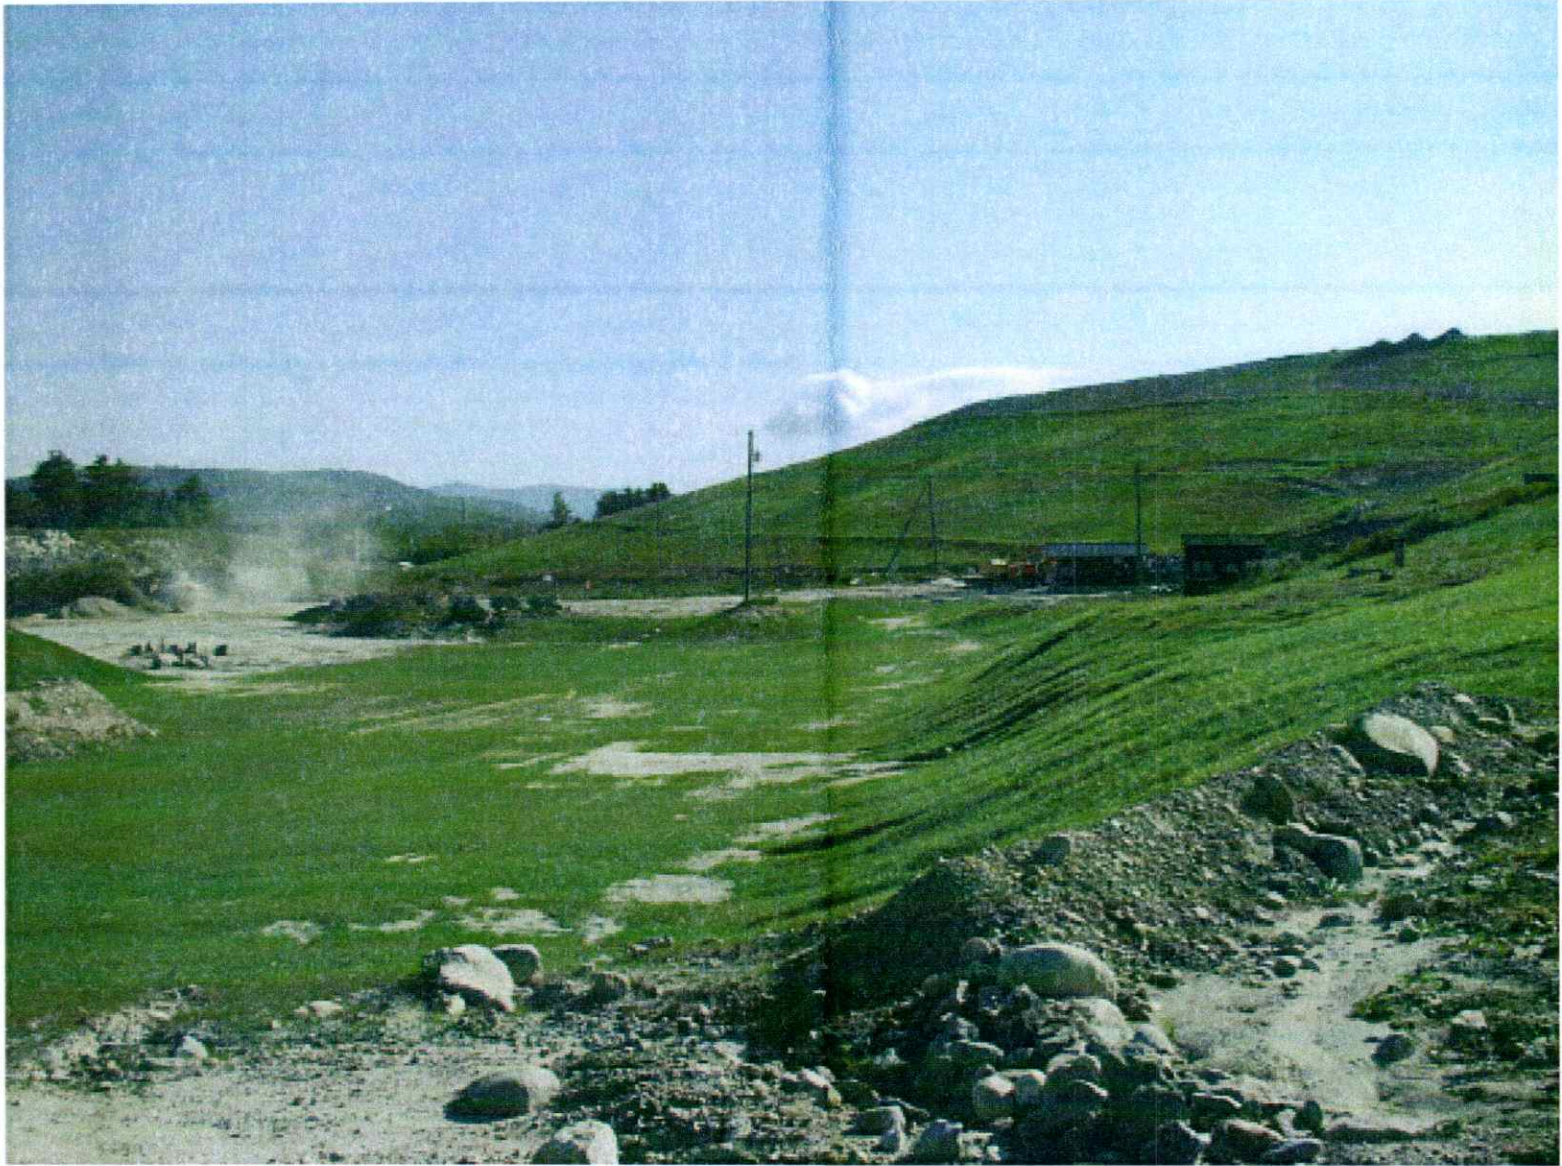
Kevin then proceeded to show us the area near the Stage 1 Phase 1 downchute. While removing the 36-inch culvert, Kevin saw landfill gas coming from the direction of the Stage 1 Phase 1 anchor trench. Upon removing soil from approximately 200 feet of anchor trench and exposing the geomembrane cap, Kevin noted that the cap was badly deteriorated. It had holes in it and the cap was not welded to the liner in this area.

Picture 2. This picture is looking up (south) the Stage 1 Phase 1 downchute. The excavated anchor trench is to the right.

He explained that his intent was to have CMA prepare a plan to replace the existing cap and to weld it to the liner.

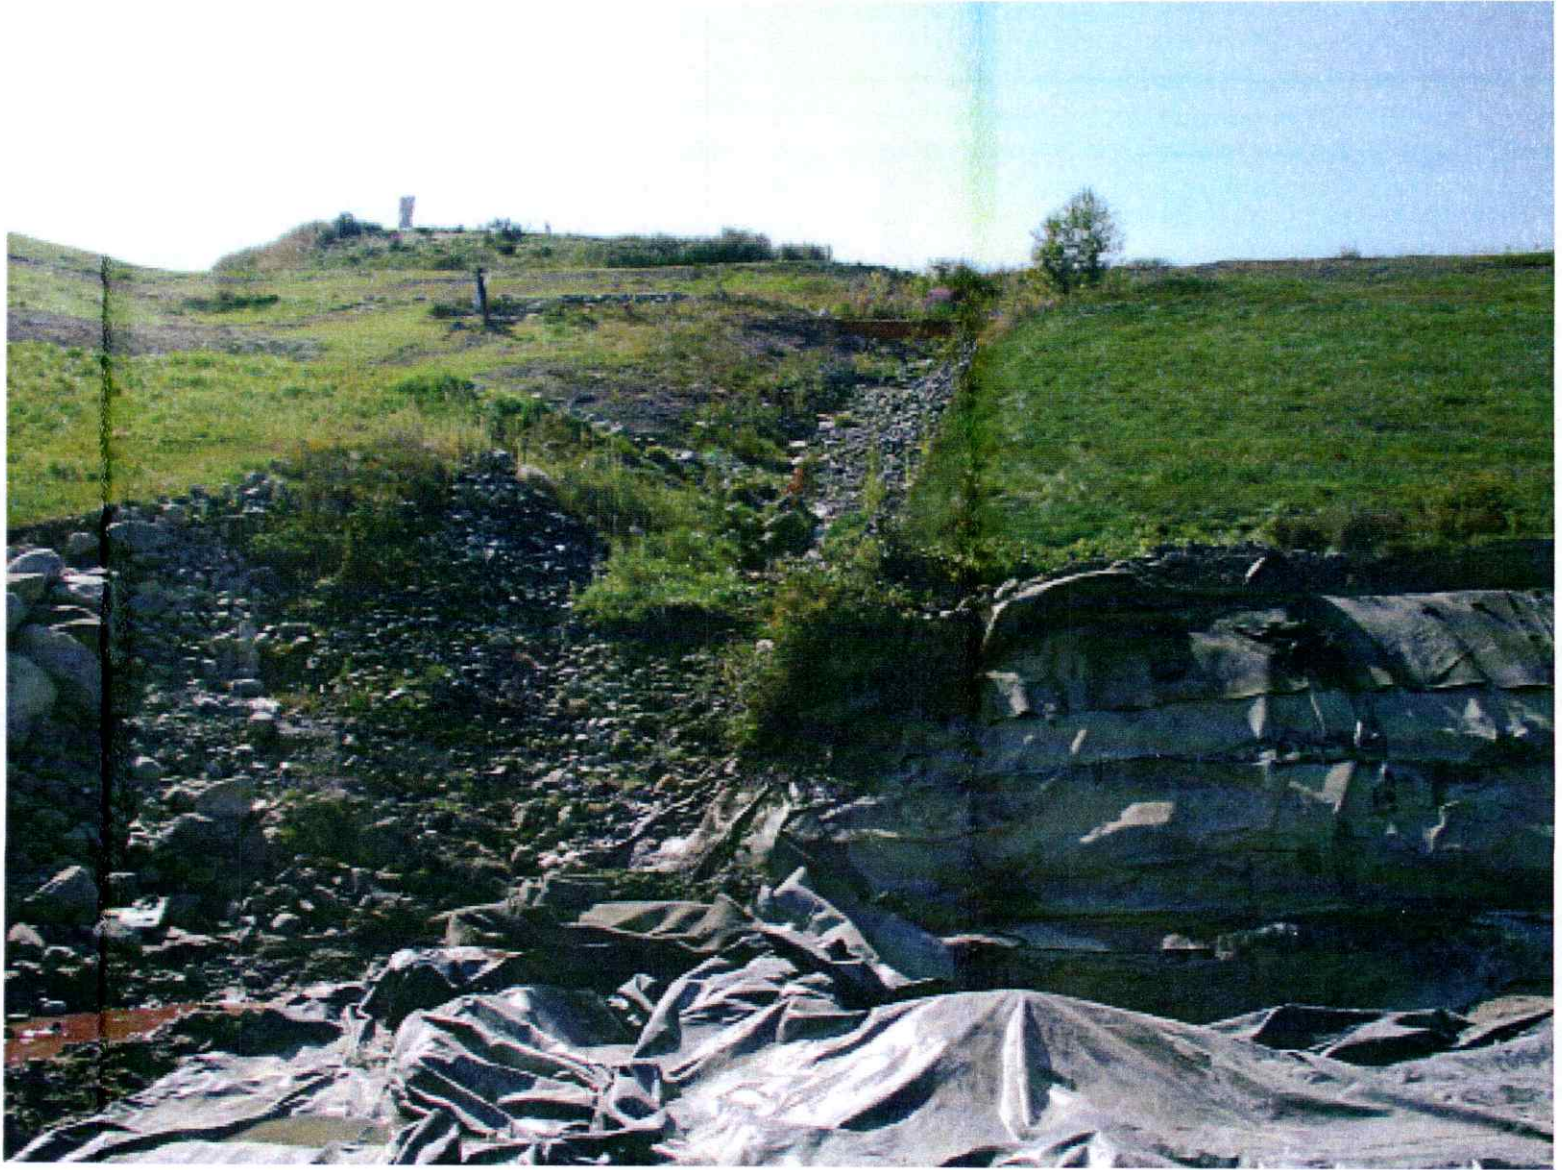
Picture 3. This picture is looking north at the Stage 1 Phase 1 anchor trench. Note arrow pointing out hole in geomembrane cap.

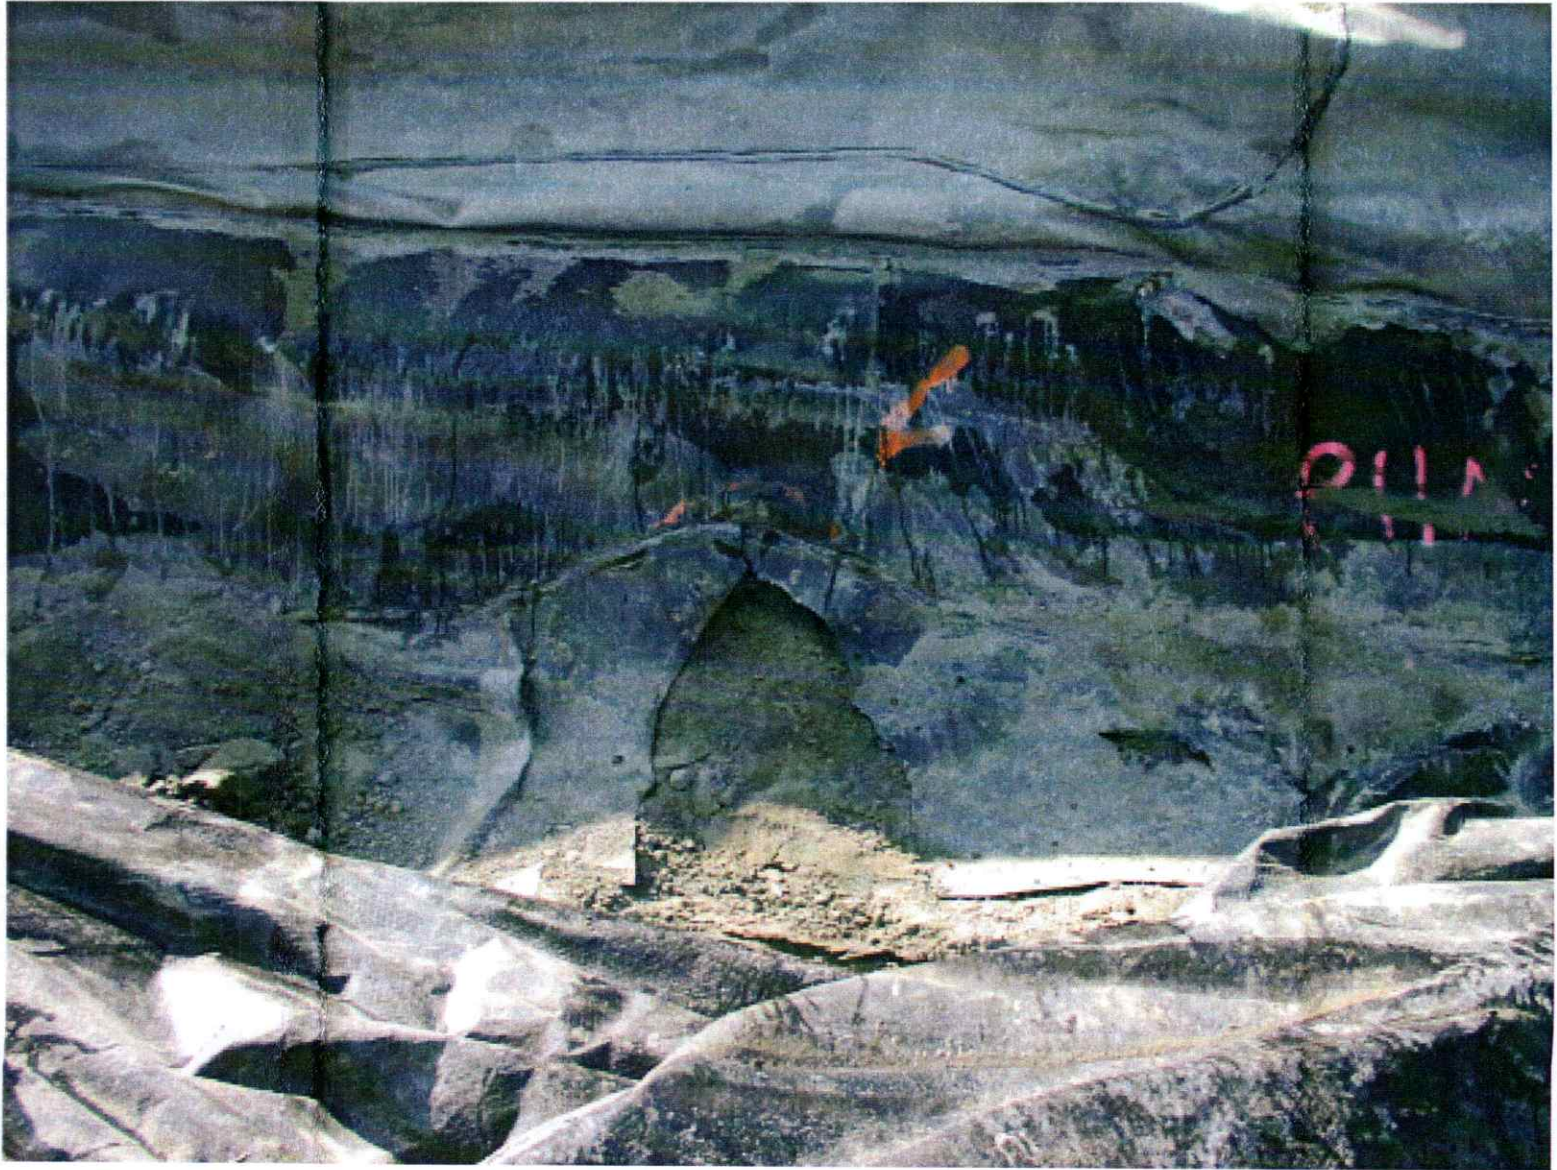
Picture 4. This picture is looking north towards MW 913M. The open trench is where the 36" culvert connecting the Stage 1 Phase 1 down chute to detention pond 3 was located.

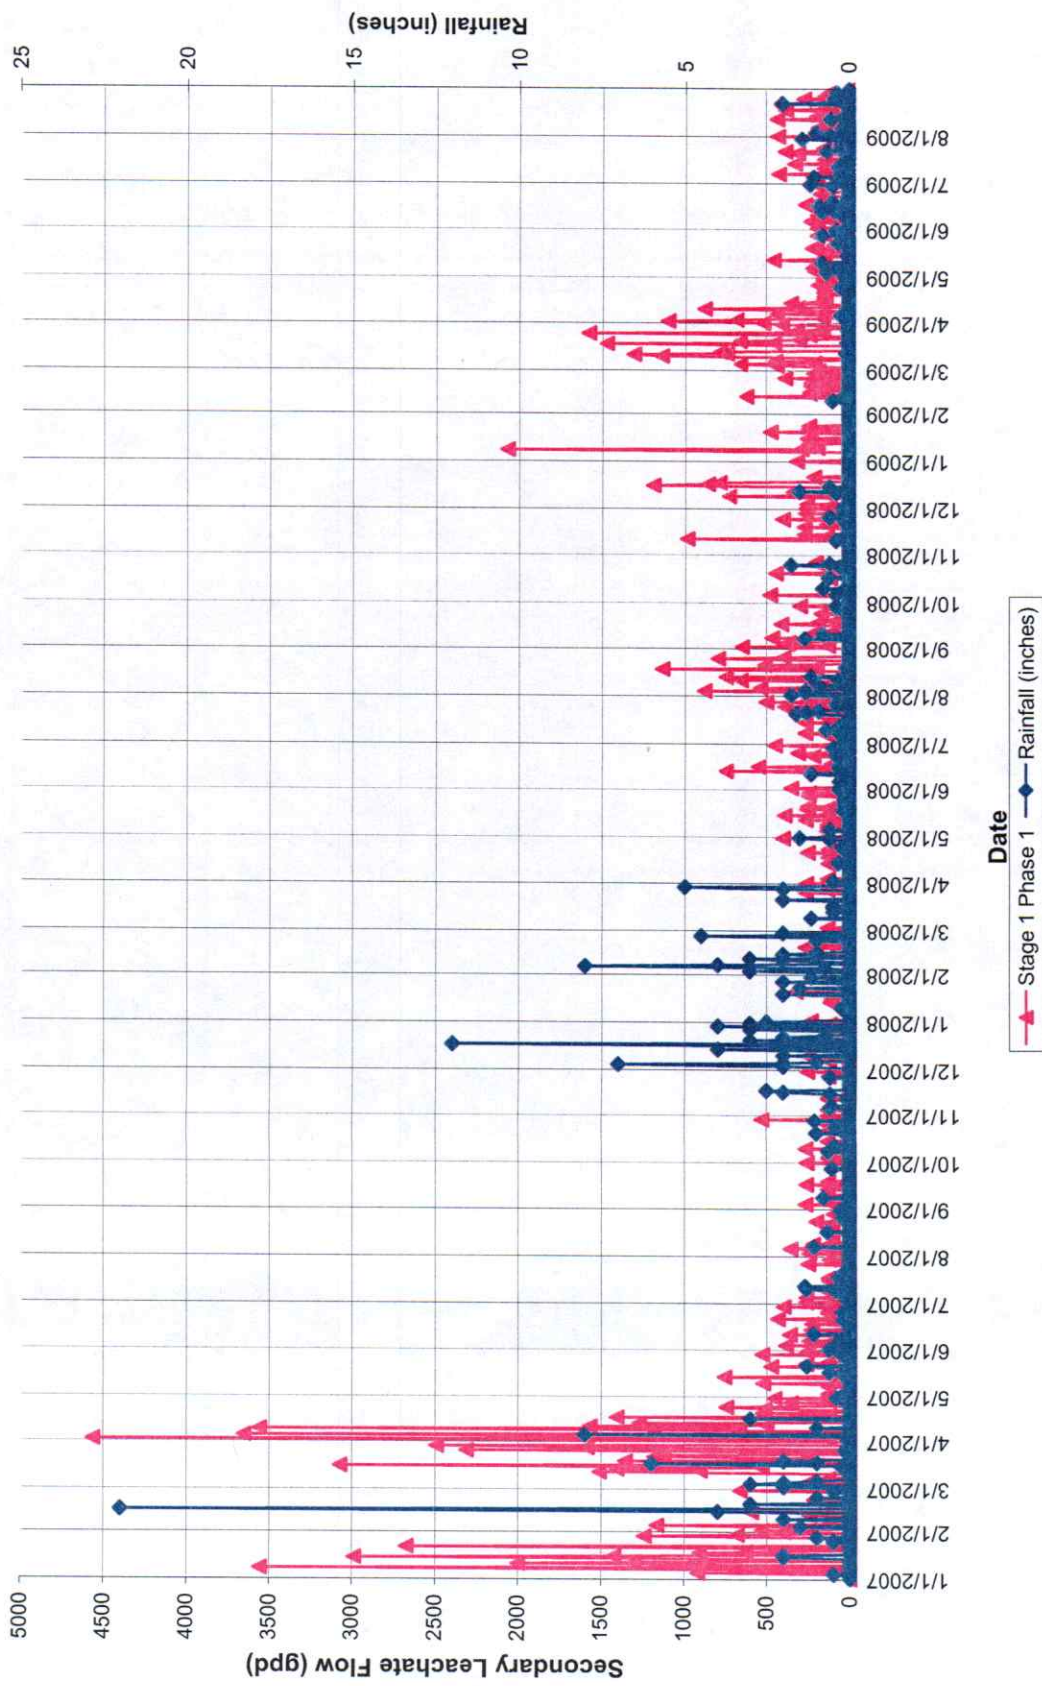
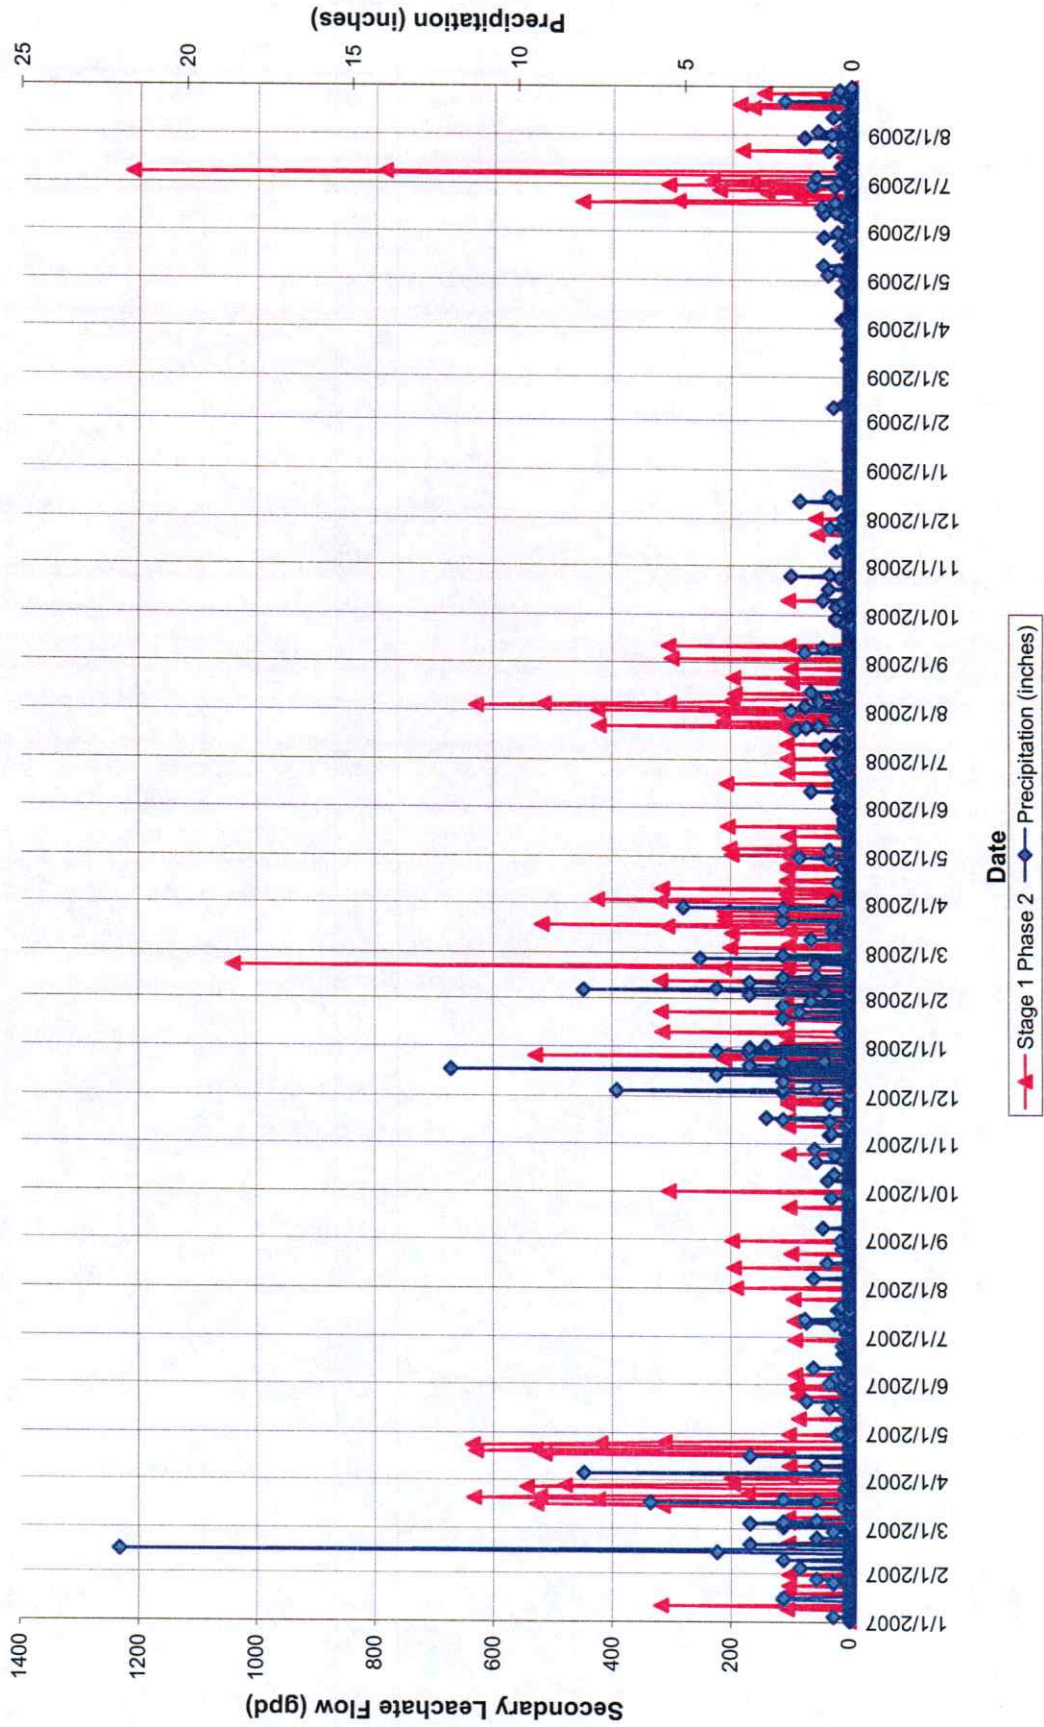
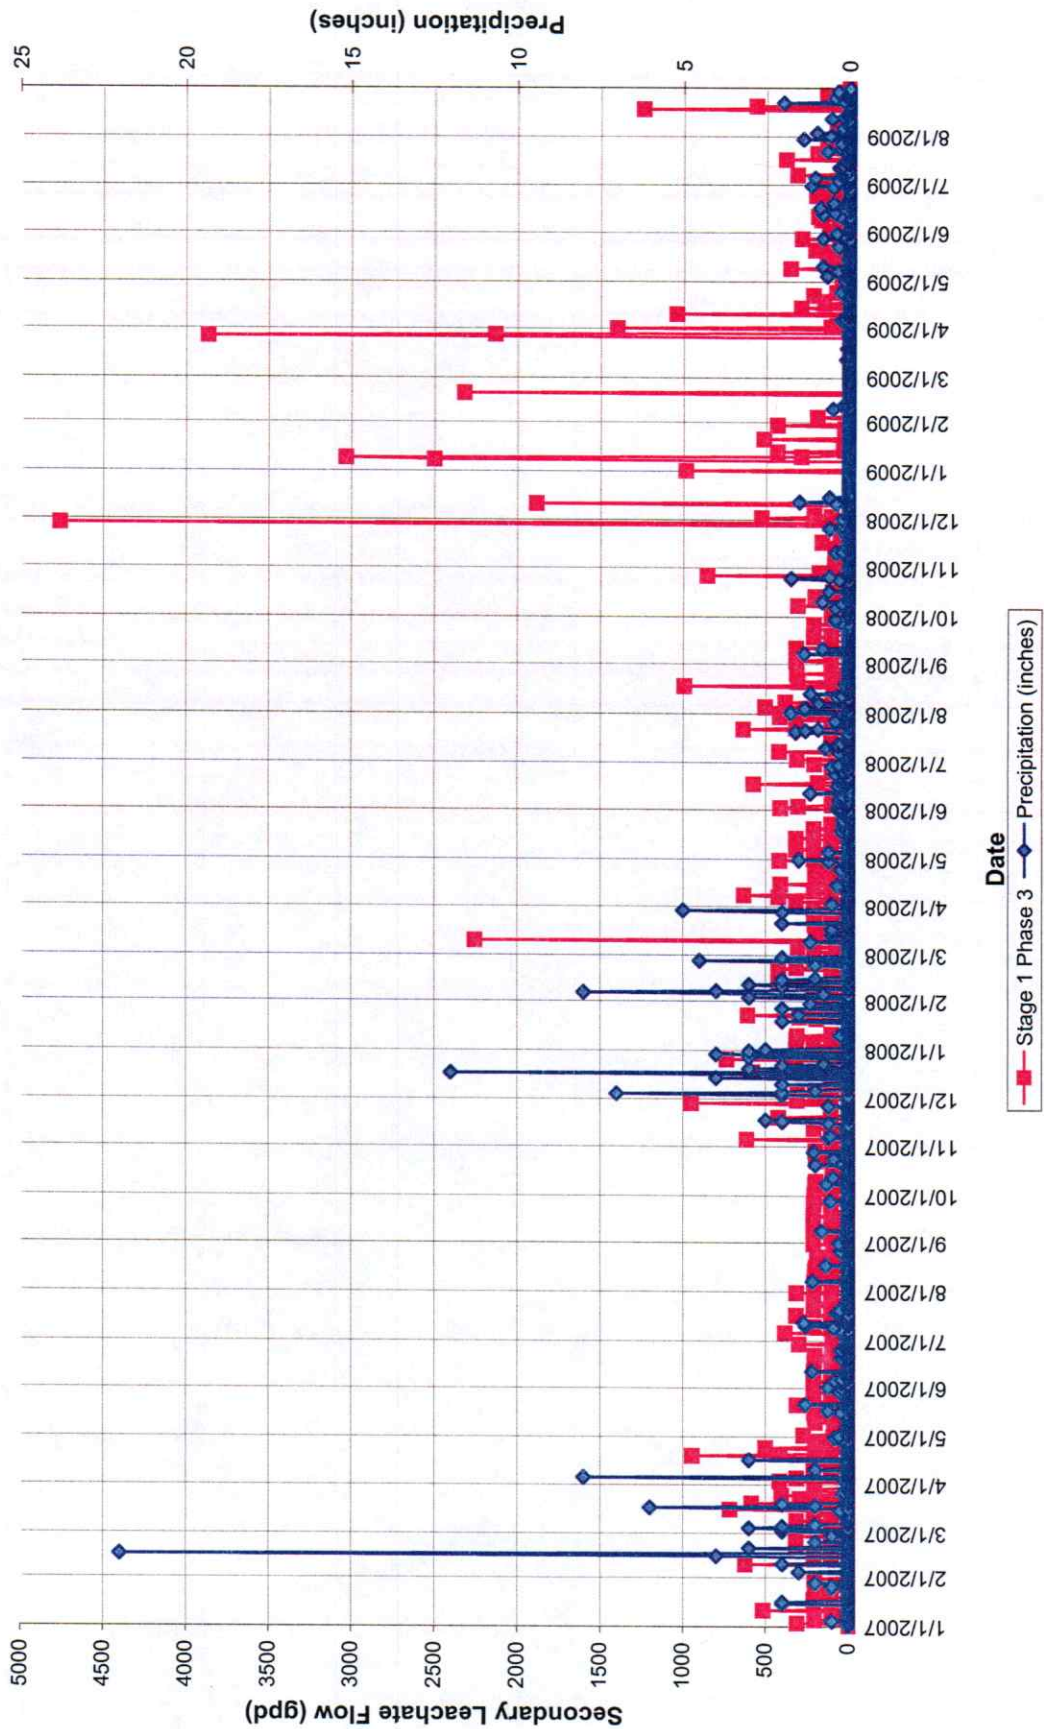
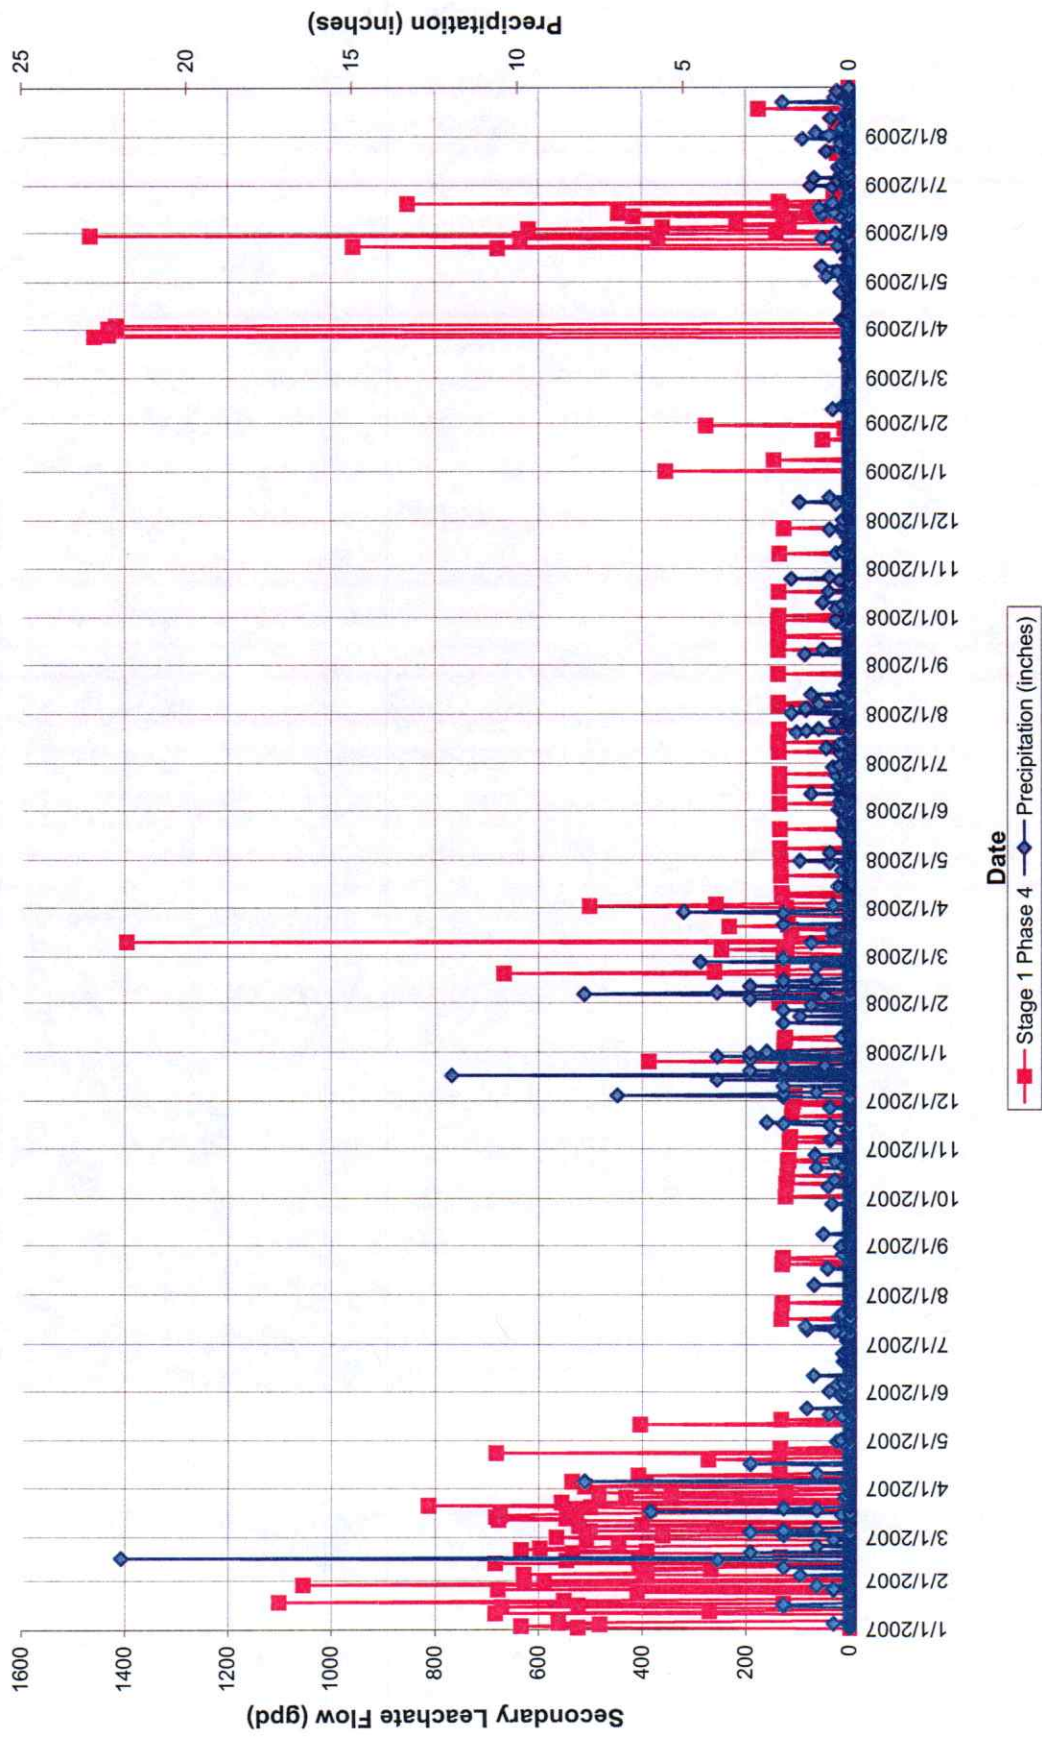
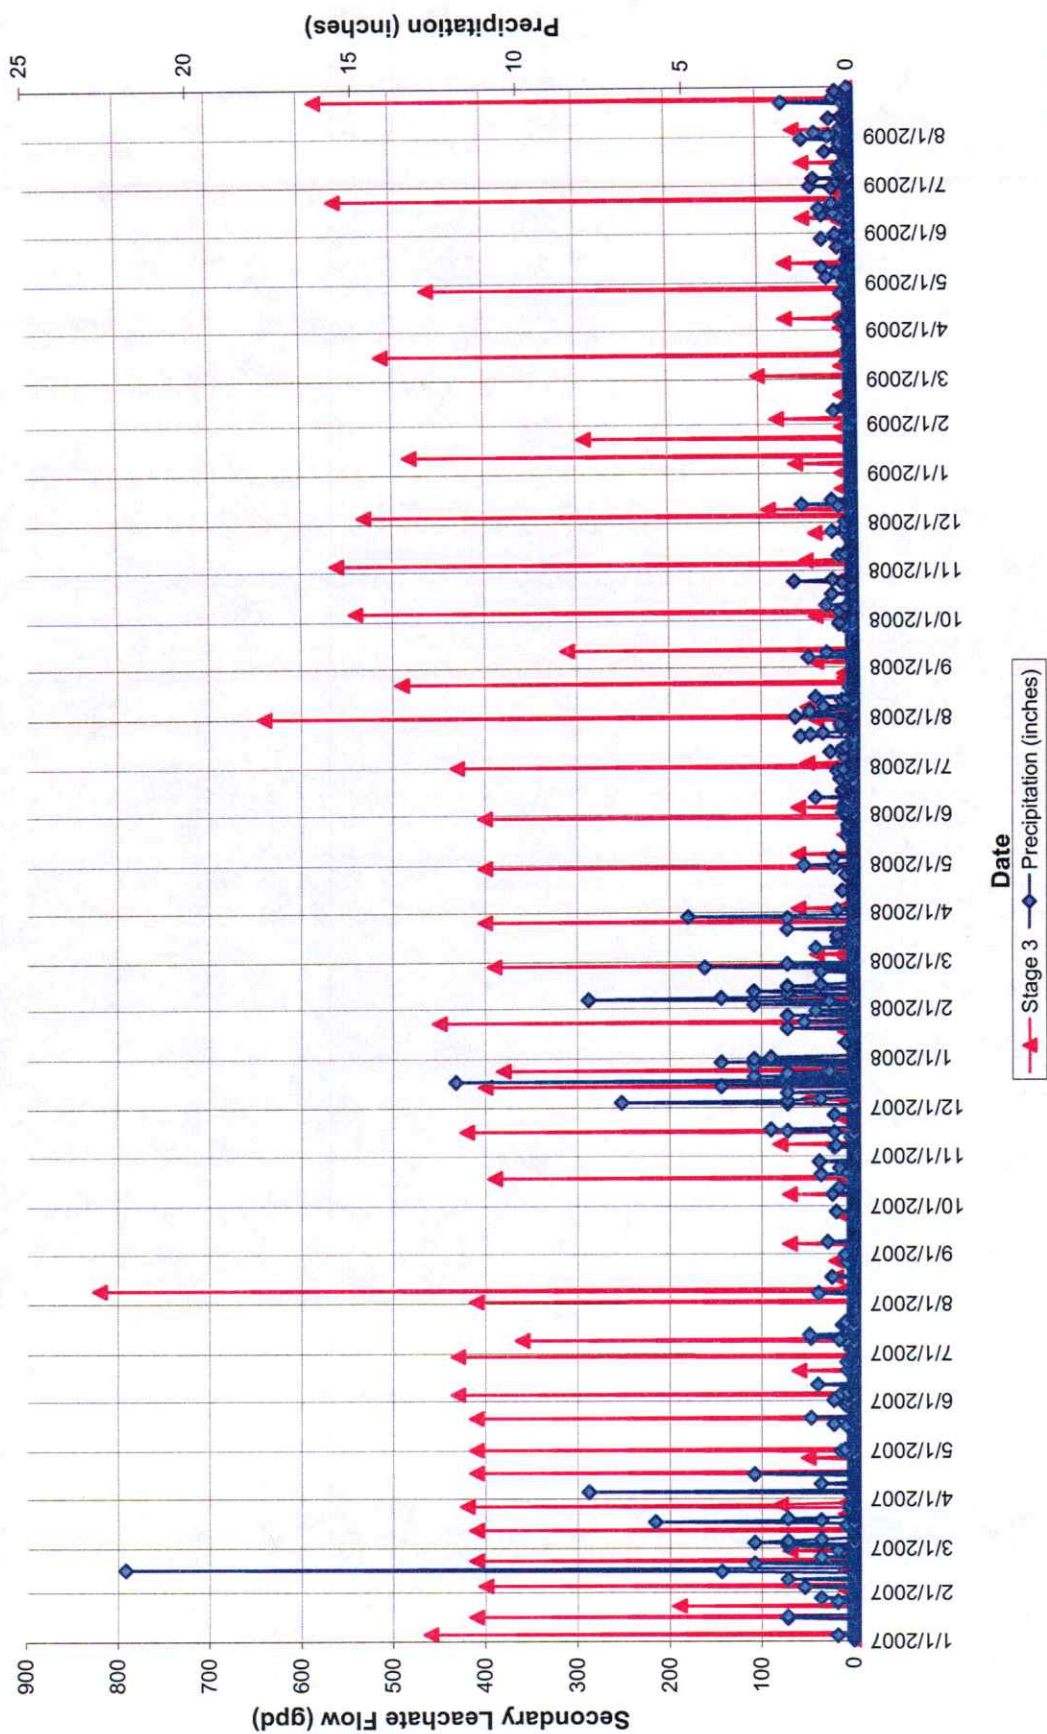
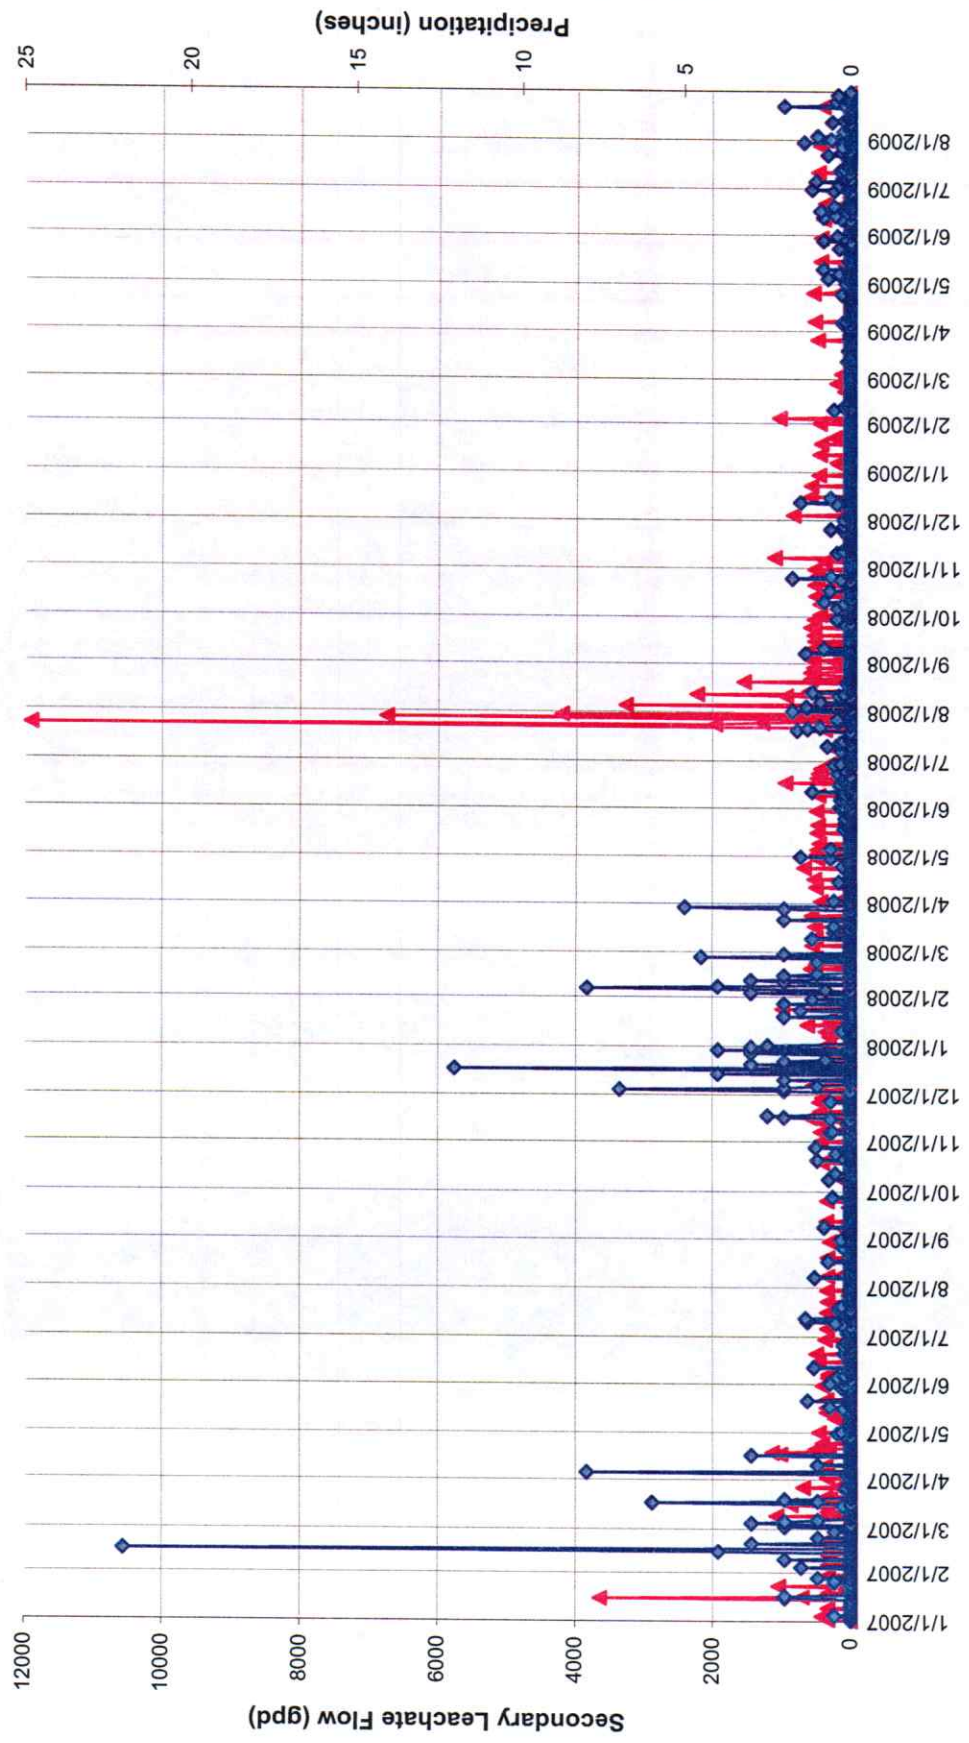
NCES Secondary Leachate Flows

As shown the Stage 1 Leachate Flow charts (esp. Phases 1 and 4), secondary leachate flows appear to have substantially decreased following the repairs.

As shown on the attached charts, Stage 1 secondary flows appear to be influenced by either rainfall events or runoff. In addition and as shown on the attached charts, there appears to be a relationship between total VOCs measured at MW B-913M and secondary leachate flows. I have also plotted Total VOCs for each of the Stage 1 phases.
