Case Study 1

Location: SEZ, Dahej, Gujarat

Customer Category: Specialty Chemical Manufacturer & Exporter

Problem Statement

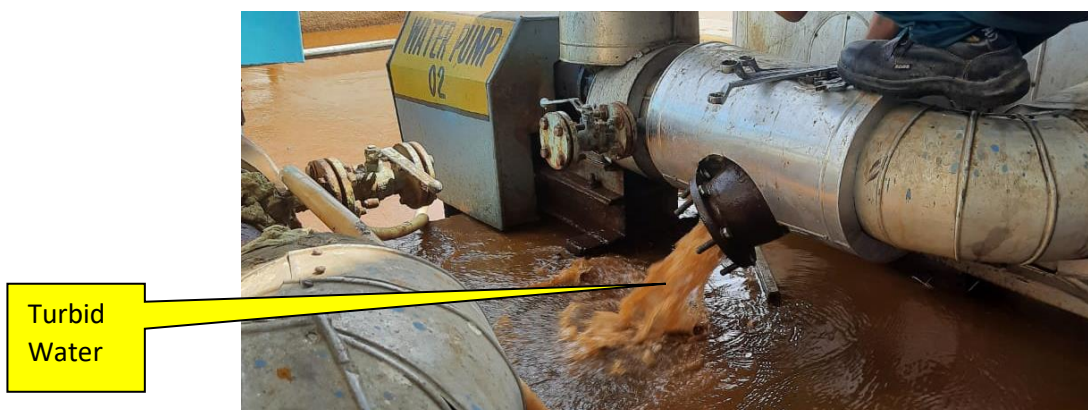
- Based on the details provided & observed, COP calculated was to be 2.94
- Strainer was full of iron chips.
- Chilled water tank was corroded due to MIC. Blisters were observed.

- Corrosion was also due to caustic attack also as caustic was being used to elevate pH in circulating water.
- Water parameters were as follow:

It was summarized that strainer was being choke because of iron chip and there was severe corrosion because of poor water treatment quality and ineffective water treatment program.

Precleaning and passivation was carried out which was followed by regular water treatment program.
