**Residential Home Inspection Report for
Your Name**

Inspection Address: 100 Your Lane, My Township, NC 27540-8441

Inspection Date: May 18, 2017

Supplemental Aerial Roof Inspection Observations

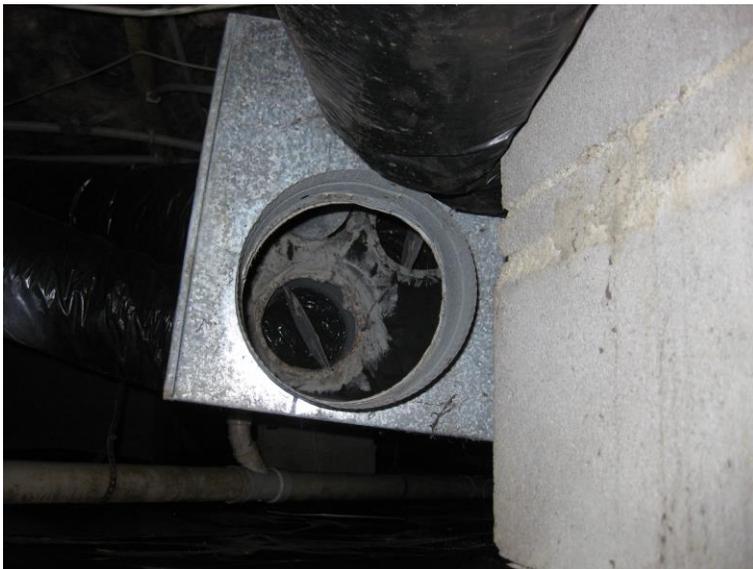
CHECKPOINT	CONDITION	COMMENTS
Air Ducts	Needs Repairs	Noticed insulated air ducts damaged and separated from distribution metal boxes in the crawl space. Condition results in inefficient cooling/heating of living space and shall be inspected and repaired by a professional in the business
Chimney	Not Present	Premanufactured NG fireplace has no chimney
Flue Pipes	Not Inspected	Premanufactured NG fireplace pipes are not visible for inspection
Heat Temp Check	Serviceable	Noted system reacting when digital thermostat setting was changed
Return/Plenum	Needs Repairs	Filters on hallways are in need of replacement. Clogged filters results increases energy consumption and reduces the HVAC systems' performance. Recommend filters be replaced before closing
Inside Fan	Needs Repairs	Low flow was noted due to insulated flexible ducts being disconnected from metal distribution boxes in the crawl space. A professional in the business shall inspect, repair, and replace ducts as necessary followed by properly verifying flow in living spaces

Flexible insulated ducts in crawl space are damaged, sagging or loose from hanger straps and/or separated from the metal distribution boxes. This condition results in inefficient use of the HVAC system preventing proper conditioning of living spaces of the property and increase consumption of energy
