# LEVEL 2 Home Survey Report

Client Name:  
**Mrs Jo Blogs**

Property Address:  
**Green Gardens, Wharlingham, CR8 9PQ**

Date of Inspection:  
**Wednesday 1<sup>st</sup> October 2025**

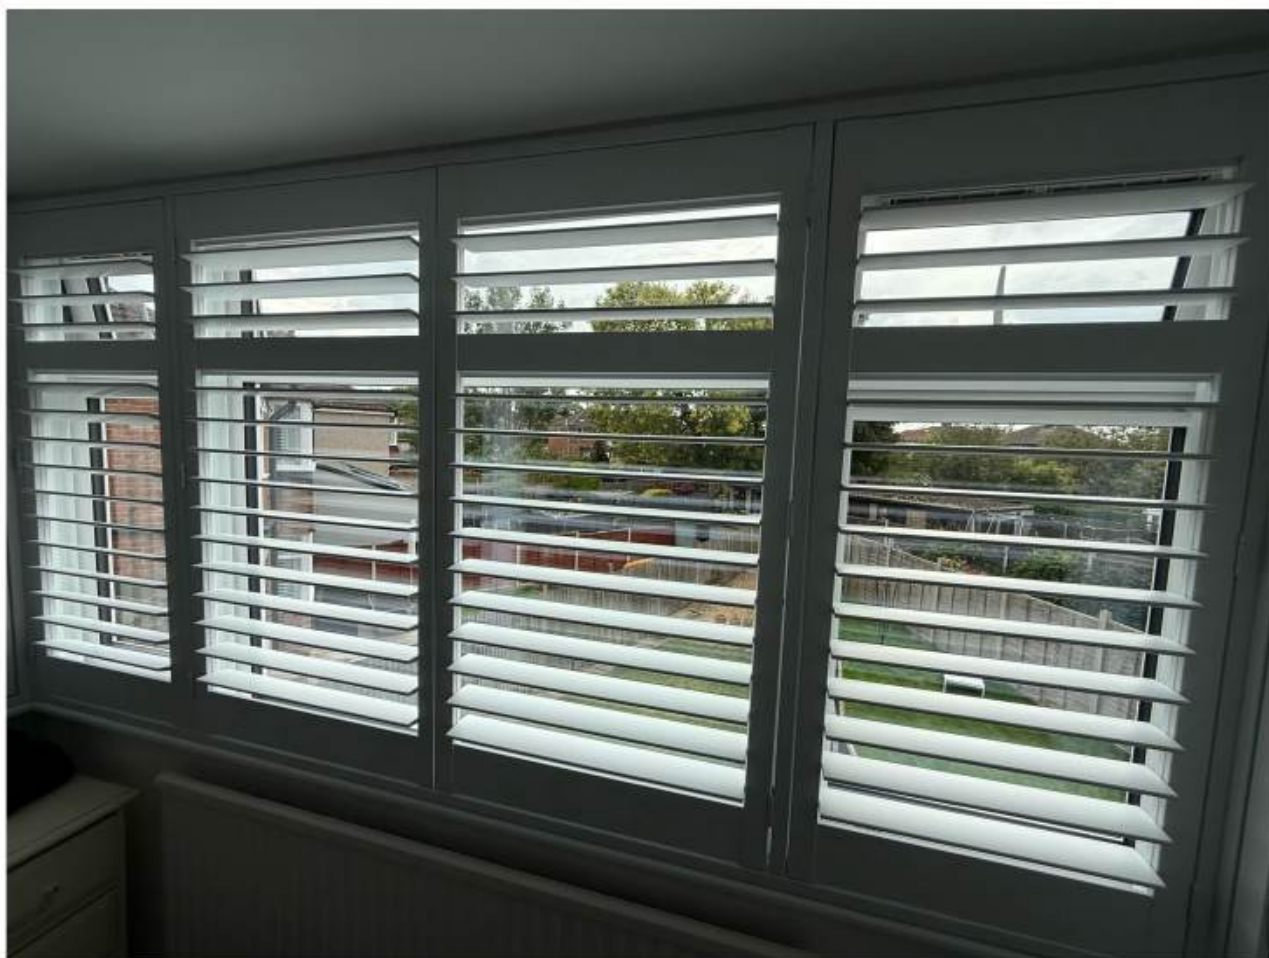
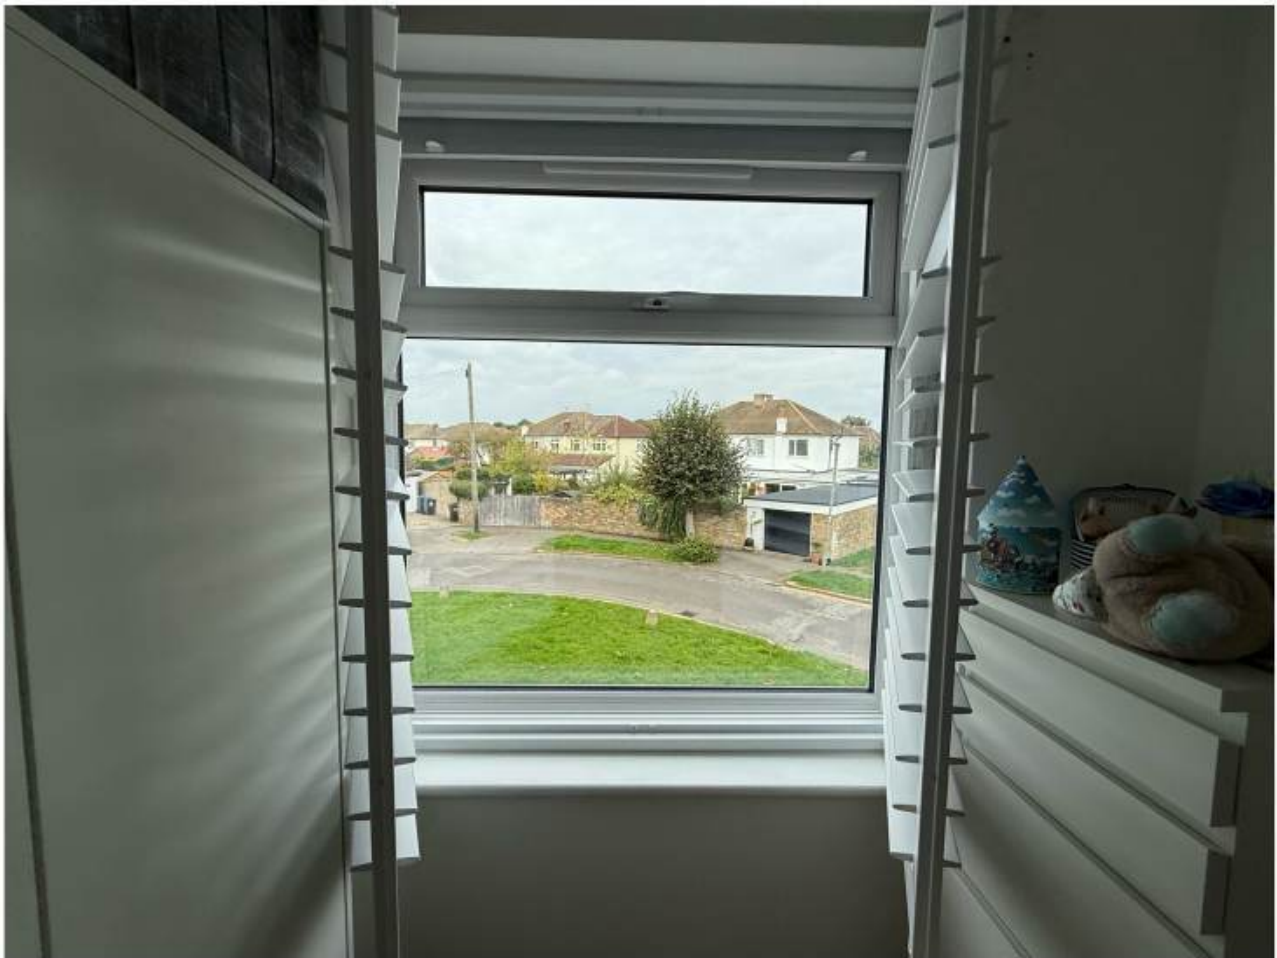
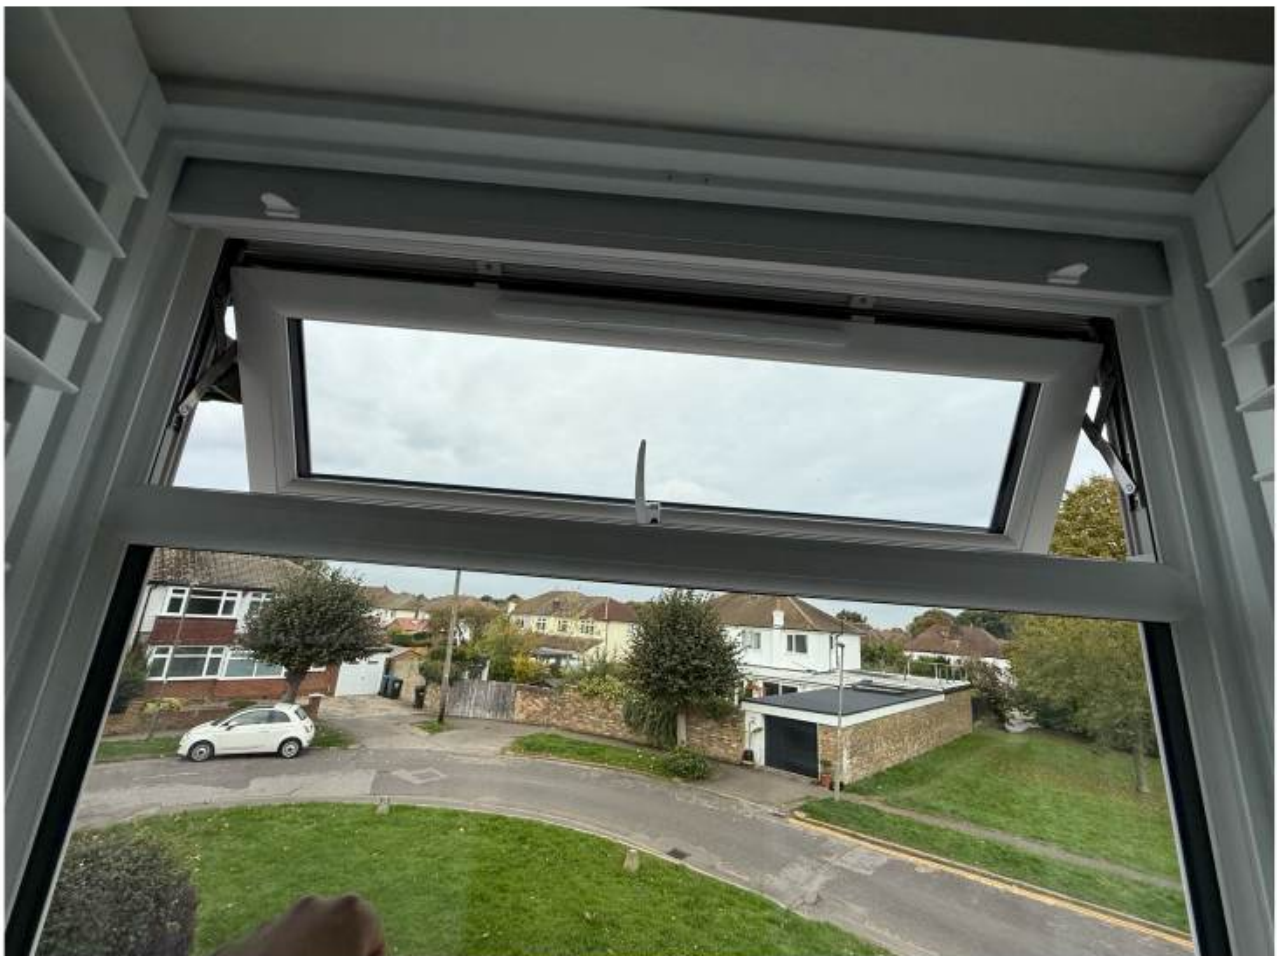
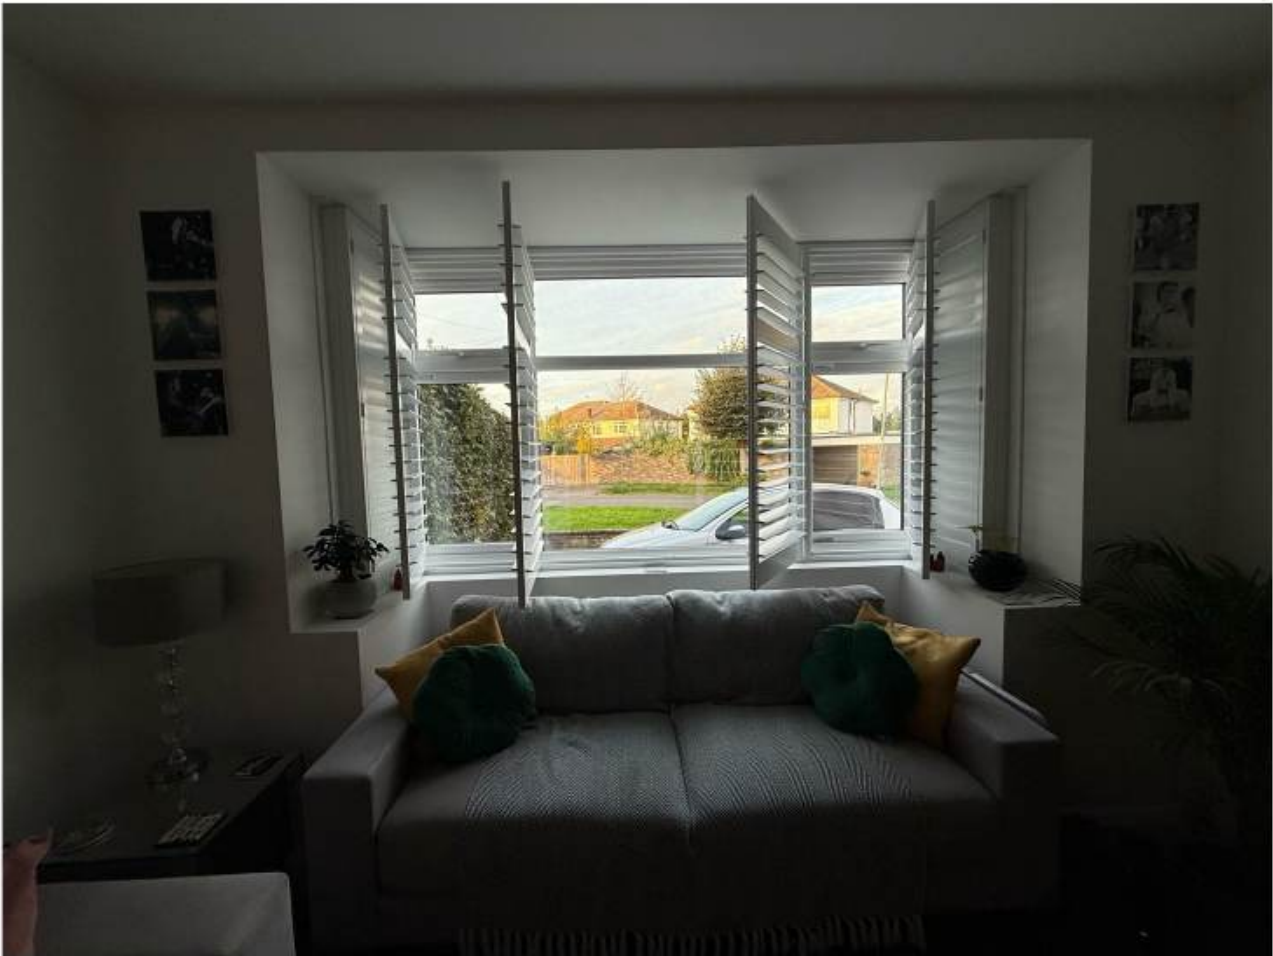
No immediate repairs are required. The windows should be maintained in the normal way, with the moving components cleaned and lubricated periodically.
