Up Close Inspections LLC

EXAMPLE Home Inspection Report

EXAMPLE REPORT: 102 N This away
AZ

Prepared for John2 Doe2
Date of Inspection: 01/01/2024

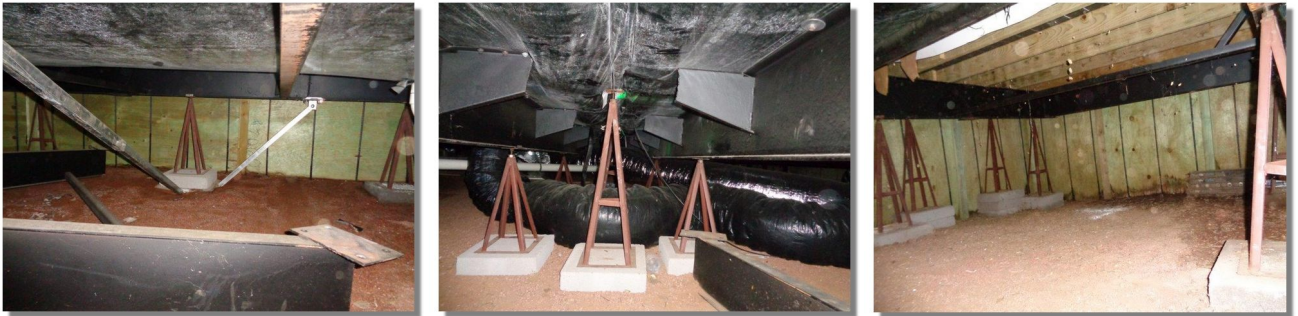
- Foundation Types: Engineer jack stands with skirting

- **INSTALLATION CERTIFICATE** - Present. Under the kitchen Sink

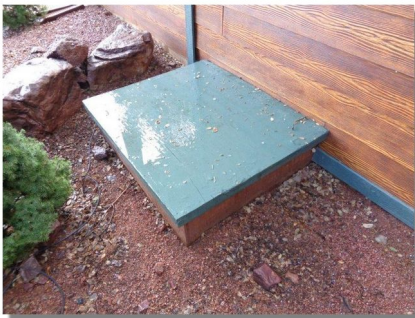
- Crawl space access location: West Right of Building
Access door: Crawl Space meets the min 18x24 inch
Inspected from: From inside the crawl space
- Floor framing type: Metal Frame with wood floor decking
- Ventilation: Foundation Vents

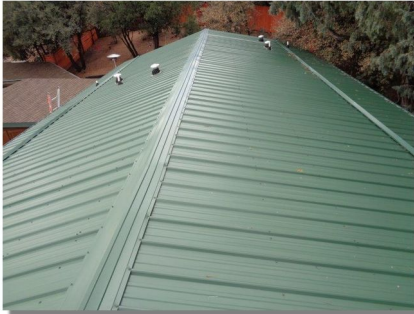
Visible inspection Type: Walked on roof

- Roof Style: Gable, Lean-to
- Pitch/Slope: 3/12 to 4/12 pitch
- Framing type: Trusses
- Roof sheathing or roof deck material: Unable to verify. Covered
- Roof covering(s): Metal panels
- Layers on Roof: 1
- Eave and soffit Types: Covered Eaves
- Roof Flashing Material Type(s): Metal
- Flashing around penetrations: Material Type(s): Metal
- Pipes material Type(s): ABS
- Vents material Type(s): Metal
- Chimney(s) flashing: Metal

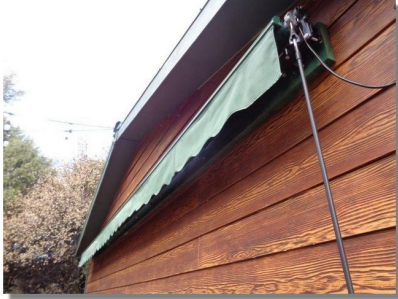
Location: South Rear of Building

Comments: Awning is operational

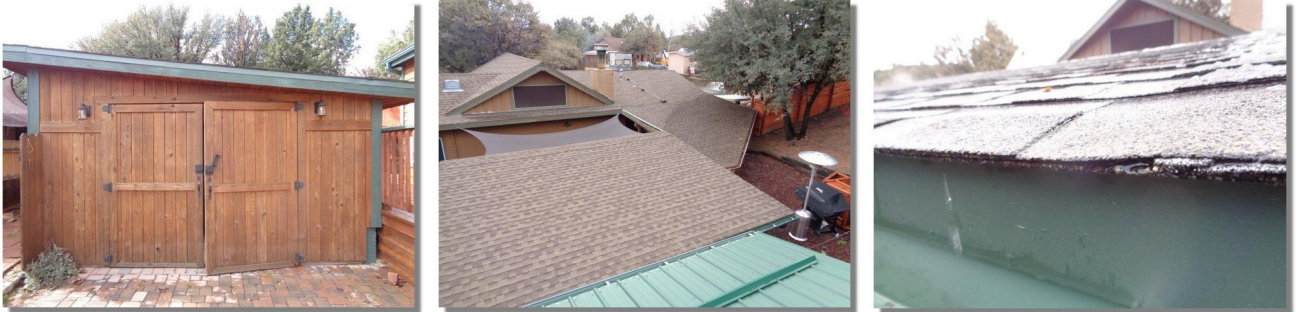
- Structure Type: Detached
- Location of entry: North
- Foundation Type: Concrete slab
- Floor: Concrete Poured slab
- Vehicle Door Type: Barn Door side-to-side.
- Exterior siding: Material Type: Wood T&G (Tongue and Groove)
- Roof: Shingle (Asphalt)
- Electrical: No issues noted in garage.

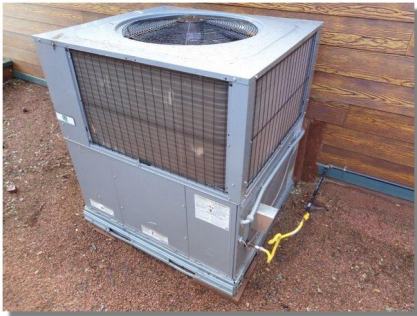
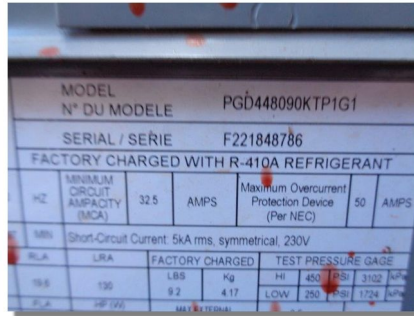
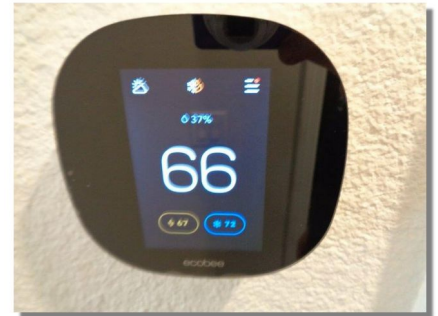
Location: West Right of Building

- Equipment Type: Dual Pack / Gas-Pack (gas heat, electric cooled)
- Manufacture: Day and Night
- Data Plate: Shows more information
 Year Manufactured: 2022
 Model Number: PGD448090KTP1G1
 Serial Number: F221848786
- Energy Type: Electric Gas
- Capacity or Size: 4 Ton
- Controls: Thermostat. Located: Living room
- Automatic Safety Controls: Hi Lo limit switch are present Yes No Not visible
- Distribution: Flexible Ductwork
- Heat source: Present in each room

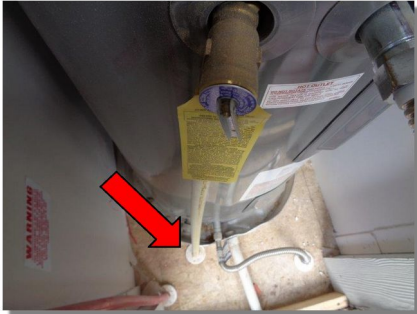
Location: Water heater closet

Comments: **TPRV NOT PIPED TO THE OUTSIDE** - Temperature Pressure Relief valve (TPRV) and drain pan should discharge to the outside and termination at a point that is readily observable by occupants. Currently piped to the crawl space which is not acceptable.

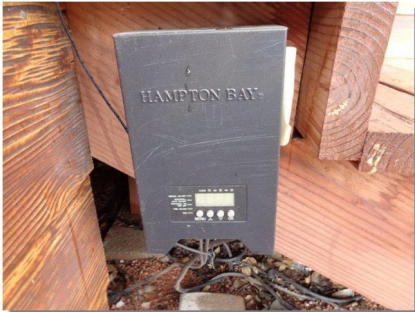
Location: Under deck stairs

A representative number of lights were inspected.

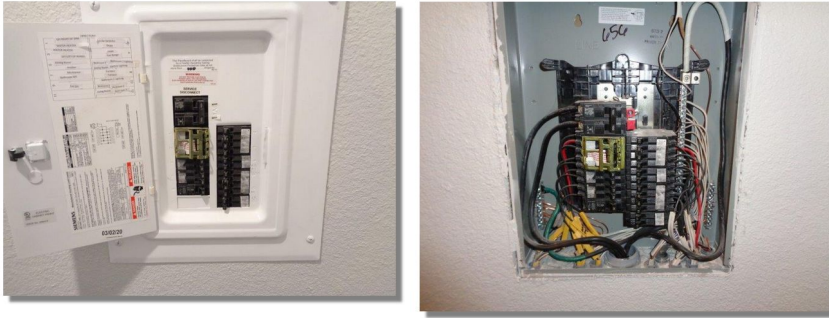
Location of Panel: Laundry room
Manufacture: Seimens
Labeled as required.
Electrical wiring appears to be serviceable at the time of inspection. Unless otherwise noted.
There are 1 additional breaker slots left in the panel.
Thermal Scan shows not hot spots.
