# Inspection Report

1122 Sunshine Street, Hometown, Florida 123456

**Inspection Date** March 23, 2020  
**Inspector** Matt Durst  
561-350-8125  
[mdurst@sunshinestatesbhi.com](mailto:mdurst@sunshinestatesbhi.com)

Sunshine State's Best Home Inspection

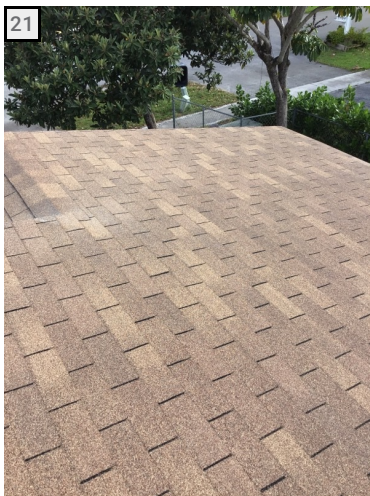
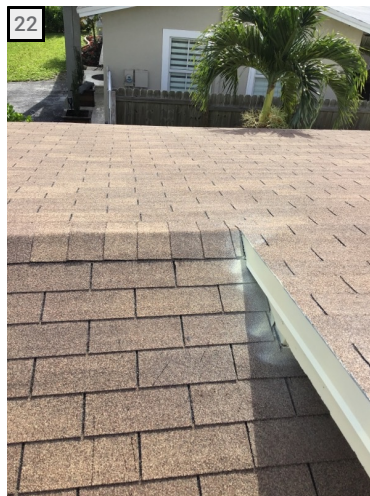
**3 Tab Asphalt Shingles covering the roof of this home exhibited moderate general deterioration commensurate with the age of the roof. They appeared to be adequately protecting the underlying home structure at the time of the inspection. Roof is 5 Years old at time of inspection**

**Impact** The expected lifespan of a 3-tab asphalt shingle roof, often called a 20-year shingle roof, is 15 to 18 years in Florida. The 15 to 18 year average lifespan estimate is based on "average" conditions.

**Suggested Action** Recommend having the roof inspected periodically by a Qualified Roofing Contractor and have the damaged roof material repaired or replaced as needed

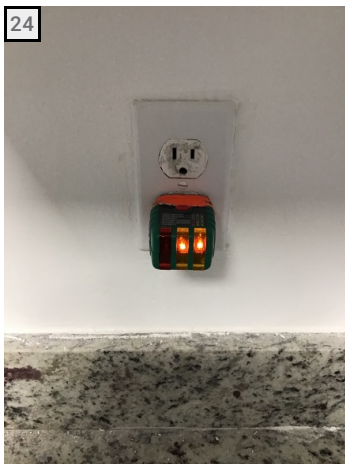
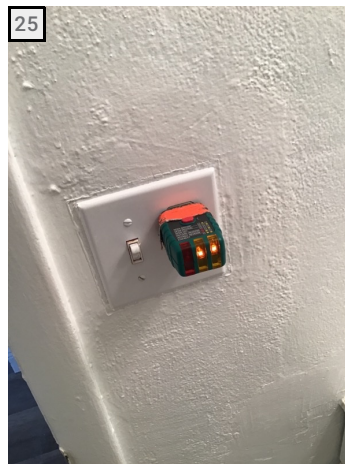
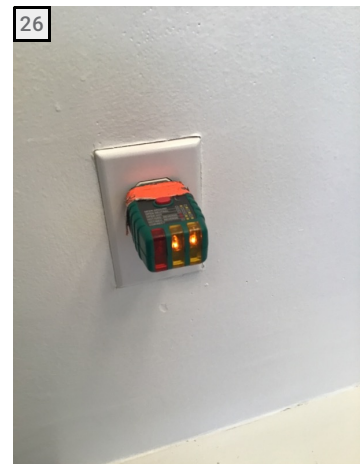
### ⚠ GFCI

Upgrade all receptacle to GFCI protection within 6 feet of all potential wet locations

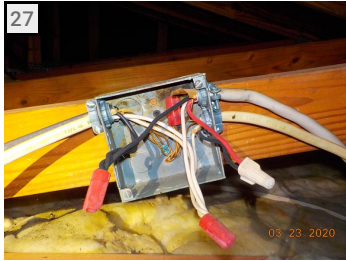
### Cover plate is missing

<b>Location</b>	Attic
<b>Impact</b>	Without a cover plate, electrical shock may result if touched
<b>Suggested Action</b>	Install a cover

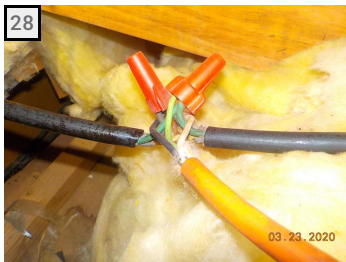
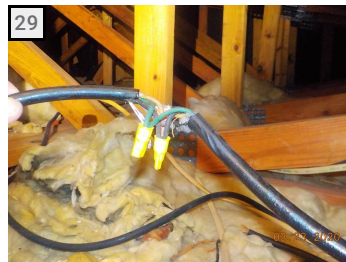
### No Junction box present. Open wires

<b>Location</b>	Attic
<b>Impact</b>	Exposed energized wiring can be hazardous to touch
<b>Suggested Action</b>	Have repaired by a licensed electrician

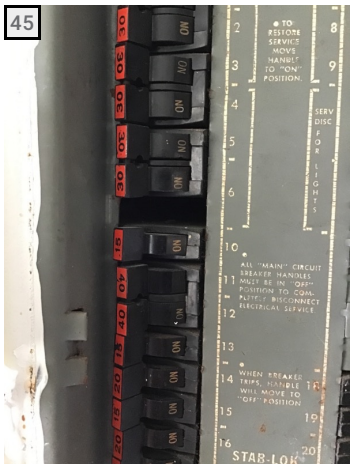
#### Knockouts are open

<b>Location</b>	Laundry Room / Mudroom
<b>Impact</b>	The sparking could escape through open knockouts causing possible ignition
<b>Suggested Action</b>	Install plugs in all open knockouts
<b>Other Information</b>	The service panel knockouts should be plugged to contain sparking

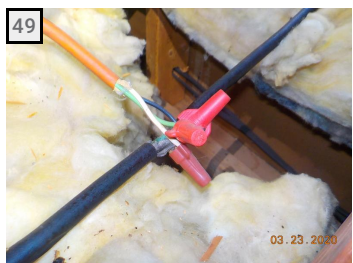
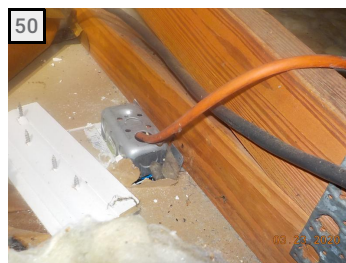
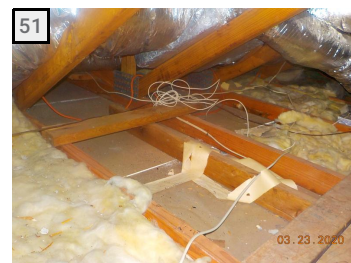
### Extension Cord wire used to power receptacle.

<b>Location</b>	Attic
<b>Impact</b>	When you purchase an extension cord, that cord has been designed and tested to operate properly under certain circumstances. Once you modify the cord in any way, you've voided any listing or labeling on the cord (UL listing, etc.). If there is ever a fire, this could be a factor
<b>Suggested Action</b>	Recommend inspection and replacement by a Qualified Electrical Contractor.

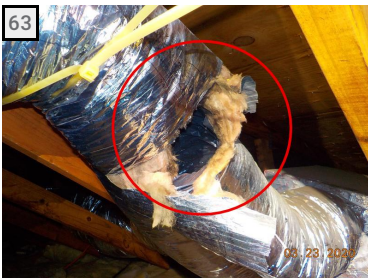
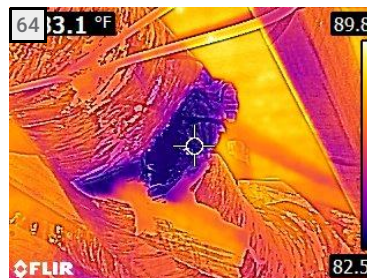
### Duct work contains gaps and conditioned air is escaping into Attic space

Cover the holes with metal tape. Do not use duct tape as it is not intended for this purpose, despite its name Duct mastic is the preferred material for sealing ductwork seams and joints. It is more durable than any available tape and generally easier for a do-it-yourself installation. Its only drawback is that it will not bridge gaps over ¼ inch. Such gaps must be first bridged with web-type drywall tape or a good quality heat approved tape. If you use tape to seal your ducts, avoid cloth-backed, rubber adhesive duct tape -- it tends to fail quickly. Instead, use mastic, butyl tape, foil tape, or other heat-approved tapes. Look for tape with the Underwriters Laboratories (UL) logo. Have all work done by a Qualified HVAC Contractor

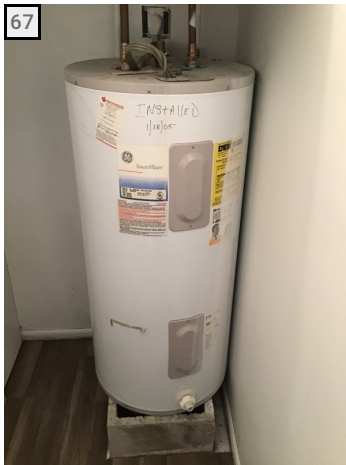
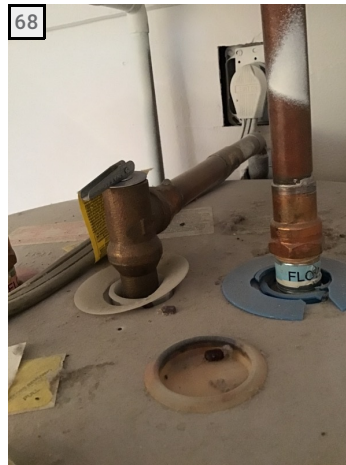
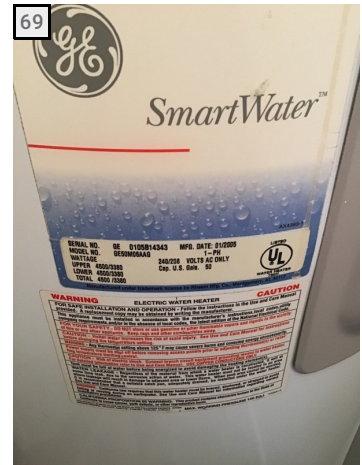
**Water Service disconnected**

**Location** 3rd Bedroom- Master  
**Impact** Unable to inspect  
**Suggested Action** Restore Water Service and have appliance inspected by a Qualified Contractor

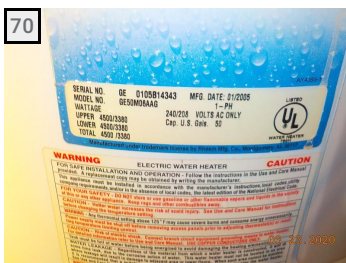
**Old**

**Nearing the end of its useful life (15 years old)**

**Location** 3rd Bedroom- Master  
**Impact** Based on the manufacturer's suggested service life, the life expectancy of a water heater is about 8 to 12 years. That varies with the location and design of the unit, quality of installation, maintenance schedule and water quality.  
**Suggested Action** Budget for a newer unit. In the interim, a higher level of maintenance can be expected

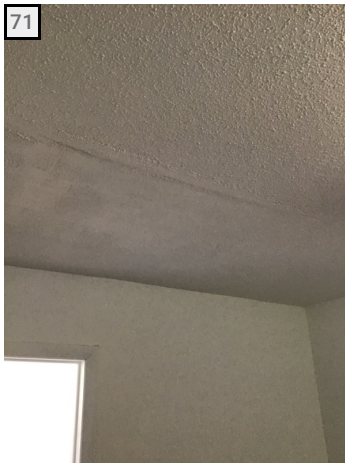
**Location** 3rd Bedroom- Master

**Impact** Seal and Paint

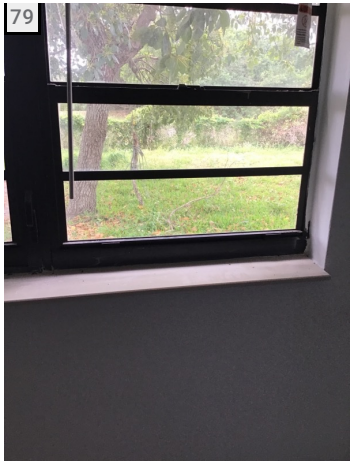
#### no closing mechanism

**Location** 3rd Bedroom- Master

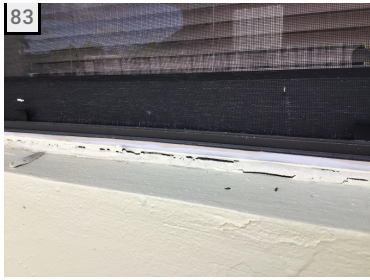
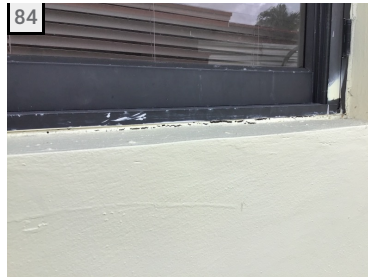
#### Caulking or sealant is deteriorated

<b>Location</b>	Exterior: Ground View
<b>Impact</b>	Without proper caulking, air, moisture and/or insect intrusion may occur. Often, water leaks at a window result from a breakdown in the connection between the window frame and the wall.
<b>Suggested Action</b>	Re-caulk all windows and doors where caulking has deteriorated. To prevent leaks, caulk the window where it meets the exterior siding. If the window is surrounded by trim, use a high-grade polyurethane caulk to seal all gaps between the trim and the siding (and the trim and the window).

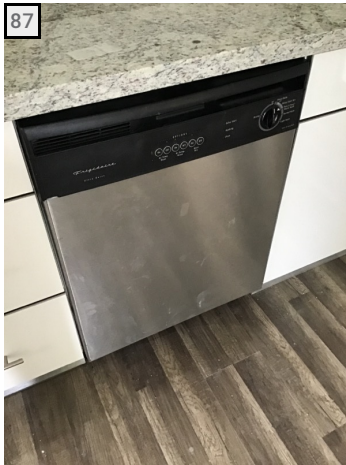
##### Water Service disconnected

<b>Location</b>	Kitchen
<b>Impact</b>	Unable to inspect
<b>Suggested Action</b>	Restore Water Service and have appliance inspected by a Qualified Contractor

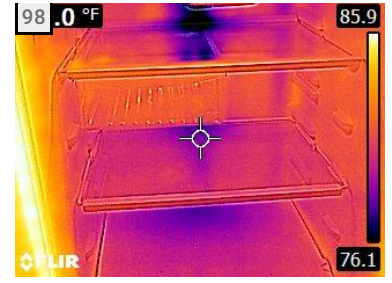
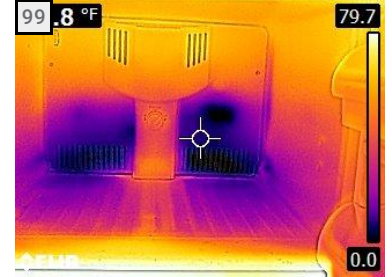
**Not Working**

**Refrigerator was off prior to beginning of inspection. After 2 hours of operation, freezer was cooling properly but refrigerator side was not**

**Location** Kitchen  
**Suggested Action** Repair or replace the unit

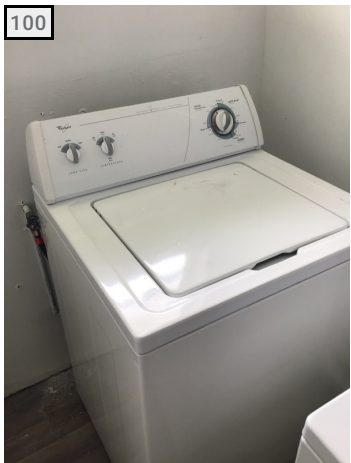
#### Water Service disconnected

**Location** Laundry Room / Mudroom  
**Impact** Unable to inspect  
**Suggested Action** Restore Water Service and have appliance inspected by a Qualified Contractor

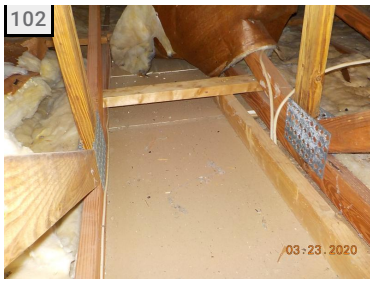
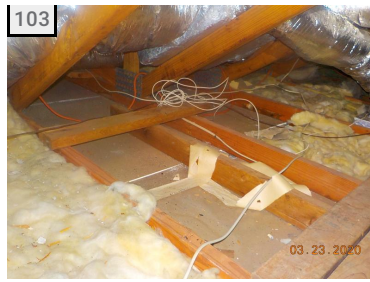
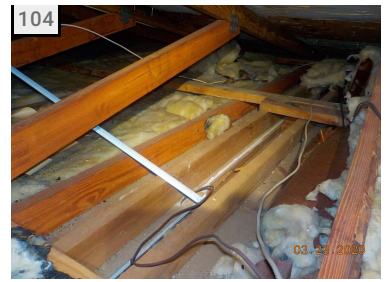
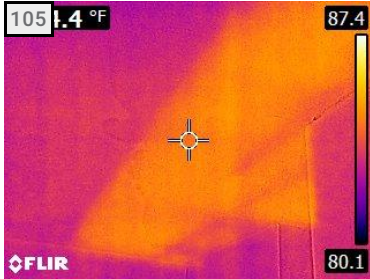
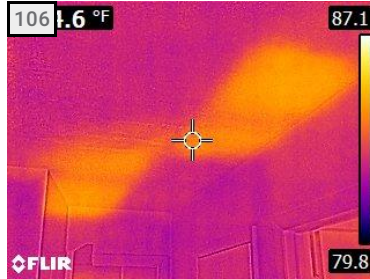
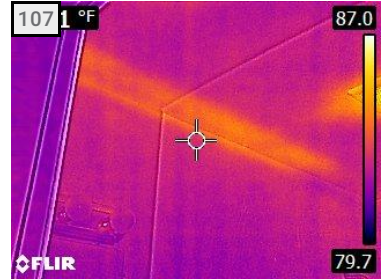
**Location** Attic  
**Impact** 5% missing insulation equals 54% drop in R-value, These thermal defects undermine the R-value of your attic insulation. Simple thermal analysis reveals that if you have 5% missing insulation in an attic (bare sheet rock) you'll have a slightly more than a 54% drop in R-value. R-value simply means resistance to heat flow. These thermal defects not only undermine the R-value of your insulation, but they also make rooms uncomfortable and increase your utility bill.

**Suggested Action** Redistribute the existing insulation to a uniform thickness

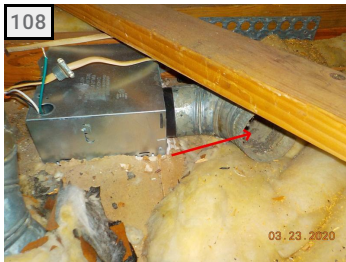
**↕ Kitchen / Bath Exhaust**

When exhausting to the interior, humidity or other particulates are not expelled from the home increasing health risks

Re-route the exhaust to exit to the exterior using an exterior wall or roof vent
