**Triangle Pond Management**  
 405 S Rogers Ln  
 Raleigh, NC 27610  
 (919)398-3221  
 Office@TrianglePondManagement.com  
 www.TrianglePondManagement.com  
**Maintenance Service Report**

<b>Customer Name:</b>		<b>Date:</b>	
Chandler Woods MOA		2/23/2026	
<b>Address:</b>			
214 Abbot Pl			
<b>Aquatic Technician:</b>			
Jordan Woosley			
<b>Time of Arrival:</b>		<b>Time of Departure:</b>	
10:10 AM		1:38 PM	
<b>Drive Time:</b>			
11 min			
<b>Type of Device(s) Maintained:</b>			
BMP 1, BMP 2, BMP 3

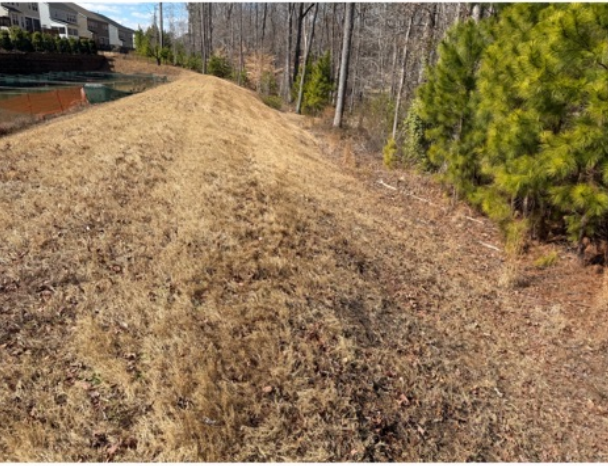
The wildlife exclusion fencing has come apart from the stakes around BMP 2, may require repairs.

<p>BMP 2 wildlife exclusion fencing coming apart from stakes</p>	<p>BMP 2 backside of dam</p>
Photo 19:	Photo 20:

Please contact our office with any additional questions, concerns, or to schedule repairs.
