# Annual Inspection and Maintenance Reports for Stormwater Control Measures (SCMs)

**CHANDLER WOODS – CHAPEL HILL, NC**  
 Stormwater Control Measure (SCM) Location Map

Site Name:	Chandler Woods	Date:	04/19/2024
SCM Location:	Abbot Place	SCM ID Number: (if applicable, per approved plans)

### SCM #1 – WET DETENTION POND #1 (WEST)

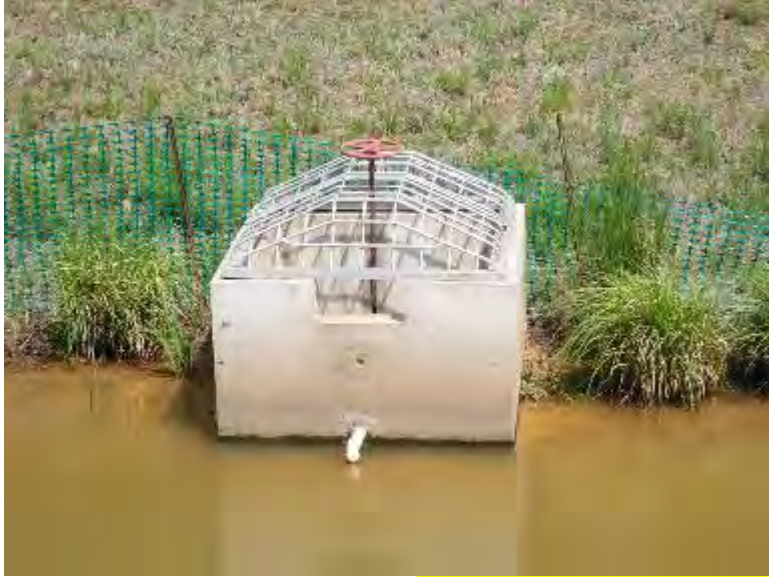
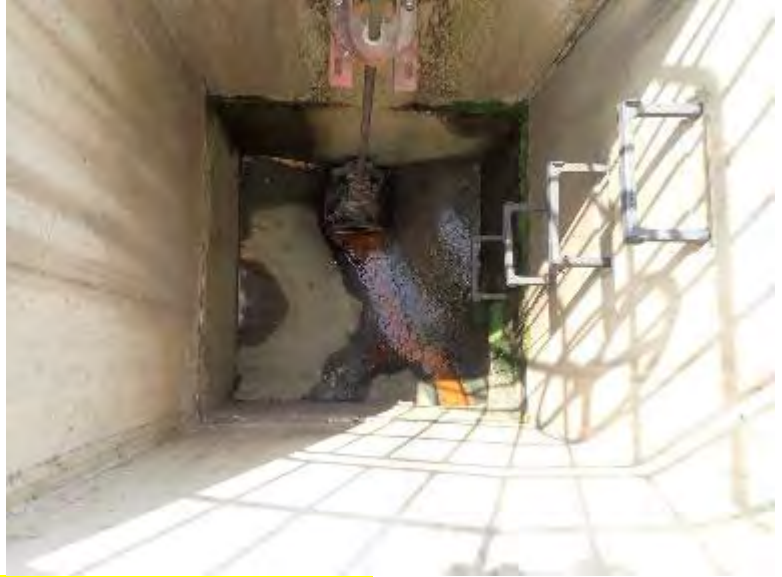
**E: VIEW OF RISER EXTERIOR AND INTERIOR**

ASSESSMENT	CODE	COMMENTS
Obstruction: Vegetation, Debris, Sediment, Other	PASS	
Structural Condition	PASS	
Velocity Dissipator Pad Condition	PASS	
Pipe Condition	PASS	
Orifice Condition	PASS	
Erosion or Undercutting	PASS	
High-flow Bypass	PASS	
Other (describe)	M	Seepage at riser outlet structure; see photographic journal

**D: REMEDIATE LOW POOL LEVEL RESULTING FROM OUTLET STRUCTURE LEAKS: THOROUGHLY CLEAN ORGANICS FROM ALL SEEPAGE POINTS & SEAL W/ NON-SHRINK HYDRAULIC GROUT**

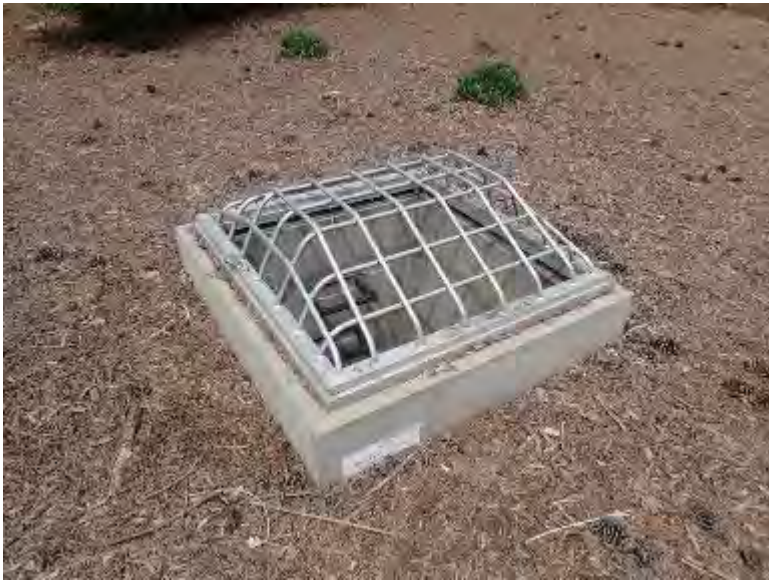
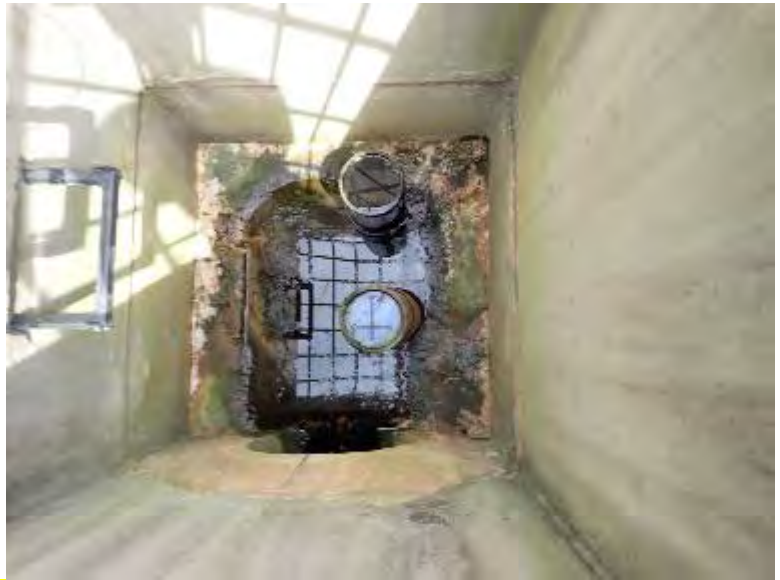
**D: VIEW OF RISER OUTLET STRUCTURE EXTERIOR AND INTERIOR**  
**(FUNCTIONAL INTERNAL WATER STORAGE CONFIRMED)**
