GEOLOGIC HAZARDS ASSESSMENT

**GENESEE PROPERTIES, INC.
SOCIETY TURN PARCEL
HIGHWAY 145
SAN MIGUEL COUNTY, COLORADO**

June 15, 2020

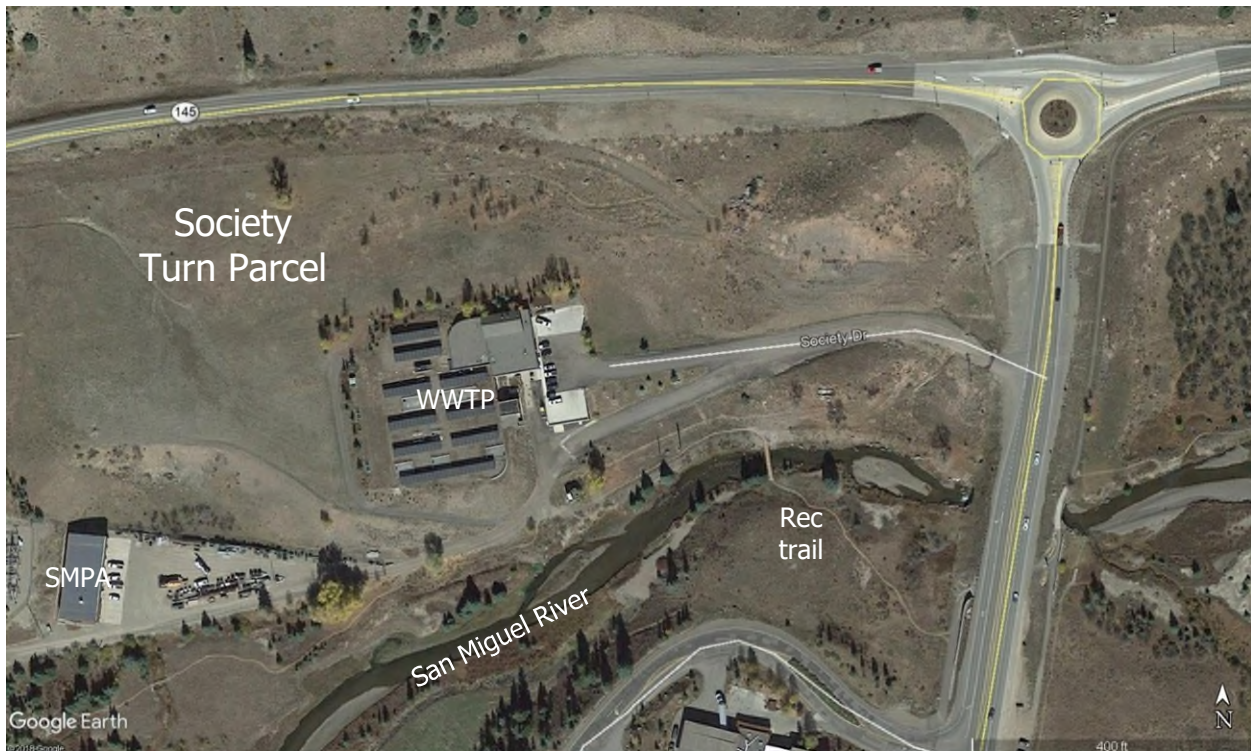
Photo 2. Aerial image of eastern portion of Society Turn Parcel. Note the location of the San Miguel River, nearby facilities, Highway 145 on the north and east, and part of a recreational trail and bridge. (This Google Earth image is from 10/12/15).

A public, non-motorized recreation trail, called the Remine Creek Trail, crosses the Society Turn Parcel. The southeast portion of it is seen on the aerial image above (Photo 2). It connects to the Valley Floor Trails near the pedestrian/bike path underpass to the east. The trail crosses the San Miguel River on a pedestrian bridge on the Society Turn Parcel (seen in Photo 2) and continues north to northeast to cross the entrance road of the WWTP. The trail continues through a gate and traverses the north edge of the property to the west trailhead where there is another gate and the trail crosses Highway 145 to continue up the Remine Creek drainage (Photo 1).

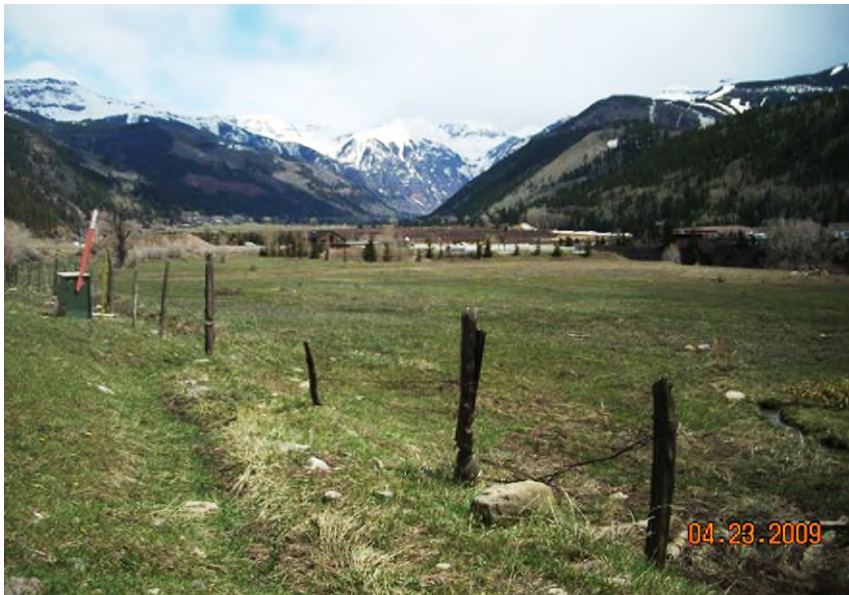
The shape of the Remine Creek fan (*Qac*) on the western half of the Society Turn Parcel can be seen in the contour lines of Map 4. Near the western corner of the Society Turn Parcel, Remine Creek incises into this fan as it drops steeply to its' confluence with the San Miguel River within a narrow gorge. The following photograph (Photo 3) shows the low gradient of the Remine Creek fan from a view to the east.

Photo 3. Looking east across the Remine Creek fan towards Telluride from near the northwest corner of the Society Turn Parcel shows the vegetative cover and the gentle slope of the alluvial fan. Highway 145 is to the left of the image.

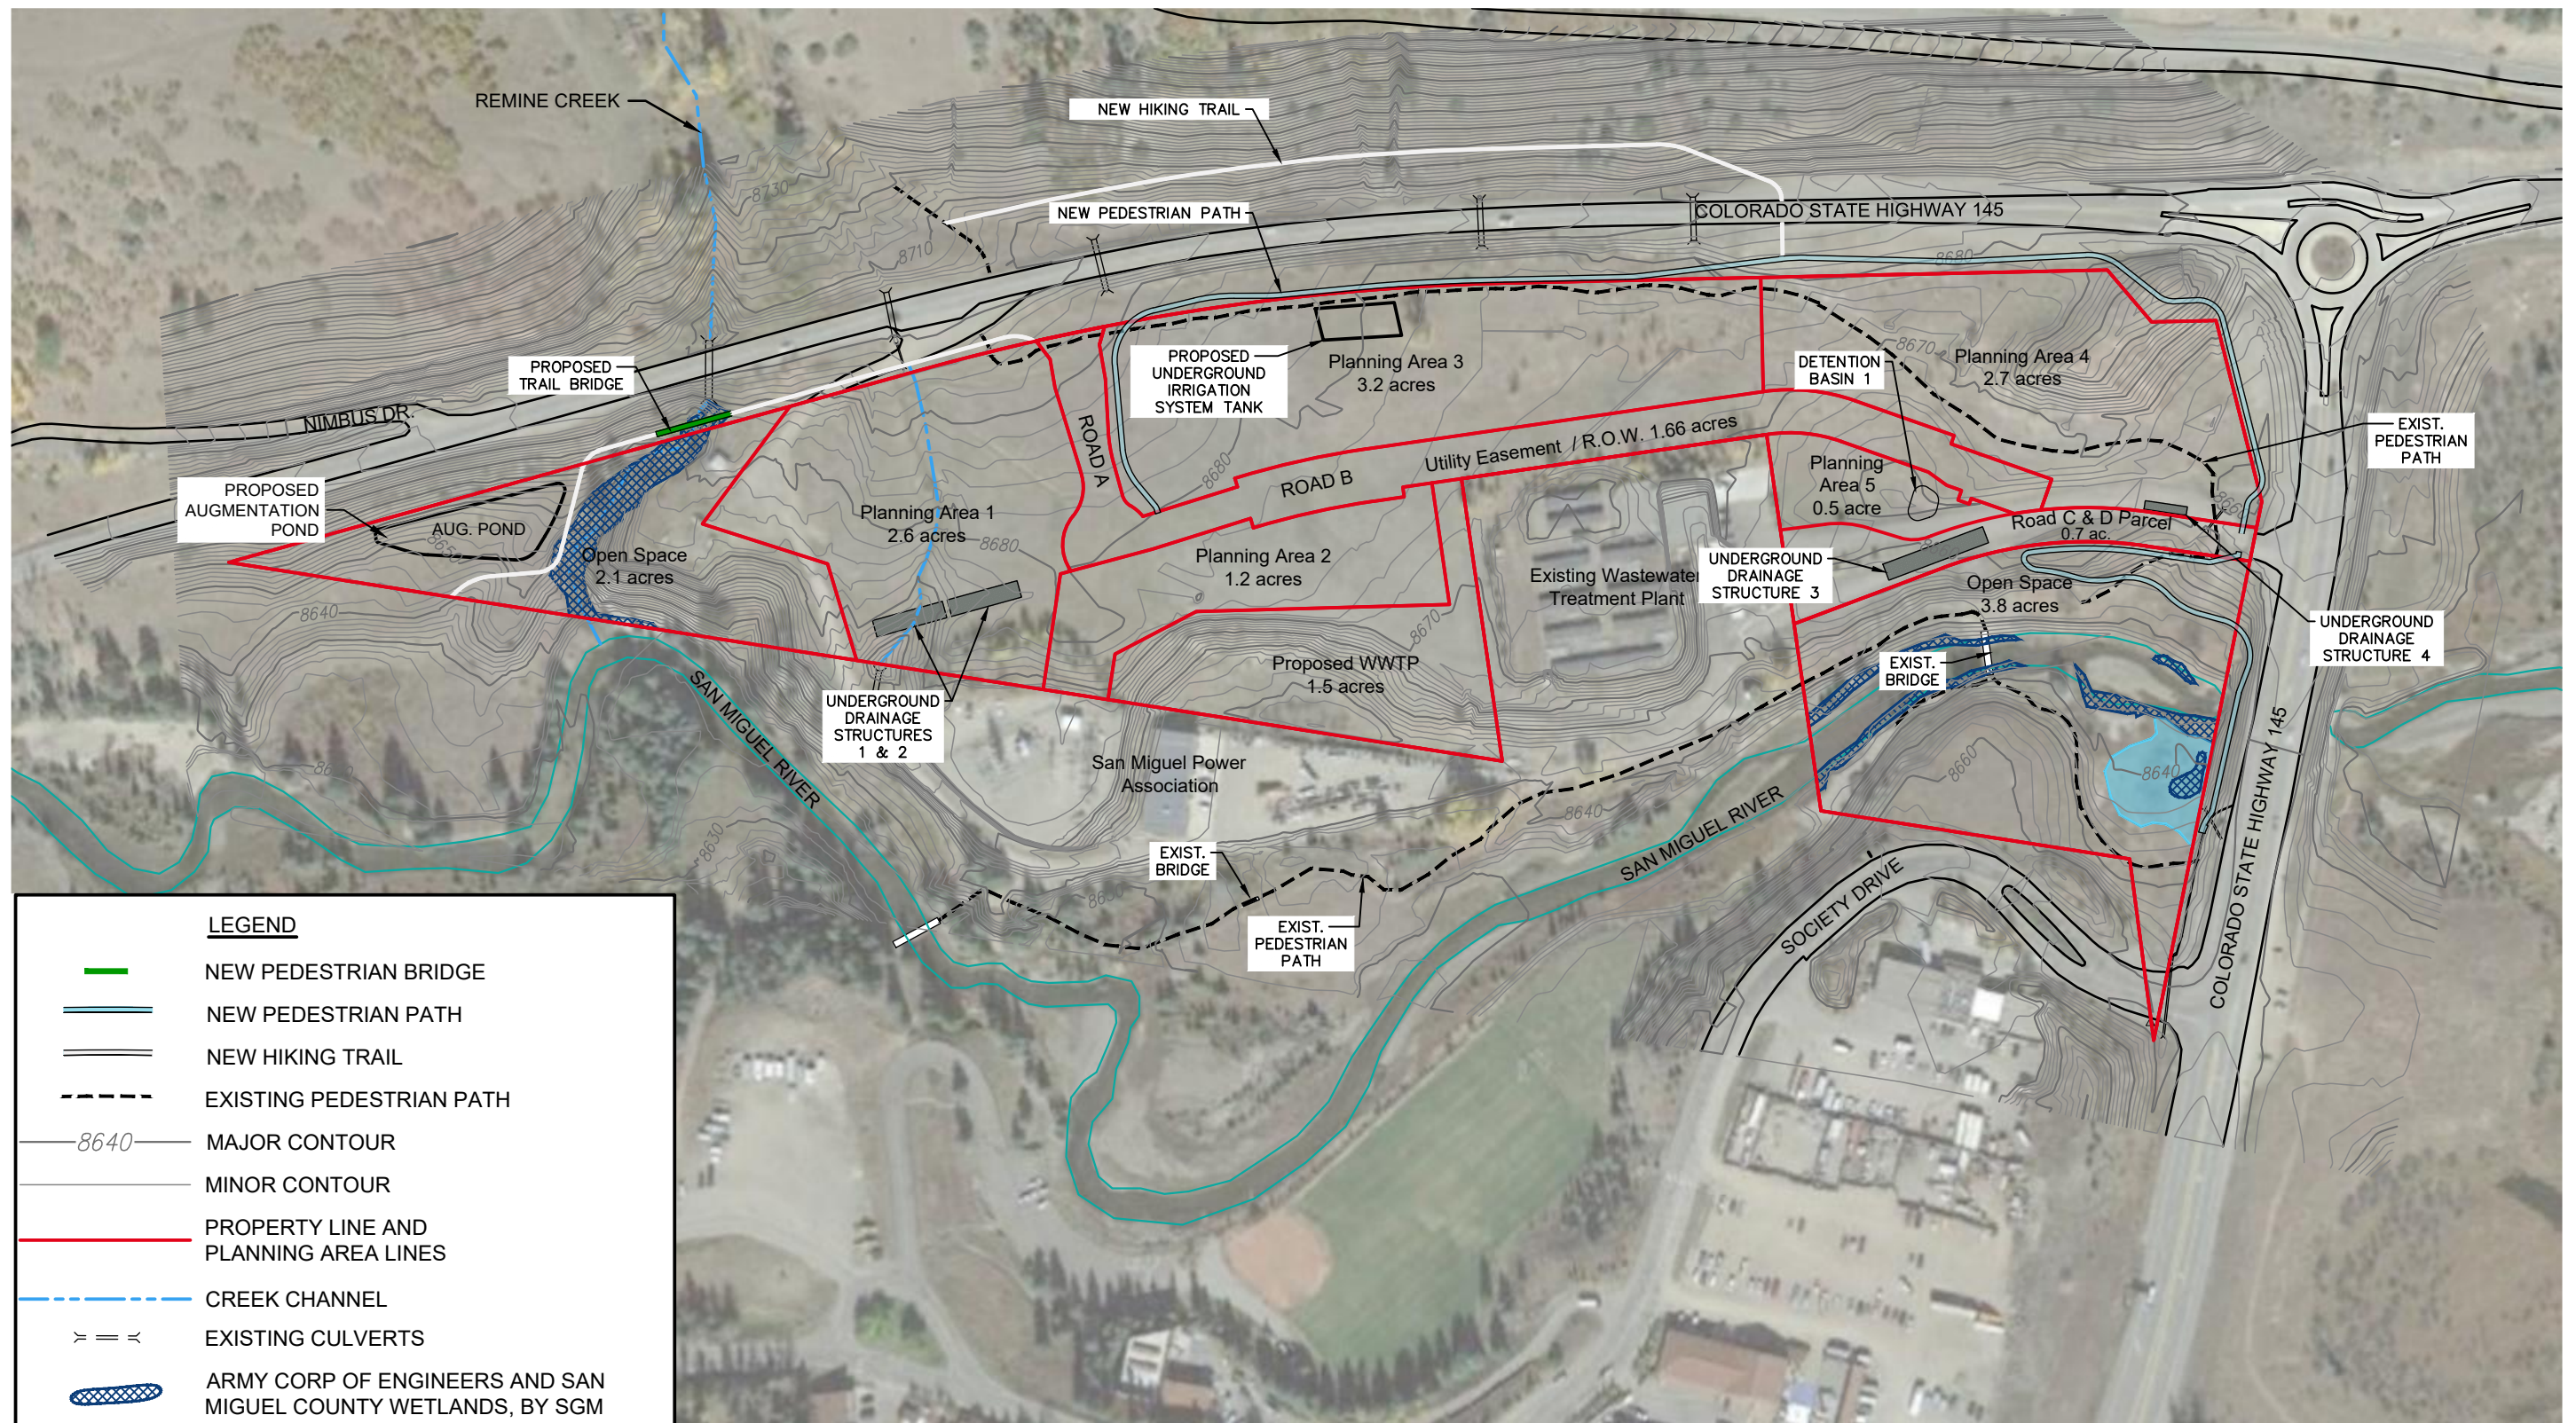
PROJECT	7122.74614.01
DATE	06/24/2020
MAP 2

As seen in Photo 1 and Map 2, there are several roads and facilities on or near the Society Turn Parcel. Black Hills Energy has a small gas facility to the west of an access road on the Society Turn Parcel's west end. San Miguel Power Association (SMPA)/Tri-State Generation and Transmission have a substation, building, parking and storage accessed by the same dirt road along the southern edge of the Society Turn Parcel and the Town of Telluride's Waste Water Treatment Plant (WWTP) is along the south-central edge of the Society Turn Parcel in a "cut-out" area of the Society Turn Parcel that is accessed from the east from Highway 145.

As seen in Photo 1 and on Map 2, there are some ditches that currently provide irrigation water from Remine Creek to the pastureland on PA1, PA2 and PA3. Photo 10 below shows the ditch that carries water seasonally onto PA1, which is then distributed throughout the pasture area for livestock grazing. There are no delineated wetlands associated with these water sources. These irrigation ditches will be relocated to easterly areas of the Society Turn Parcel, contemplated for future development phases, and ultimately eliminated as full development buildout occurs. By removing the irrigation ditches as part of the initial development of PA1, potential for water to enter the subsurface from this source will be eliminated. No shallow groundwater was encountered during our July geotechnical drilling investigation to depths of up to 26.5 feet on the property. The granular nature of the soils allows for good drainage of these soils except in topographically low areas adjacent to the San Miguel River and Remine Creek.

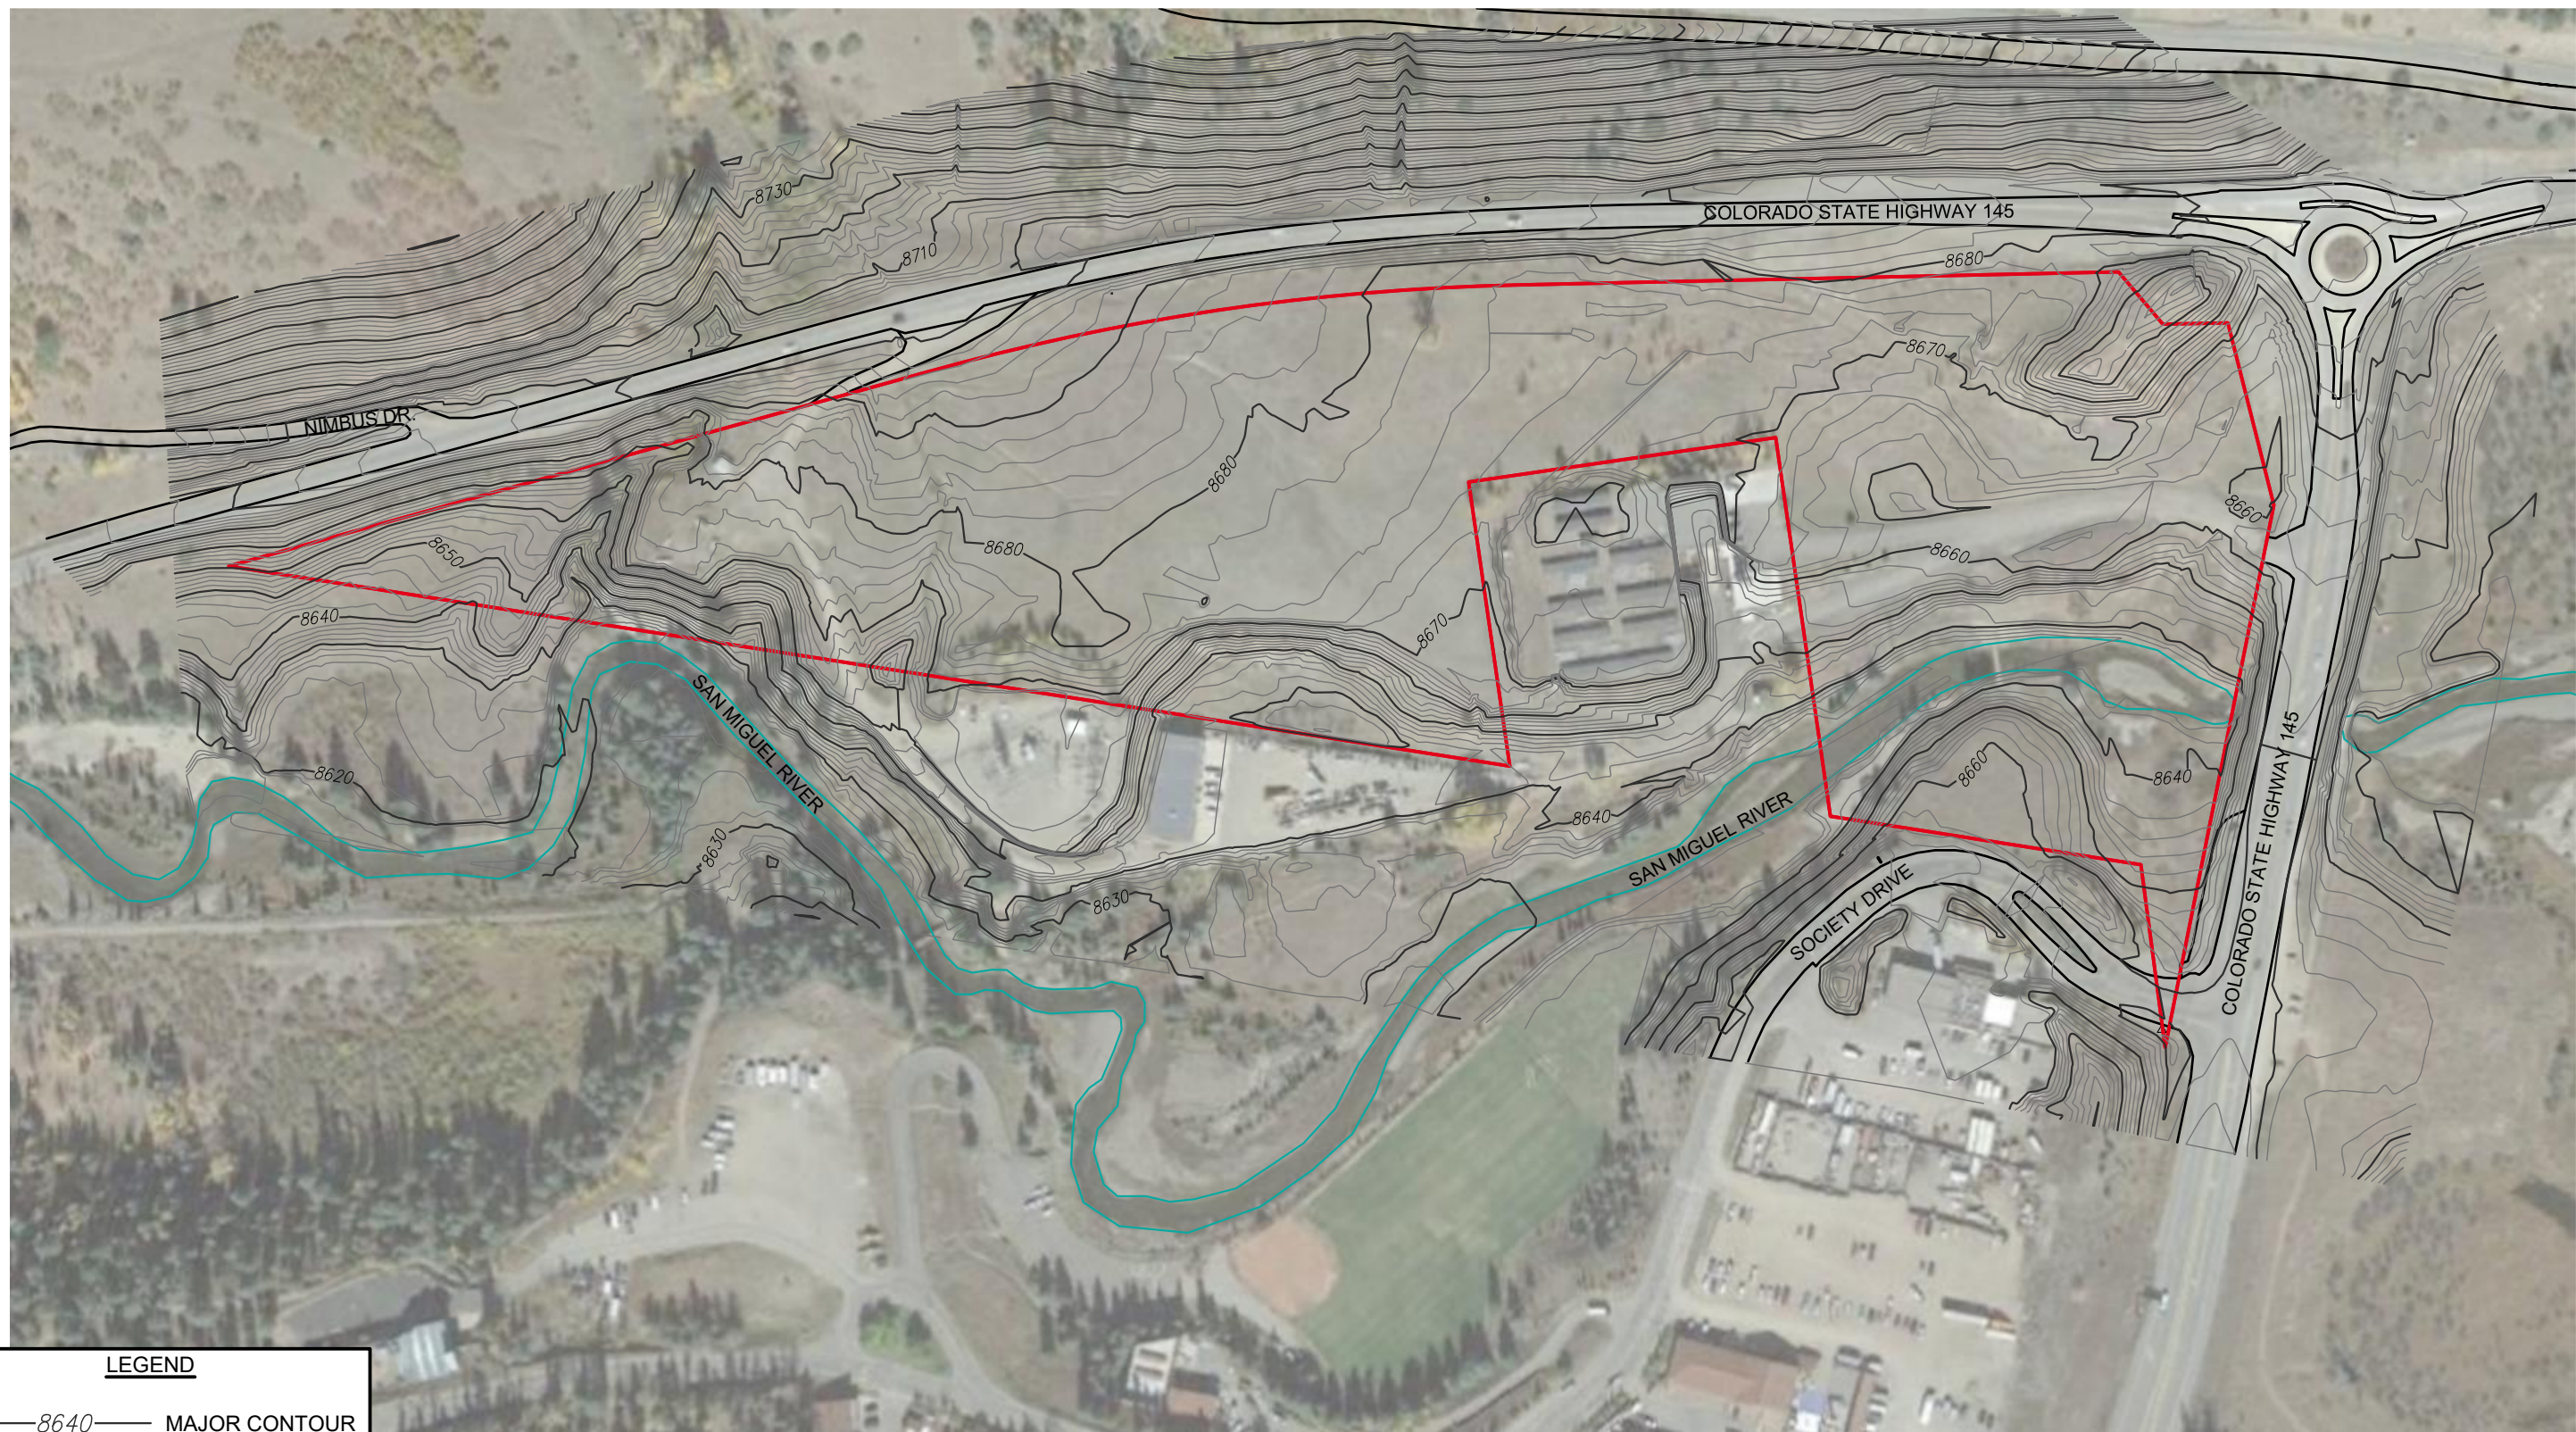
MAP 3

Elevations range from 8,632 feet along the San Miguel River to 8,698 feet in the northeast corner of the Society Turn Parcel. The topographic map (Map 3) was generated by Foley Associates Inc. in conjunction with Olympus Aerial Surveys in 2008. Slopes range from 0-10% in upland areas in the majority of the Society Turn Parcel to over 30% along the present banks of the San Miguel River, in abandoned cut banks in the meander scars of the San Miguel River, along Remine Creek, and on a glacial moraine remnant in the northeast corner of the property (see Slope Classes, Map 6). There are five culverts that pass under Highway 145 and drain onto the property, shown on Map 2. In addition to the natural drainages of the San Miguel River and Remine Creek which cross portions of the Society Turn Parcel, there are three irrigation ditches in the western portion of the property that are seen on the aerial image of Photo 1 below.

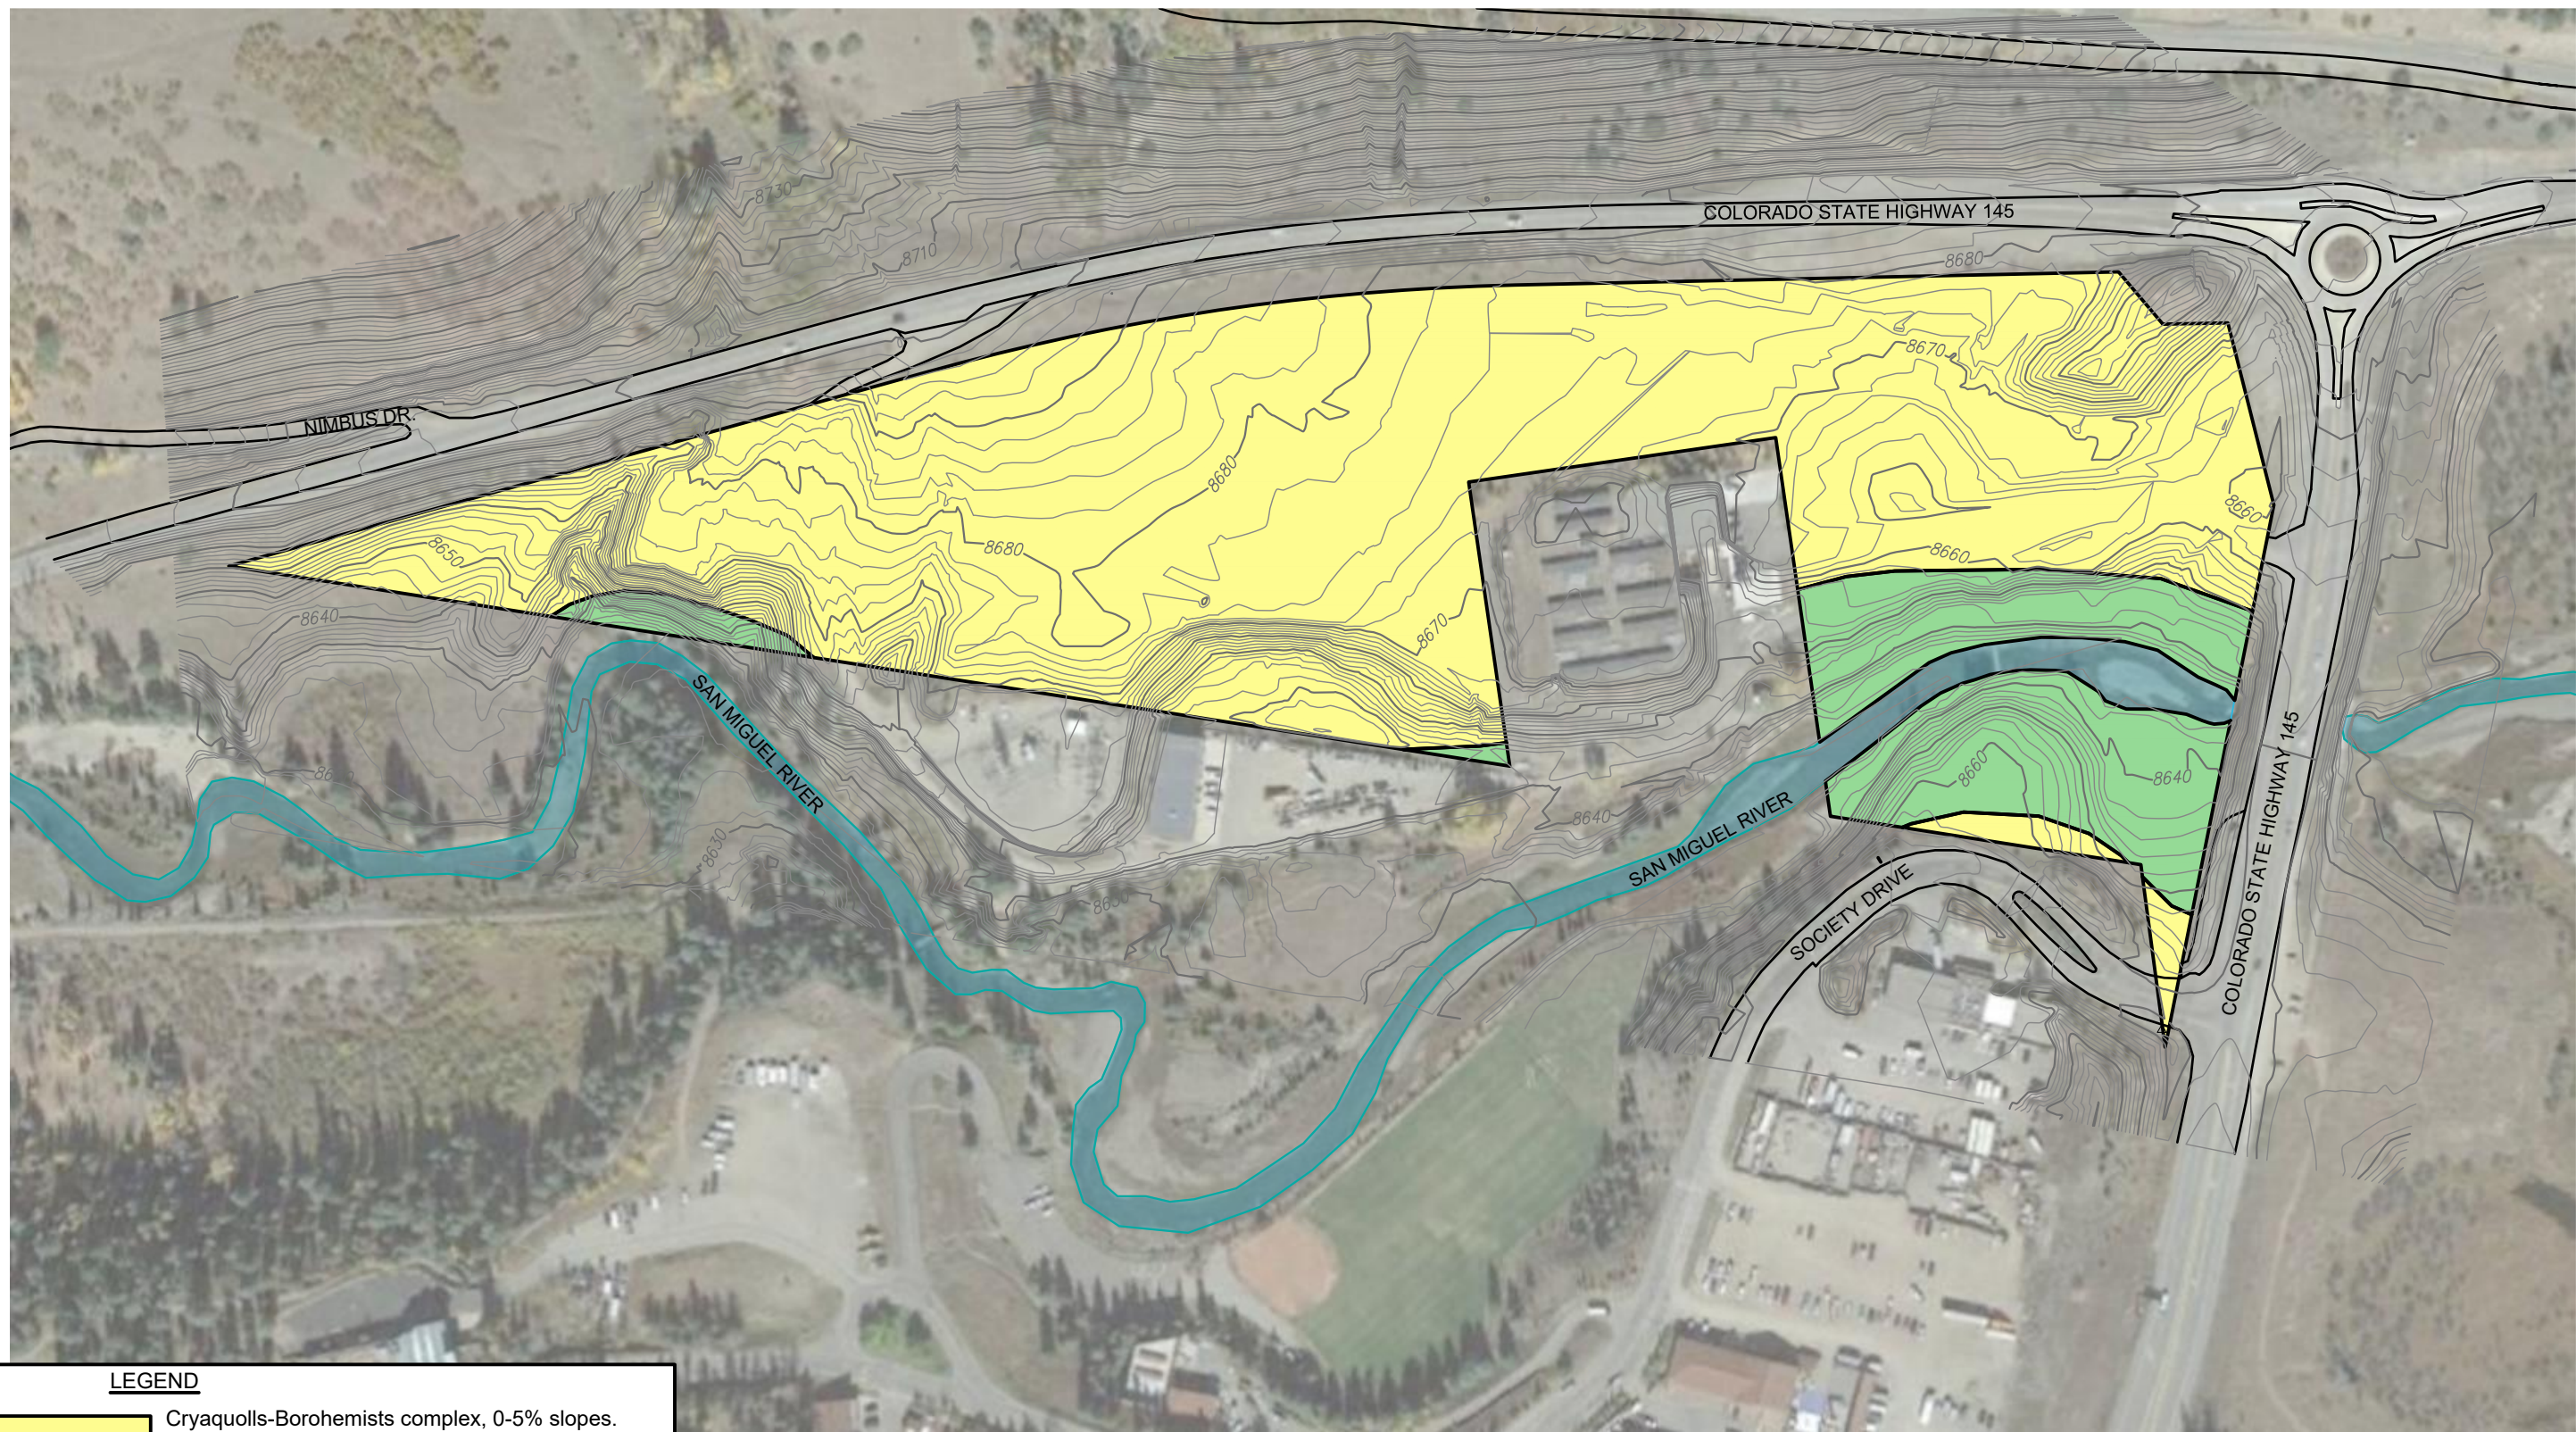
MAP 5

These soils have similar textures and composition but are on different landforms and/or slopes. Most of the Society Turn Parcel is located on Cryaquolls-Borochemists complex with gentle slopes. Most of the steeper slopes of the Cryoborolls-Cryaquolls complex are found along the steep banks of the San Miguel River and on glacial moraine deposits. These areas were avoided for development and most are planned for open space use. A portion of Planning Area 5 and Planning Area 6 also contain the Cryoborolls-Cryaquolls soils, as they form on stream terraces.

According to the Web Soil Survey (WSS), shrink-swell potential is low, soil materials are predominately granular, and these soils are somewhat erodible due to low cohesion. According to the engineering properties tables offered in the WWS, both these soils classify as sandy to clayey gravels, gravelly sandy clay loams, silt loams, and sandy clay (Unified Soil Classification: GC-GM-GW-GP, ML, and SC). Limitations to roads, shallow excavations, and dwellings are primarily flooding and depth to saturated zone, and secondarily, potential for frost action and cutbank caving.

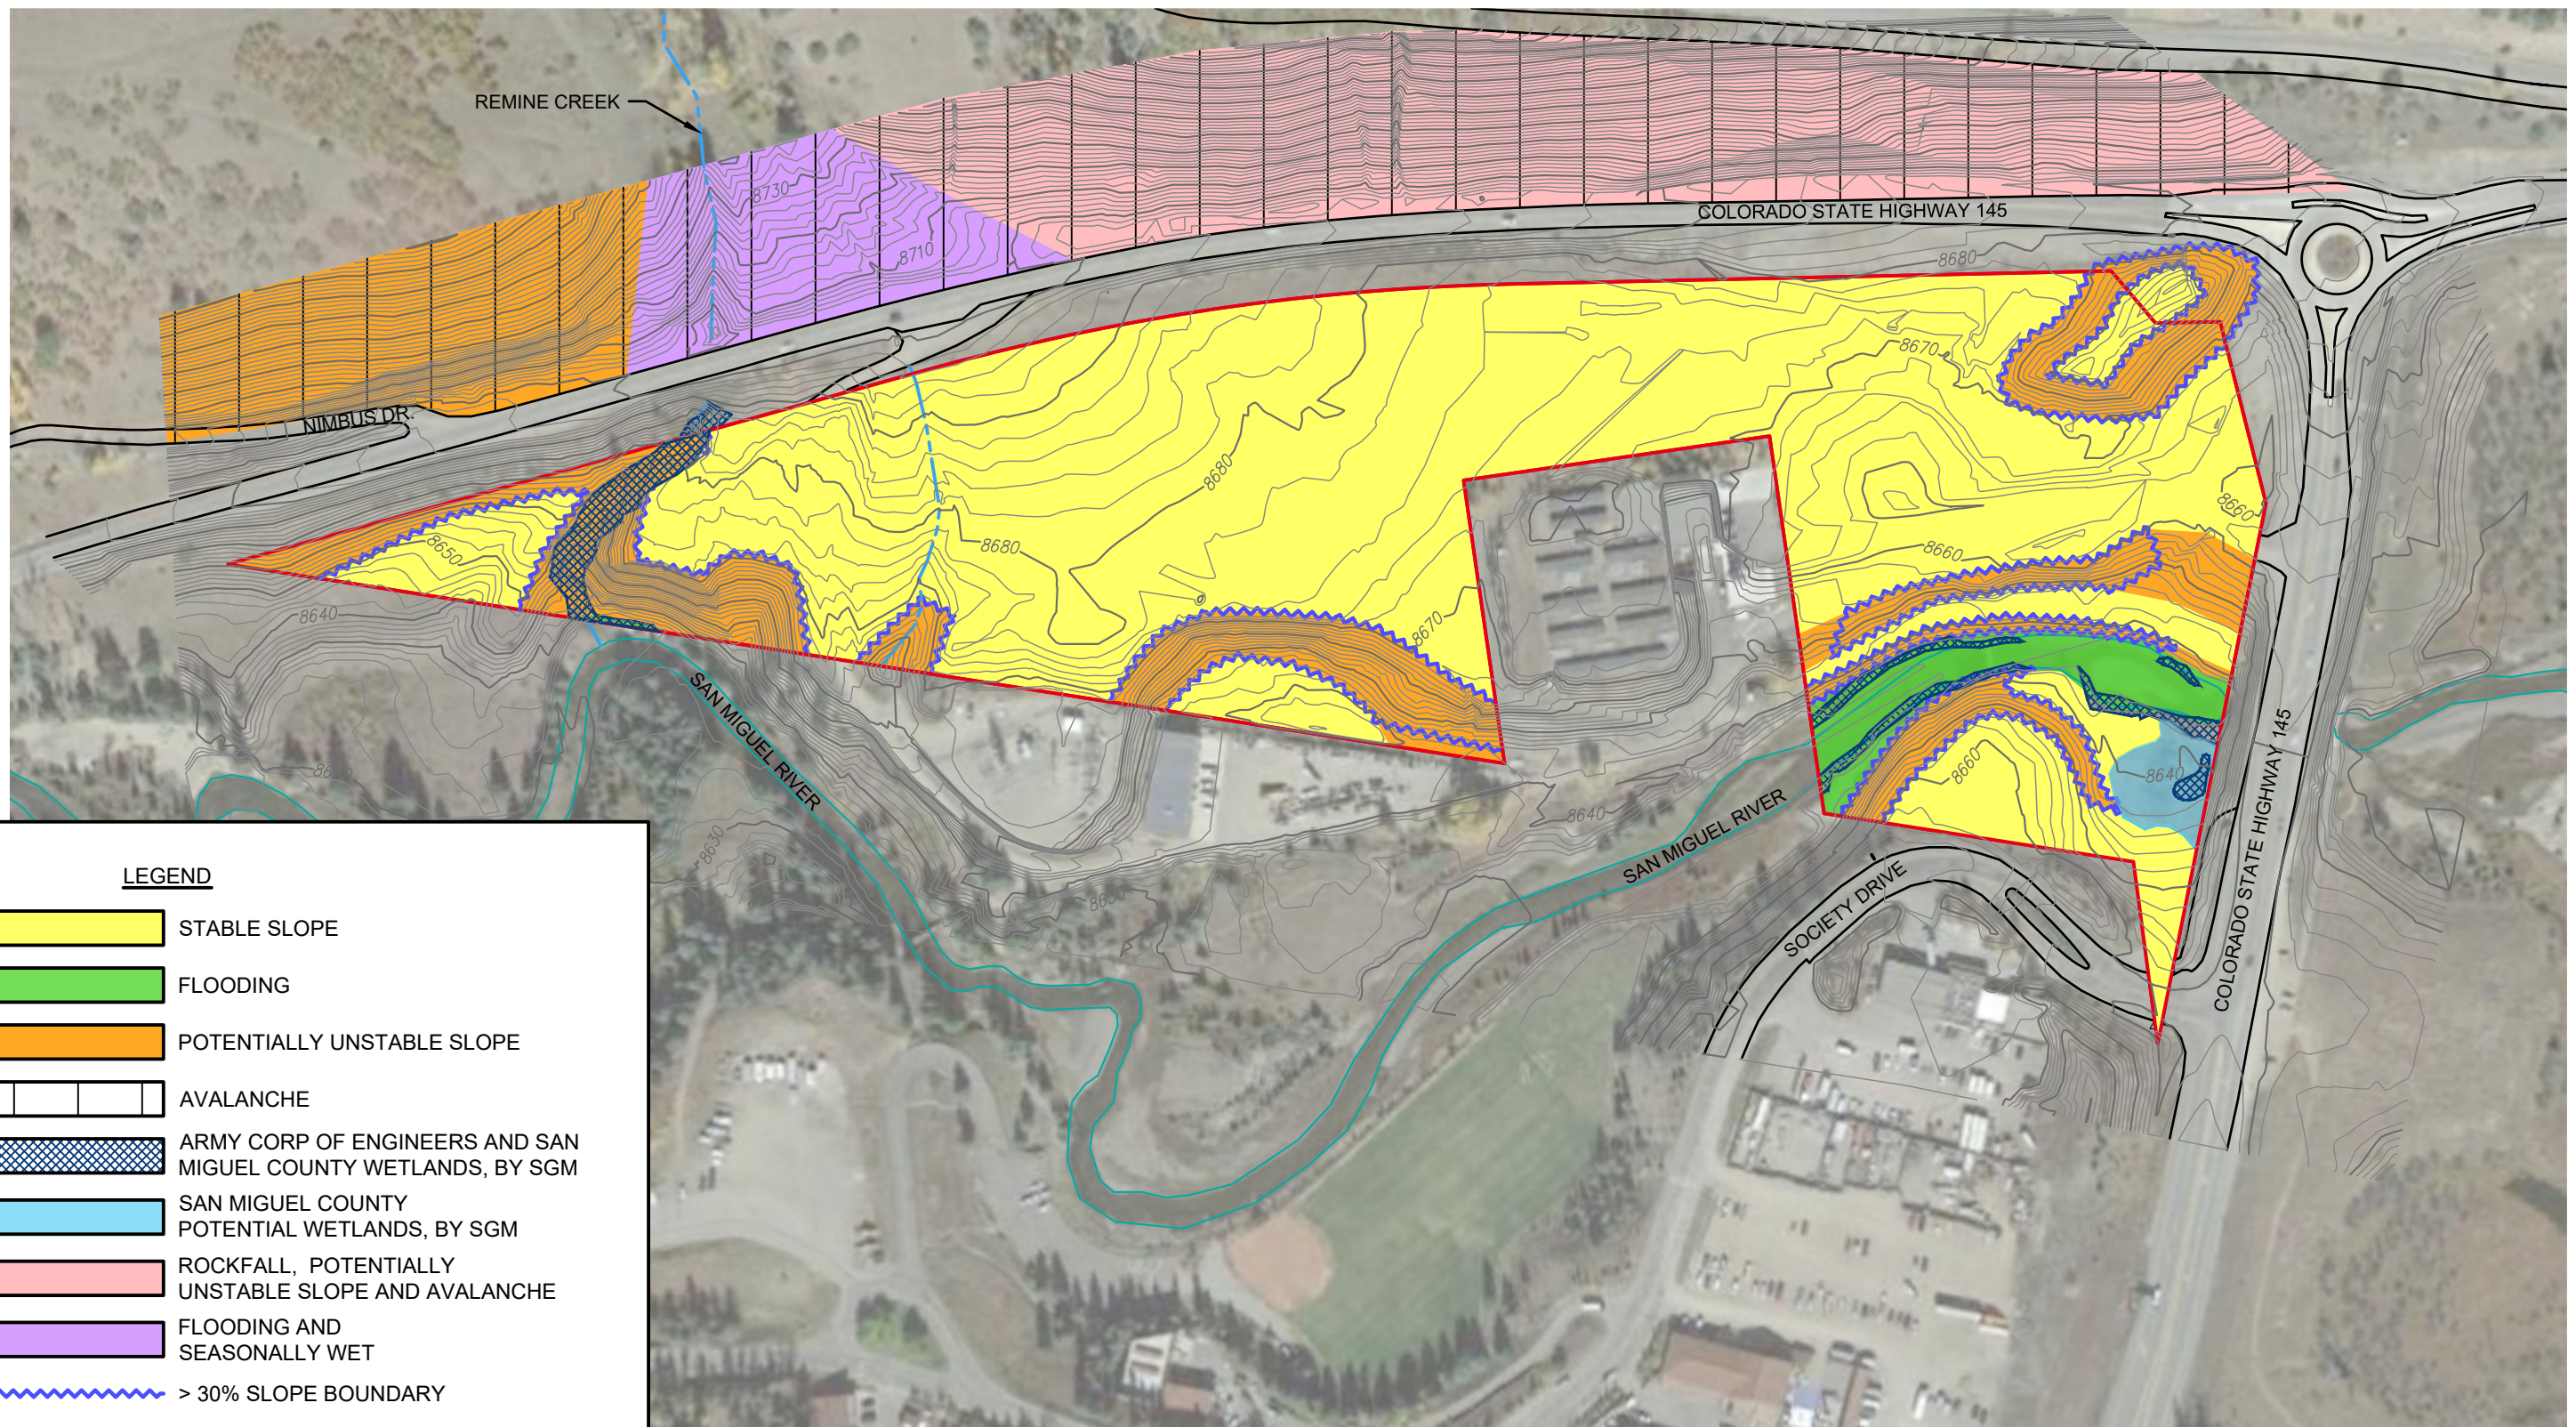
MAP 8

Most of the Society Turn Parcel was identified as “stable slopes,” indicating that these areas have gentle terrain that are considered stable, with minimal potential for the presence of geologic hazards. These relevant hazard categories are presented on Maps 8 and 9 for the Society Turn Parcel. The following is a discussion of all geologic hazards required to be evaluated on the Society Turn Parcel.

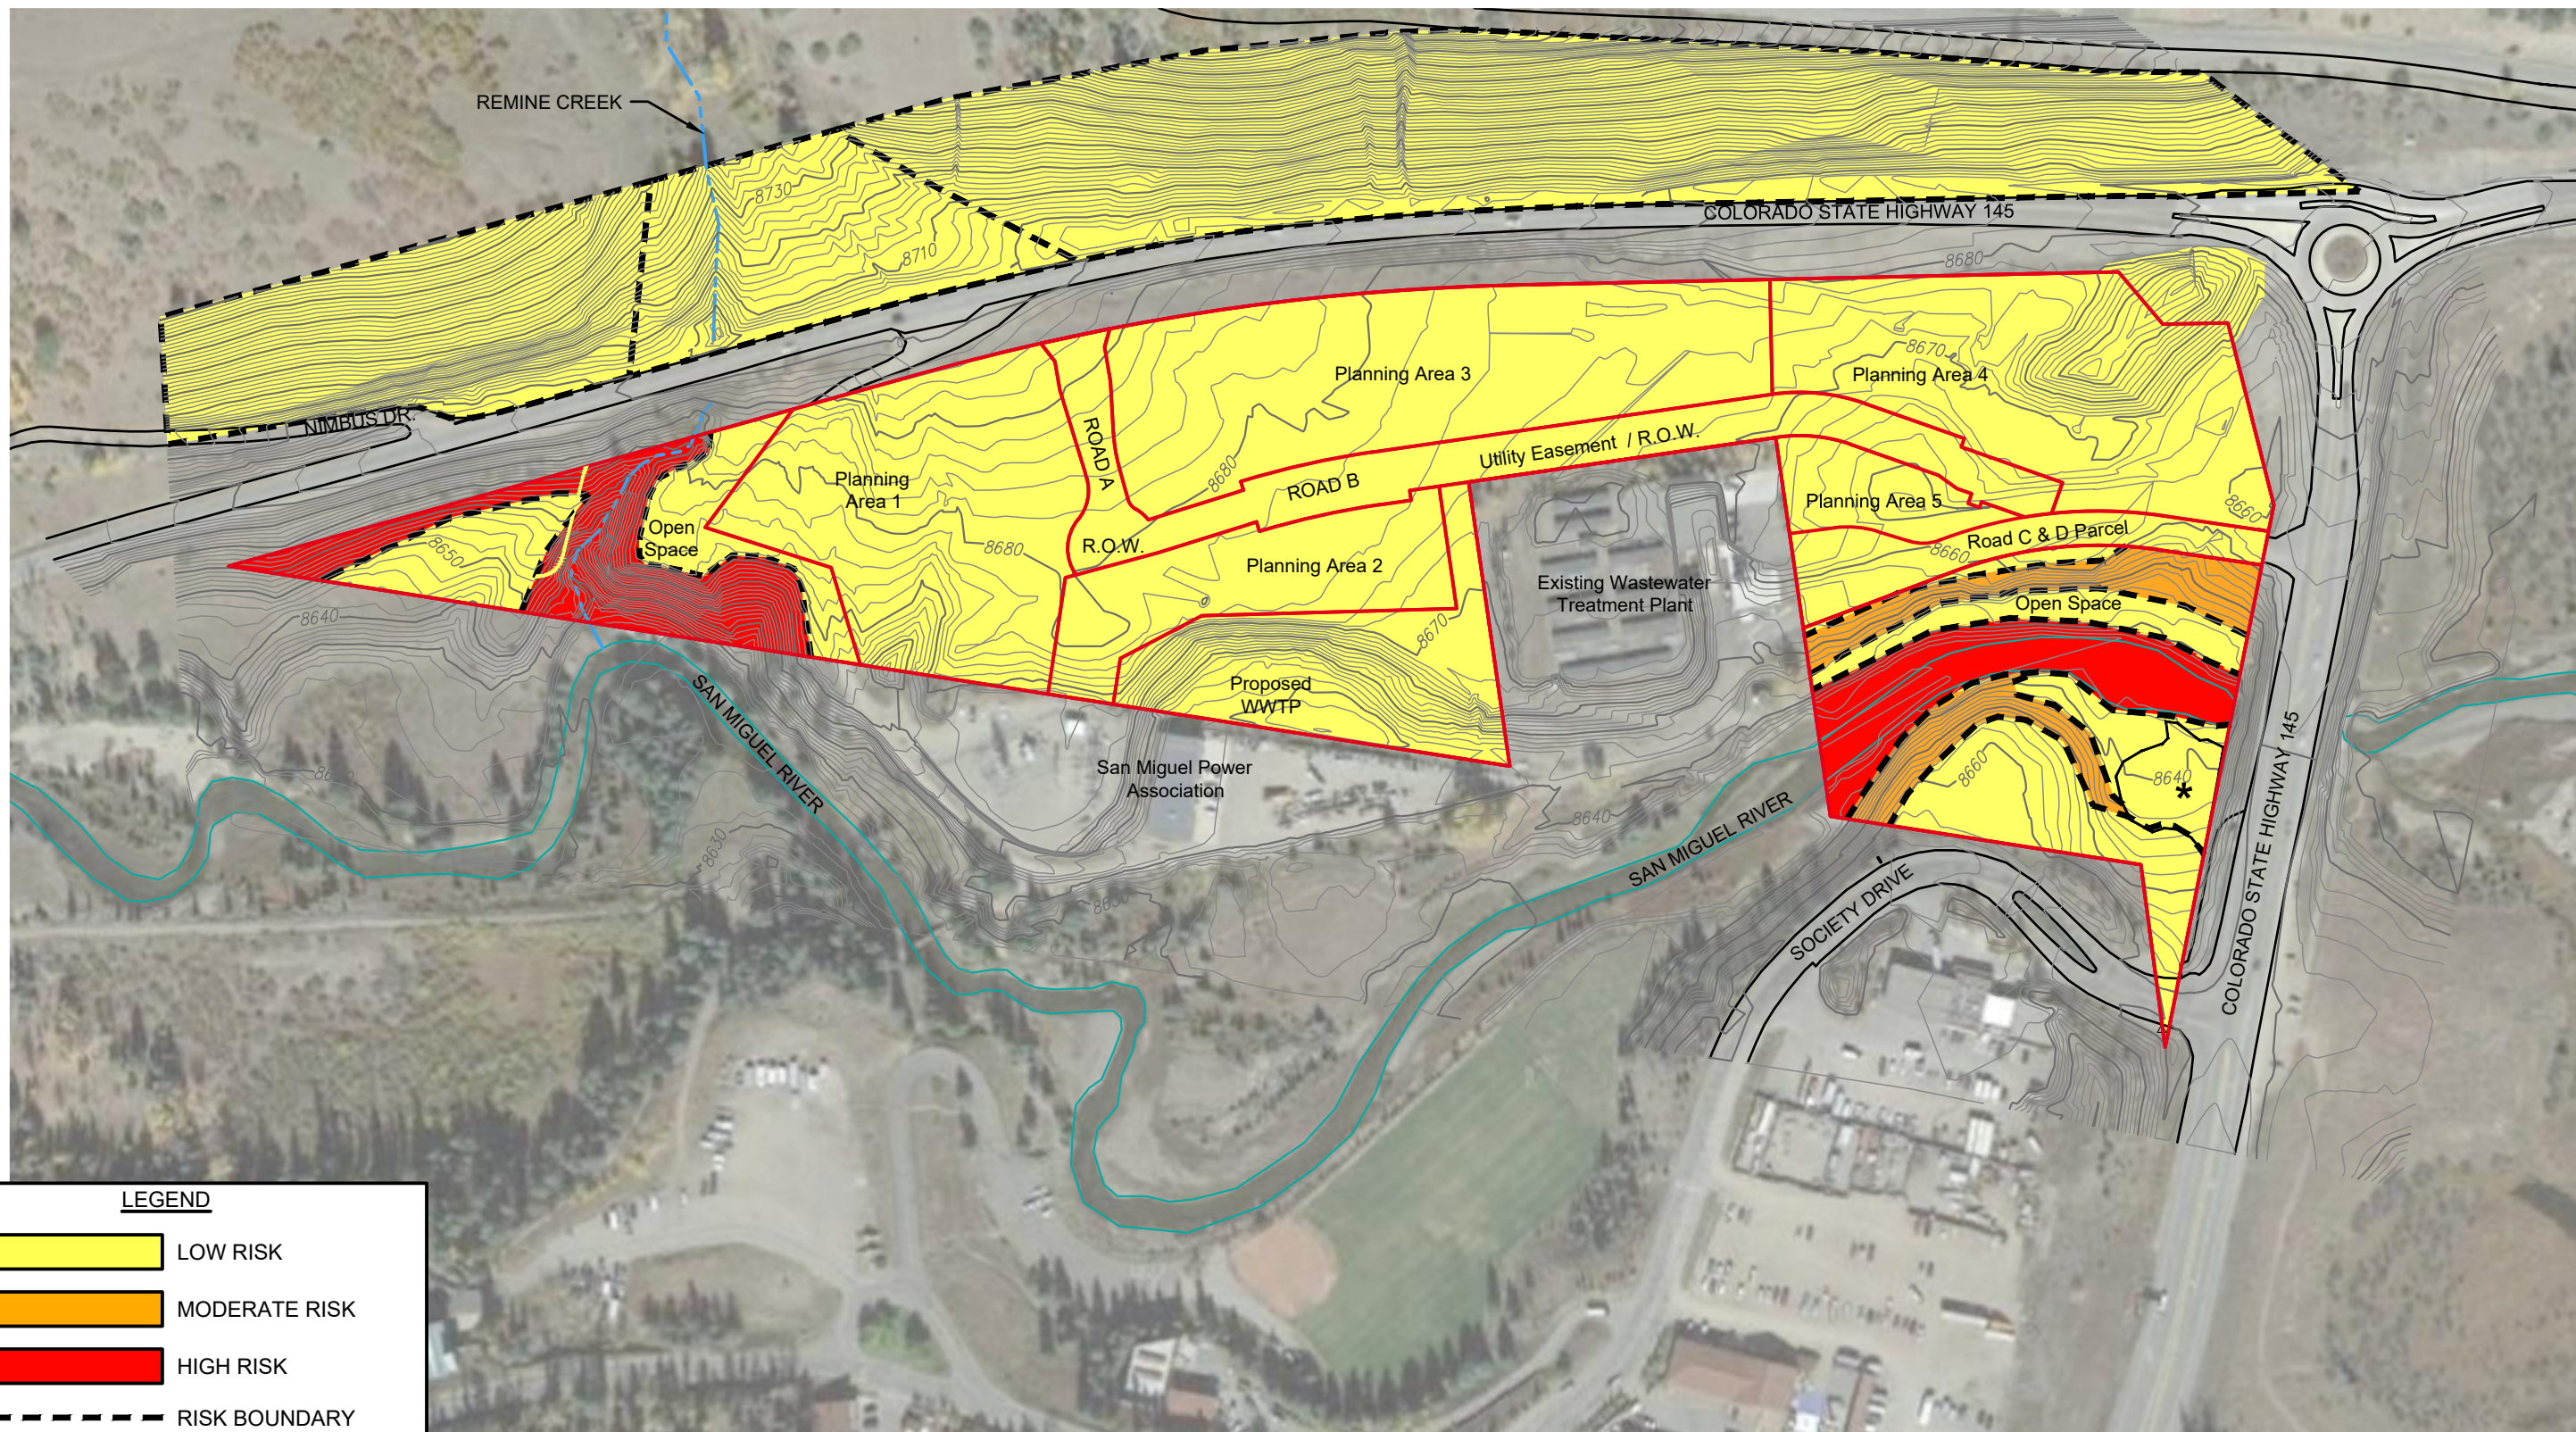
MAP 10

* Further study of the surface and subsurface hydraulics of this area would be necessary to determine drainage options which could reduce groundwater hazard in this area to low risk.
