**Subject: Society Turn Parcel**

**RE: Geohazard Report**

**GEOLOGIC HAZARDS ASSESSMENT**

**February 4, 2020**

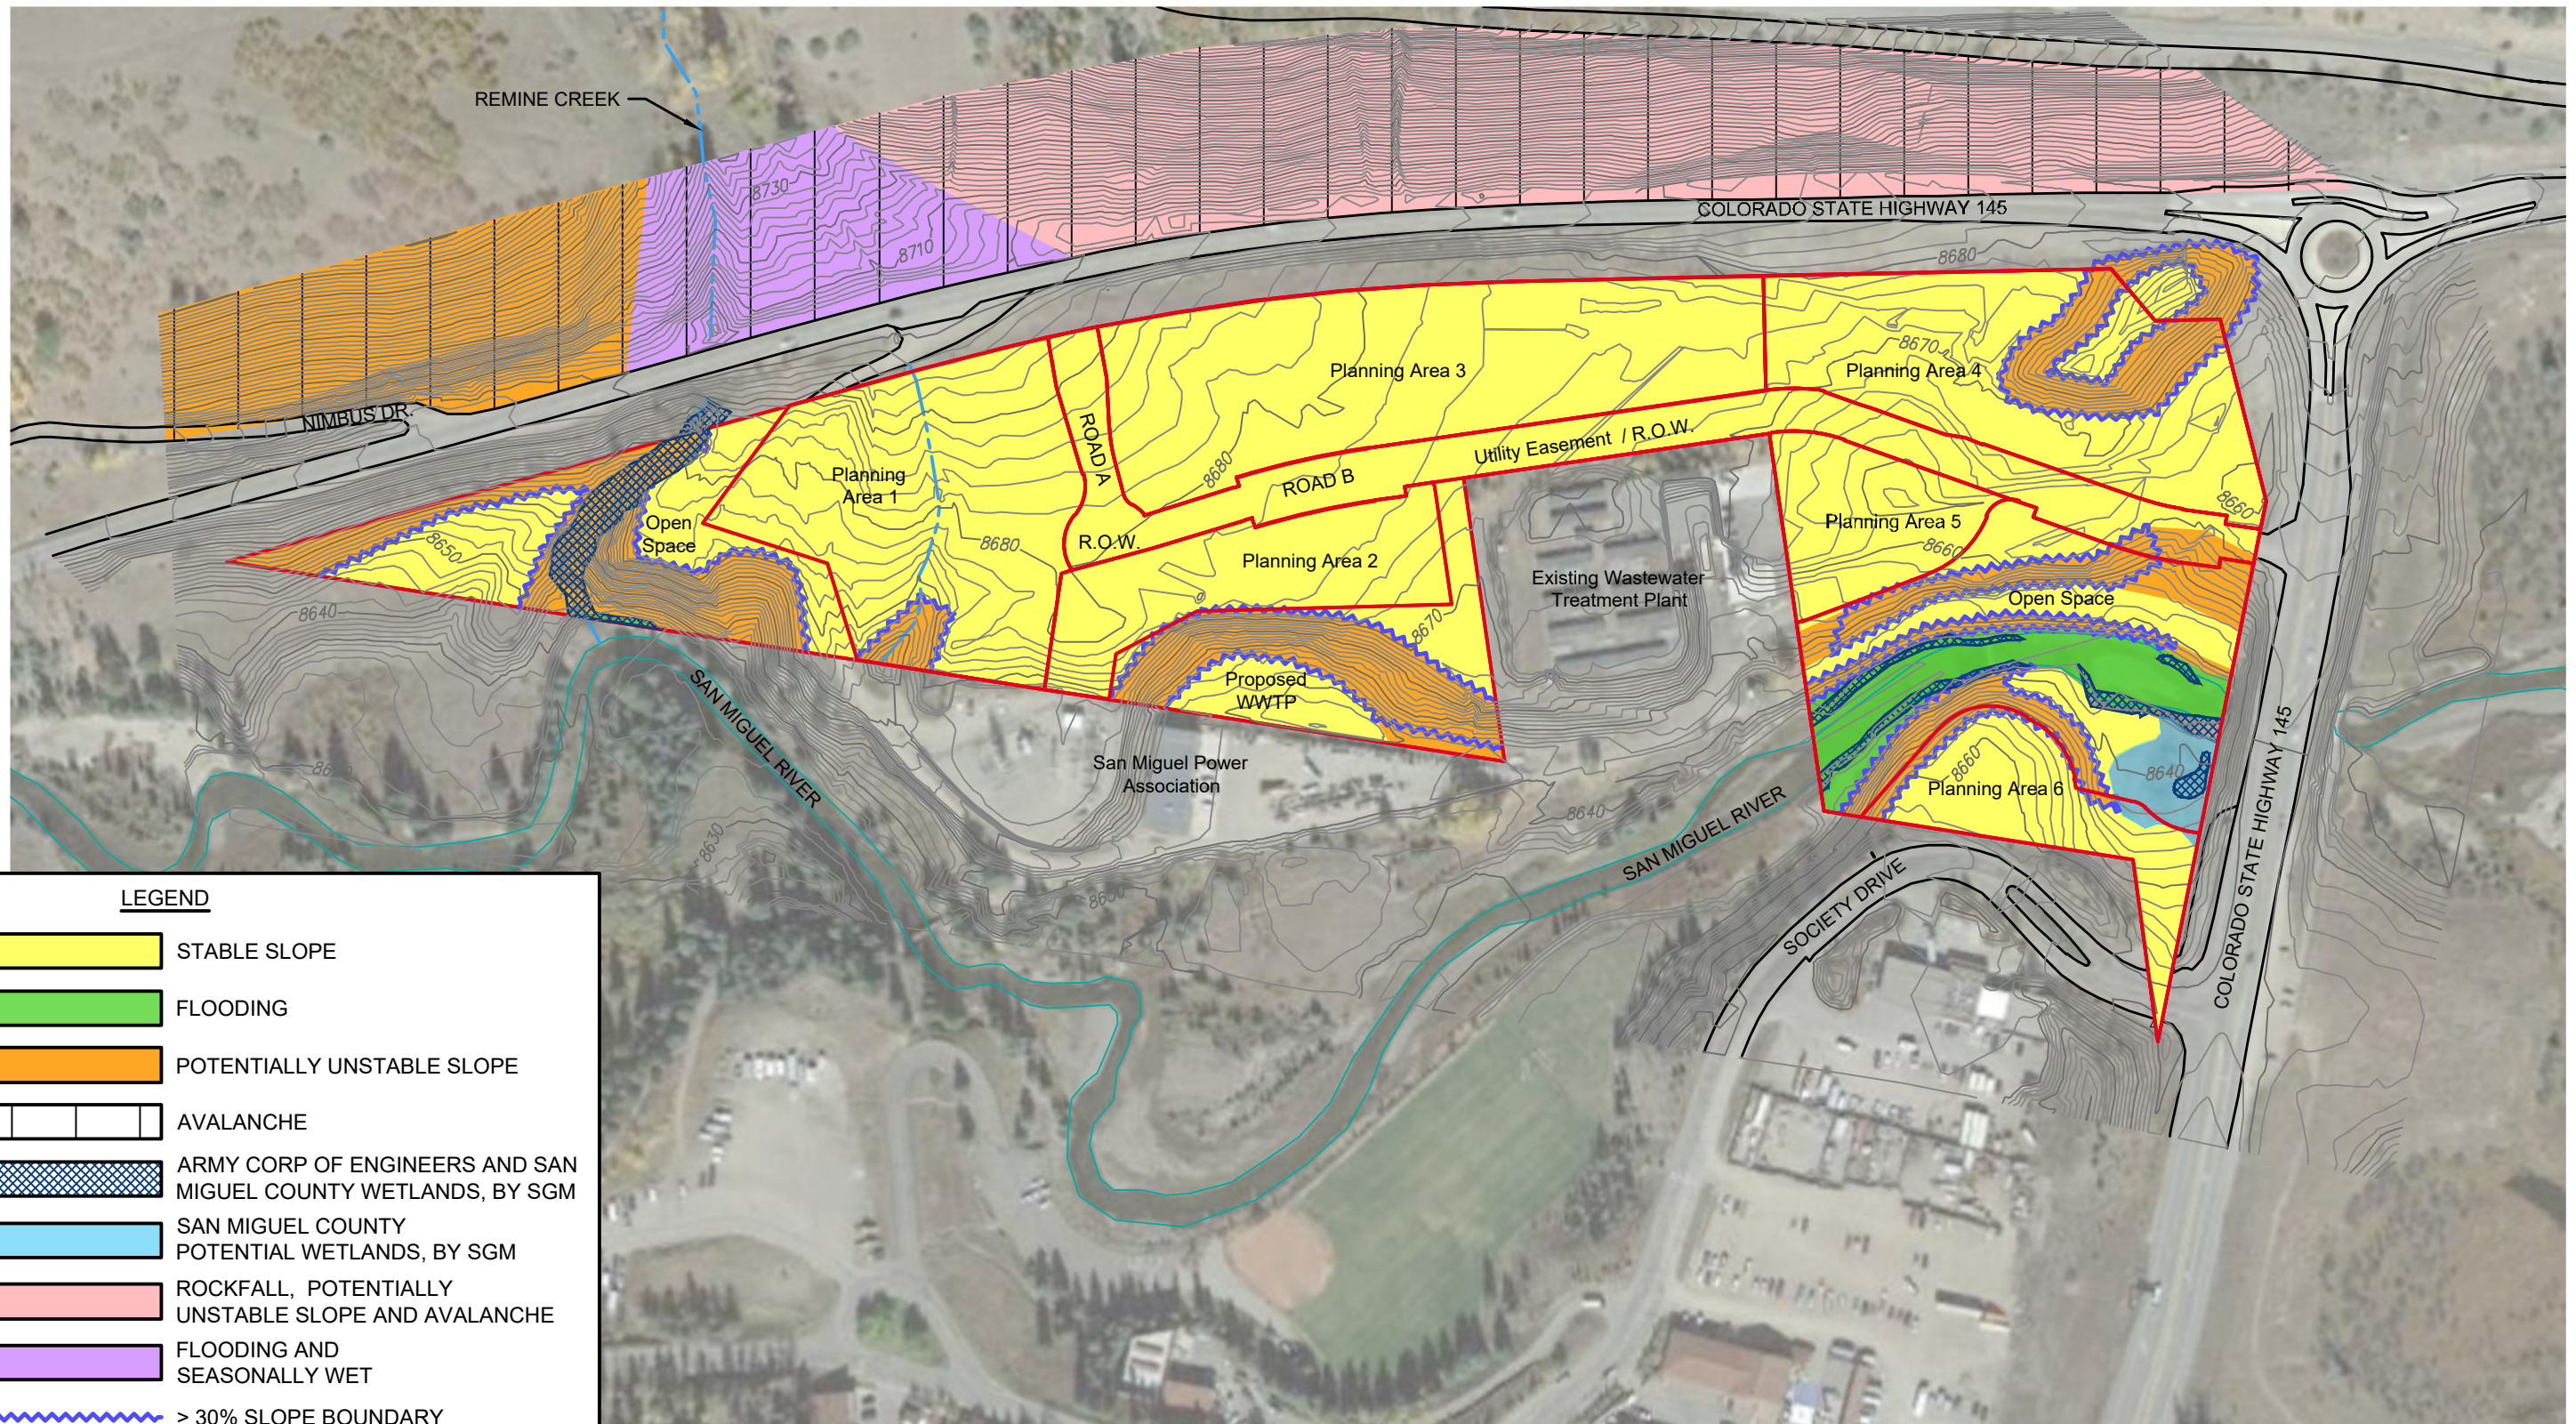
MAP 8

Potentially unstable slope and slopes >30% generally lie on the steep slopes along the western and southern edges of the Society Turn Parcel associated with former or present channels of the San Miguel River and Remine Creek. Hazards relating to potential slope movement can be mitigated by avoiding these slopes, allowing for proper set-backs, and for providing site-specific shoring, where needed. Most of the Society Turn Parcel is mapped as "stable" with low risk of geologic hazards, while the small areas with moderate to high risk can be either completely avoided or can be reduced to low risk by implementing mitigation measures recommended herein during the PUD design process.
