Project	Example End Lane 80,82
Client Name	Example Client– Example Construction
Site Address	80,82 Example Lane, EX6 2LX
Date of Survey	23.02.26
Surveyor	Paul Connolly
In Attendance	Example C (Contractor). Example M (Manufacturer)
Equipment	Camera, Drill, Borescope, Core sample kit
Scope of Work	Intrusive survey of roofs to property no's 80 & 82. Visual survey 82e
Weather	Dry, overcast

1.0 Overview

3.0 Core Sample Findings

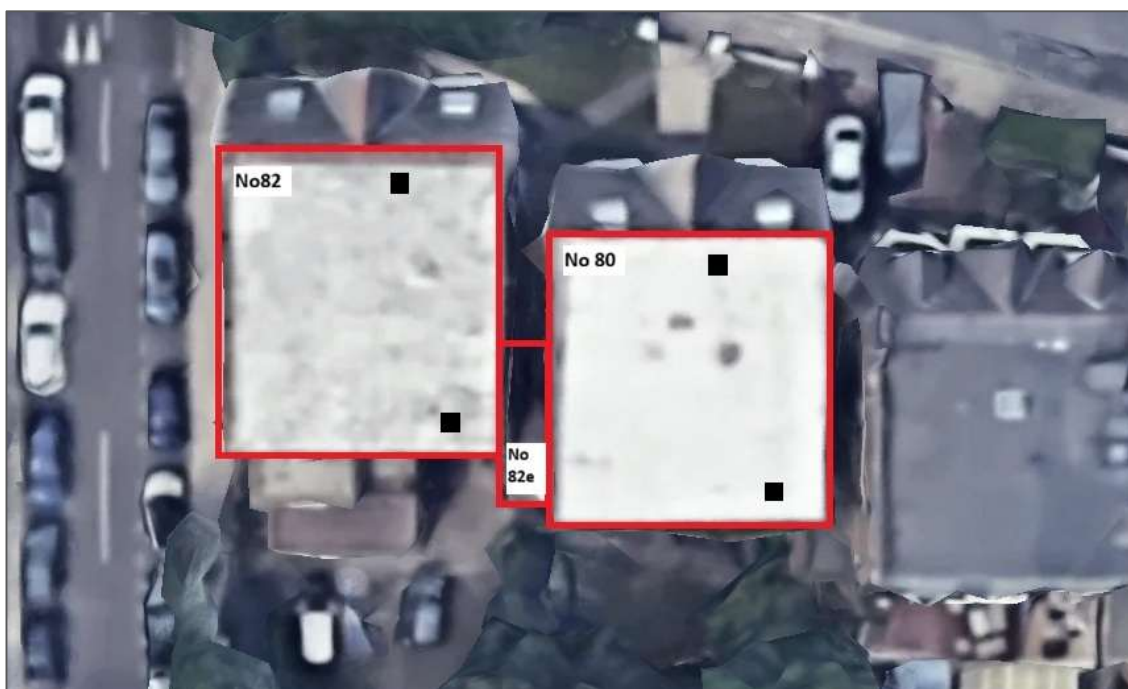
Aerial View

Approximate core sample locations

Two core samples were taken at a high and low point of the roof (refer to aerial view). The waterproofing was exposed, the deck and void below was inspected with a borescope.

Two core samples were taken at a high and low point of the roof (refer to aerial view). The waterproofing was exposed and the deck below was inspected with a borescope.
