## Condition Report – Example, Address, GU50

### 1.0 Overview

This report has been prepared exclusively for Example client to support the refurbishment of the specified roof areas at the aforementioned property. It is based on our site inspection of Example project conducted on 6<sup>th</sup> October 2025, and should be read in conjunction with the enclosed photographs.

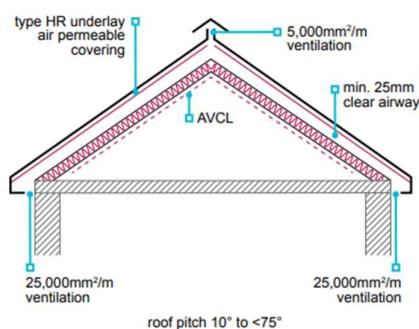
Figure 48: Warm roof

The building features multiple pitched roof sections. Given the absence of vents or their specific placement within these sections, it is reasonable to conclude that the roofs adopt a cold roof construction, representative of the configuration illustrated in the accompanying image (inclusive of insulation, where applicable).

Should a detailed thermal performance assessment be necessary, we recommend consulting a specialised roofing system provider, such as Marley, to verify that the roof assemblies conform to Part L (Conservation of Fuel and Power) of the Building Regulations, as well as the requirements outlined in BS 5250:2021, Code of Practice for the Management of Moisture in Buildings.

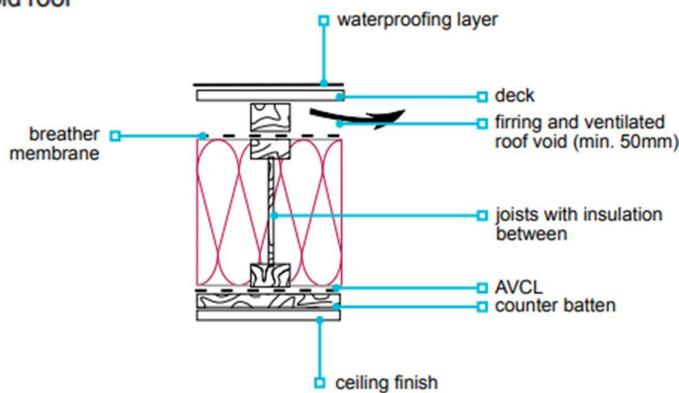
No ventilation was observed across the flat roof areas, indicating that these roofs employ a warm roof construction, as depicted in the accompanying image.

Should a detailed thermal performance assessment be necessary, we recommend consulting a specialised roofing system provider, such as Langley Waterproofing, to verify that the roof assemblies conform to Part L (Conservation of Fuel and Power) of the Building Regulations, as well as the requirements outlined in BS 5250:2021, Code of Practice for the Management of Moisture in Buildings.

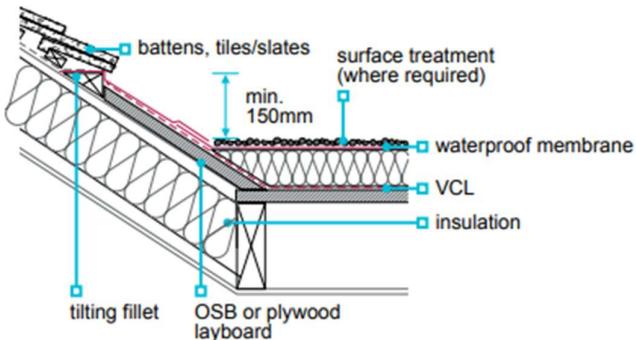
Figure 36: Pitched roof abutment

The kerb at the junction between the flat & pitched roof should have an upstand of at least 150mm as indicated on the drawing below. This could be a possible route for water ingress which has been identified directly below this detail.
